# Briles Stream Restoration Monitoring Report Year 2 of 5 (2010)

Randolph County, North Carolina

Project ID No. 047

Submitted November 2010

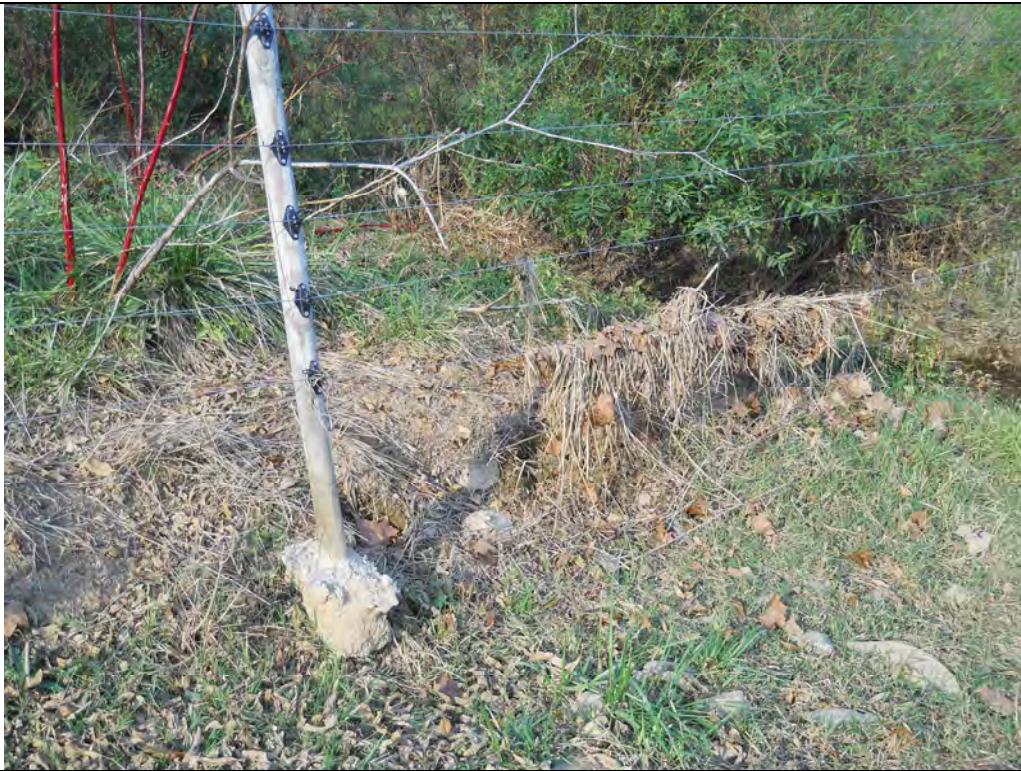
A visual assessment and geomorphic survey were completed for the site, and indicated that the project reaches were performing within established success criteria ranges as shown below. No significant bank erosion was recorded, and the geomorphic measurements are within the range of the design parameters. The fence that borders the ford crossing on reach UTJC1 was observed to have erosion around the base of the fence posts, and appears to have been subjected to high flood waters (see SP1).

SP1: Fence damage at UTJC1 with rack line  
Taken On: 2010

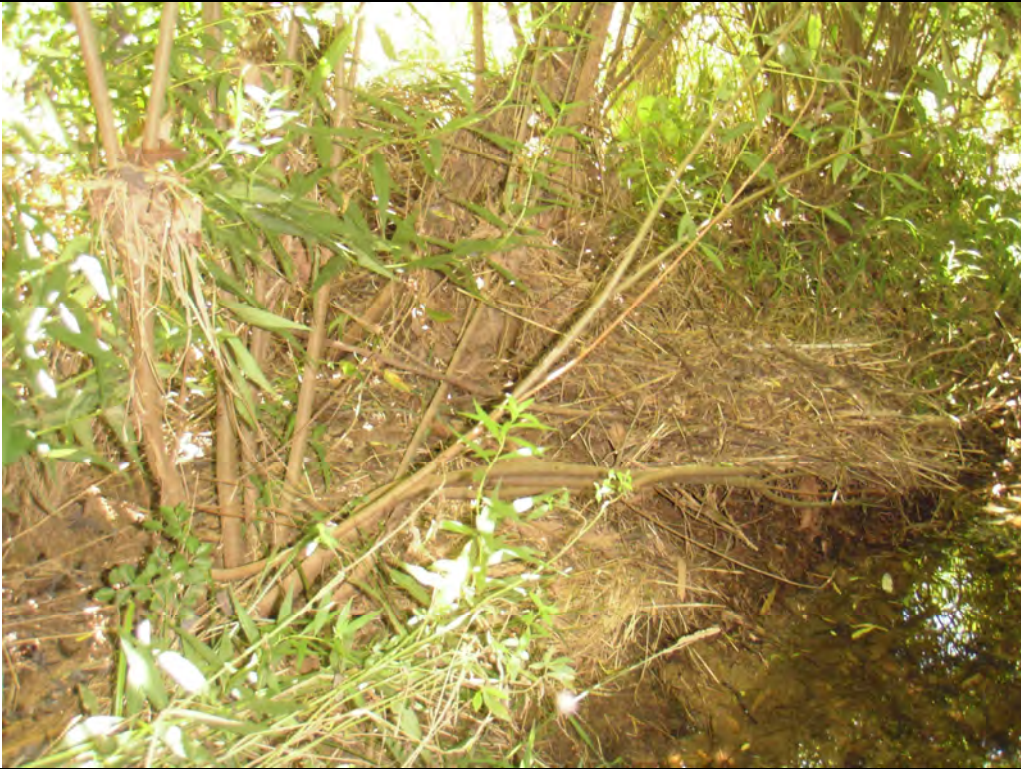
SP2: Observed rack line approximately at Design Bankfull elevation  
Taken On: 2010

Date of Data Collection	Date of Occurrence	Method	Photo # (if available)
7/6/2011	N/A	Rack lines observed along channel bank	SP2

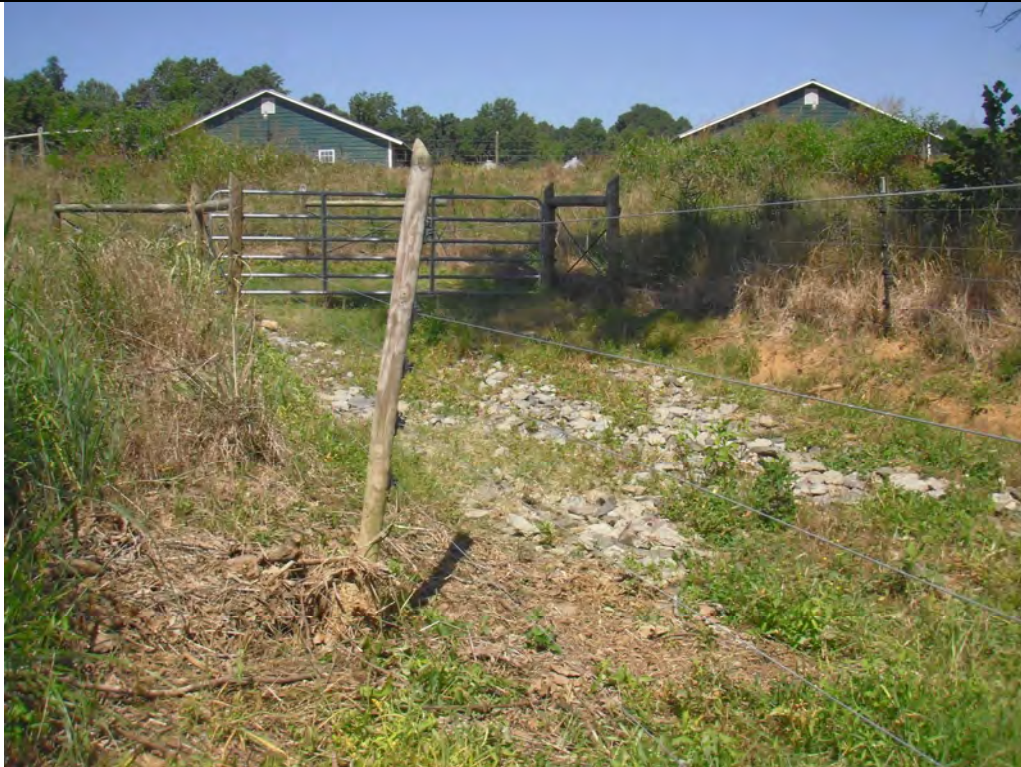
SP3: Rack line along ford crossing approximately above Design Bankfull elevation  
Taken On: 2010

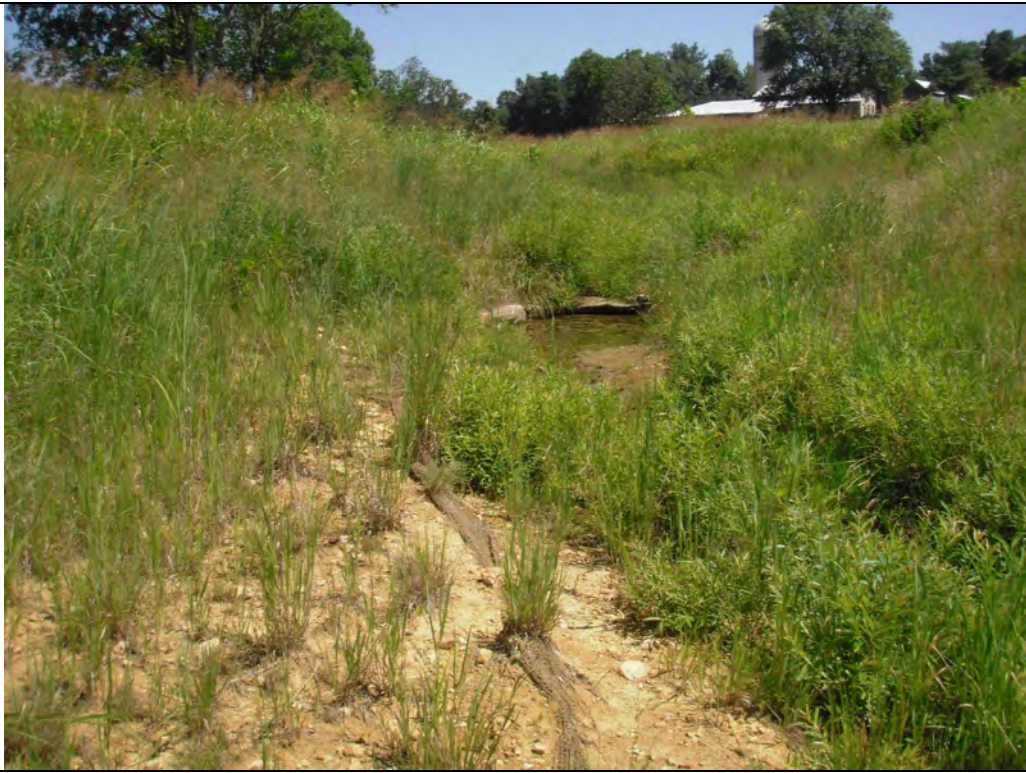
SP5: Bank scour on UTJC1  
Taken On: 2010

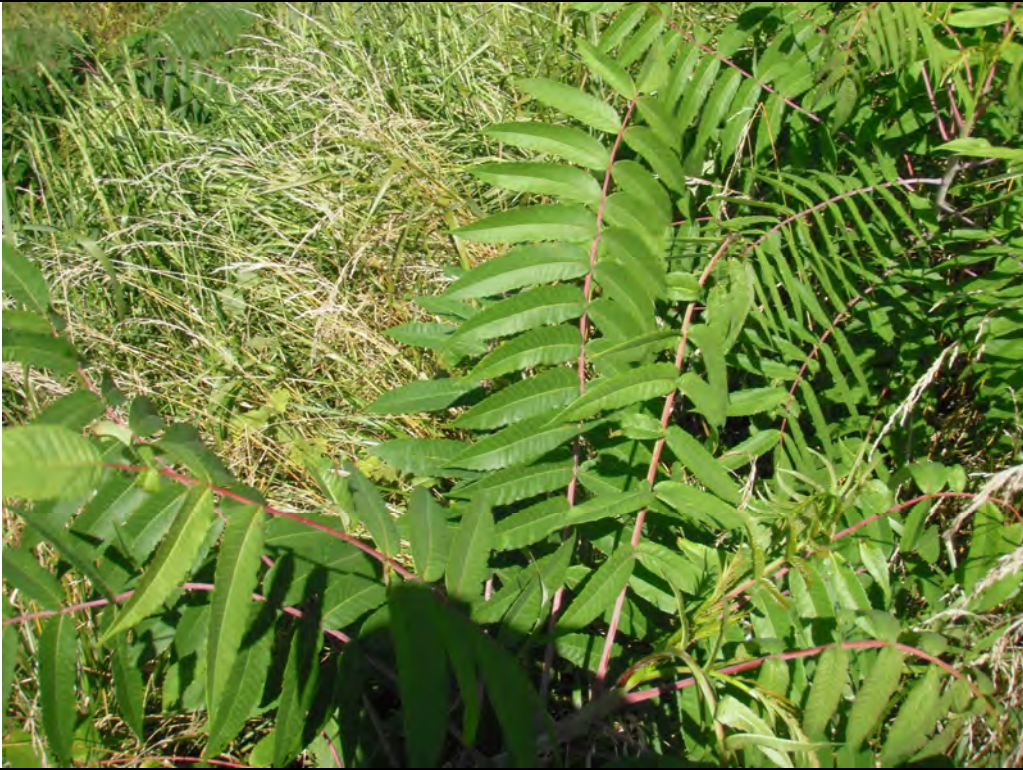
VP3: Tree of Heaven (Invasive)  
Taken: 2010
