FINAL
ANNUAL MONITORING REPORT
YEAR 4 (2012)
BRILES STREAM RESTORTION SITE
RANDOLPH COUNTY, NORTH CAROLINA
(EEP Project No. 047, Contract No. 004809)
Construction Completed November 2007

January 2013

Prepared by:
Axiom Environmental, Inc.
218 Snow Avenue
Raleigh, North Carolina 27603

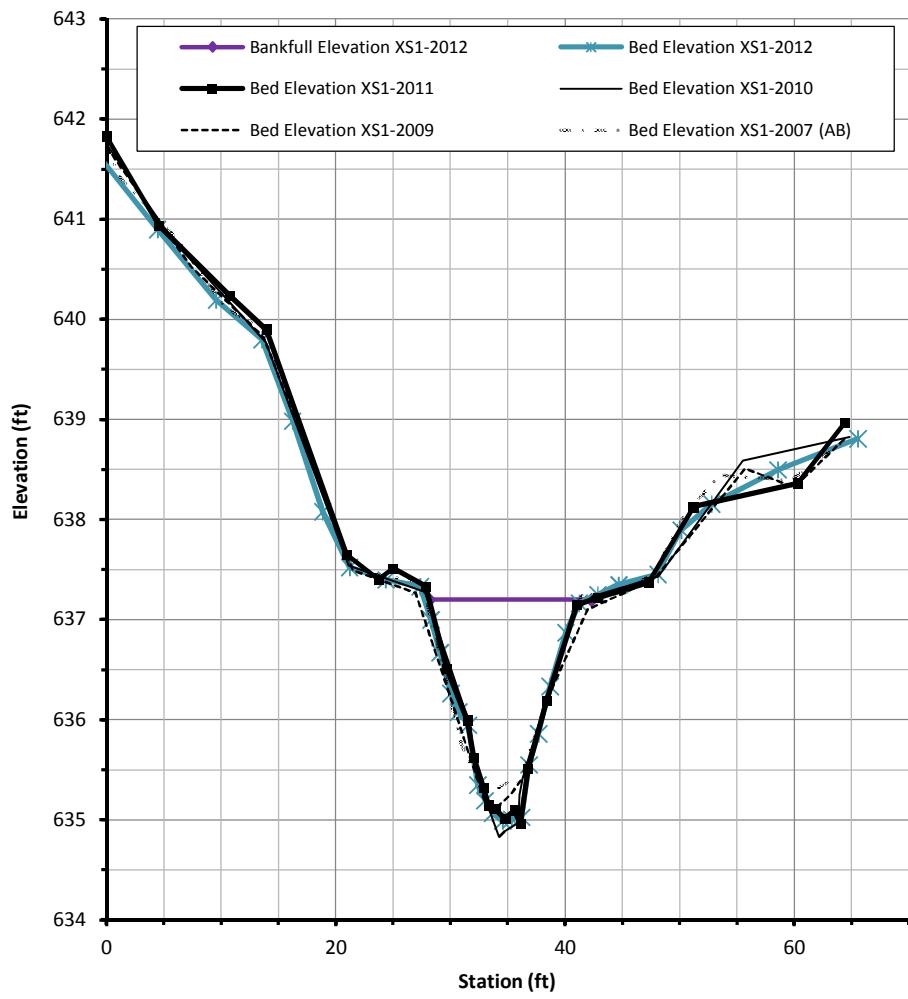
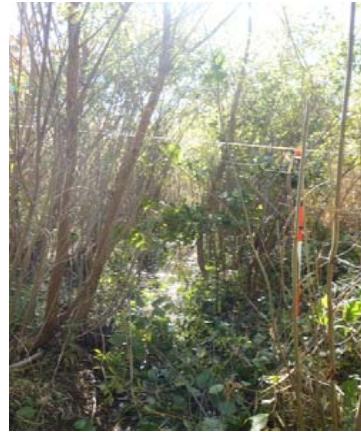
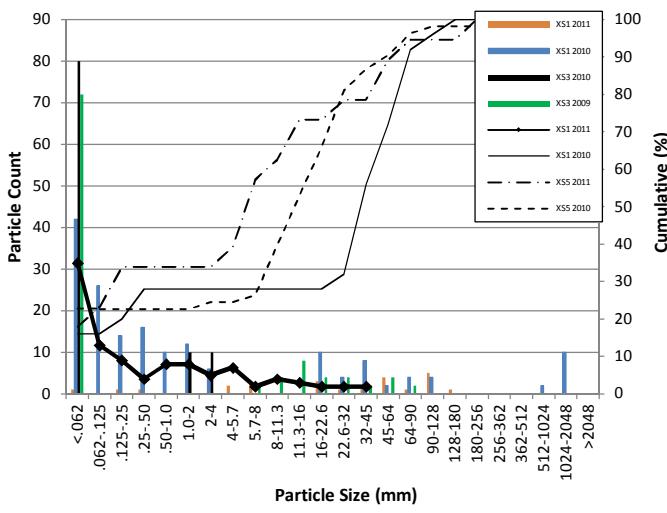
ID	Year	Phase	Facet Type	Wbkf	Abkf	Dbkf
XS1	2007	AB	Riffle	13.4	15.9	1.2
XS1	2009	MY1	Riffle	14.6	16	1.1
XS1	2010	MY2	Riffle	14.5	16.5	1.1
XS1	2011	MY3	Riffle	14.3	16.2	1.1
XS1	2012	MY4	Riffle	13.5	16.4	1.2

ID	Year	Phase	d50(mm)	d84(mm)
XS1	2007	AB	0.07	5.02
XS1	2009	MY1	11.73	31
XS1	2010	MY2	8	22.3
XS1	2011	MY3	7.84	29.15
XS1	2012	MY4	34.8	104

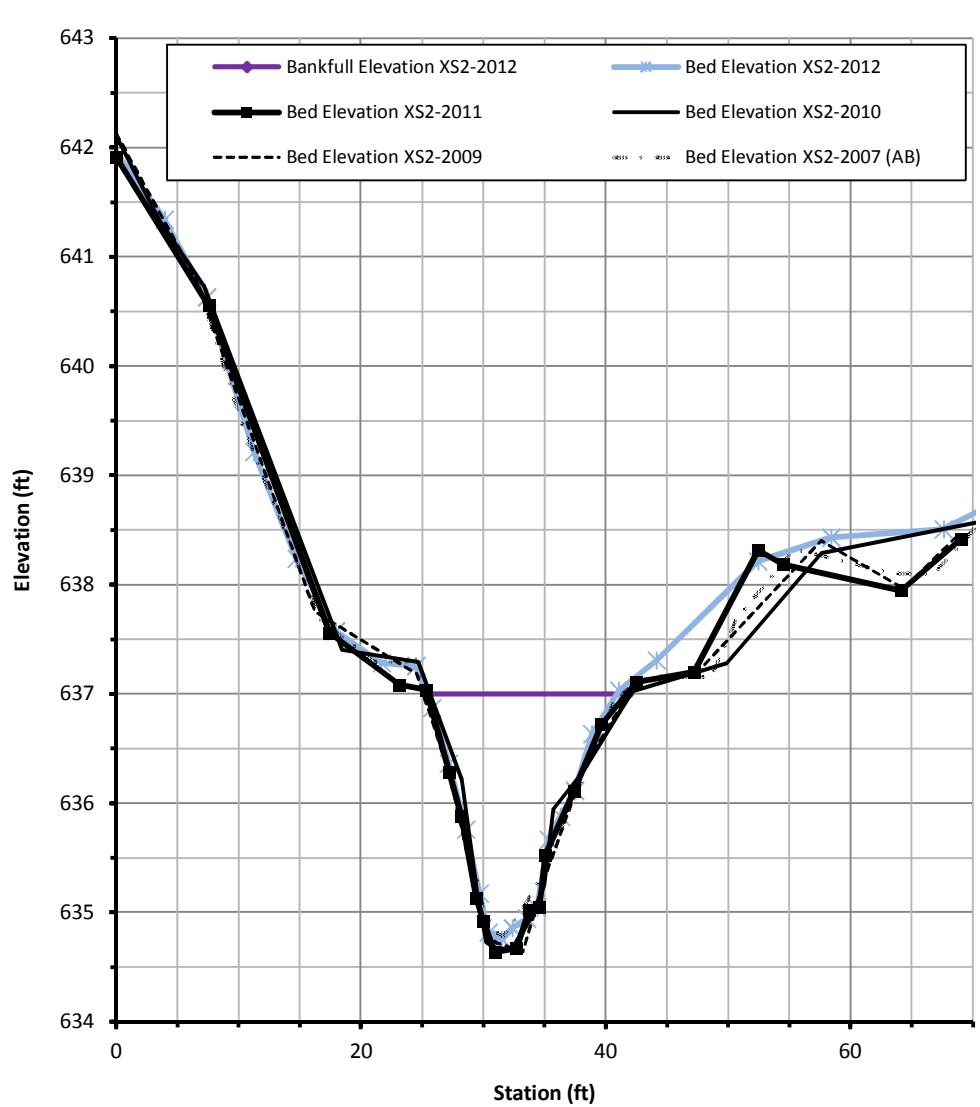
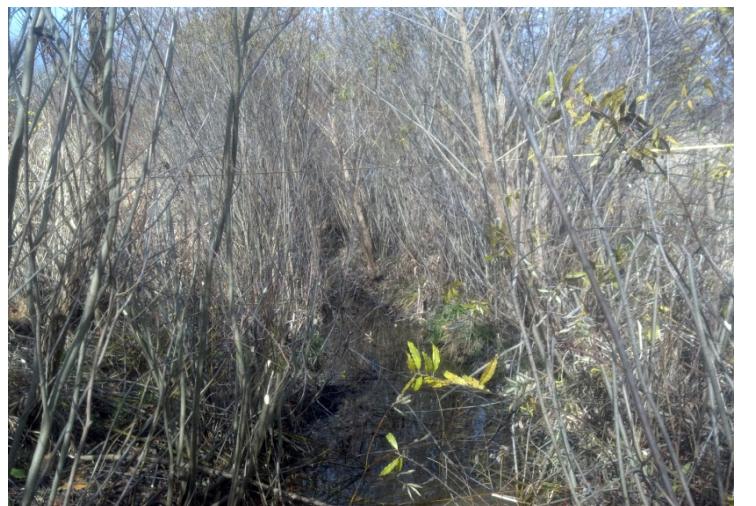
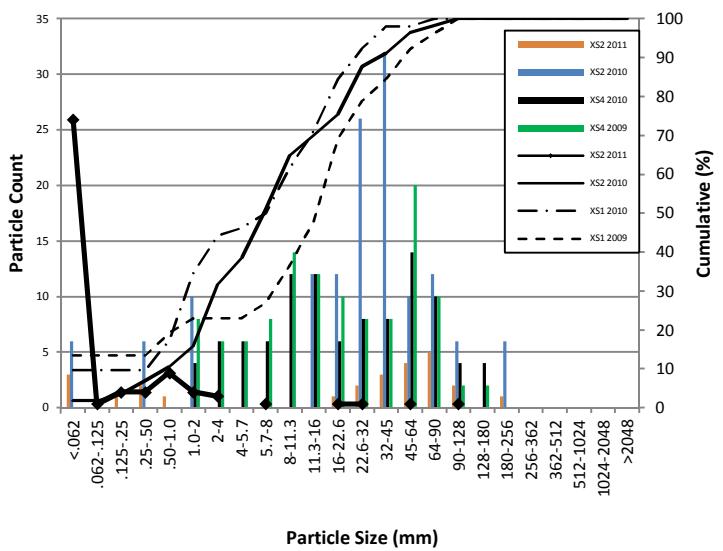
ID	Year	Phase	Facet Type	Wbkf	Abkf	Dbkf	ID	Year	Phase	d50(mm)	d84(mm)
XS2	2007	AB	Pool	15.9	18.9	1.2	XS2	2007	AB	0.14	3.6
XS2	2009	MY1	Pool	17.6	22.5	1.3	XS2	2009	MY1	28.2	62.7
XS2	2010	MY2	Pool	16.6	19.4	1.2	XS2	2010	MY2	38.5	89.6
XS2	2011	MY3	Pool	16.3	19.8	1.2	XS2	2011	MY3	3.2	57.7
XS2	2012	MY4	Pool	19.4	23.2	1.2	XS2	2012	MY4	--	--

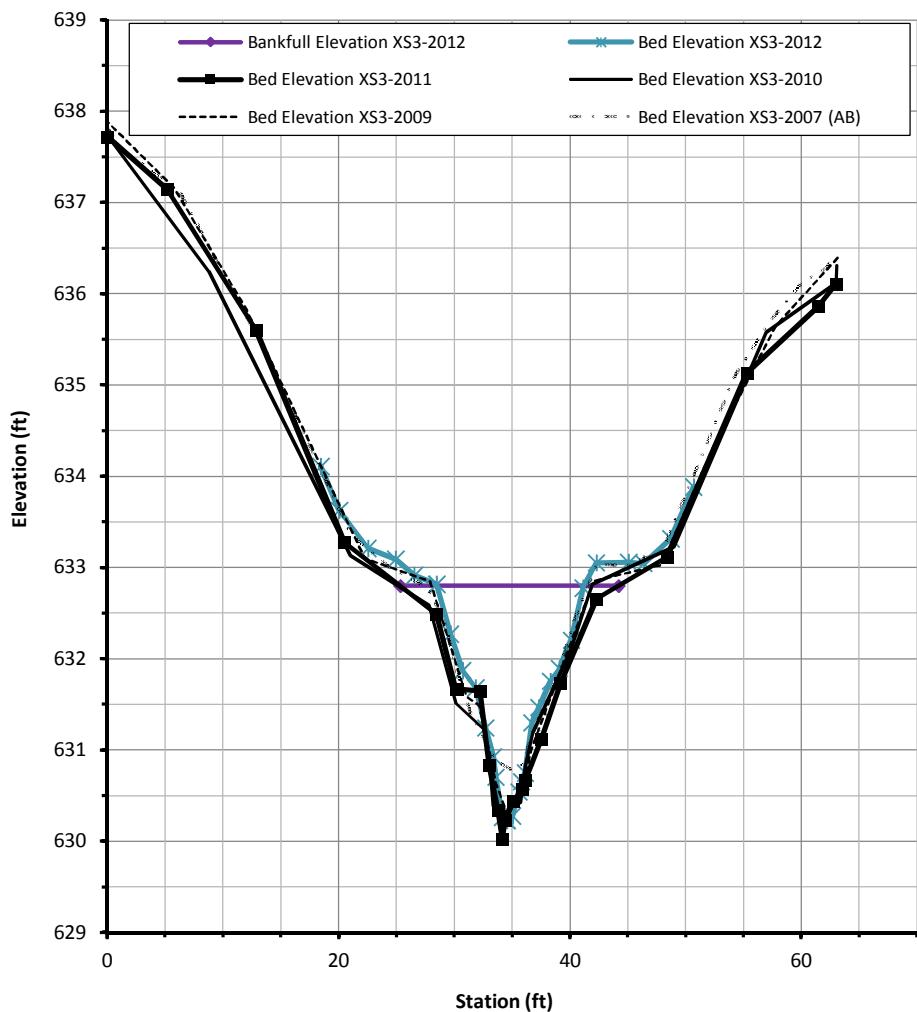
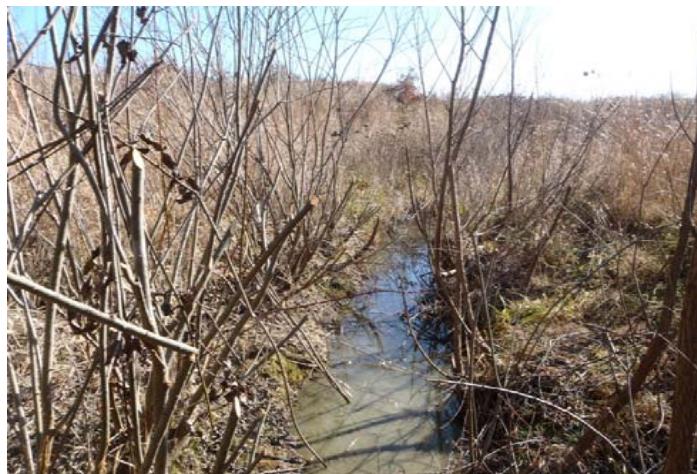
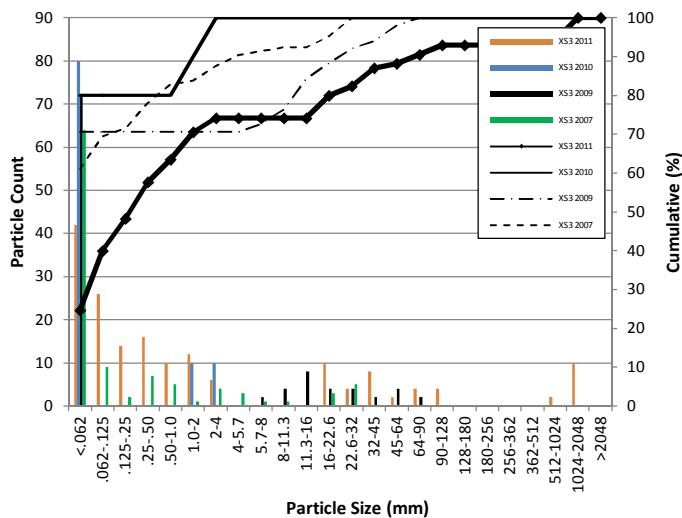
ID	Year	Phase	Facet Type	Wbkf	Abkf	Dbkf
XS3	2007	AB	Pool	14.2	16.2	1.1
XS3	2009	MY1	Pool	14.1	17.9	1.3
XS3	2010	MY2	Pool	13.6	16	1.2
XS3	2011	MY3	Pool	18.9	19.7	1
XS3	2012	MY4	Pool	12.9	16.1	1.3

ID	Year	Phase	d50(mm)	d84(mm)
XS3	2007	AB	--	1.05
XS3	2009	MY1	--	11.2
XS3	2010	MY2	0.04	1.4
XS3	2011	MY3	0.3	36.6
XS3	2012	MY4	--	--

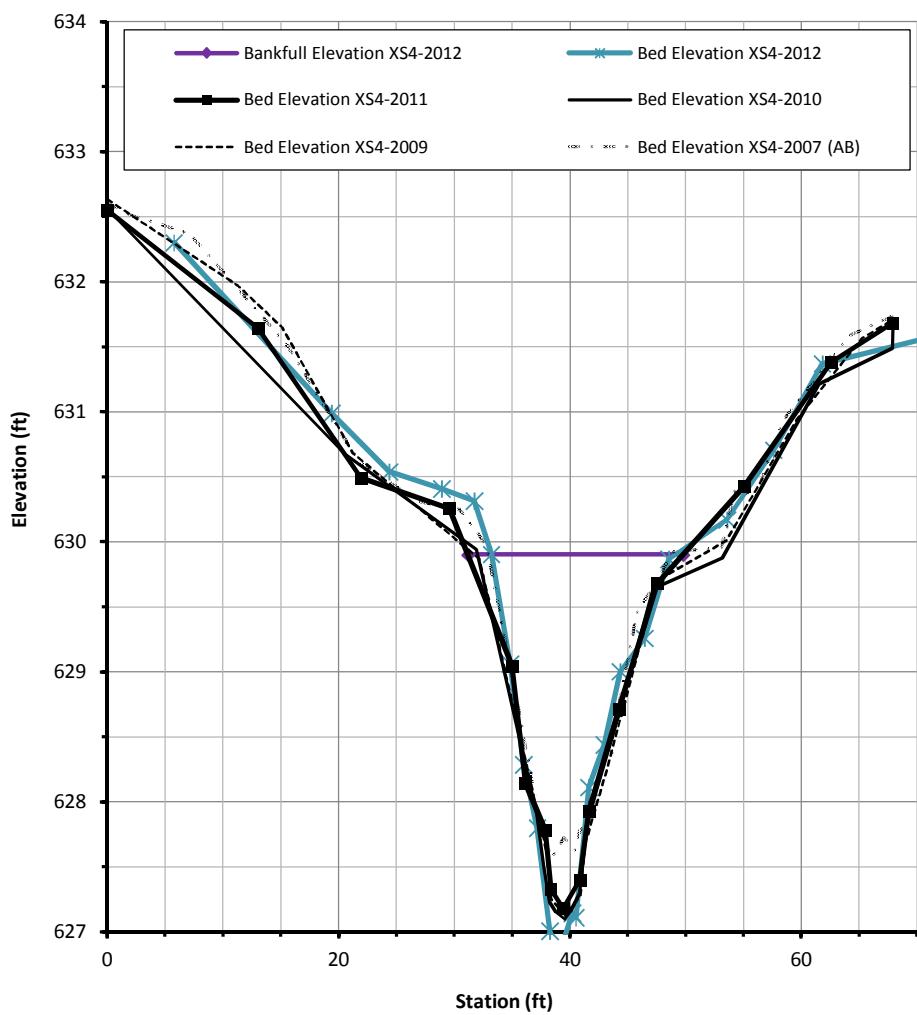
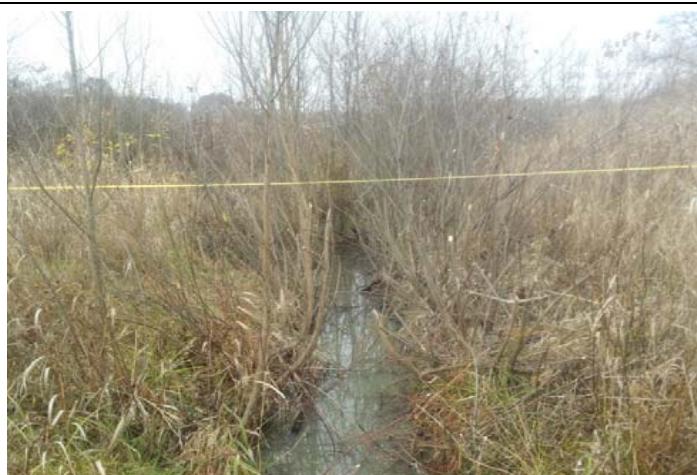
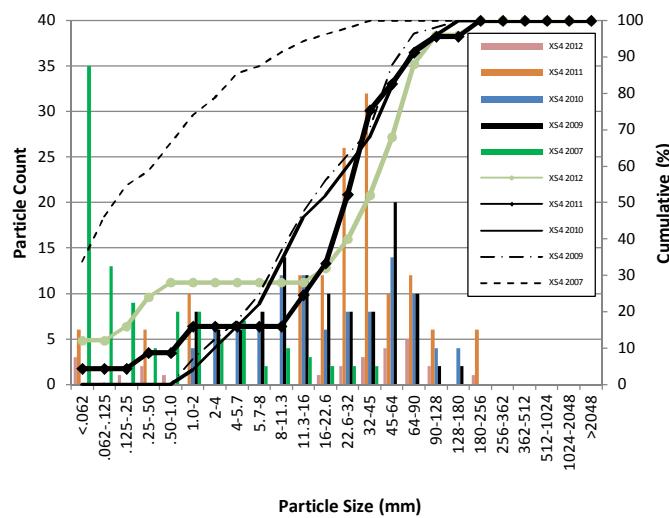
ID	Year	Phase	Facet Type	Wbkf	Abkf	Dbkf
XS4	2007	AB	Riffle	15.8	19.8	1.3
XS4	2009	MY1	Riffle	15	20.2	1.4
XS4	2010	MY2	Riffle	14.5	19.1	1.3
XS4	2011	MY3	Riffle	18.6	22.6	1.2
XS4	2012	MY4	Riffle	15.4	21.8	1.4

ID	Year	Phase	d50(mm)	d84(mm)
XS4	2007	AB	0.09	3.5
XS4	2009	MY1	12.7	42.2
XS4	2010	MY2	20.4	69.2
XS4	2011	MY3	30.9	68.2
XS4	2012	MY4	42.5	84

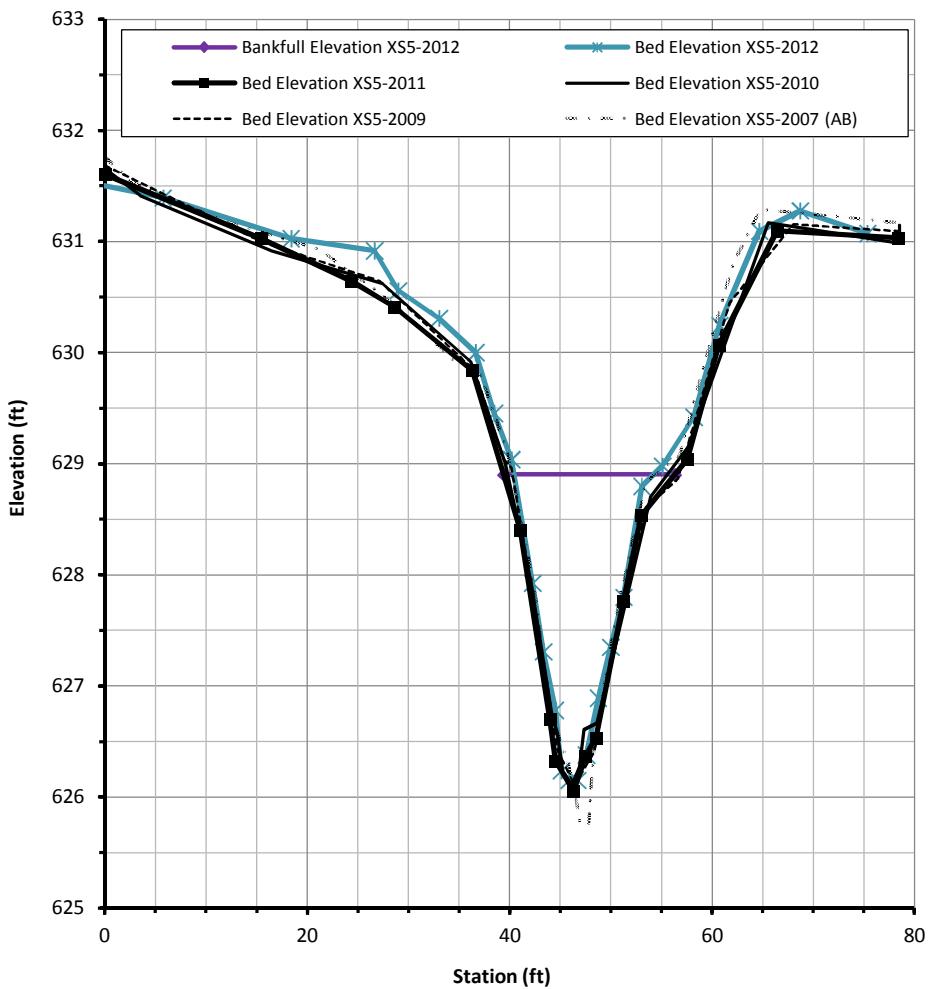
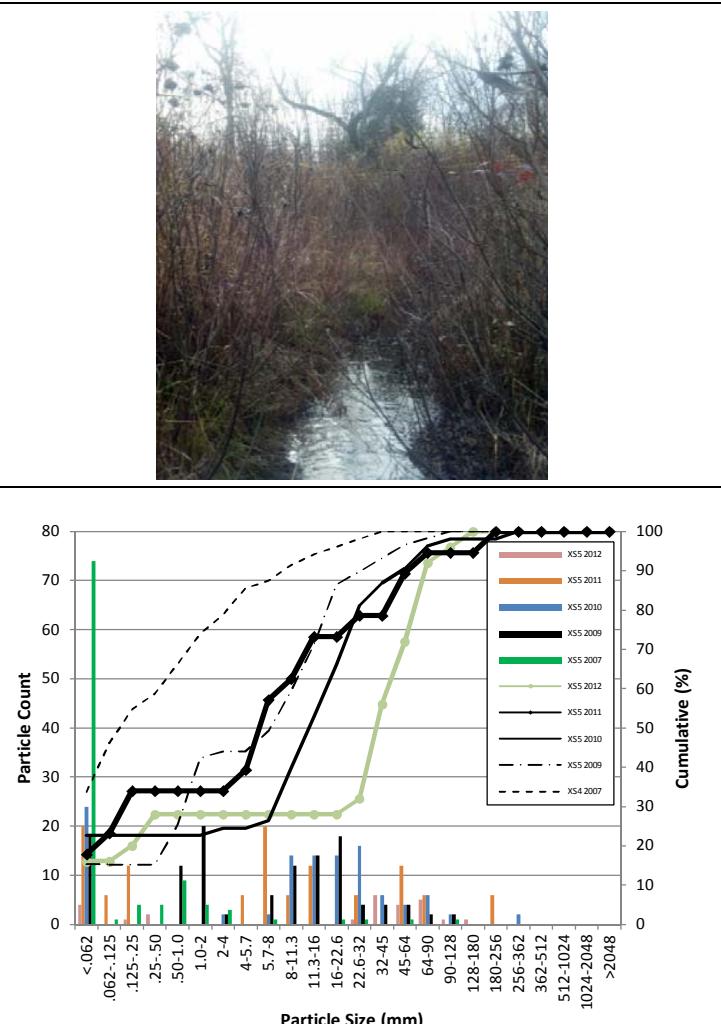
ID	Year	Phase	Facet Type	Wbkf	Abkf	Dbkf	ID	Year	Phase	d50(mm)	d84(mm)
XS5	2007	AB	Riffle	14	21.4	1.5	XS5	2007	AB	--	0.37
XS5	2009	MY1	Riffle	12.7	18.2	1.4	XS5	2009	MY1	5.9	15.3
XS5	2010	MY2	Riffle	13.6	19.1	1.4	XS5	2010	MY2	15	38.6
XS5	2011	MY3	Riffle	16.9	23	1.4	XS5	2011	MY3	7.1	54.6
XS5	2012	MY4	Riffle	15.3	22.2	1.5	XS5	2012	MY4	41.3	79

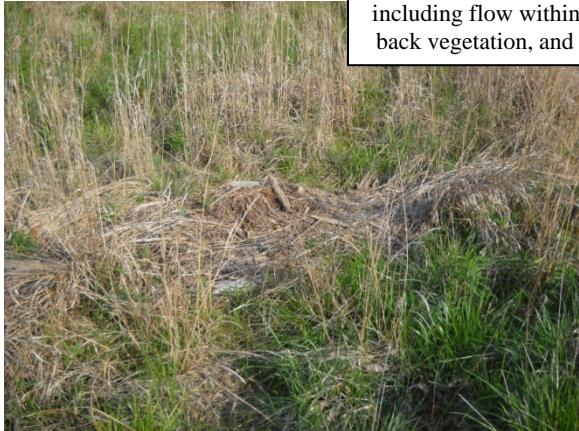
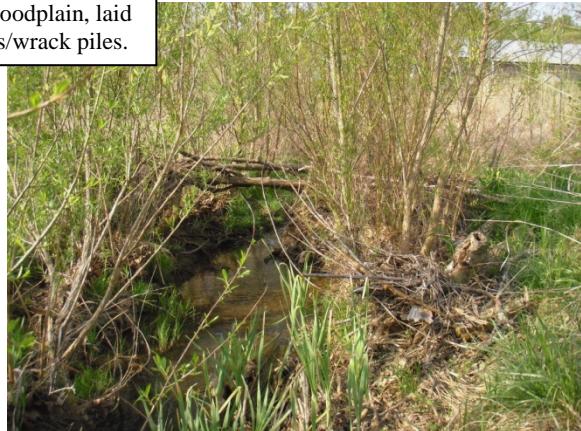
Photos SP3/SP4: Evidence of overbank including flow within adjacent floodplain, laid back vegetation, and large debris/wrack piles.
