# **Clear Creek Final Monitoring Report**

## **Year 4 of 5 (2007)**

**Henderson County, North Carolina**

**USGS HUC: 06010105**  
**Project ID No. 92**

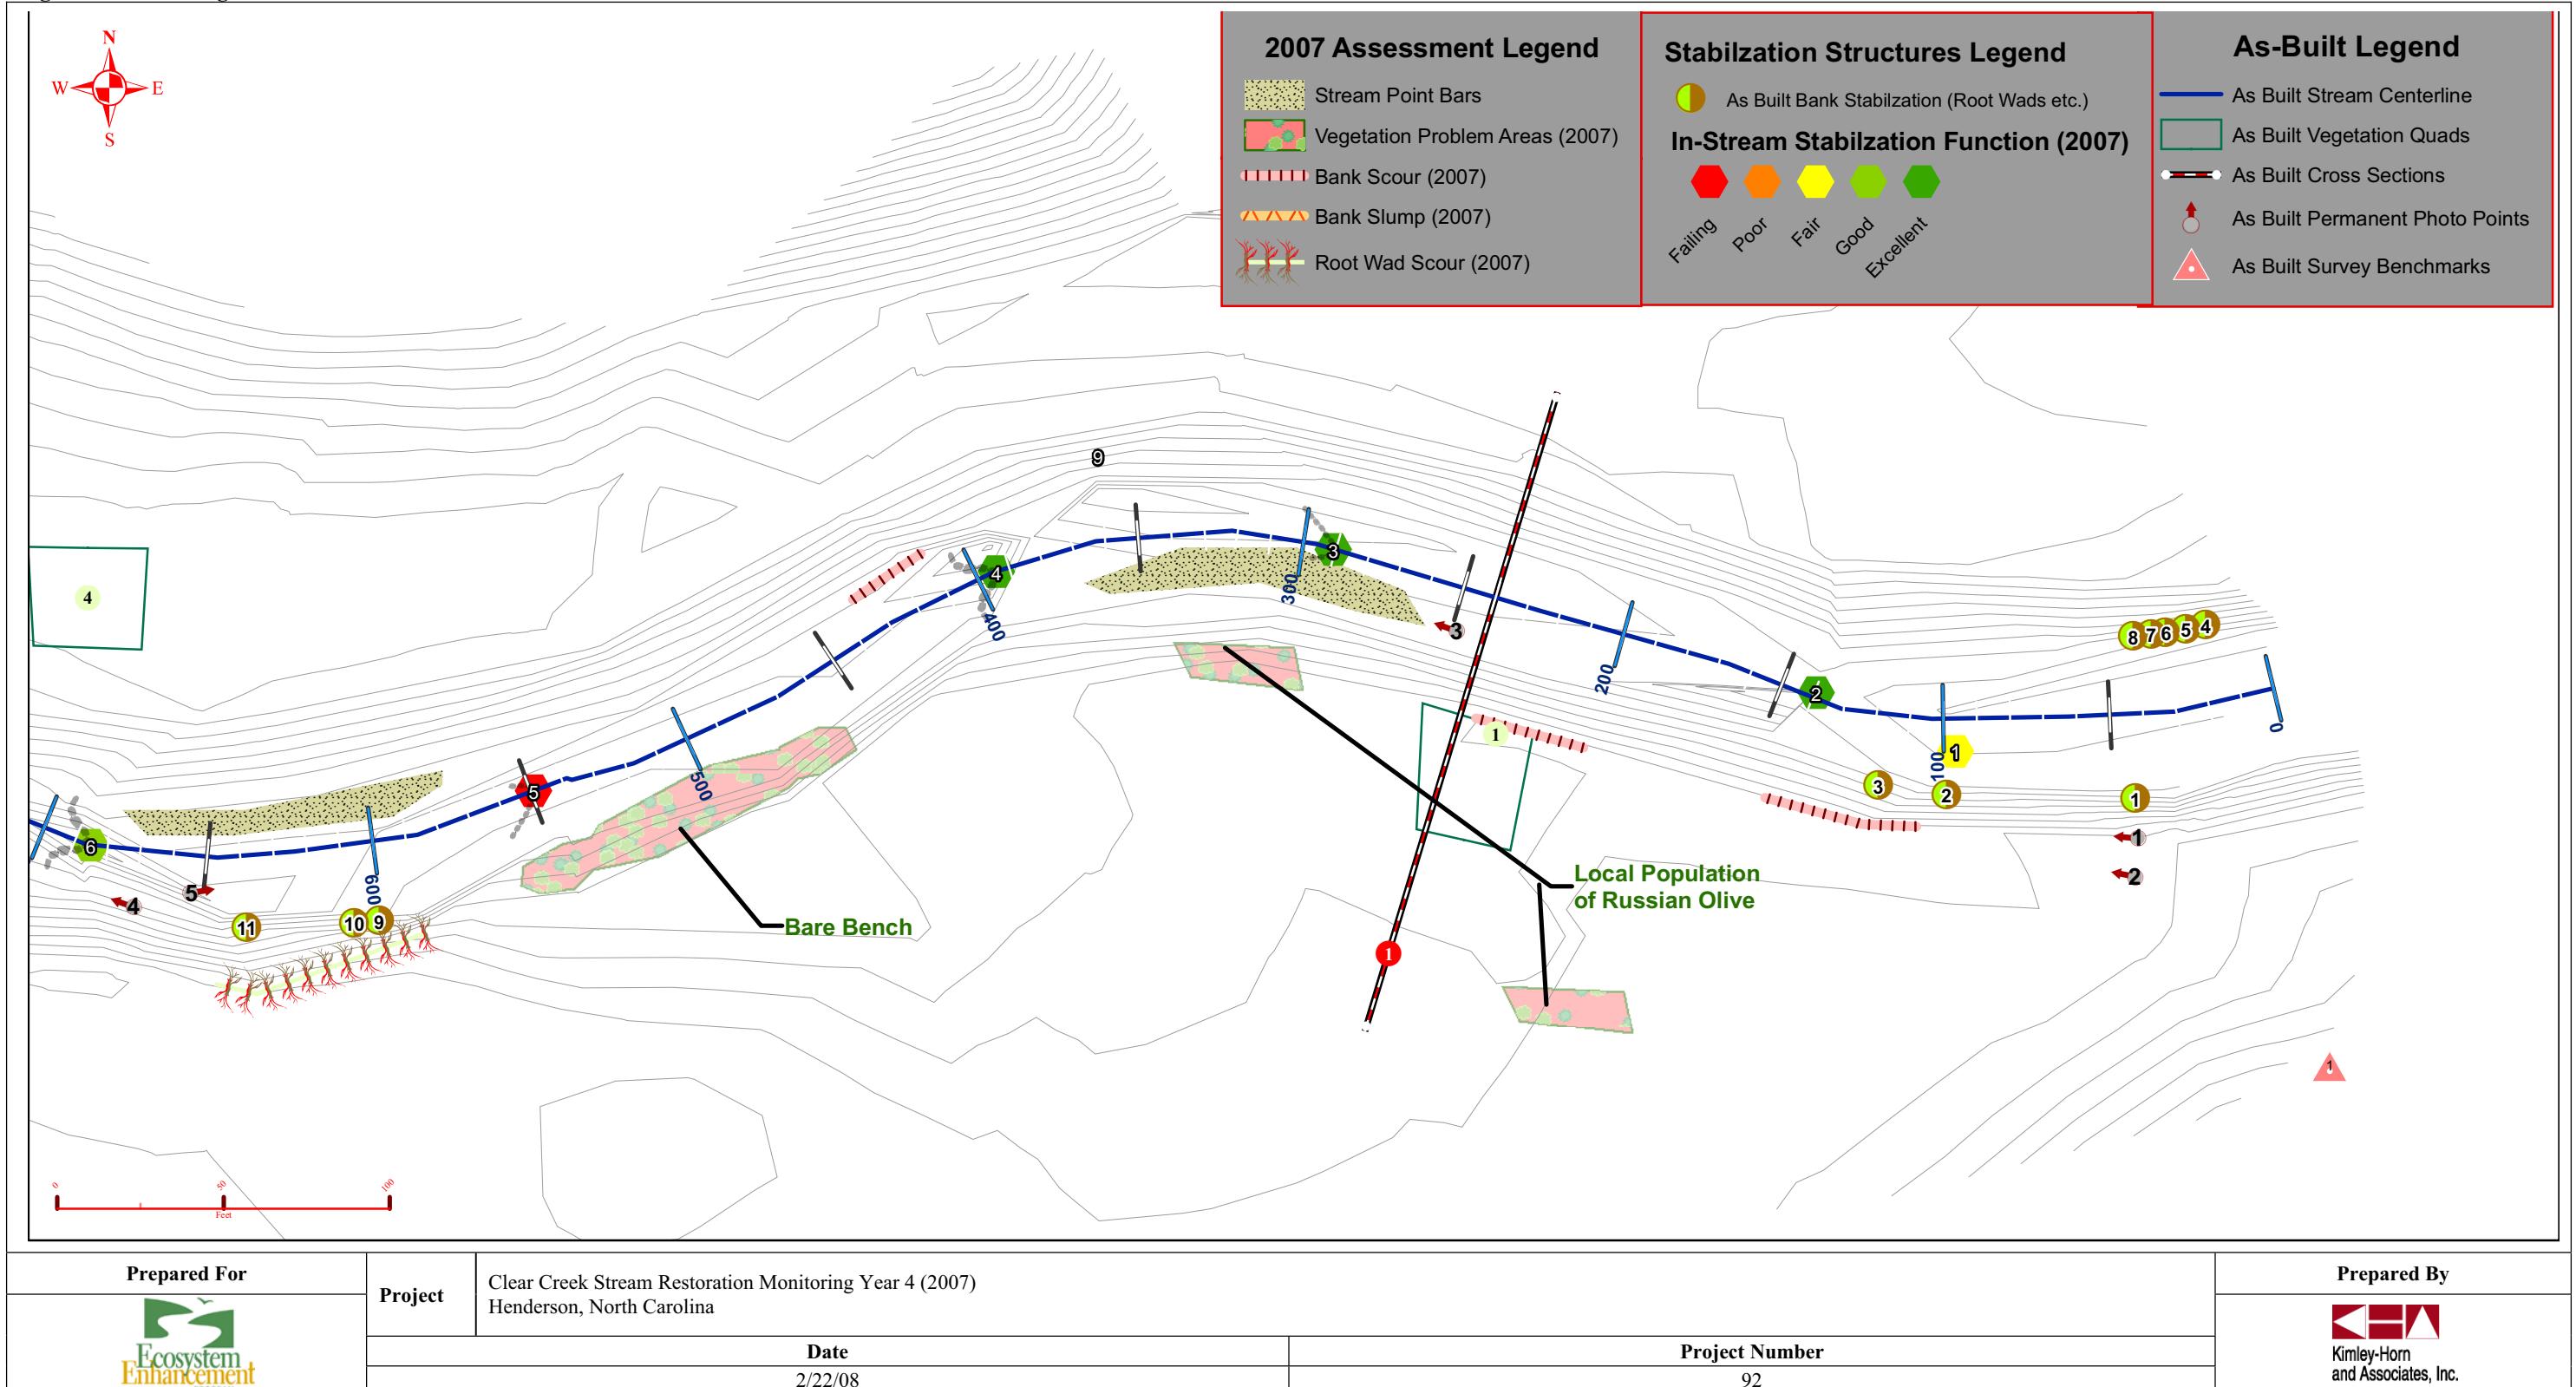
Figure 2: Monitoring Plan View Sheet 1

The Kudzu population reported during the MY2 2005 and MY3 2006 monitoring reports remains on site. The population falls within an isolated area near Clear Creek Road and does not appear be spreading. A small riparian area upstream of the Kudzu population along the right bank does not appear to be thriving. Vegetation growth in this area is more scattered and less vigorous than the rest of the site. A small floodplain bench on the left side of the channel between stations 455 and 560 is covered with grasses and lacks significant numbers of woody vegetation. Russian Olive (*Elaeagnus pungens*) grows in isolated populations (3-4 specimens) throughout the site. The larger populations are show on Figure 2.

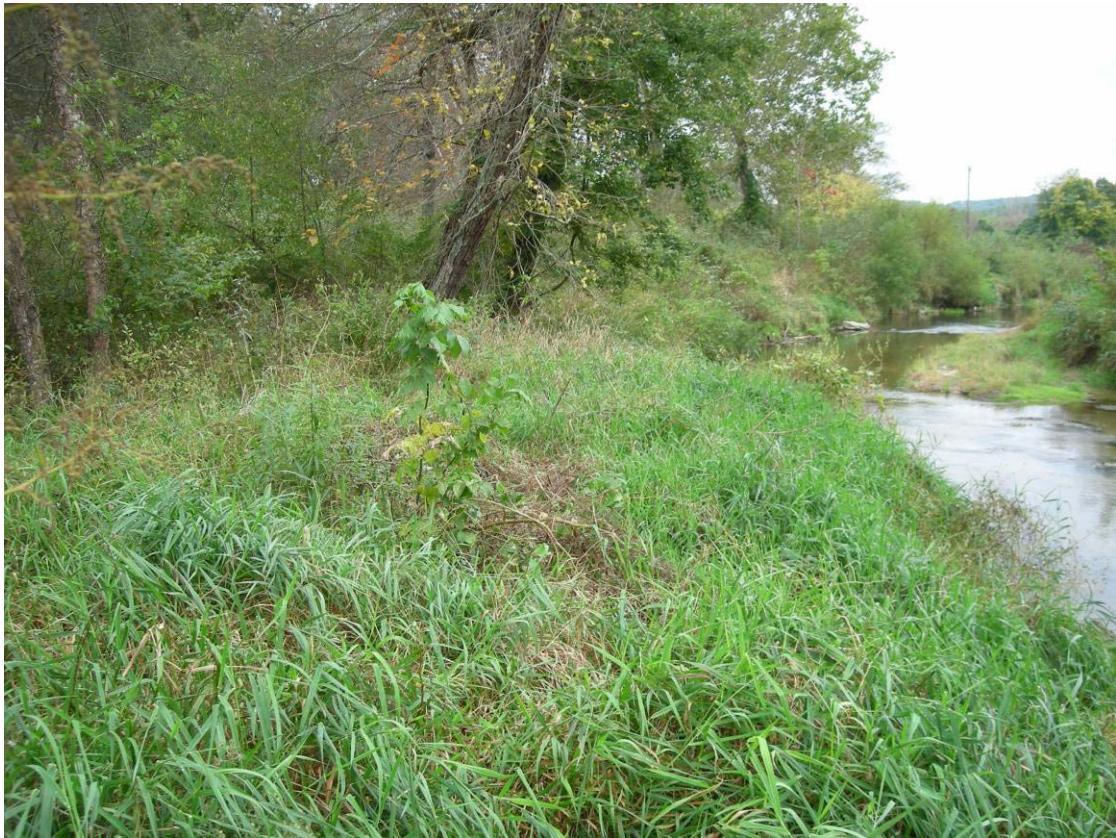
VP1 – Bare bench lacking woody vegetation

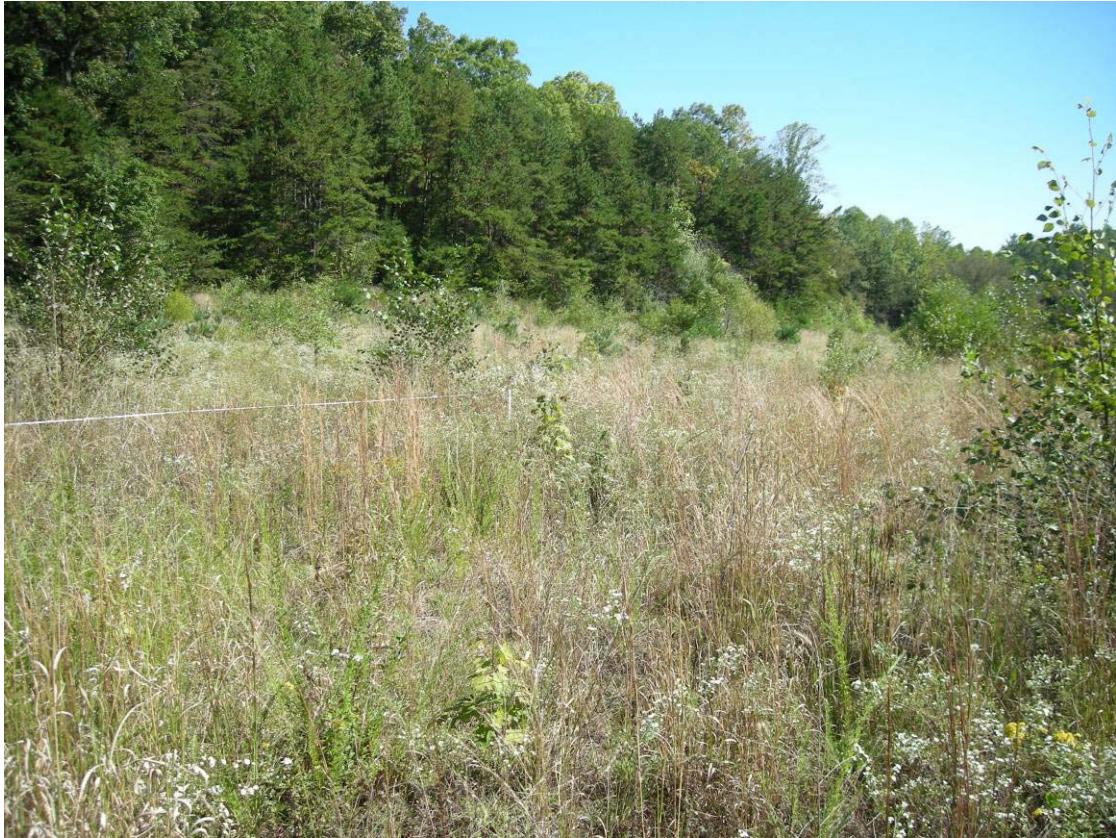
VP2 – Limited coverage of woody vegetation

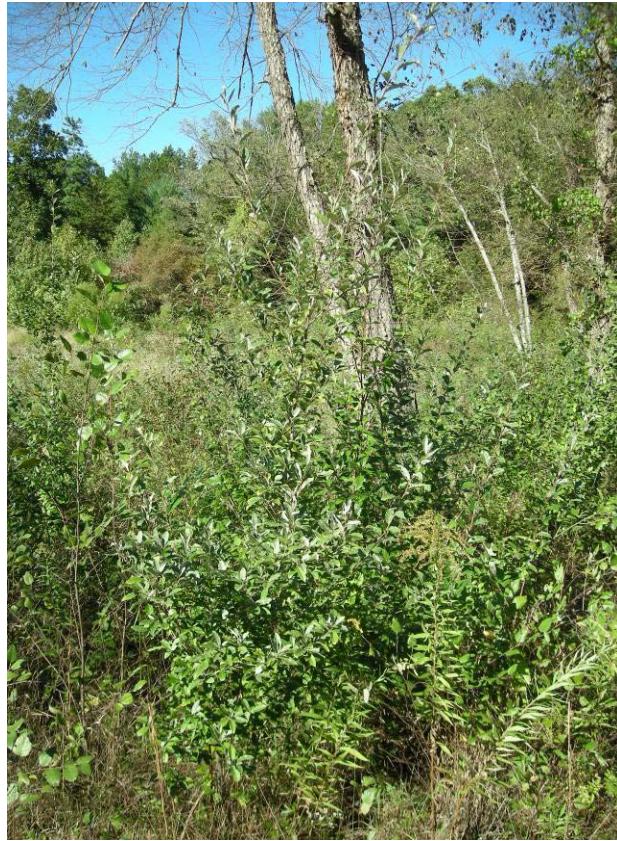
VP3 – Isolated population of Russian Olive

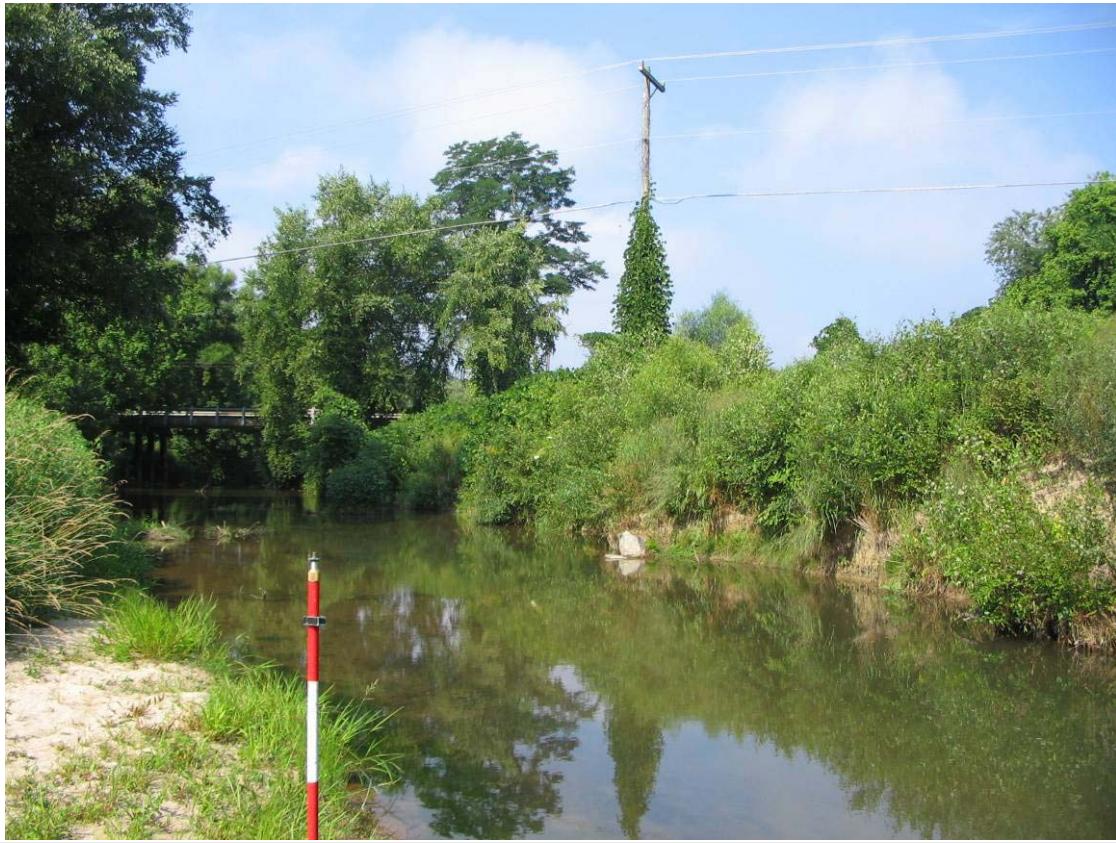
VP4 – Population of kudzu near bottom of project

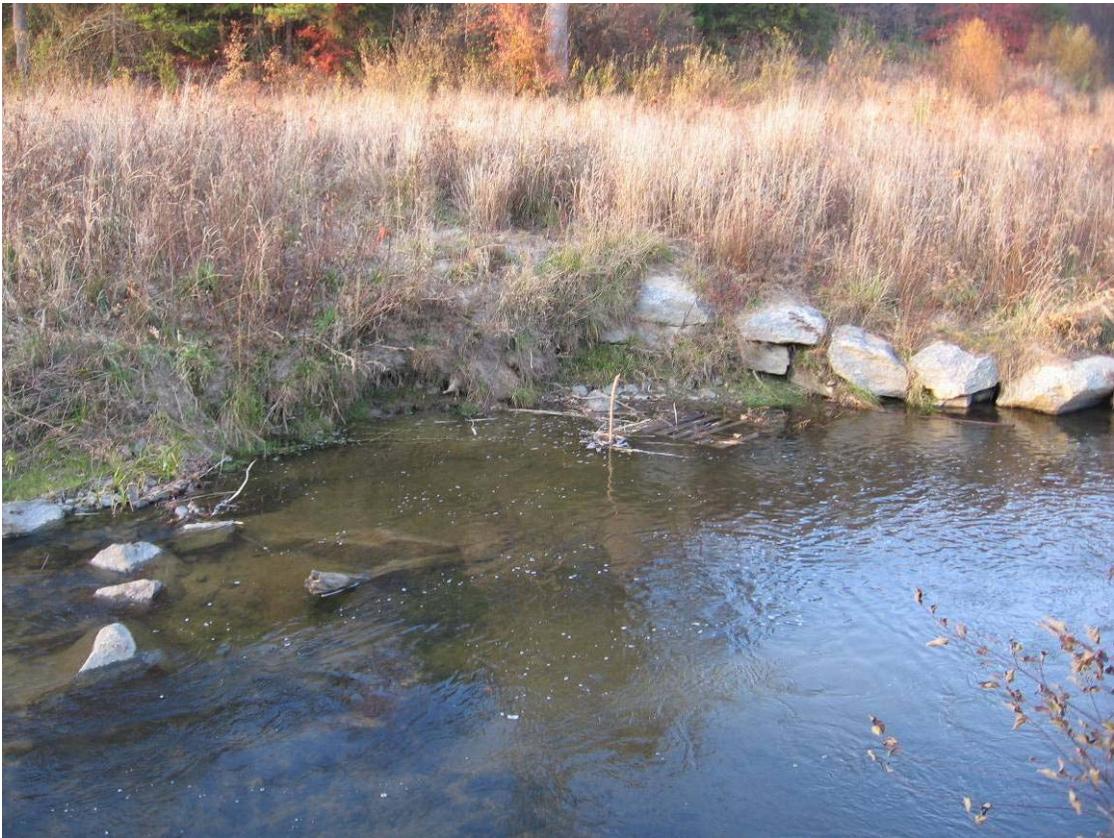
SP 1 – Looking upstream, bank scour on right bank downstream of structure arm

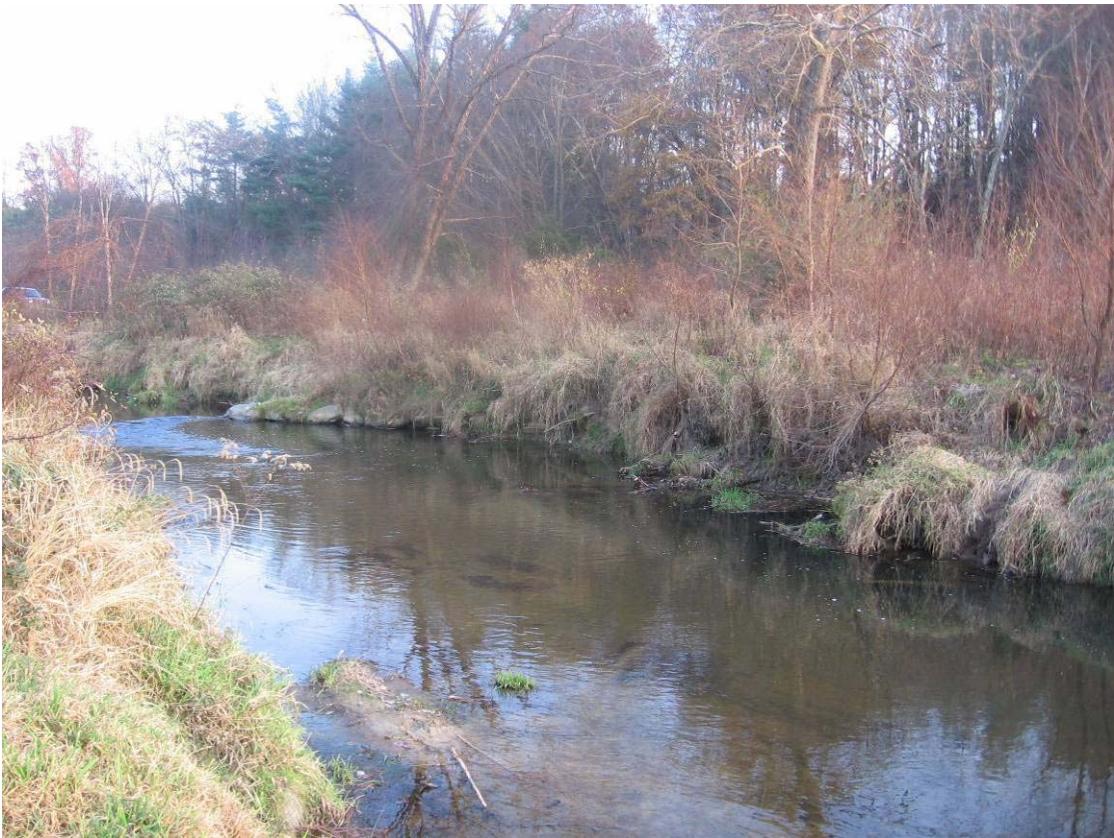
SP 2 – Looking upstream, bank scour on left bank downstream of structure arm

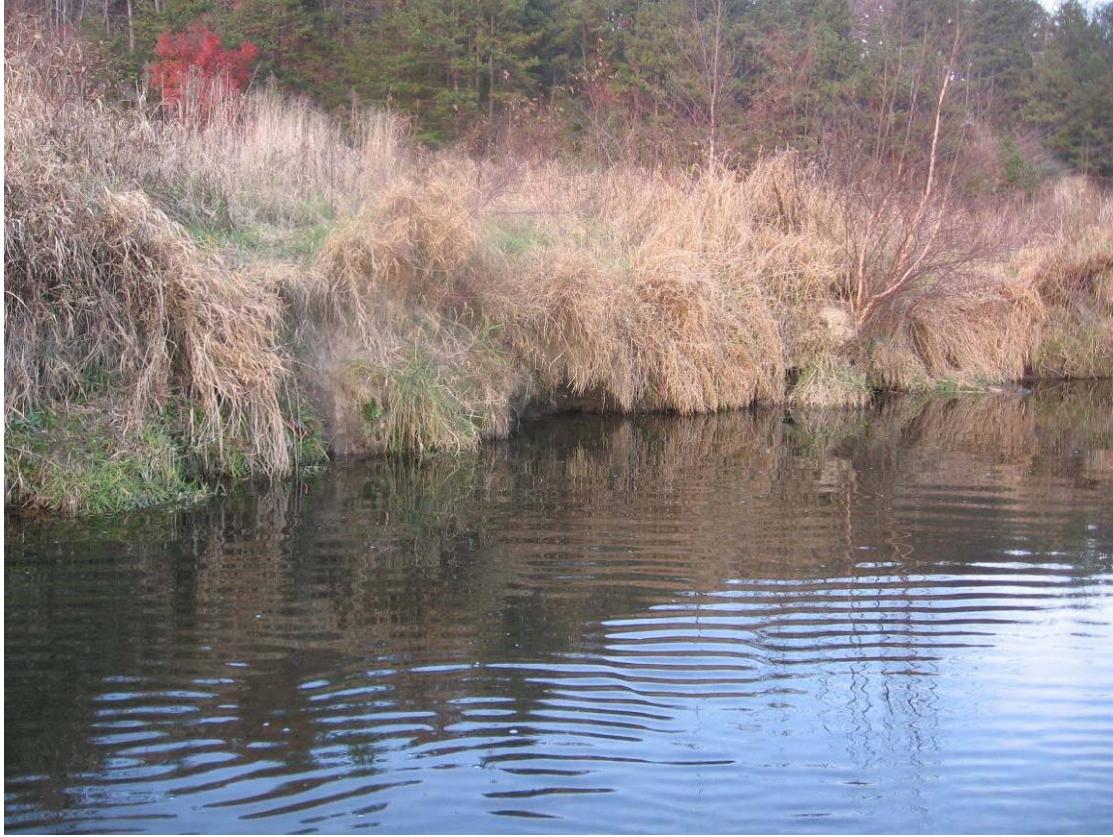
SP 3 – Looking upstream, root wad scour on right bank

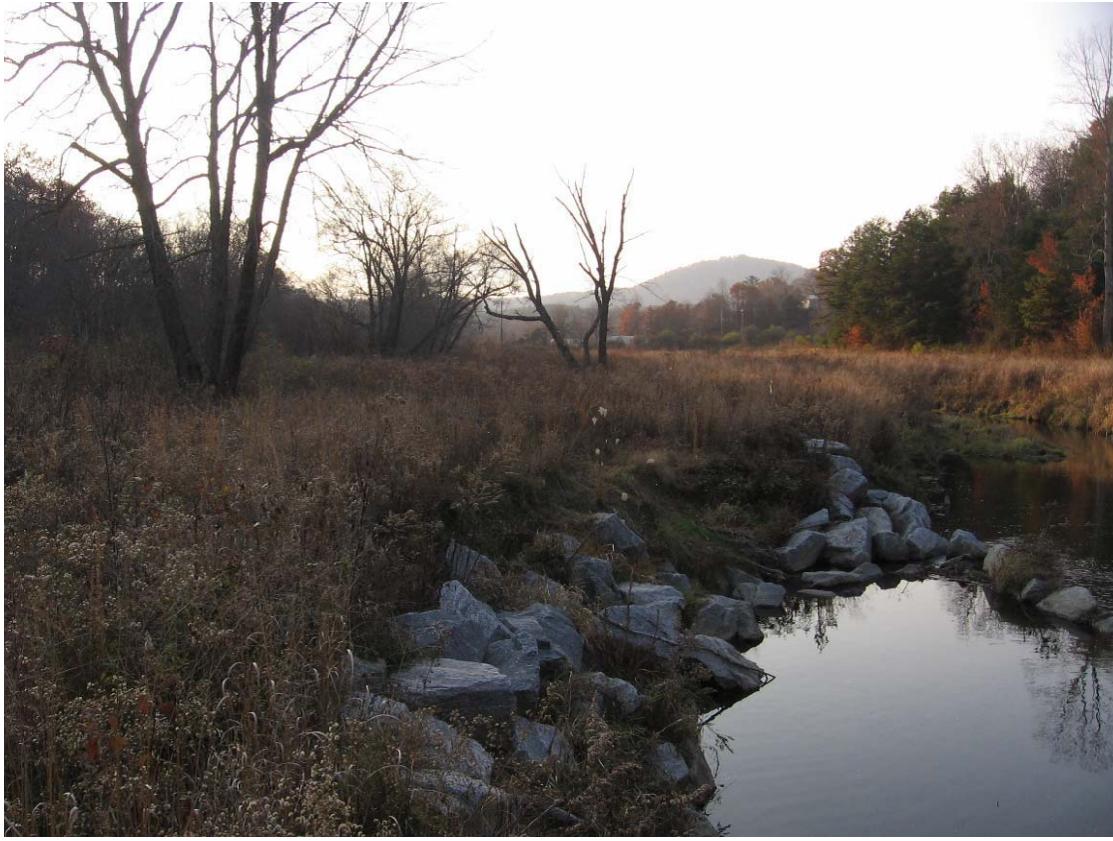
SP 4 – Looking downstream, collapse of rock used for bank protection

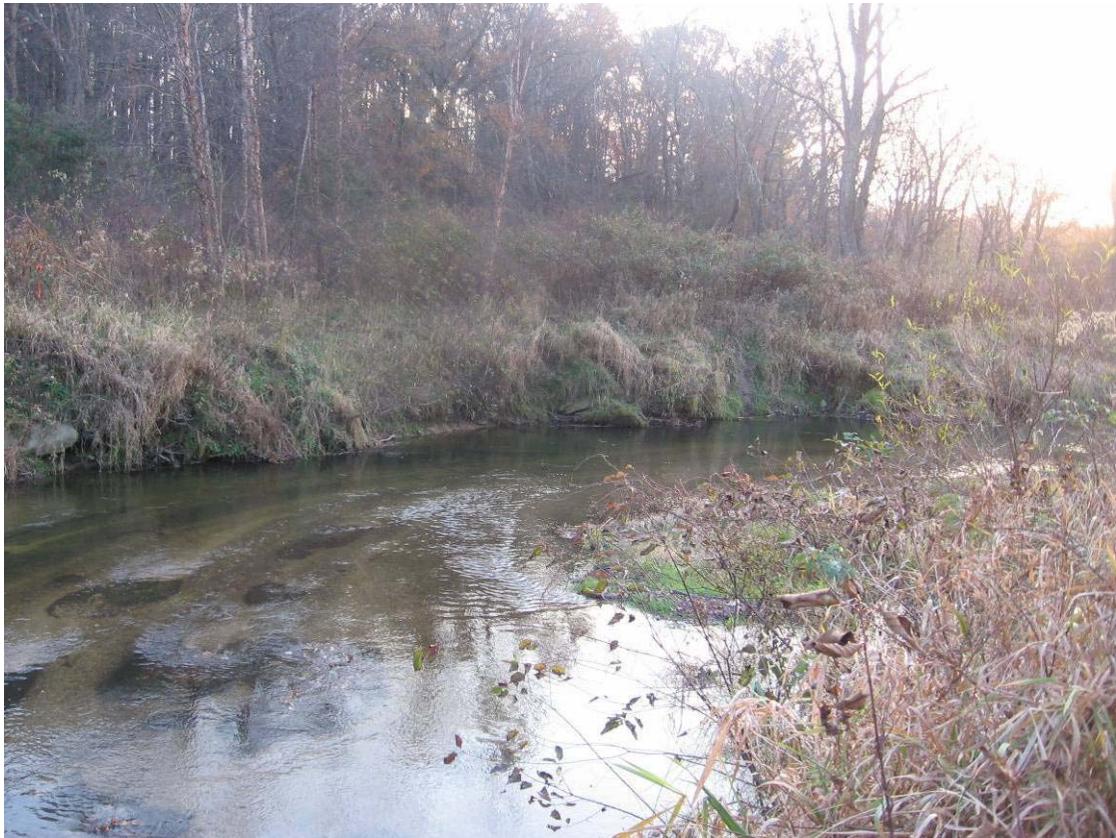
SP 5 – Looking downstream, scour of left bank

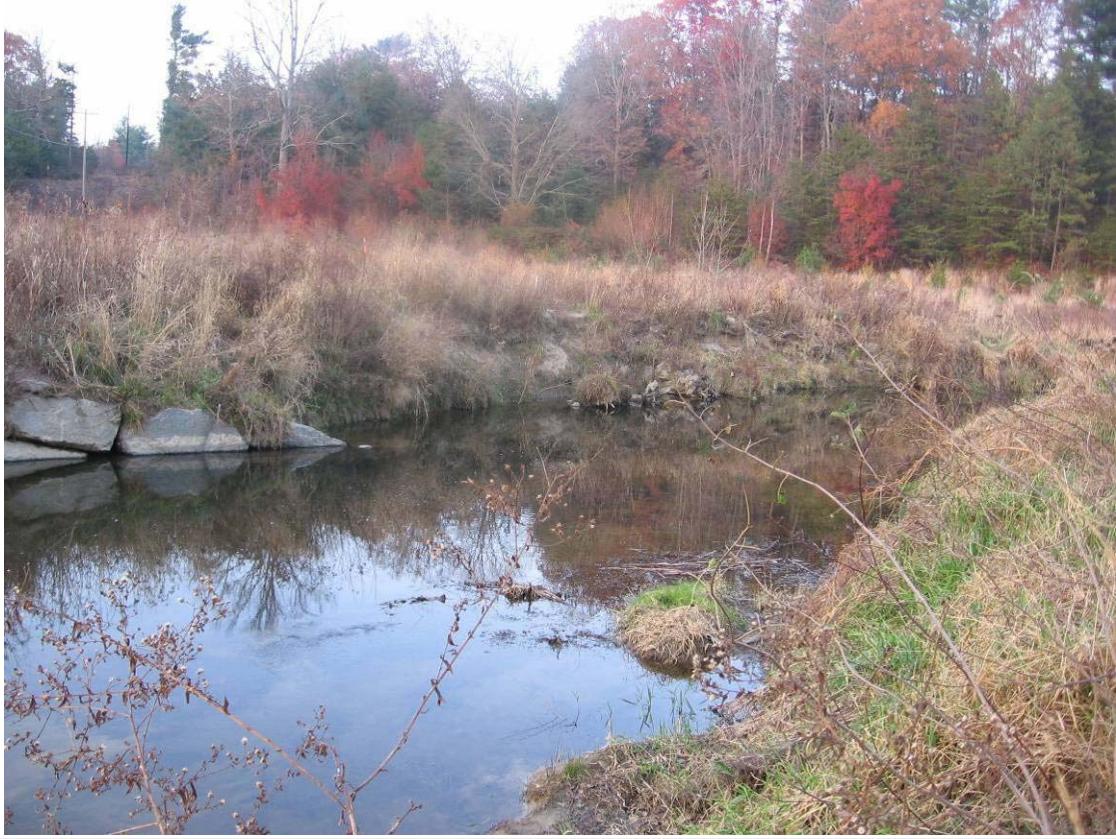
SP 6 – Looking upstream, scour of right bank and scour of root wads of right bank
