Coddle Creek Tributary (Indian Run) Stream Restoration EEP Project # 94 DENR Contract # 5360

Annual Monitoring Report Year 4 of 5 Cabarrus County, North Carolina

Construction Completed: March 27, 2011 Data Collected: September & October 2015 Report Submission: December 2015

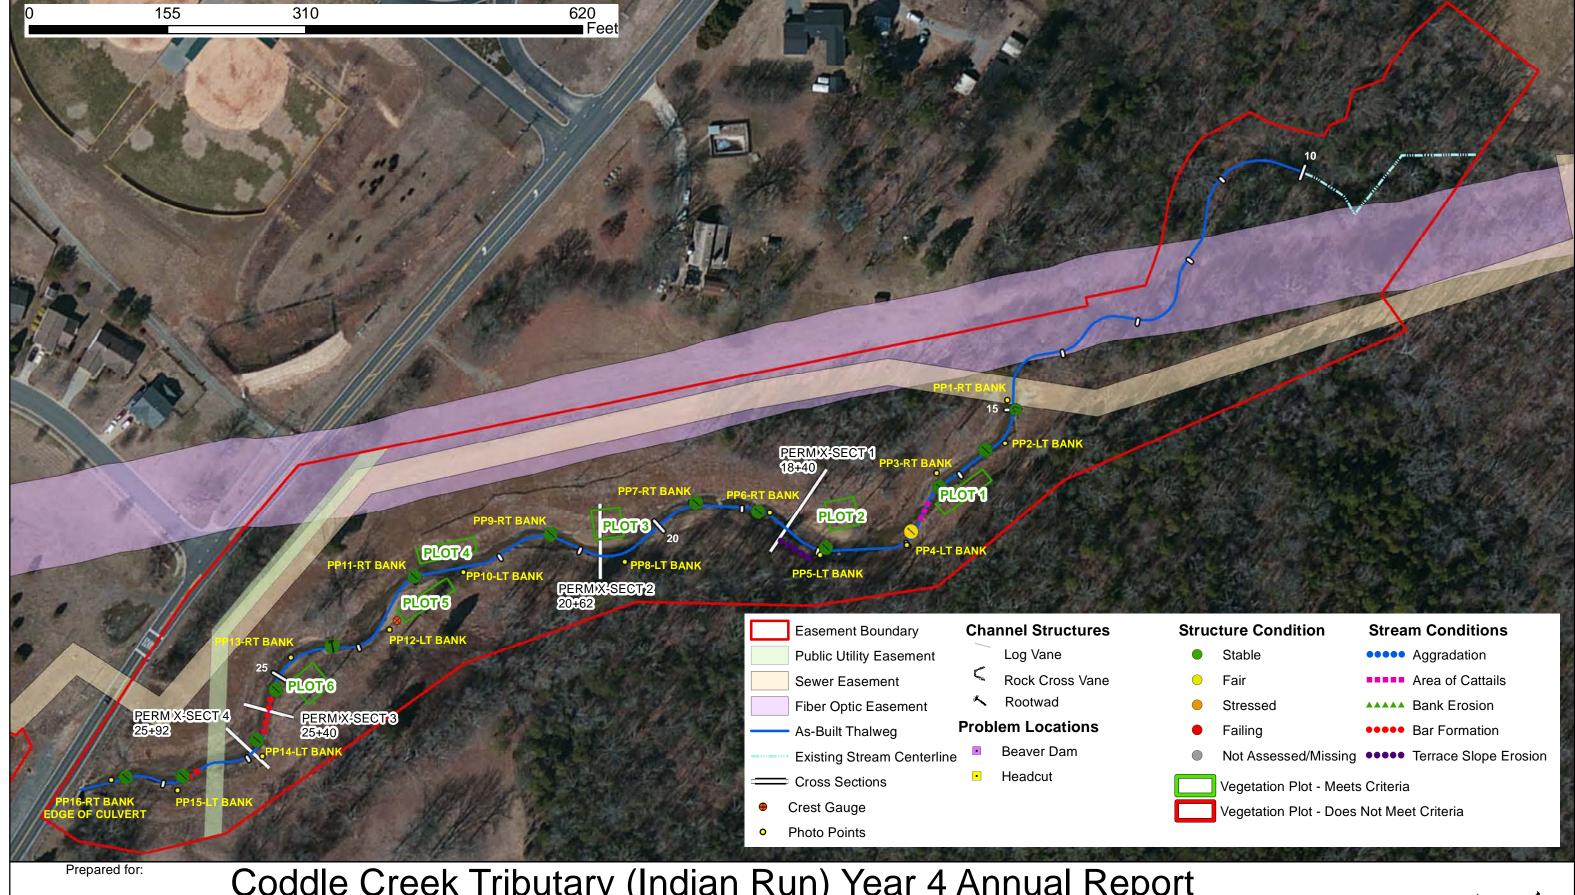
NC Department of Environmental Quality Division of Mitigation Services Coddle Creek Tributary (Indian Run) Year 4 Annual Report
Current Conditions Plan View - Upper Reach Cabarrus County, NC
December 2015 Project #94 Figure 3A

Two areas of bar formation were noted at Sta. 25+29-25+62 and Sta. 26+50-26+67 on the upper reach. The bar formation on the lower reach at Sta. 11+35 was not present this monitoring year. Areas of bank erosion noted in previous monitoring reports were stable this year and will continue to be monitored. The terrace rill at approximately Sta. 18+00 on the left bank of the upper reach was noted in the Monitoring Year 1 report, but appears to have stabilized. This area will continue to be monitored for erosion. One headcut was noted at Sta. 17+75 on the lower reach. The headcut is outside of the stream channel and seems to be due to overland flow. A debris jam noted at Sta. 15+60 on the lower reach in the previous monitoring year has been resolved. A small area of bare bank was noted just downstream of cross section 7 on the right bank. A relict beaver lodge was noted at the downstream section of the bare area. All problem areas are noted on the Current Conditions Plan View (CCPV) sheets in Appendix B.

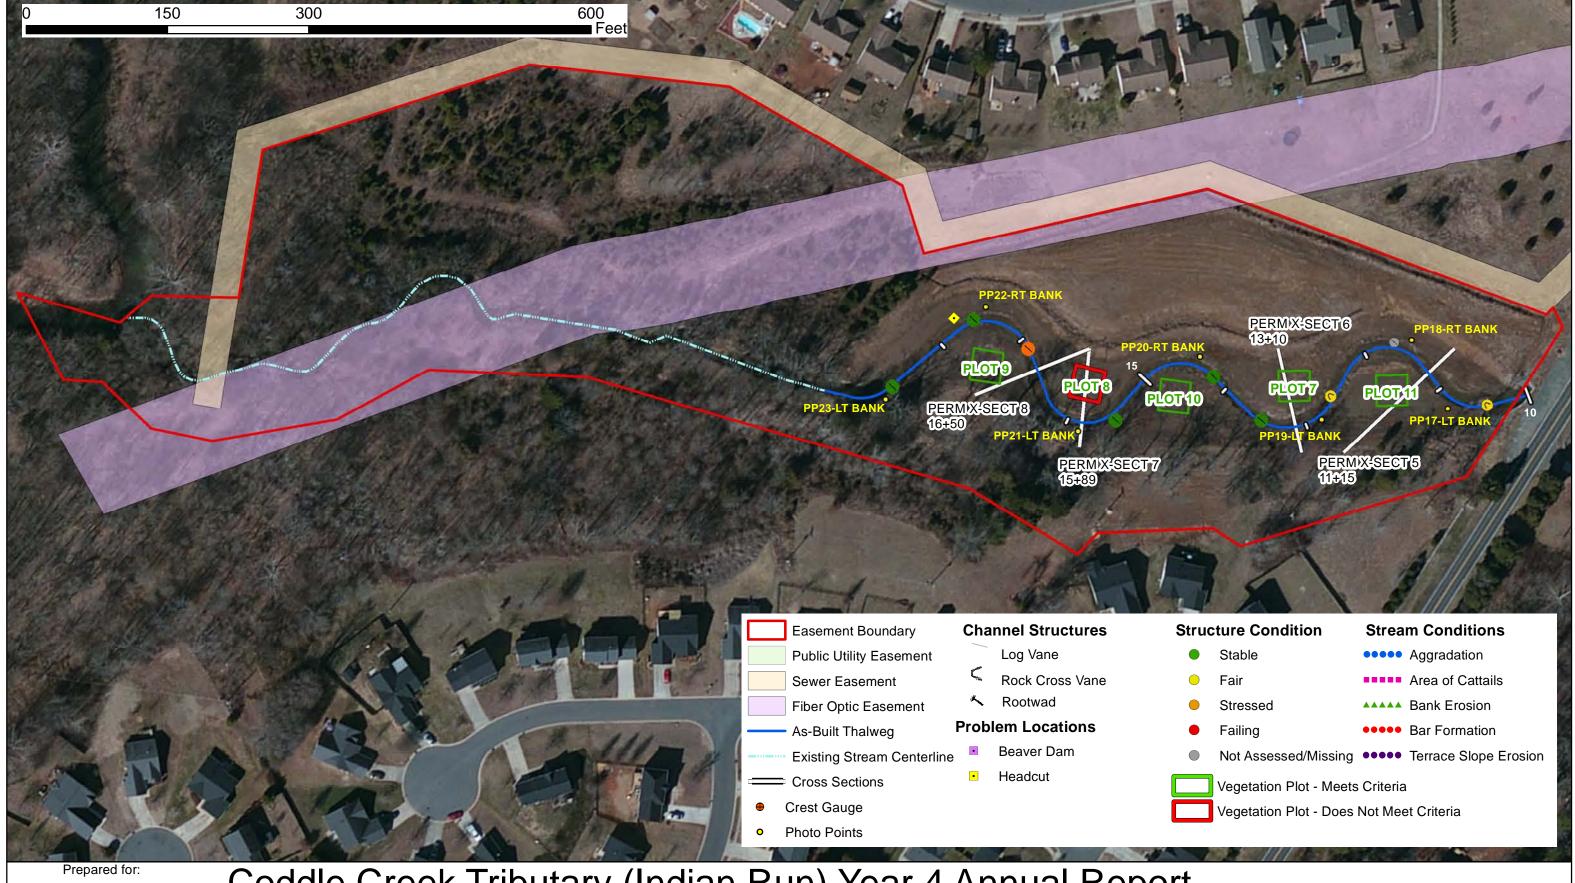
NC Department of Environmental Quality Division of Mitigation Services Coddle Creek Tributary (Indian Run) Year 4 Annual Report
Current Conditions Plan View - Lower Reach Cabarrus County, NC
December 2015 Project #94 Figure 3B

Cattails (*Typha latifolia*) growth has notably decreased throughout both reaches. Only one area of cattails was noted during monitoring. The location of the cattails are noted on the CCPV and represent

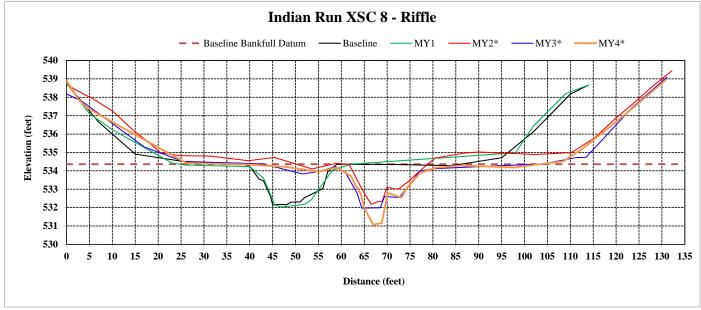
Reach	Indian Run, Lower Reach
River Basin	Yadkin/Pee Dee
Cross Section ID	XSC-8, Riffle, Lower Reach, 16+50
Drainage Area (Sq Mi)	1.5
Date	10/22/2015
Observers	P. Beach, C.Flowers, K. Hamlin

*The pins for XS8 were not located in the field. The location of the cross section for MY4 is approximate and was set during MY2.

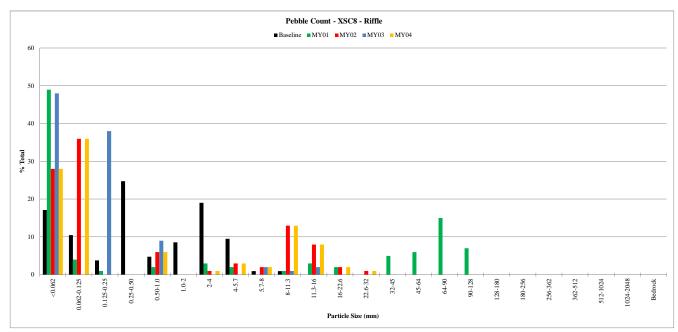
Coddle Creek Tributary - Indian Run - LR - XS8 Riffle Pebble Count

Pebble count data for the cross sections indicate similar or coarser values compared to baseline except in cross sections 1 and 8. This indicates a good movement of material at least in the upstream parts of the upper reach. The smaller particle size at cross section 1 may be from the upstream terrace rill erosion. The lower reach riffle at cross section 8 still exhibits a small particle size making up the riffle section. Effects from the relict beaver dam upstream of this area may play a role in the type of bed material observed this monitoring year. The riffle at cross section 5 exhibits larger particle sizes. As the lower reach was constructed as an offline segment, these values are not unexpected. It will take longer for coarser material to progress to the lower reach from upstream areas. Since the cross section dimensions have remained relatively the same for the lower reach, the sections are stable despite the smaller bed material.
