### **Glade Creek Stream Restoration**

NCEEP Project Number: 854
Monitoring Contract Number: D08033S
Monitoring Very 3

**Monitoring Year 3 2013 Final Report**

## **Glade Creek Stream Restoration 2013 Monitoring Report (MY 3)**

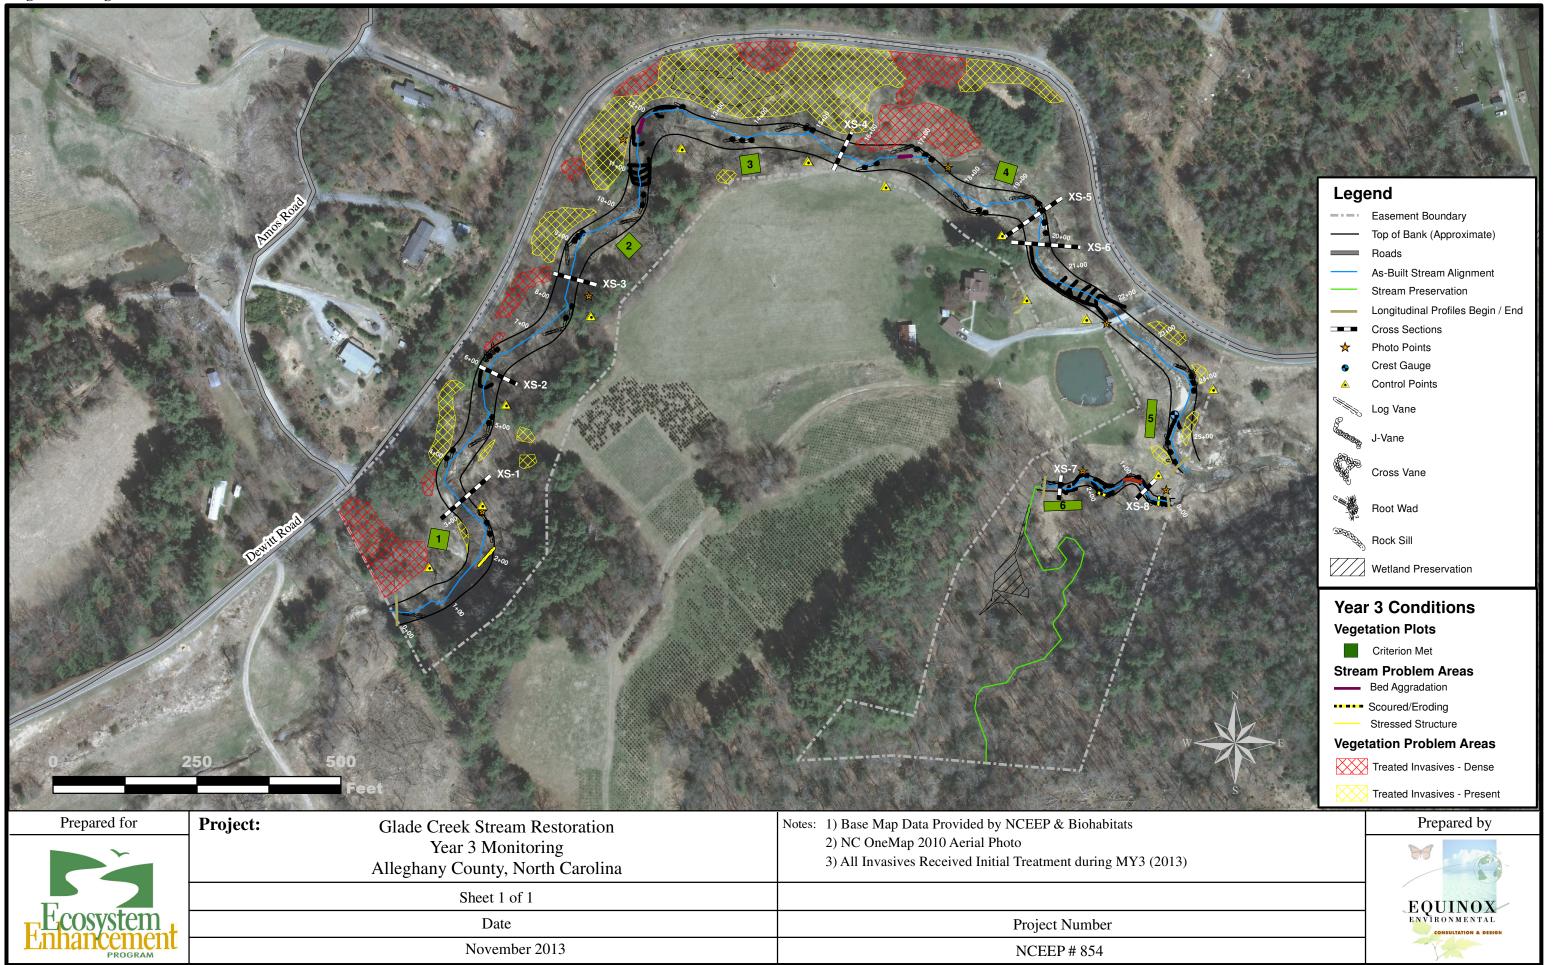
Figure 2. Integrated Current Condition Plan View - Draft

Stream longitudinal profiles remained stable between monitoring years. While three areas of bed aggradation were present, no other areas of significant instability in the stream channel were identified. Two bankfull events were documented in MY3. One bankfull event, measuring 1.7 feet above bankfull, was documented using crest gauge height. Using precipitation data, the date of occurrence was determined to be 1/18/2013. Another event, documented using wrack lines, occurred sometime between 6/19/2013 - 10/30/2013.
