Modlin Property Wetland Mitigation Site Martin County, NC

2007 Annual Monitoring Report Year 1, Baseline

NCEEP Project Number D050241

Date: December, 2007

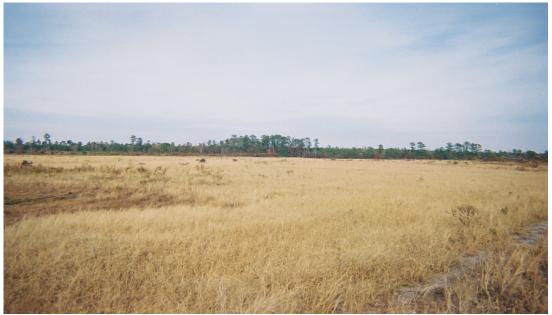
VPA 1 Indicative of entire site

Rainfall data for the area show a significant lack of much needed precipitation for newly planted stock. For the period from April 1, 2007 through October 31, 2007, there was a rainfall deficit of 8.4 inches. This deficit occurred during when evapotranspiration rates were at their annual peak. The lack of water at a crucial time for root development obviously had a significant impact on plant survival. As can be seen in general site photos in Appendix A, the project area supports a complete and heavy ground cover of herbaceous material that may have contributed to the poor survival of planted woody material through competition for scarce soil moisture in the root zone of the very upper soil horizon.

There are no obvious micro scale problem areas. The droughty conditions severely affected both the shrub/scrub and the forested communities in a broad way. The emergent zone faired the best as it was able to retain moisture for longer periods after rainfall due to drainage patterns and its lower elevation. Despite the severely droughty conditions, volunteer tree species such as sweetgum (Liqudambar styraciflua) and sourwood (Oxydendrum arboreum) have begun to seed in. There is a sufficient seed wall on two sides of the project site that should continue to supply volunteer seed.

Table 6. Vegetation Problem Areas						
Feature/Issue	Plot Probable Cause		Photo #			
Herbaceous competition	All	Dense herbaceous cover	VPA 1, VPA 2			
Poor overall stem development and survival	All	Competition and lack of moisture	VPA 3

Plot 1 met the Year 3 success criteria of a minimum of 320 stems per acre after the first growing season. Plots 3 and 4 met the Year 4 success criteria. Over the entire project, the survival rate averaged 243 live stems per acre, a survival rate of 69%. The site will be assessed in the spring of 2008 and those stems that did not survive will be replaced at that time, restoring the stocking at least to the original 350 stems per acre.

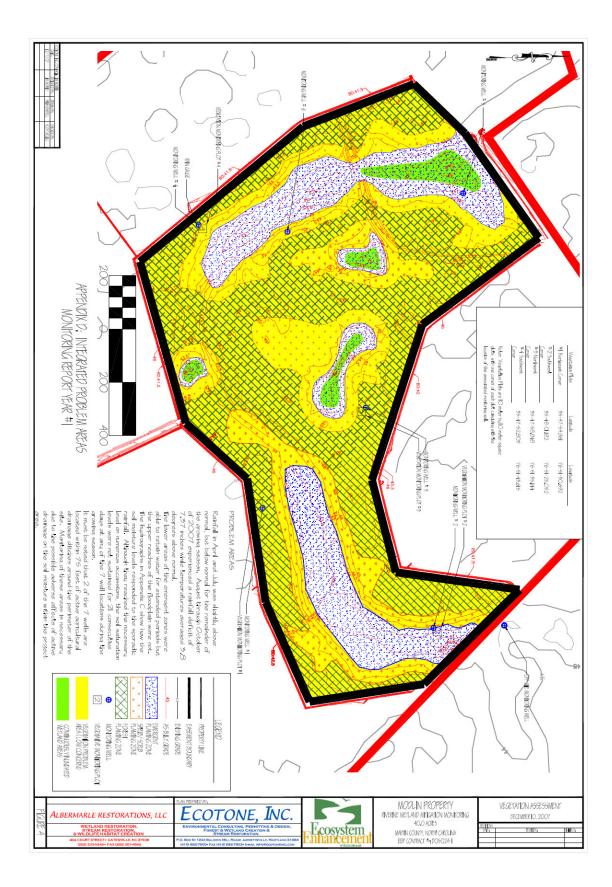
Problem Areas Plan View (Integrated)

Figure 4 in Appendix D illustrates the general poor survival of planted stock due to severely drought conditions throughout the growing season. Although there was no planting of woody material in the emergent zone, it appears to have been fully colonized by hydrophytic species.

The wetland problem areas coincide with the vegetation problem areas. The lower areas of the emergent zone were able to retain water for longer periods, but the upper reaches of the flood plain were not. The hydrographs in Appendix C show the how the soil moisture levels responded to the sporadic rainfall. Although they reached the necessary level on numerous occasions, the soil saturation levels were not sustained for 21 consecutive days at any of the 7 well locations during the growing season.

Figure 4 in Appendix D provides an overview of the hydrologic problem areas. Much of the emergent zone was ponded for some length during the growing season as evidenced by the site photos in Appendix A. In contrast, those areas higher in the flood plain remained very droughty for most of the summer and fall.
