Morgan Creek Stream Restoration Site

Haywood County, North Carolina

MONITORING REPORT 2011 (YEAR 3)

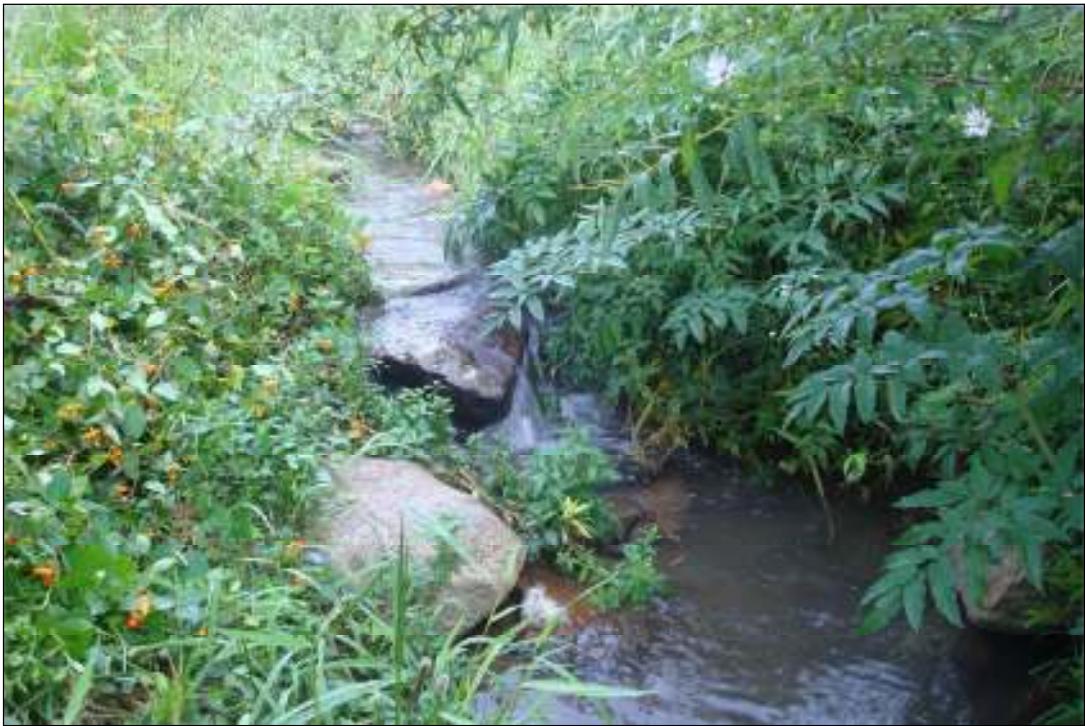
Photo No. 13

Stable Nick Point, Morgan Cr, Sta 105+50

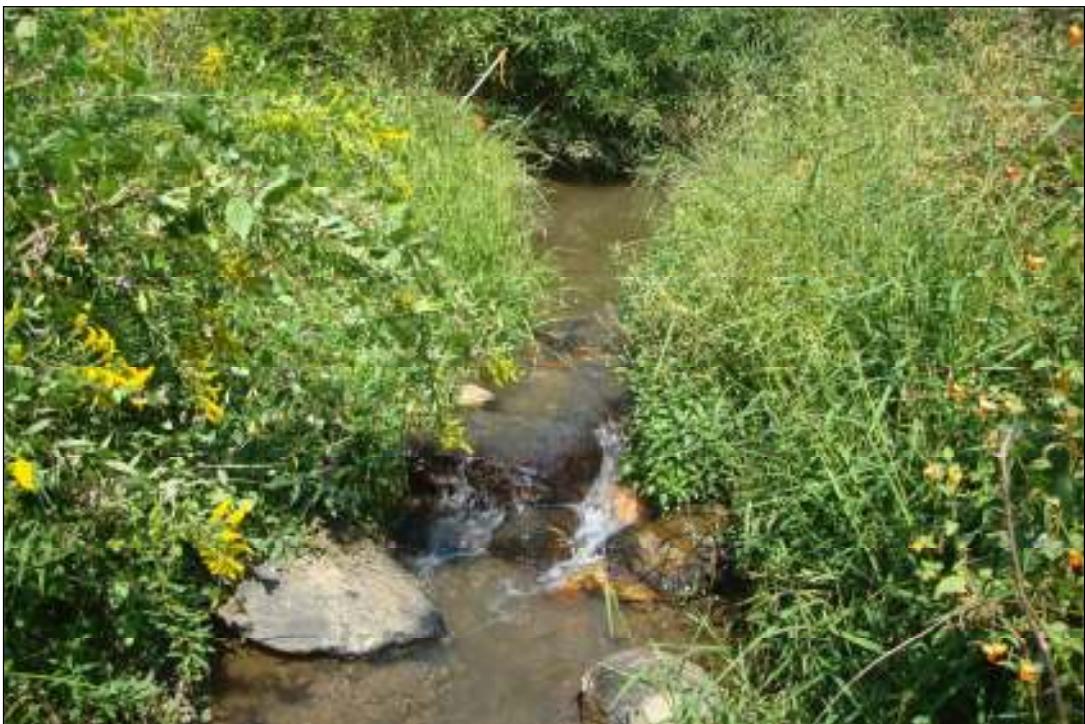
Photo No. 14

Stable Nick Point, Morgan Cr, Sta 124+50

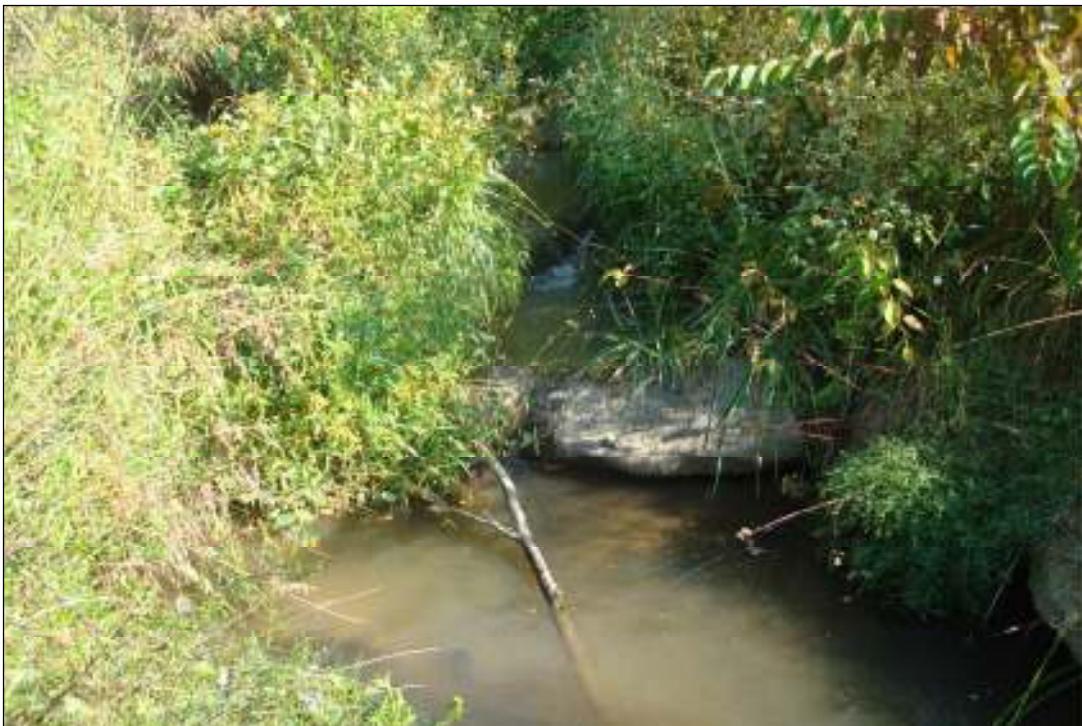
Photo No. 15

Drop at end of structure, Morgan Cr, Sta 11+10

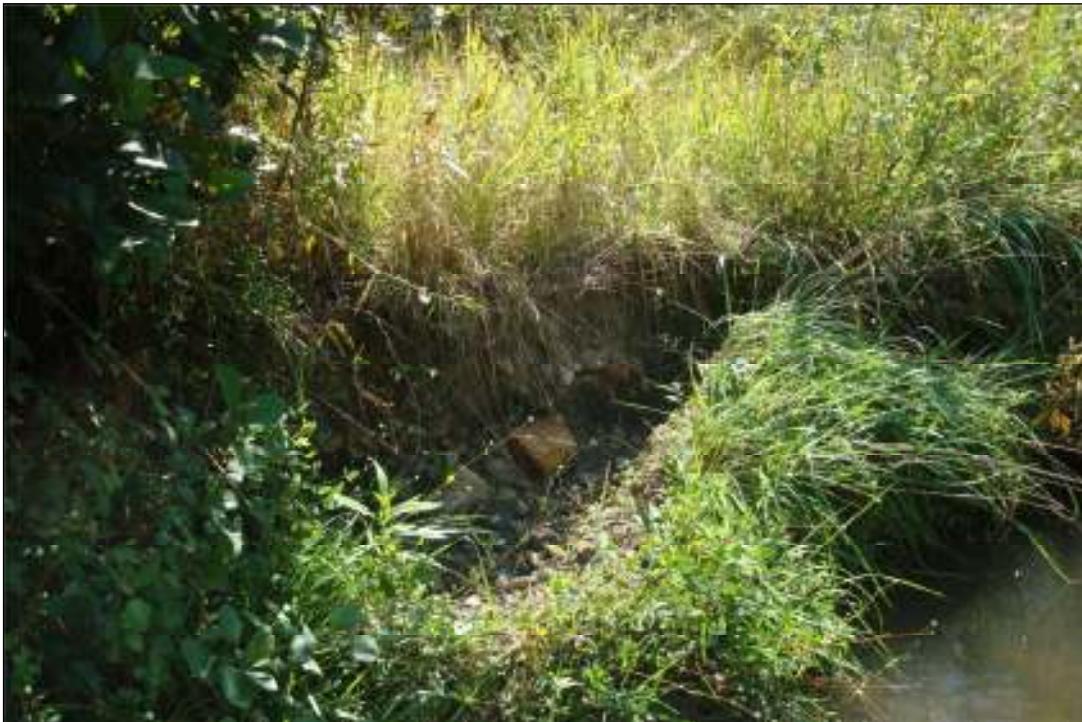
One bank failure occurred at STA 125+00 is approximately 8 ft. in length. This appears to be a localized problem that should not affect the adjacent areas. Sod from the bank failure may act to protect the toe from future erosion. Additional monitoring of the area is the only action required at this time.

Moderate Bank Failure, Morgan Cr, Sta 125+00

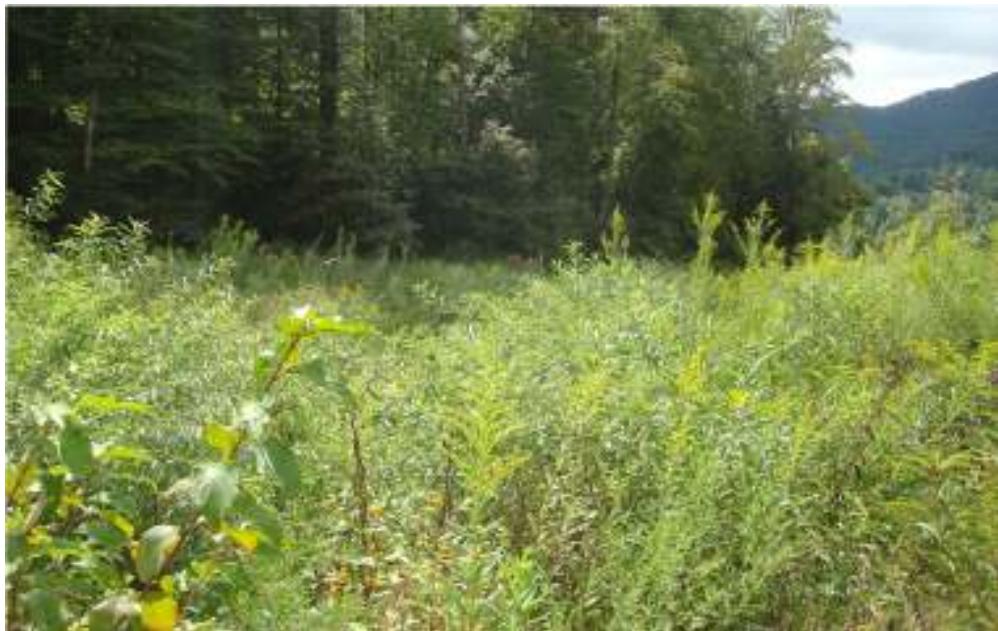
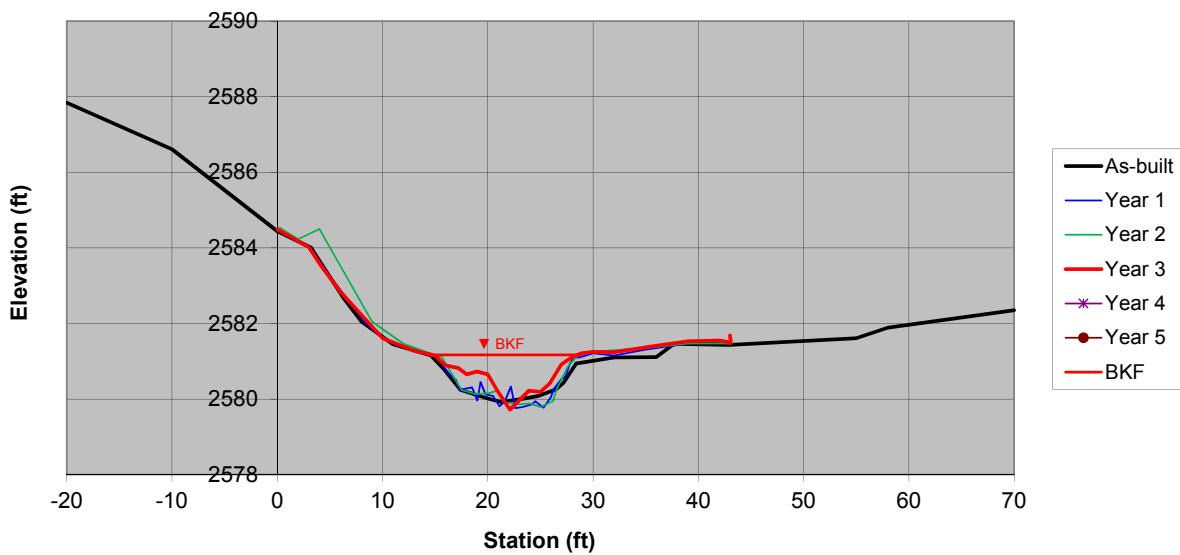
Riffle Cross Section RF1

As-Built		Year 1		Year 2		Year 3		Year 4		Year 5	
Date	1/8/09	Date	10/6/09	Date	9/29/10	Date	9/7/11	Date	0/0/0	Date	0/0/0
Area	12.2	Area	11.4	Area	11.6	Area	8.7	Area	0.0	Area	0.0
Bkf W	13.8	Bkf W	12.9	Bkf W	13	Bkf W	14.2	Bkf W	10	Bkf W	10
Dmean	0.9	Dmean	0.9	Dmean	0.9	Dmean	0.6	Dmean	0.0	Dmean	0.0
Dmax	1.2	Dmax	1.3	Dmax	1.3	Dmax	1.4	Dmax	0.0	Dmax	0.0
W/d	15.6	W/d	14.6	W/d	14.6	W/d	23.3	W/d	0.0	W/d	0.0

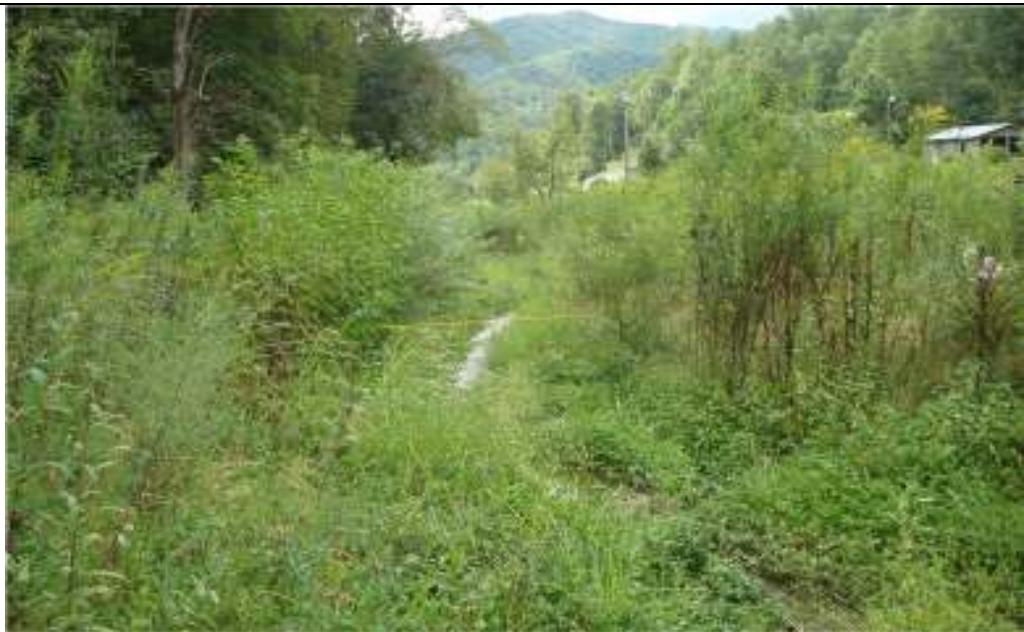
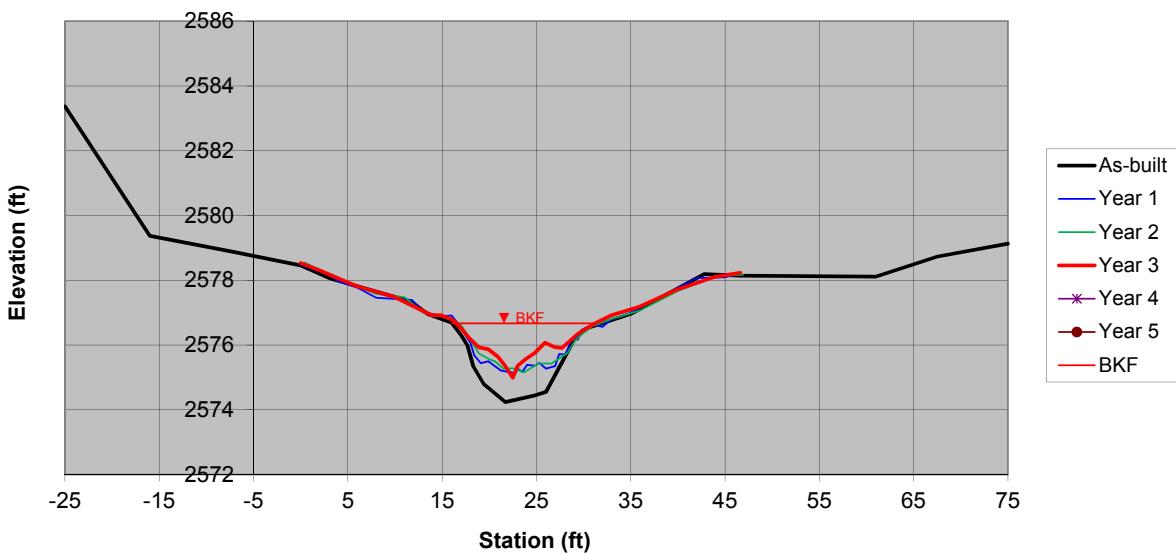
Pool Cross Section PL1

As-Built		Year 1		Year 2		Year 3		Year 4		Year 5	
Date	1/8/09	Date	10/6/09	Date	9/28/10	Date	9/13/11	Date	0/0/0	Date	0/0/0
Area	22.5	Area	13.4	Area	12.5	Area	10.8	Area	0.0	Area	0.0
Bkf W	14.4	Bkf W	14	Bkf W	13.9	Bkf W	15.1	Bkf W	10	Bkf W	10
Dmean	1.6	Dmean	1.0	Dmean	0.9	Dmean	0.7	Dmean	0.0	Dmean	0.0
Dmax	2.5	Dmax	1.5	Dmax	1.4	Dmax	1.7	Dmax	0.0	Dmax	0.0
W/d	9.2	W/d	14.6	W/d	15.4	W/d	21.2	W/d	0.0	W/d	0.0
