OAKLEY CROSSROADS STREAM & BUFFER RESTORATION

FINAL AS-BUILT & BASELINE MONITORING REPORT

Pitt County, North Carolina SCO Project Number 050659701 EEP Project Number 273

Status of Plan: Final Submission Date: August 2011 Data Collection Completed: June 2011

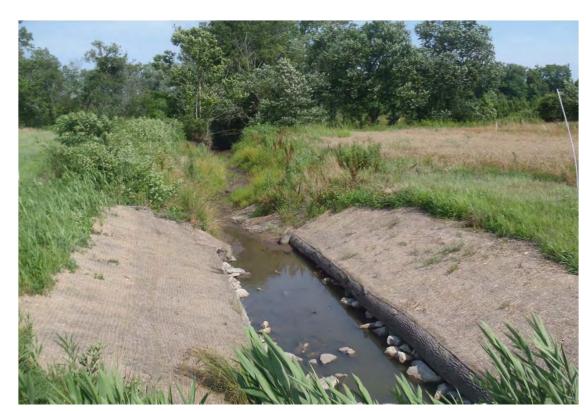
Sta. 38+71 Looking Downstream

Dimensional characteristics obtained from cross-sectional surveying on section 1 and section 2 will be compared year to year. All monitored cross-sections should fall within the quantitative parameters defined for channels of the design stream type. Natural variability is expected, however the system should not experience trends toward excessive increasing bank erosion, channel degradation, or channel aggradation. Section 3 involved riparian buffer planting as a stabilization technique to enhance stream function. Monitoring efforts for section 3 will focus on visual documentation of stability. Also, XS-7 is located just below the Briley culvert and will continue to be monitored.

Also during the Final Walk-Through, it was noted that livestakes per Change Order 3 had not been planted. The intended planting areas per Change Order 3 (upstream and downstream of the Taylor and Briley culverts and near cross-section 7) will be planted between January and March of 2012, as per NCEEP's Vegetation Agreement with Ecosystems Grading Solutions, Inc. Livestake density in other areas of the site were not assessed during the Final Walk-Through and will instead be handled at the end of the warranty period.

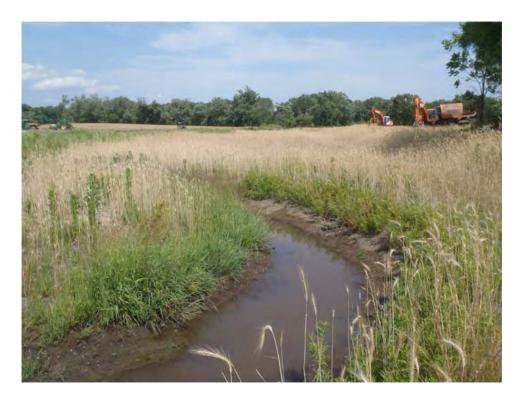
Photo Station S4 – Stream channel looking downstream at cross-section 4 Station 28+46 – Priority 2 (6/19/2011 Year 0)
