FINAL-MY3 Monitoring Report

Seniard Creek Mitigation Site

Henderson County French Broad River Basin Cataloging Unit # 06010105

NCDMS Project No. 100017 NCDMS Contract No. 7189 DMS RFP No. 16-006991

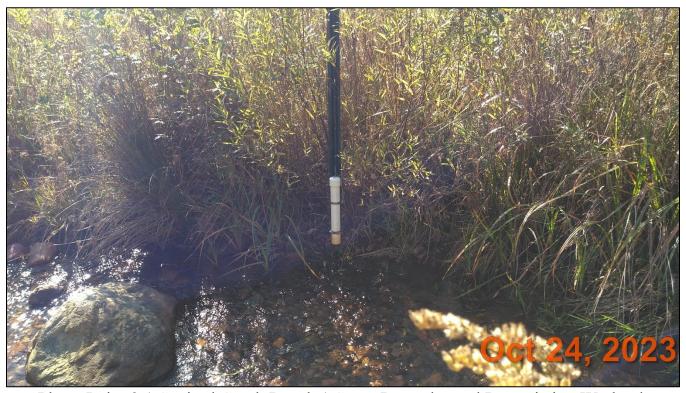
Photo Point 2.1 Seniard Creek Reach 1 Stage Recorder and Pre-existing Wetland.

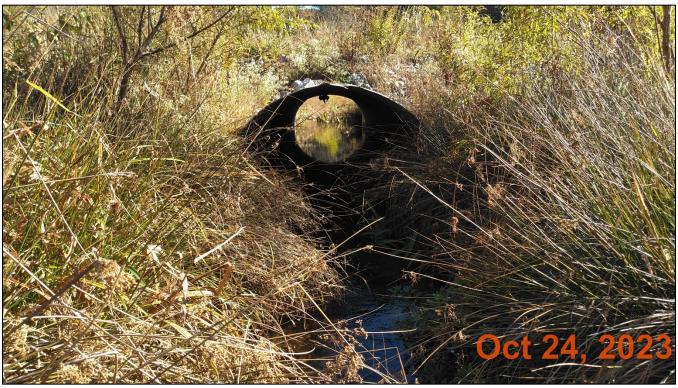
Photo Point 4. Facing downstream through culvert.

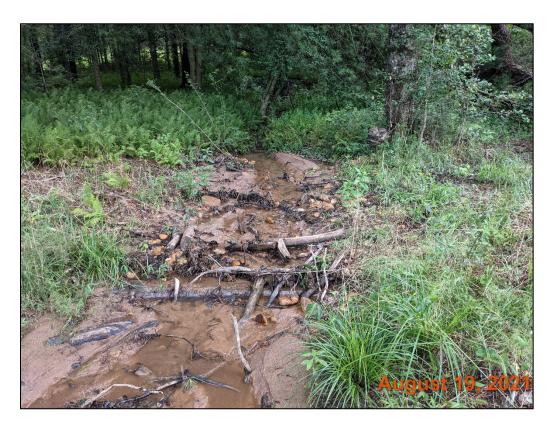
The two areas along Lee and Sitton Creek identified in MY1 as problem areas, Lee Branch at Station 300+25, and Sitton Creek at Station 211+25, have remained stable through MY3. Lee branch experienced a pulse of sediment related to a heavy storm event during MY1. The area had stabilized and revegetated by MY2. Lee Branch had undergone some bank building over the MY3 season indicating additional sediment inputs from upstream. The heavy riparian vegetation along this reach has trapped most of this deposition and Lee continues to maintain bed and bank. The area of bank scour and slump noted at Sitton Creek Station 211+25 during MY1 has completely revegetated following the installation of live stakes in MY2. No further erosion has taken place in this area following the addition and growth of live stakes (See problem area photographs, Appendix A). No additional areas of concern were identified in MY3.

MY1 (2021) Lee Branch Station 300+25 facing upstream.

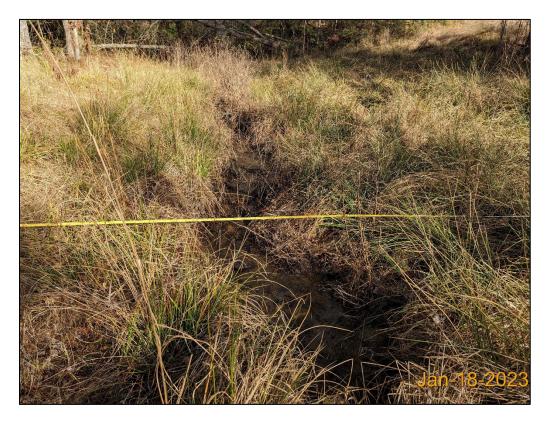
MY3 (2023) Lee Branch Station 300+25 facing upstream.

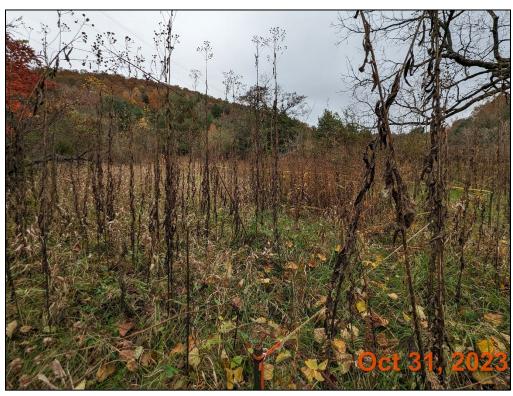
Vegetation Monitoring Plot 9

nine had been previously impacted by a mowing encroachment in MY1, and again by an overhead right-of-way crew in MY3. The overhead right-of-way is slated to be moved adjacent to the conservation easement. Following realignment, the impacted area will be replanted with height appropriate stems. Veg plot #10 contains a stand of previously established alders which have shaded some planted stems and allowed for increased establishment of volunteer alder seedlings. The one temporary plot established to evaluate stem density and heights within a noted "bare area" was meeting performance standards. Plots will continue to be monitored for stem survival and growth throughout the life of the project.
