**ANNUAL MONITORING REPORT
UPPER UT to CANE CREEK (PICKARD)
RESTORATION SITE**

**ALAMANCE COUNTY, NORTH CAROLINA
EEP Project No. 395**

Monitoring Year 2 of 5 (2010)

January 2011

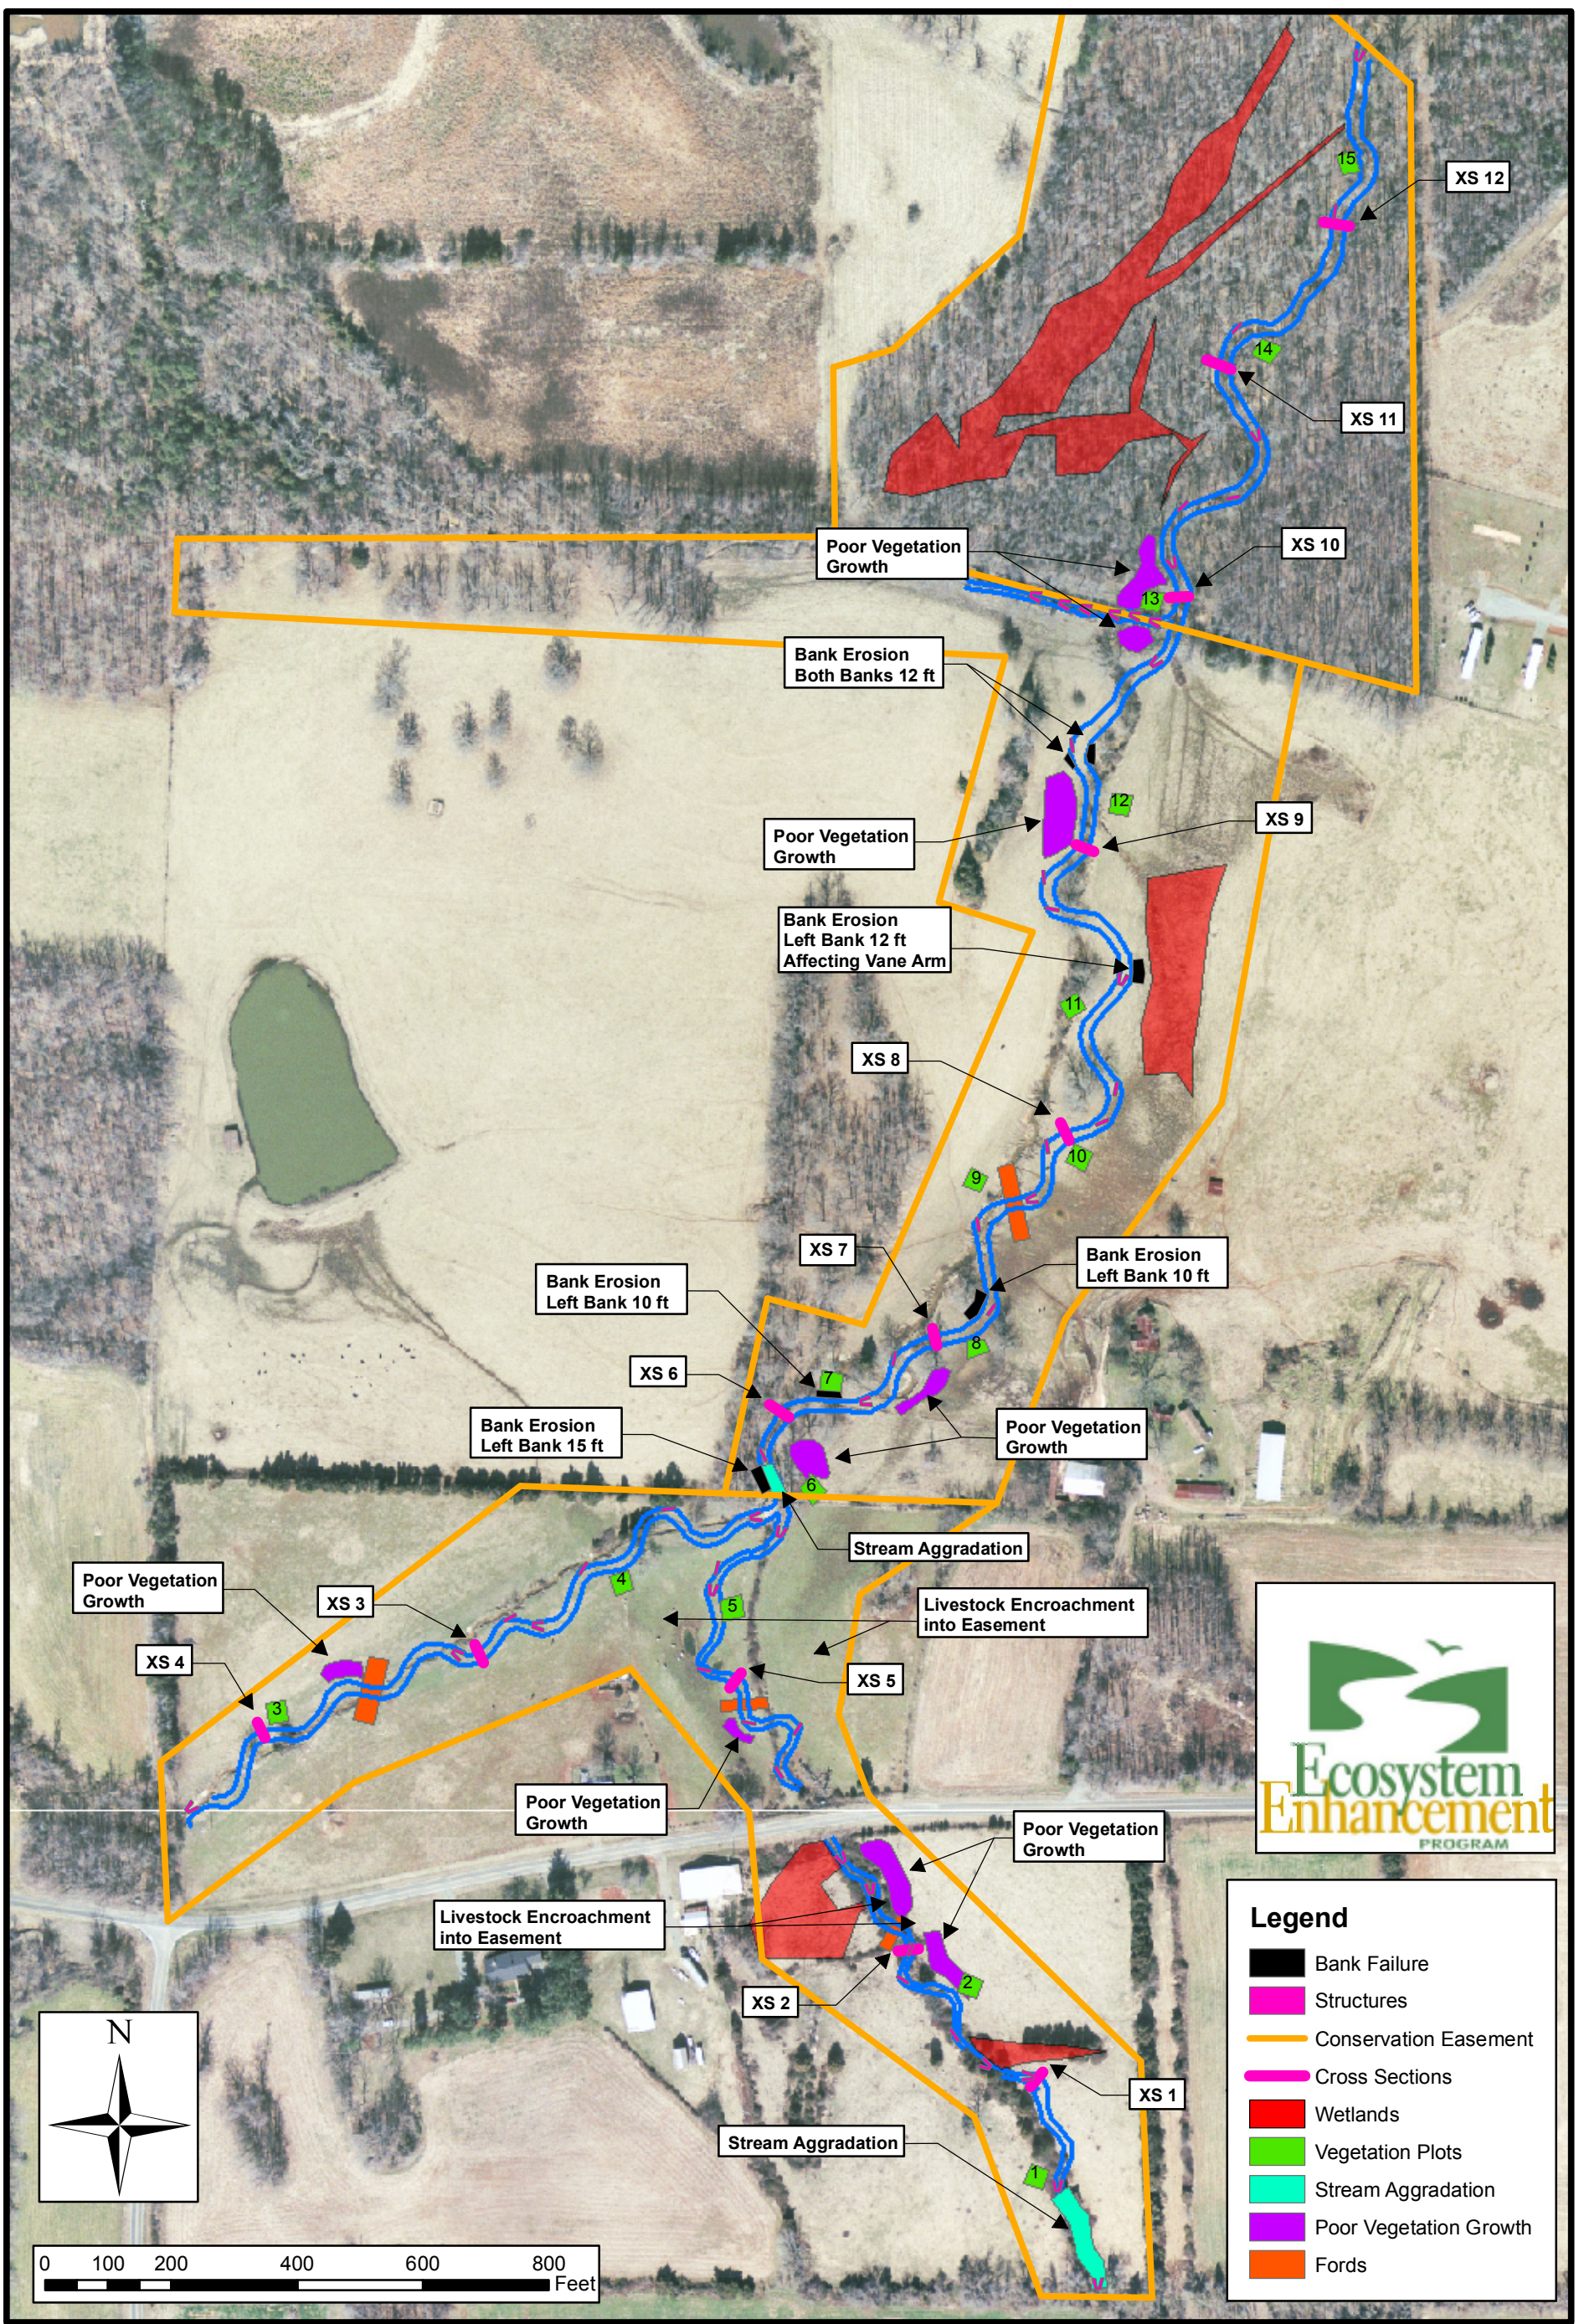
**FIGURE
 3**

**PROBLEM AREA PLANVIEW
 UT to CANE CREEK RESTORATION SITE
 EEP Project # 395
 Alamance County, North Carolina**
