Year 2 Monitoring Report

UT to Uwharrie River Stream Restoration Project Randolph County, North Carolina EEP Project No. 847

Construction Completed: March 2011 Vegetation Data Collected: September 2013 Morphology Data Collected: November 2013 Submission Date: December 2013

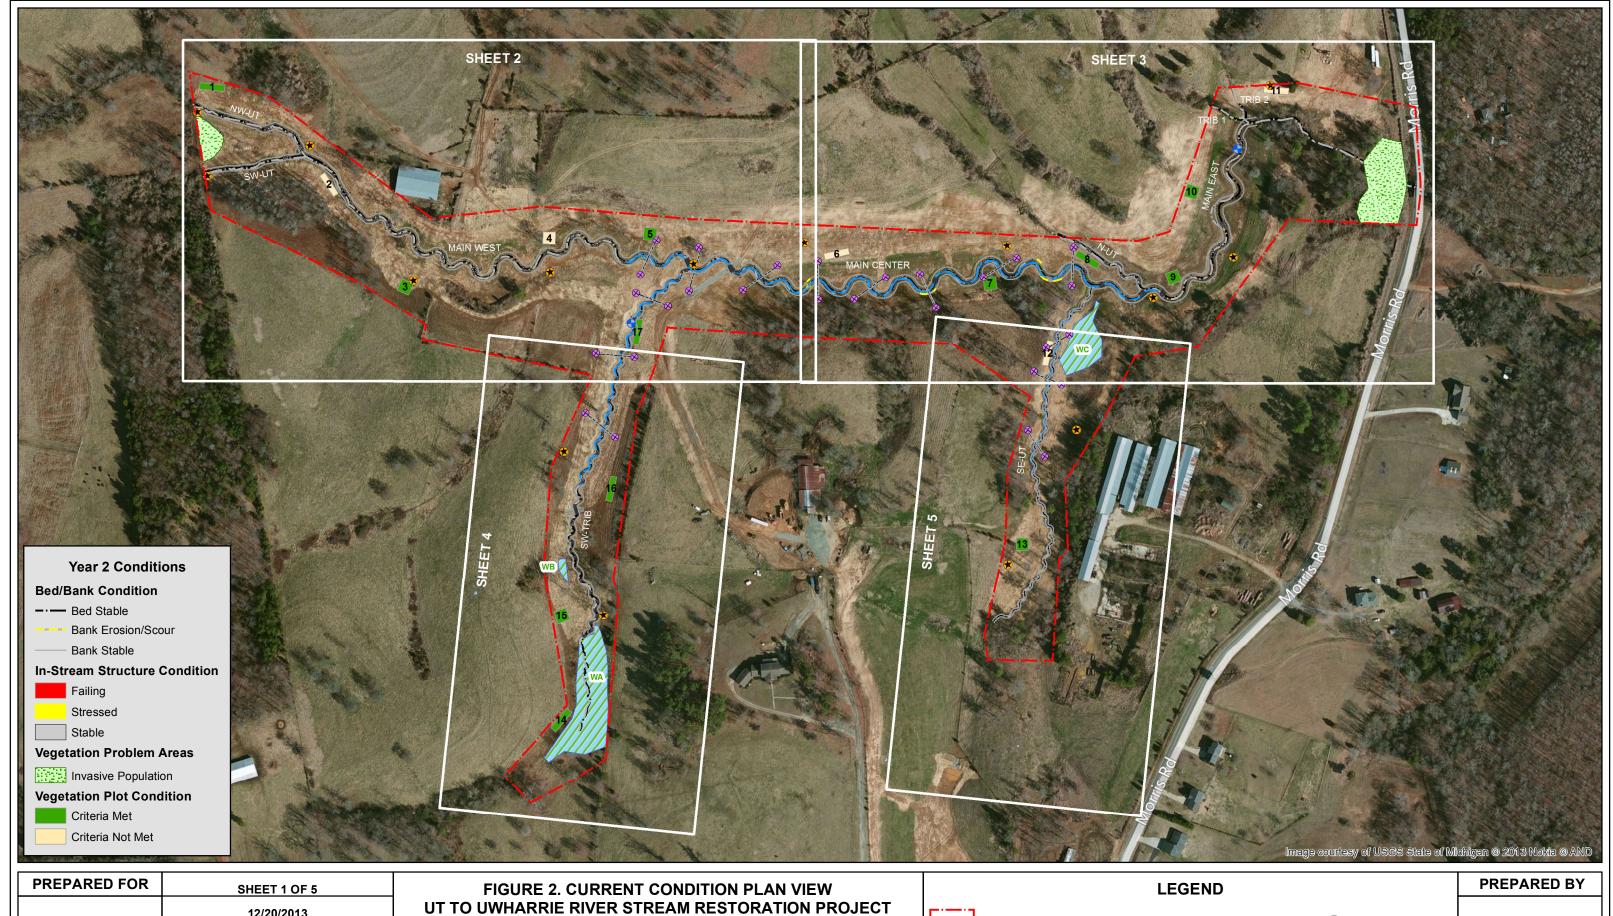
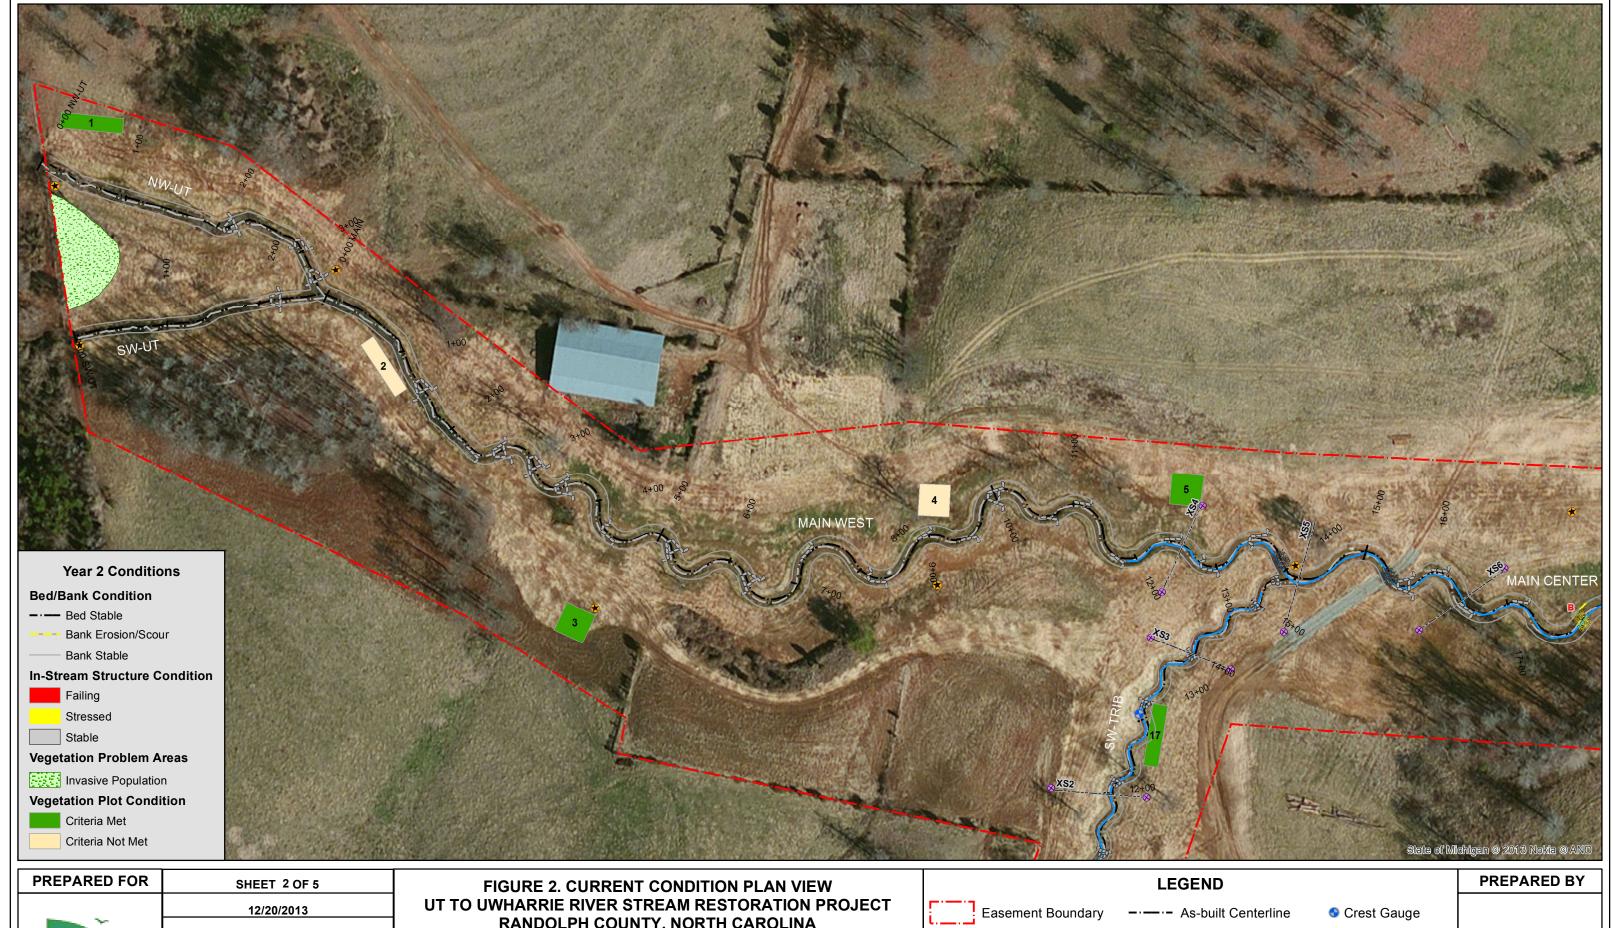
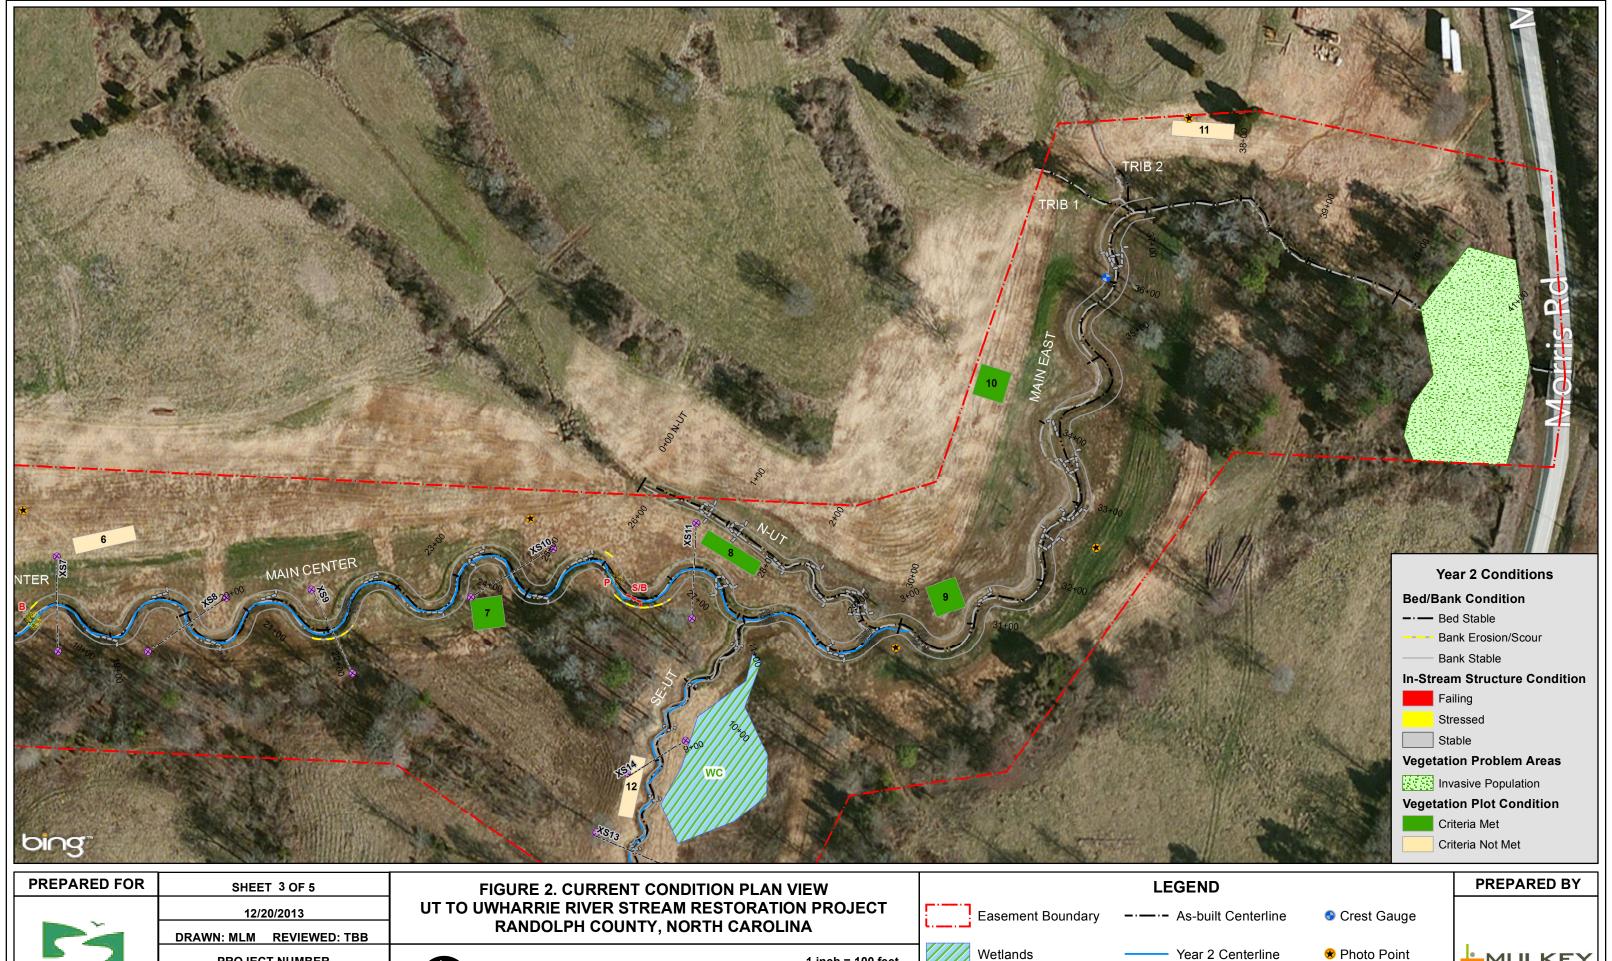
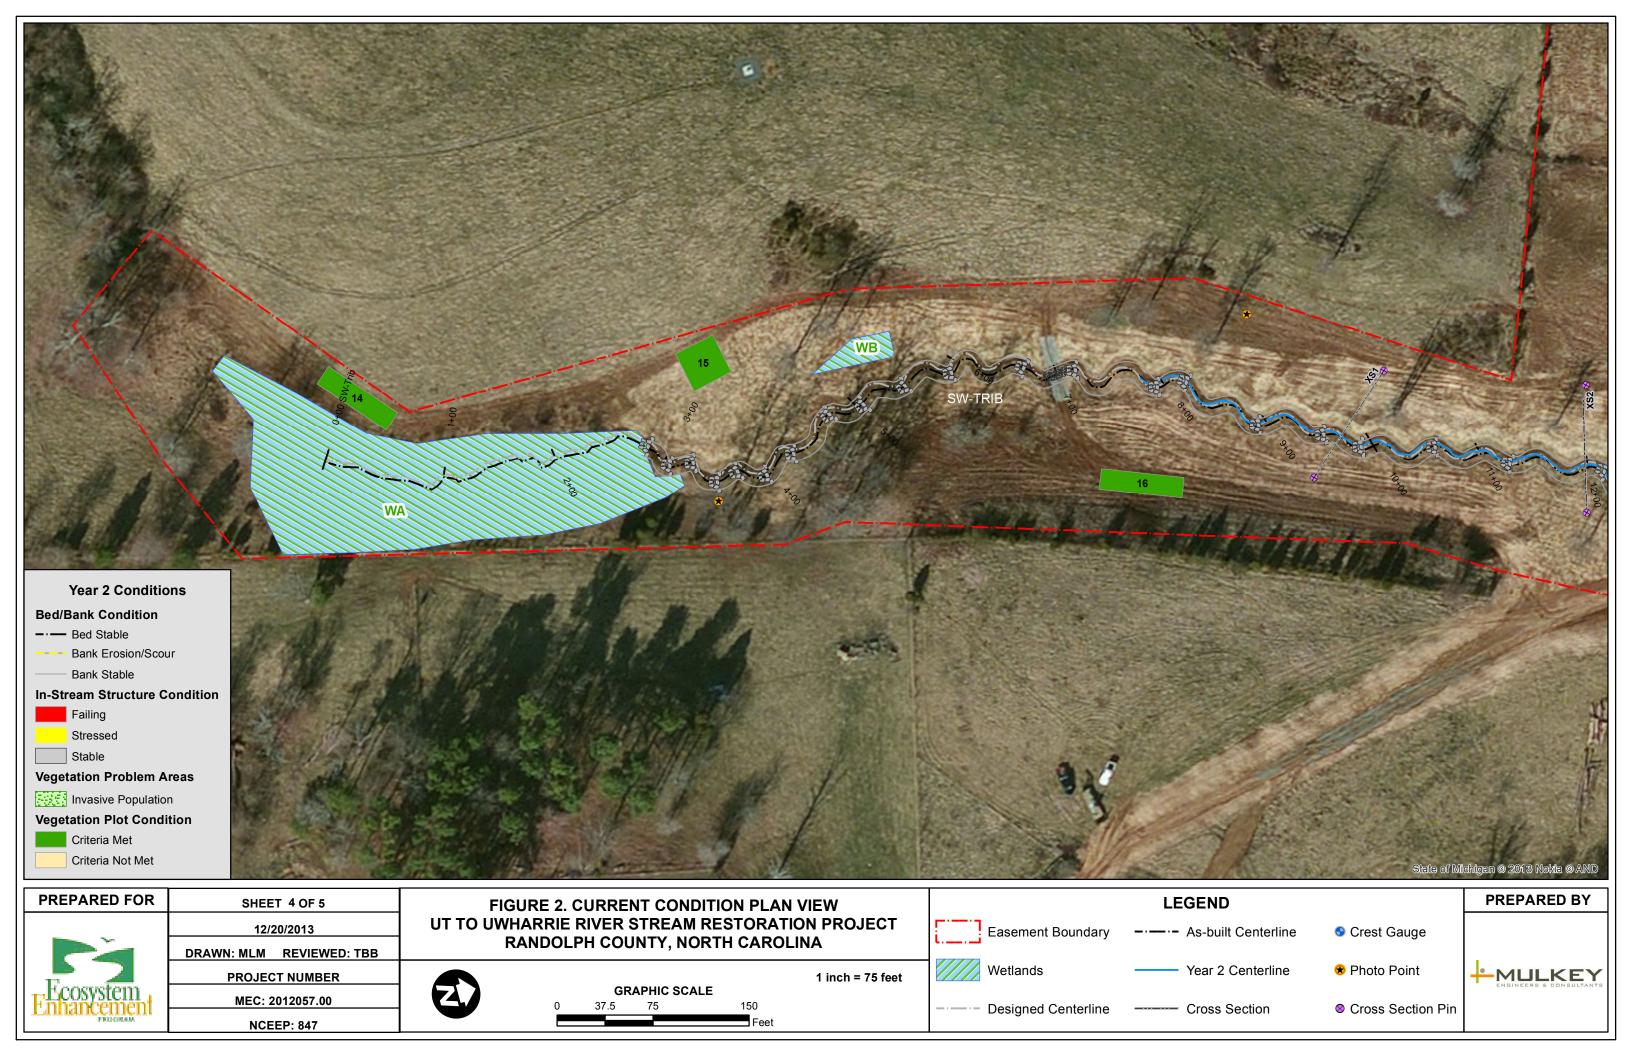
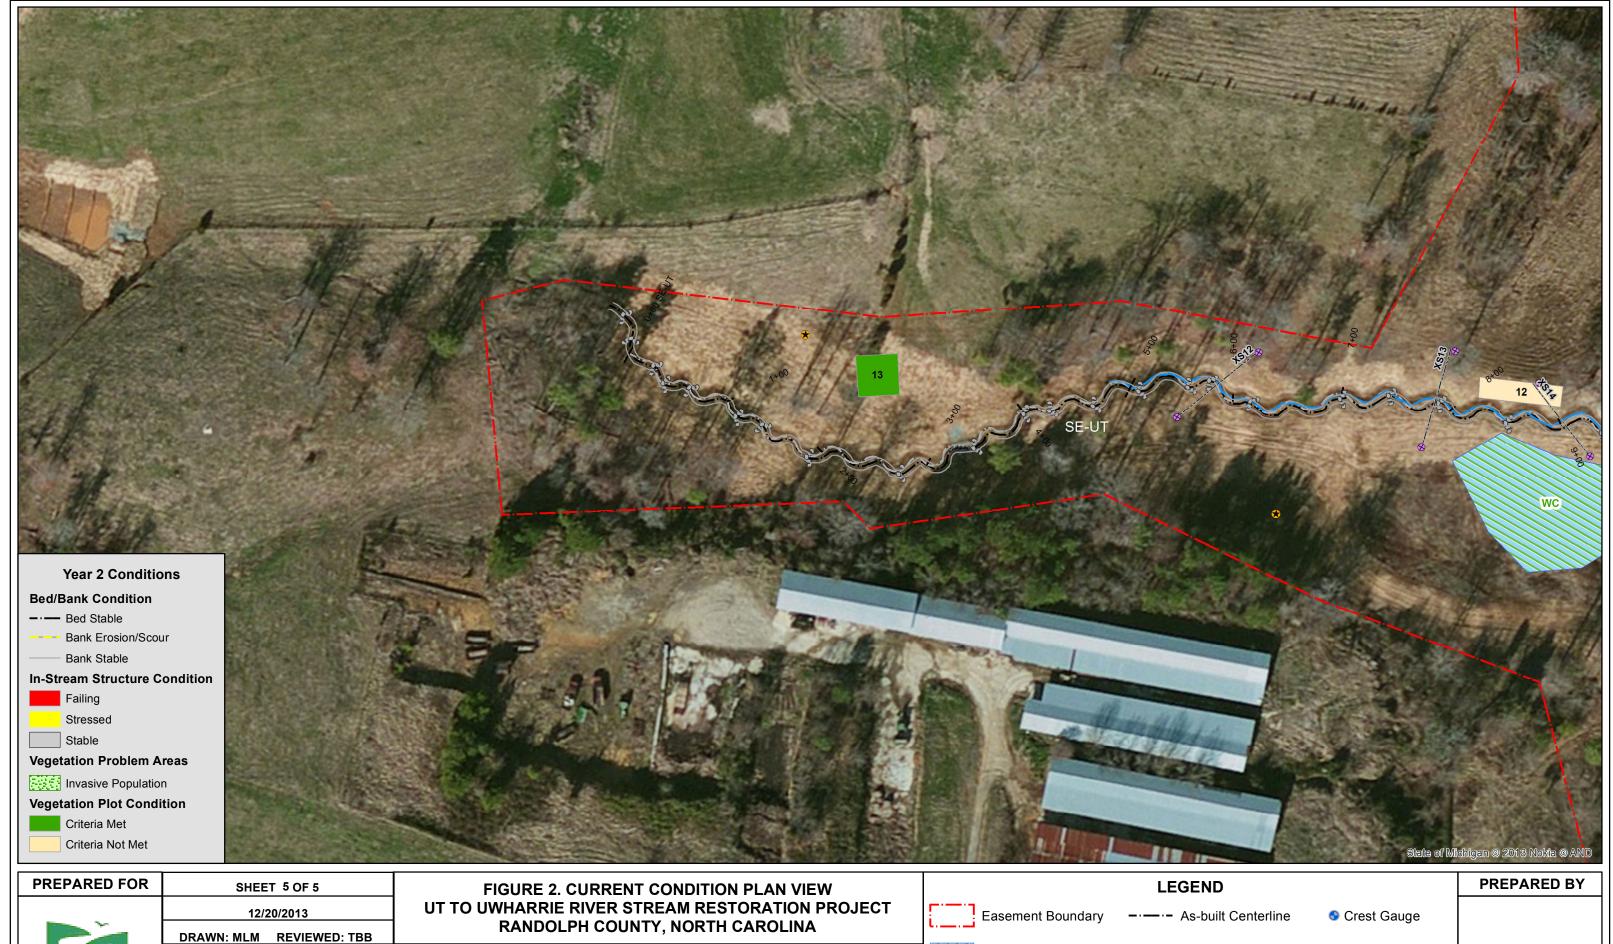
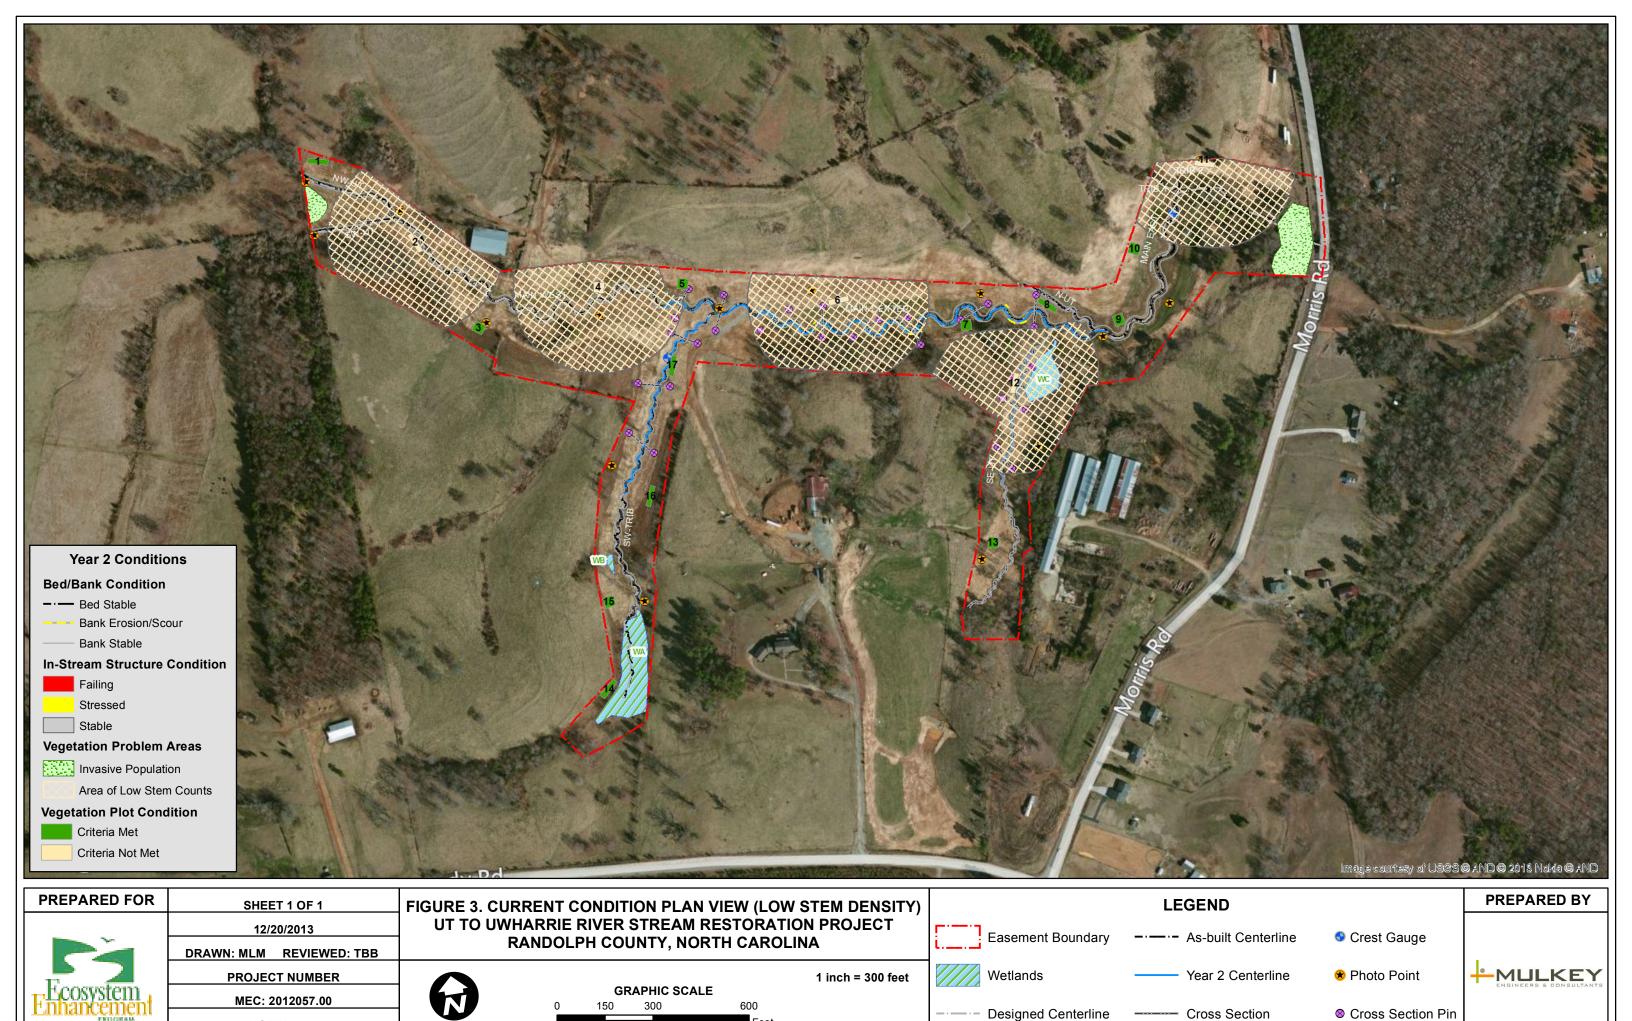
Figure 2. Current Condition Plan View (CCPV) Current Condition Plan View (CCPV) Figure 3.

A visual assessment was conducted during April, September, and November of 2013 to assess the vegetation at the Site. Figure 3 represents areas of low planted and volunteer stem densities within the easement. These areas comprise approximately 16 acres or almost 50% of the Site. Immediate action is recommended to ensure the proper stem densities at the Site.

Two populations of kudzu (*Pueraria lobata*) are located just inside the easement boundary at the western and eastern ends of the Site. The locations of these populations are mapped on the Current Condition Plan View (CCPV) (Figure 2). Invasive/exotic vegetation is not currently compromising the vegetative success of the site. However, due to the highly invasive nature of kudzu, immediate attention should be given to the two populations during the coming year (2014).

Year 2 monitoring surveys along UT to Uwharrie occurred in November 2013. Several areas of instability were noted during longitudinal surveys and are documented on the CCPV (Figure 2). Four areas of bank erosion and scour were observed along the Main Center reach between Stations 17+00 to 27+00. Additionally, one rock vane has been compromised as a result of stream bank erosion around the vane arm and two constructed riffles are stressed within this Station range. One short section of bed degradation was observed along the SW-Trib reach between Stations 11+25 and 11+50. No areas of instability were observed during longitudinal surveys of the SE-UT or Main West.

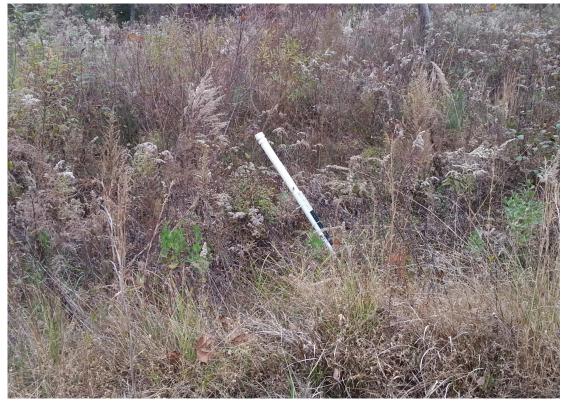
^{1 -} The storm event was measured at 1.4 feet above bankfull elevation.

Crest Gauge (Main East) Leaning Over Following Bankfull Event
