# **MY1 MONITORING REPORT**

# Wits End Stream and Wetland Mitigation Site

Union County, North Carolina Yadkin River Basin Cataloging Unit 03040105

> Data Collection: March - November 2023 Submission: February 2024

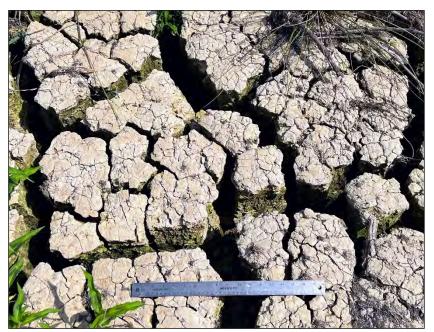
Detail Area 1: AMP Type 3B -Severe Soil Cracking - Bare Soil

Photo 3: Soil cracking - mid-Summer conditions

Due to insufficient planted stem survival and a lack of wetland hydrology within the former pond bed along Waxhaw Branch, RS has implemented an Adaptive Management Plan to address the observed surface cracking in former pod sediments left behind after Site construction. The hydrology issues have been addressed by: (1) physically mixing 0.427 acres of existing top soils that were observed to be severely cracked, then reincorporating the soil along with additional large woody debris to help reestablish healthy soil structure; and (2) installing 2 floodplain grade control (VGC) structures to eliminate subsurface groundwater flow through existing surface cracks and to encourage sediment deposition within the cracks instead of on the floodplain itself. The VGC structures were installed in areas where outer bends of Waxhaw Branch come within close proximity of the former pond boundary. These management activities are expected to improve groundwater hydrology in this area during future monitoring years. Soil mixing areas and locations of the VGC structures are depicted on Figure 1 (Appendix A). Details regarding soil and hydrology improvement-related activities are in the 2023 Adaptive Management Plan (Appendix F).

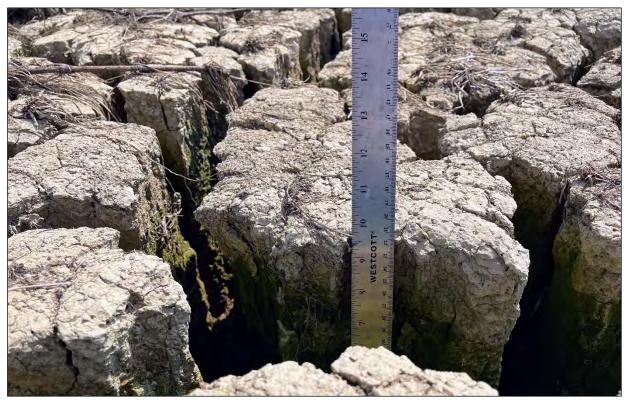
Photo 4: Depth to un-cracked sub-grade/soil

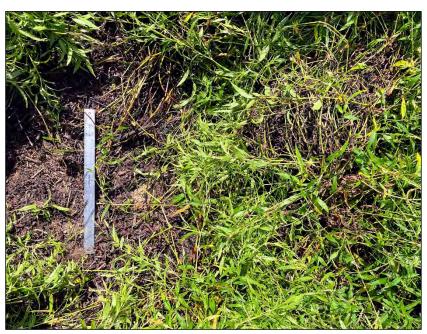
Detail Area 2: AMP Type 1 -No Physical Intervention

Photo 5: Soil cracking - mid-Summer conditions

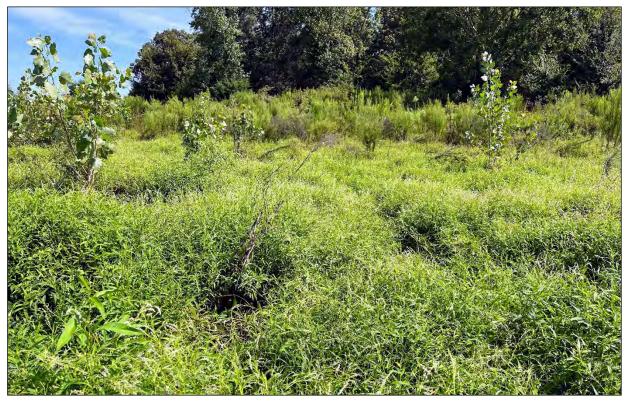
Photo 6: Vegetation conditions

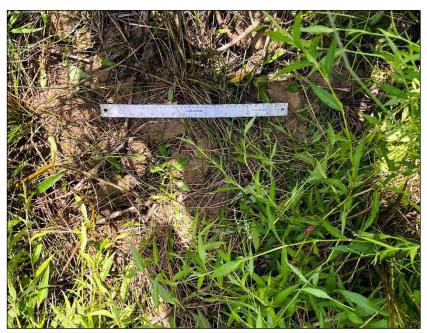
Detail Area 3: AMP Type 1 -No Physical Intervention

Photo 5: Soil cracking – mid-Summer conditions

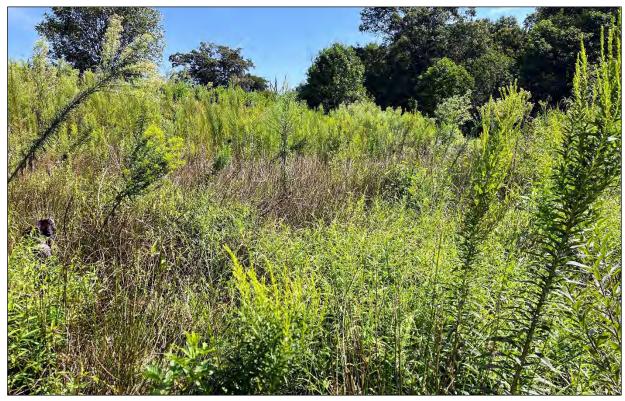
Photo 6: Photo 6: Vegetation conditions
