BUXTON GROIN REPAIR
COUNTY OF DARE, NORTH CAROLINA

NARRATIVE DESCRIPTION OF PROJECT

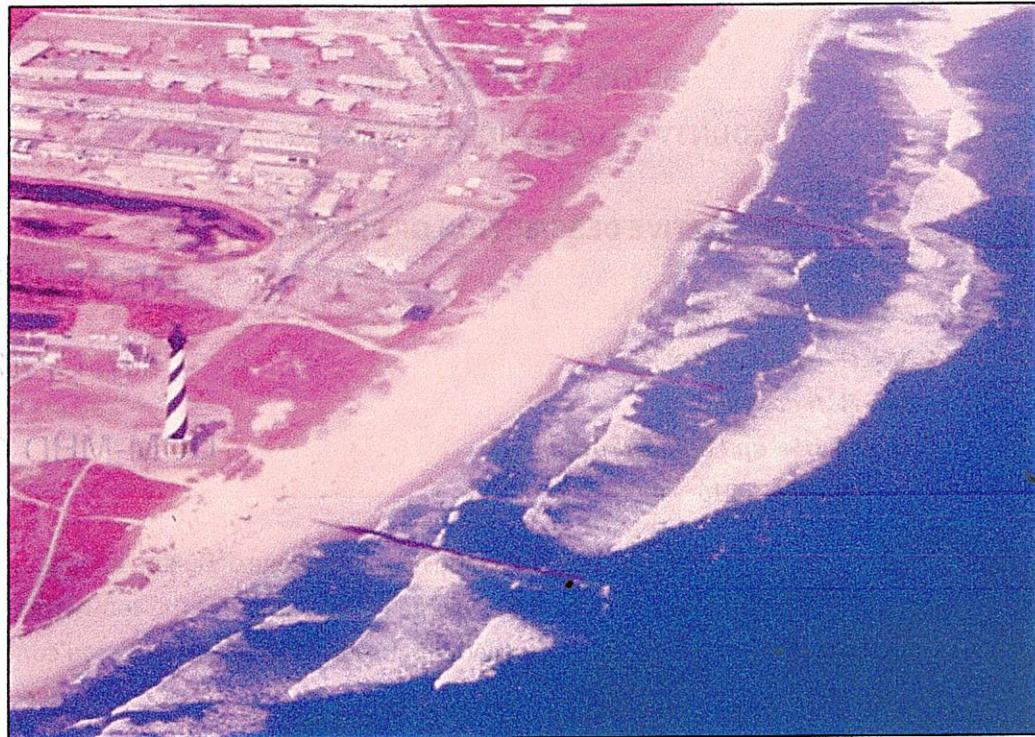
Figure A. Much of the original 1,670 ft length of the three groins remained in place as of September 1978 as shown here. *Photo by T. Kana.*

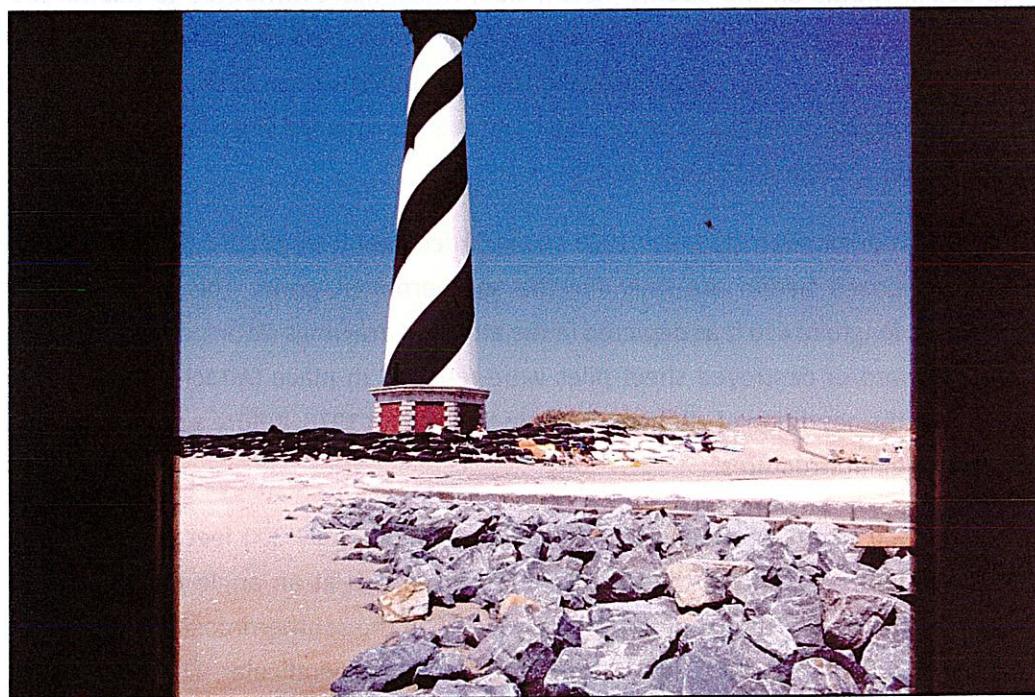
Following the 1980 storm, between 1980 and 1982 an additional ~300 feet of sheet piles were installed at the landward end of the southernmost groin and at an angle to the original piles (Attachment 3 Figure 2.5). This extended the total length of the southernmost groin to 910 ft, with 300 ft angled as an upland tie in and 610 ft oriented shore perpendicular. The total length of all three groins as of 1982 was 1,970 ft. By 1984, armor stone scour protection had been installed along the structure as shown in Figure B, along with a number of sandbags around the base of the Cape Hatteras Lighthouse.

Figure B. By 1984, following the landward extension of the southernmost groin by 300 ft, armor stone scour protection had been installed along the structure and sandbags had been installed at the lighthouse. *Photo by T. Kana.*

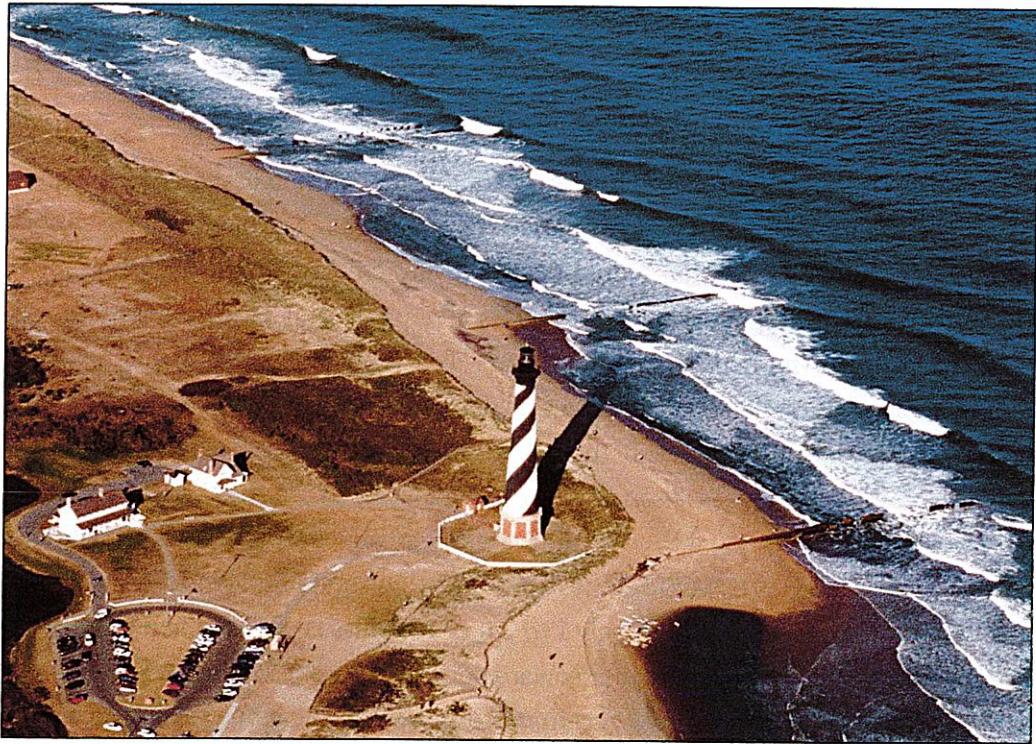
Figure C. By 1999, most of the scour protection and sandbags had been buried or removed. *Photo by USAF.*

The most recent repairs made to the structure (in 1994) consisted of new sheet piles driven adjacent to the original sheet piles, and additional scour protection at the base of the structure. According to engineered drawings (Attachment 3 Figure 2.7), ~180 ft of sheet piles were installed. By 1999, much of the scour protection was buried along with the sandbags as shown in Figure C.

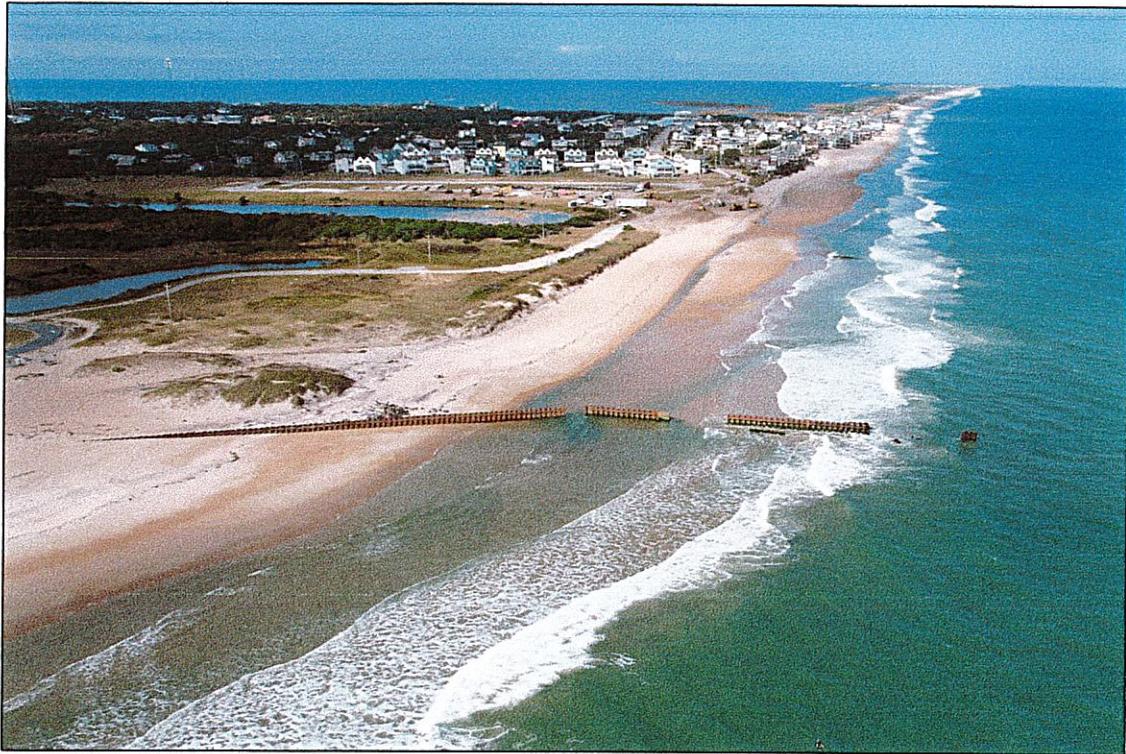
As of October 2024, sheet piles remain in place along approximately 410 feet of the linear footprint of the southernmost groin (Fig D, E). An additional ~20 feet of buried sheet piles remain at the landward tie-in of repairs constructed following the 1980 storm. The proposed repairs consist of reconstruction of 640 ft of the original linear footprint of the southernmost groin (Fig E).

Figure D. As of late 2024, approximately 410 ft of the sheet piles remain in place along the original linear footprint of the southernmost groin. Photo by D Giles.

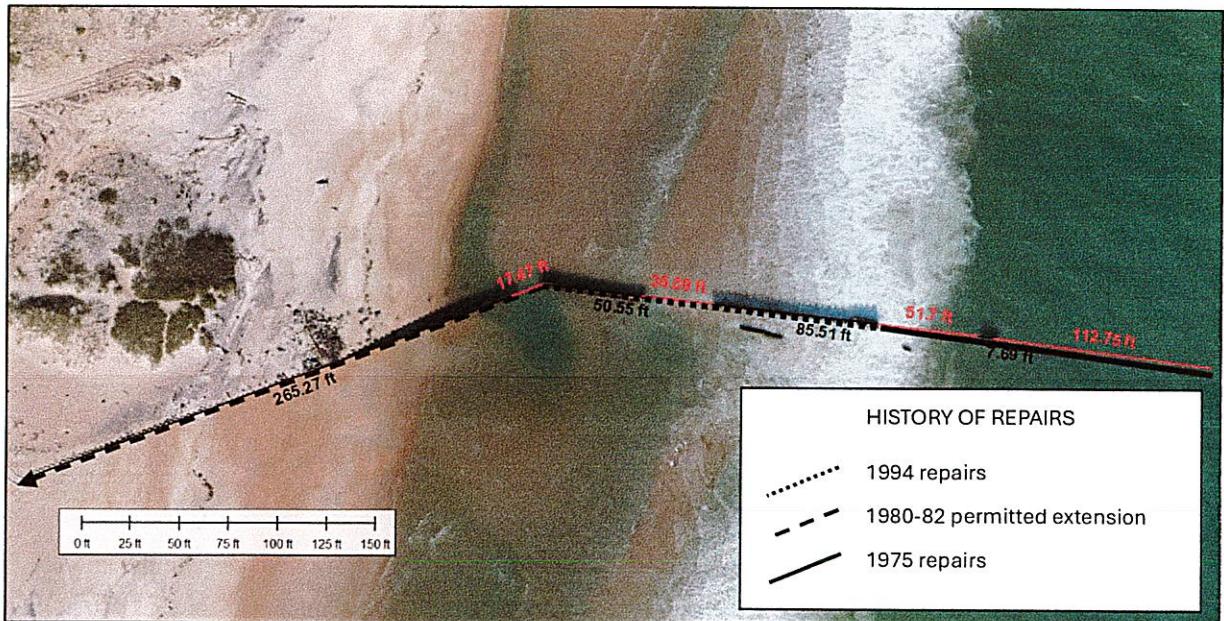
Figure E. Proposed repairs consist of placing sister sheet piles along 640 ft of the original footprint of the structure. Black segments indicate portions of sheet piles remaining in place, while red sections indicate portions of sheet pile lying below MSL (eg heavily damaged).

These repairs would involve placing sheet piles and armor stone along the same path as the existing structure. Existing sheeting will be removed and replaced by new sheets along the

landward end of the structure (between station 0+00 and 4+57). Note that conditions and buried pieces of material may prevent driving sheets along the seaward end of this section. Armor stone will be placed along the seaward end of the structure to aid in scour protection and restore sand the sand trapping capacity in areas too deep to effectively install new sheet pile.
