PROJECT NARRATIVE

**EXISTING GROIN REHABILITATION
FEASIBILITY STUDY**

CAPE HATTERAS, NORTH CAROLINA

5 JULY 2006

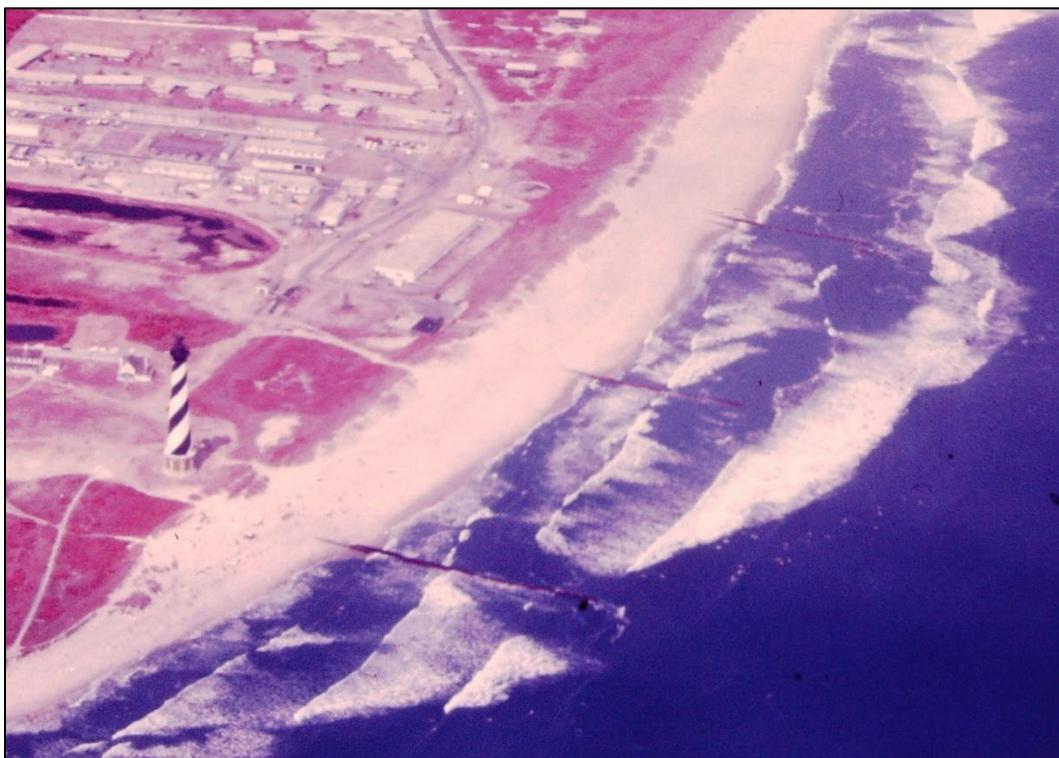
Figure A. Much of the original 1,670 ft length of the three groins remained in place as of September 1978 as shown here. *Photo by T. Kana.*

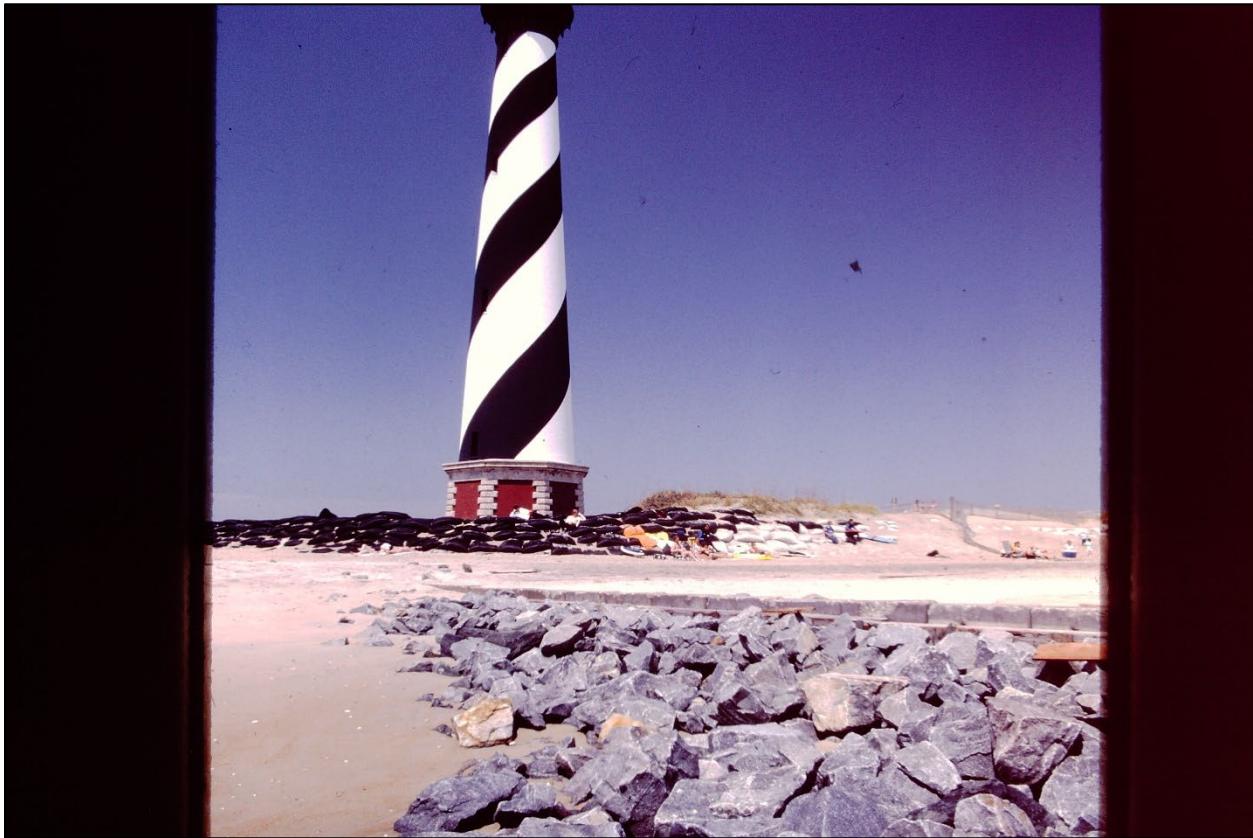
Figure B. By 1984, following the landward extension of the southernmost groin by 300 ft, armor stone scour protection had been installed along the structure and sandbags had been installed at the lighthouse. *Photo by T. Kana.*

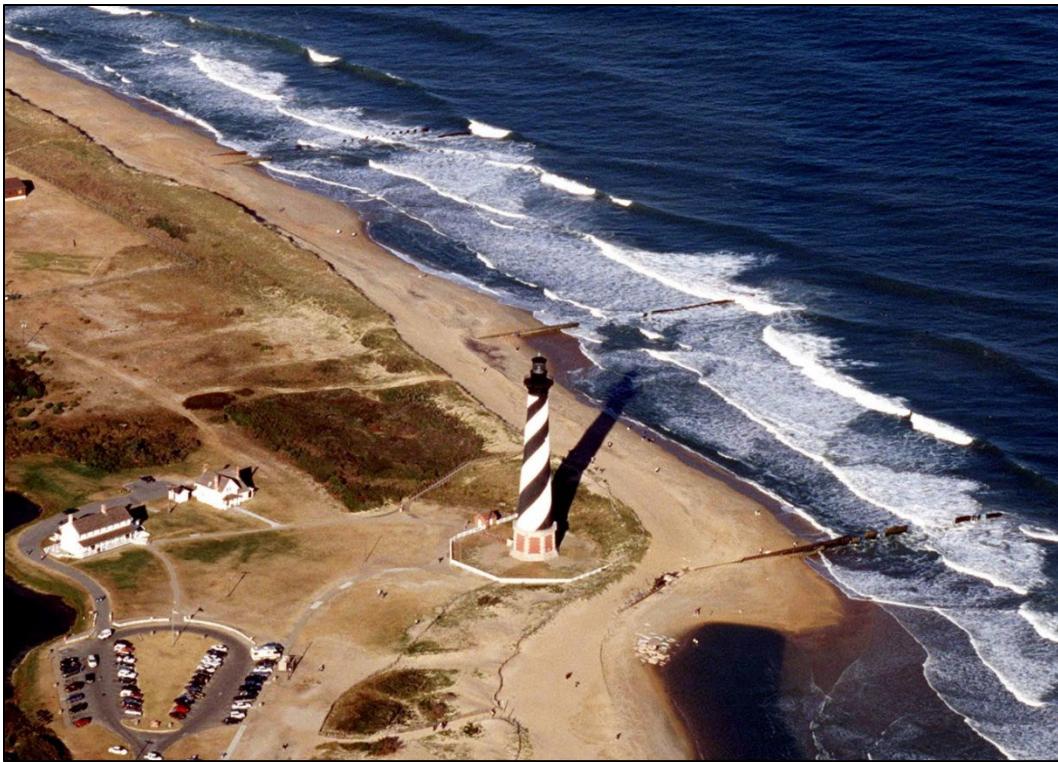
The most recent repairs made to the structure (in 1994) consisted of new sheet piles driven adjacent to the original sheet piles, and additional scour protection at the base of the structure. According to engineered drawings (Attachment 3 Figure 2.7), ~180 ft of sheet piles were installed. By 1999, much of the scour protection was buried along with the sandbags as shown in Figure C.

Figure C. By 1999, most of the scour protection and sandbags had been buried or removed. *Photo by USAF.*

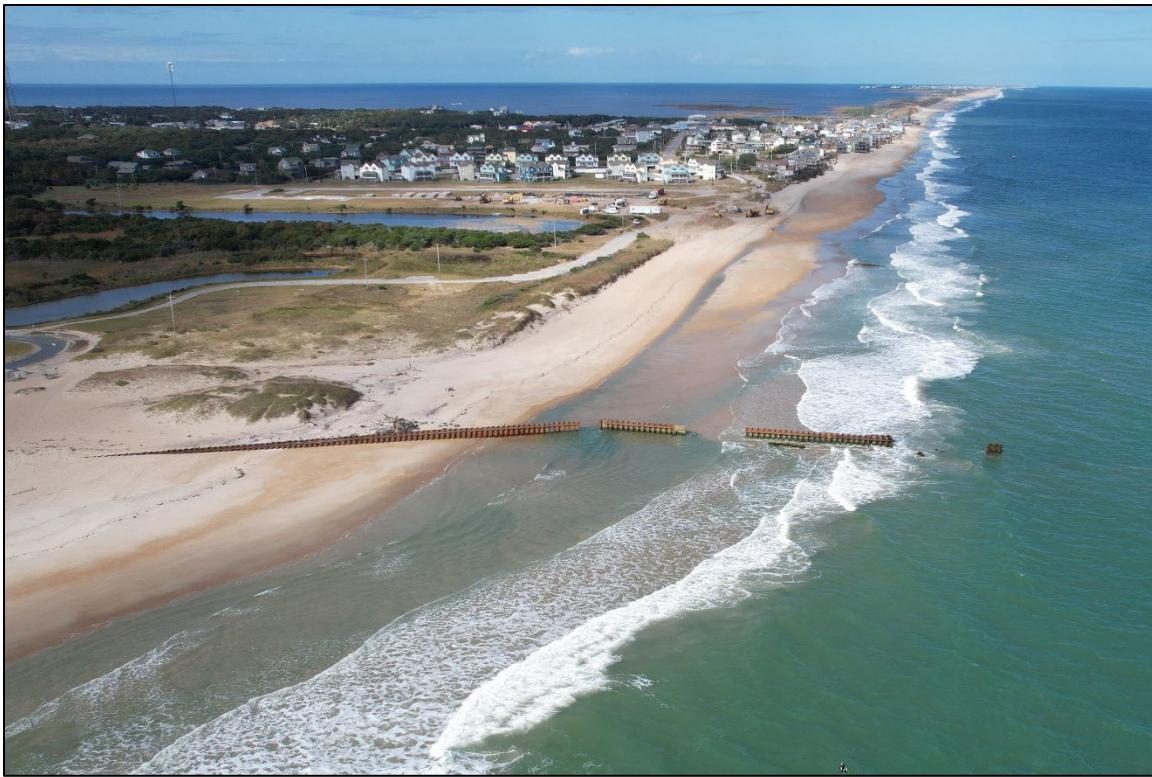
As of October 2024, sheet piles remain in place along approximately 410 feet of the linear footprint of the southernmost groin (Fig D, E). An additional ~20 feet of buried sheet piles remain at the landward tie-in of repairs constructed following the 1980 storm. The proposed repairs consist of driving steel sheet piles along 640 ft of the original linear footprint of the southernmost groin (Fig E). Following a similar design as the original work, this length approximates the length of sheet pile repairs made in 1975, 1980-1982, and 1994 along the southernmost groin. These repairs would involve placing sister sheet piles along the existing damaged portions of the structure (black segments, Fig E), and placing new sheet piles to close the gaps in the structure created by storm damage (red segments, Fig E). The maximum crest elevation of the proposed repairs is 8 ft NAVD, matching the original permitted design (Fig F, Fig G, Attachment 4). Final design elevations of the crest may be lower, to reduce the force of incoming wave energy and create an equilibrium beach profile closer to the natural slope. Scour protection would be placed adjacent to the shore normal section of the repaired structure below mean low water (Fig G).

Figure D. As of late 2024, approximately 410 ft of the sheet piles remain in place along the original linear footprint of the southernmost groin. *Photo by D Giles.*

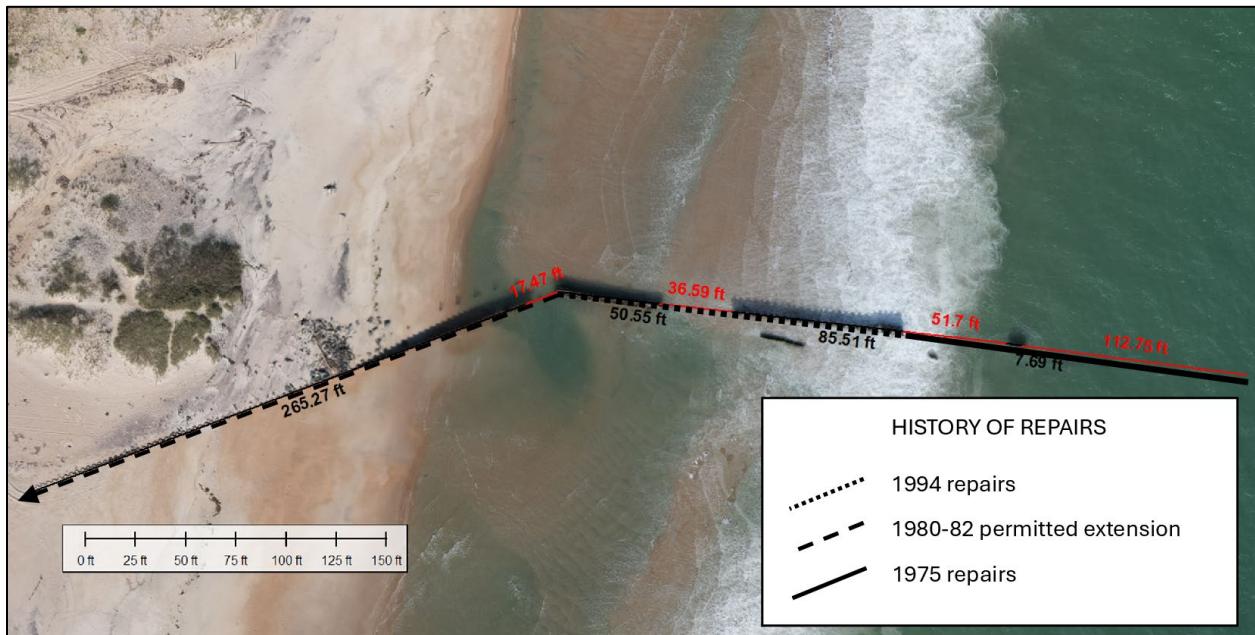
Figure E. Proposed repairs consist of placing sister sheet piles along 640 ft of the original footprint of the structure. Black segments indicate portions of sheet piles remaining in place, while red sections indicate portions of sheet pile lying below MSL (eg heavily damaged).

The total length of the groin system at Buxton including original construction and permitted extensions is 1,970 ft. The proposed repairs would restore functionality to 640 ft of the southernmost groin. Therefore, repairs do not require a Major Permit application according to Code 15A NCAC 07J .0210 ‘REPLACEMENT OF EXISTING STRUCTURES’ (Attachment 5).

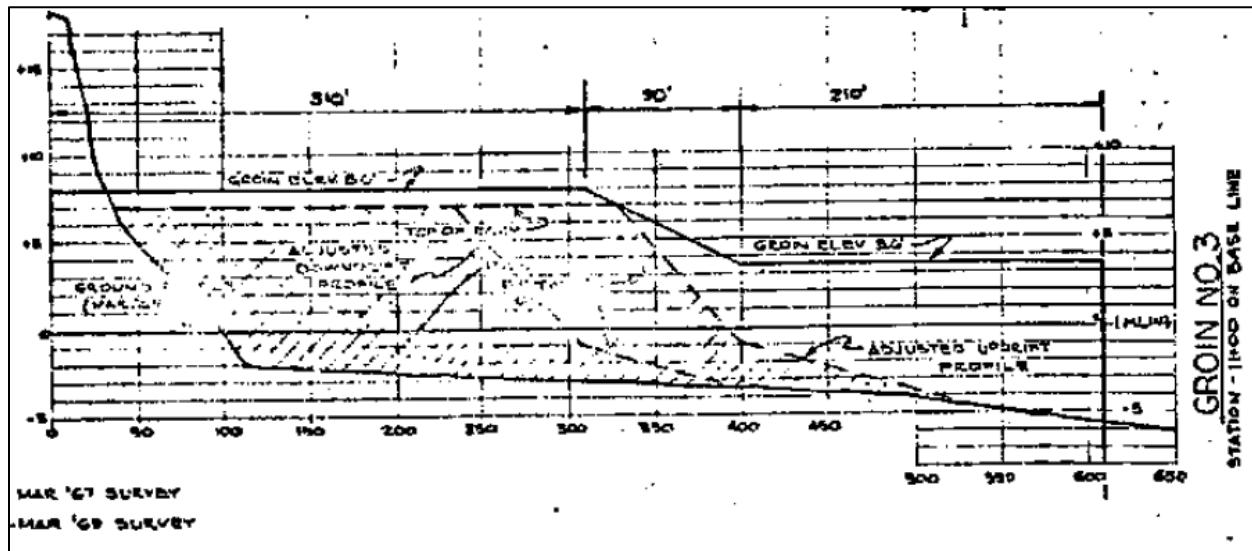
Figure F. The original groin profile designed and constructed by the US Navy in 1969. The proposed repairs emulate the 8-ft elevation portion of the crest between 90 and 310 ft on the x axis shown above, but do not include the 300-ft sloping section with lower crest elevations. A full copy of the original design plans is included in Attachment 4 to this request.

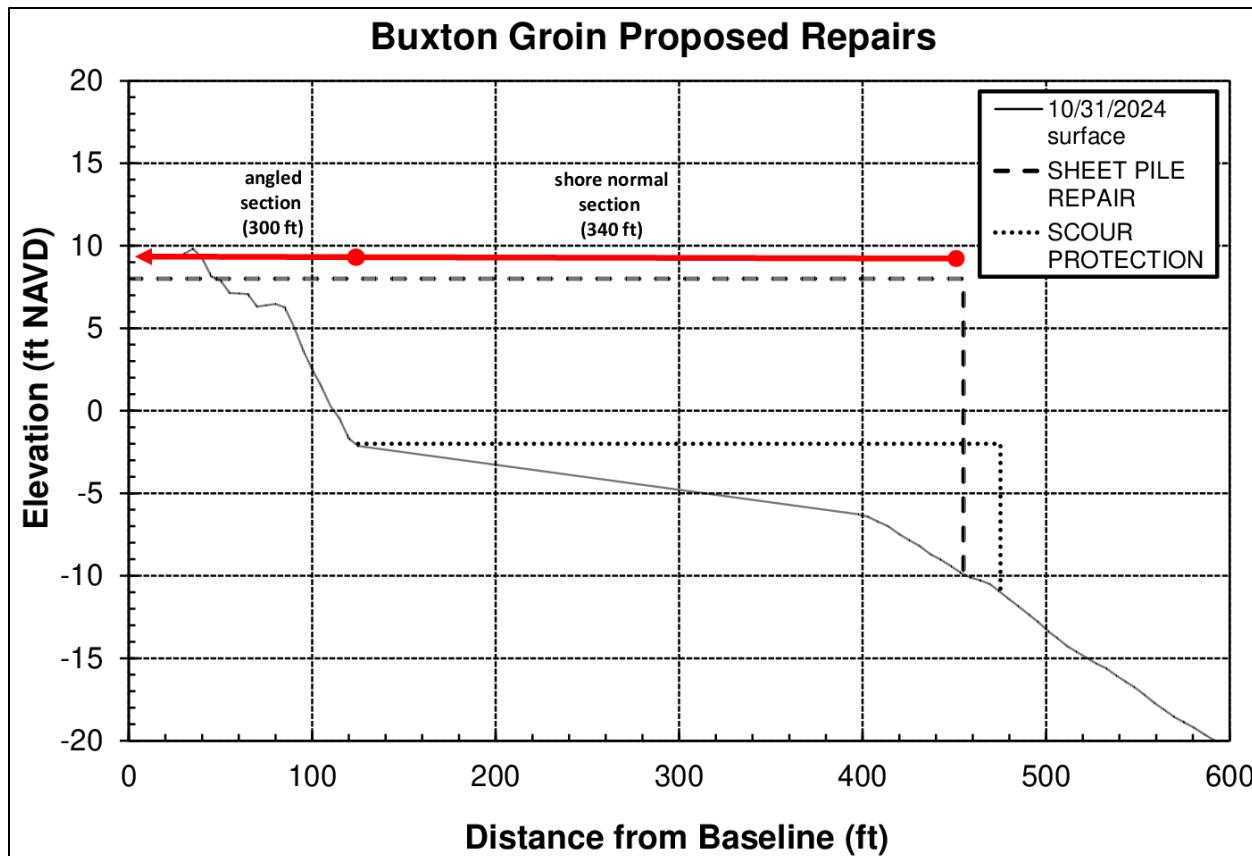
Figure G. Proposed repairs consist of placing sister sheet piles along 640 ft of the original footprint of the structure. The shore normal section measures 340 ft in length while the angled upland tie-in section measures 300 ft in length. Scour protection will be placed along the shore normal section from below MLW to below existing grade at the time of construction.

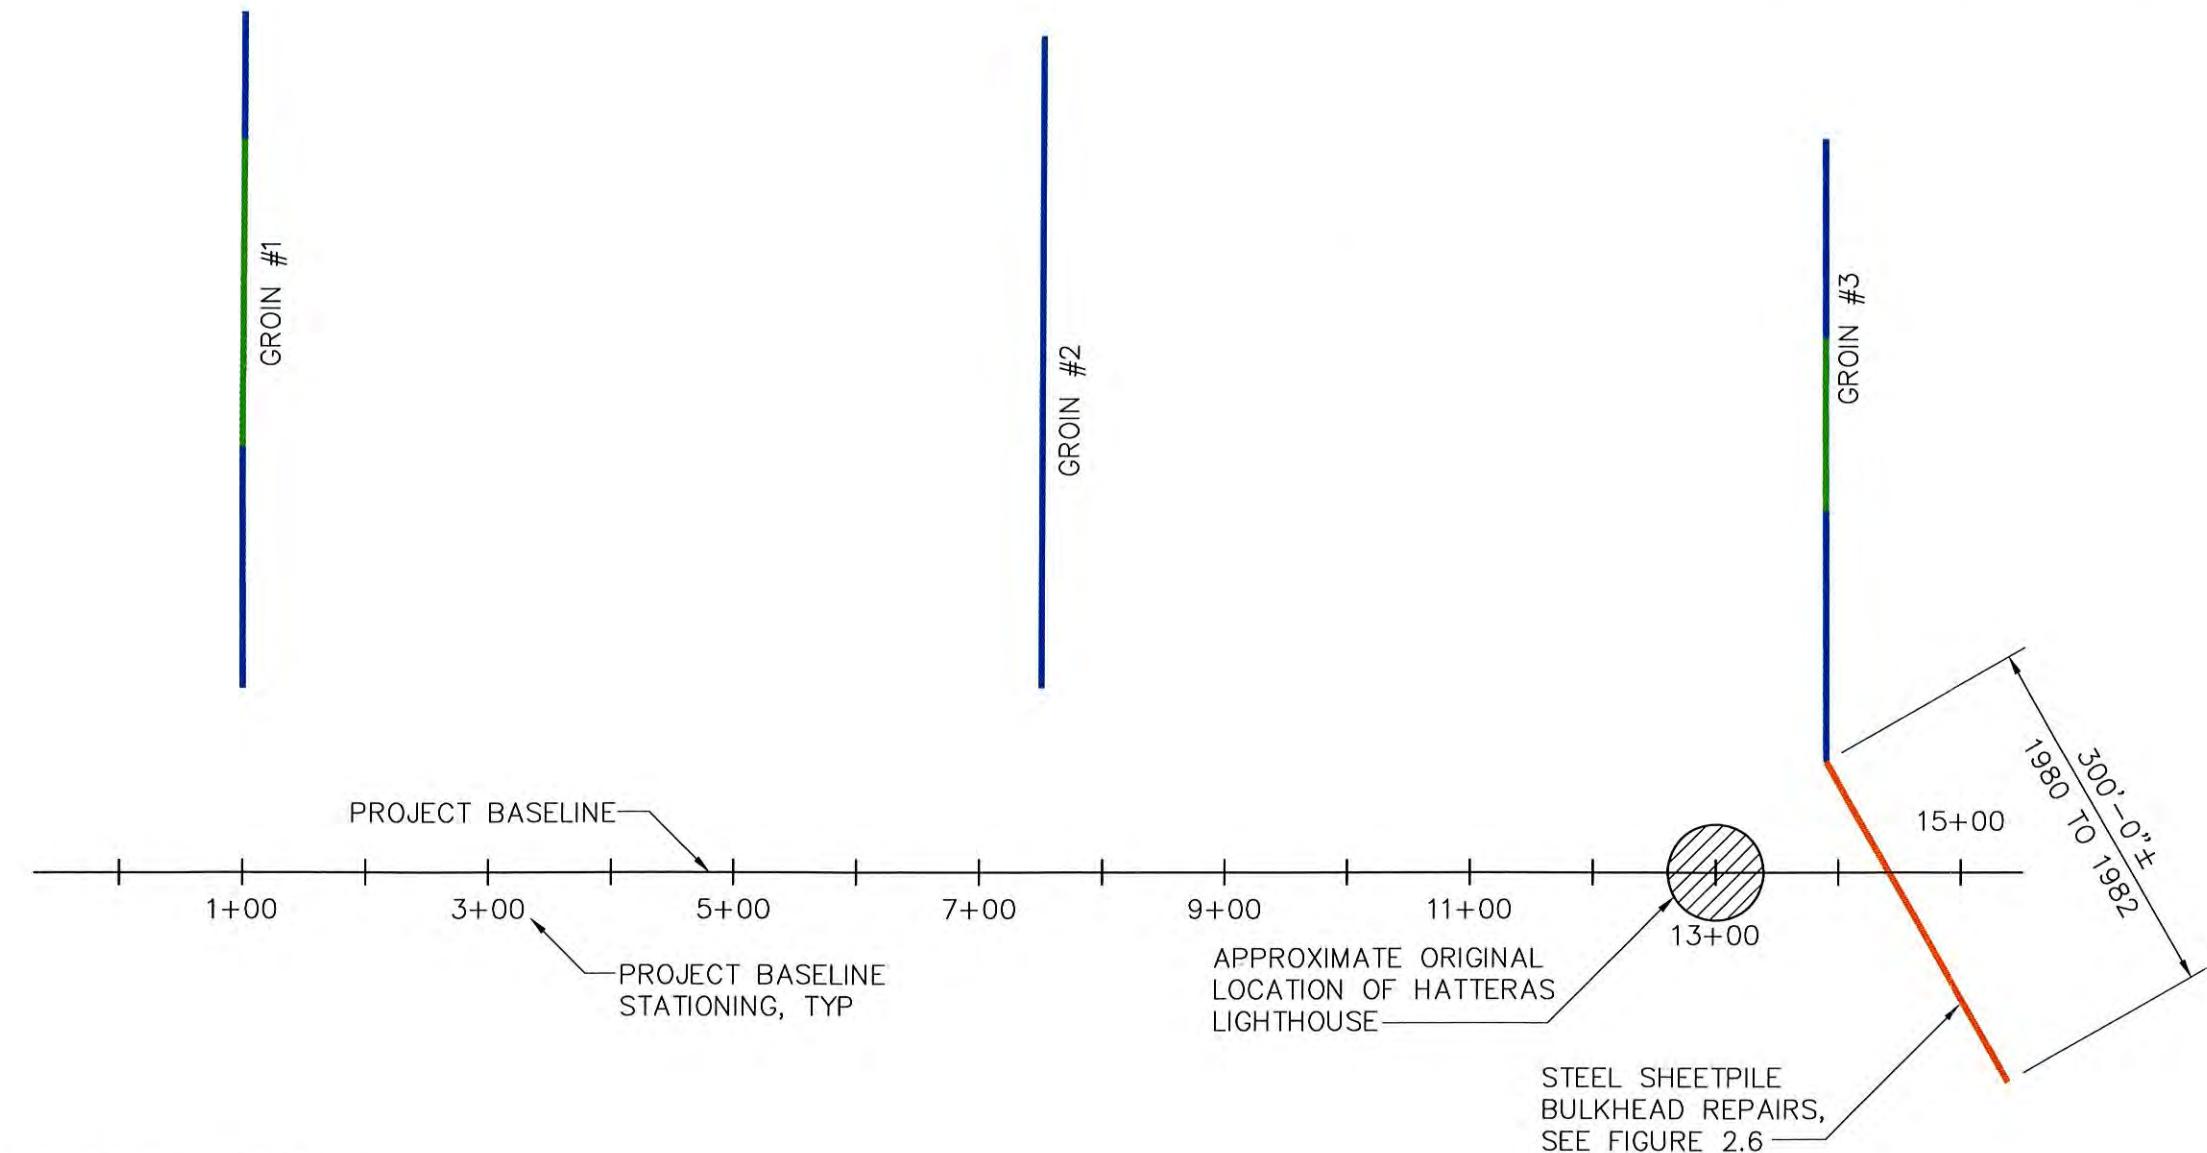
FIGURE 2.5

Following the 1980 storm, between 1980 and 1982 an additional ~300 feet of sheet piles were installed at the landward end of the southernmost groin and at an angle to the original piles (Attachment 3 Figure 2.5). This extended the total length of the southernmost groin to 910 ft, with 300 ft angled as an upland tie in and 610 ft oriented shore perpendicular. The total length of all three groins as of 1982 was 1,970 ft. By 1984, armor stone scour protection had been installed along the structure as shown in Figure B, along with a number of sandbags around the base of the Cape Hatteras Lighthouse.

Between 1980 and 1982, Groin 3 had approximately 300 feet of steel sheet piles installed mostly near the landside end of the original construction. These sheets ran approximately at a 30 degree angle to the south of the existing bulkhead line. The steel sheets were PZ-27 sheet piles and appeared to have sacrificial anodes installed near the top of each sheet. Figure 2.5 and 2.6 in Appendix A show conceptually the construction of this improvement.

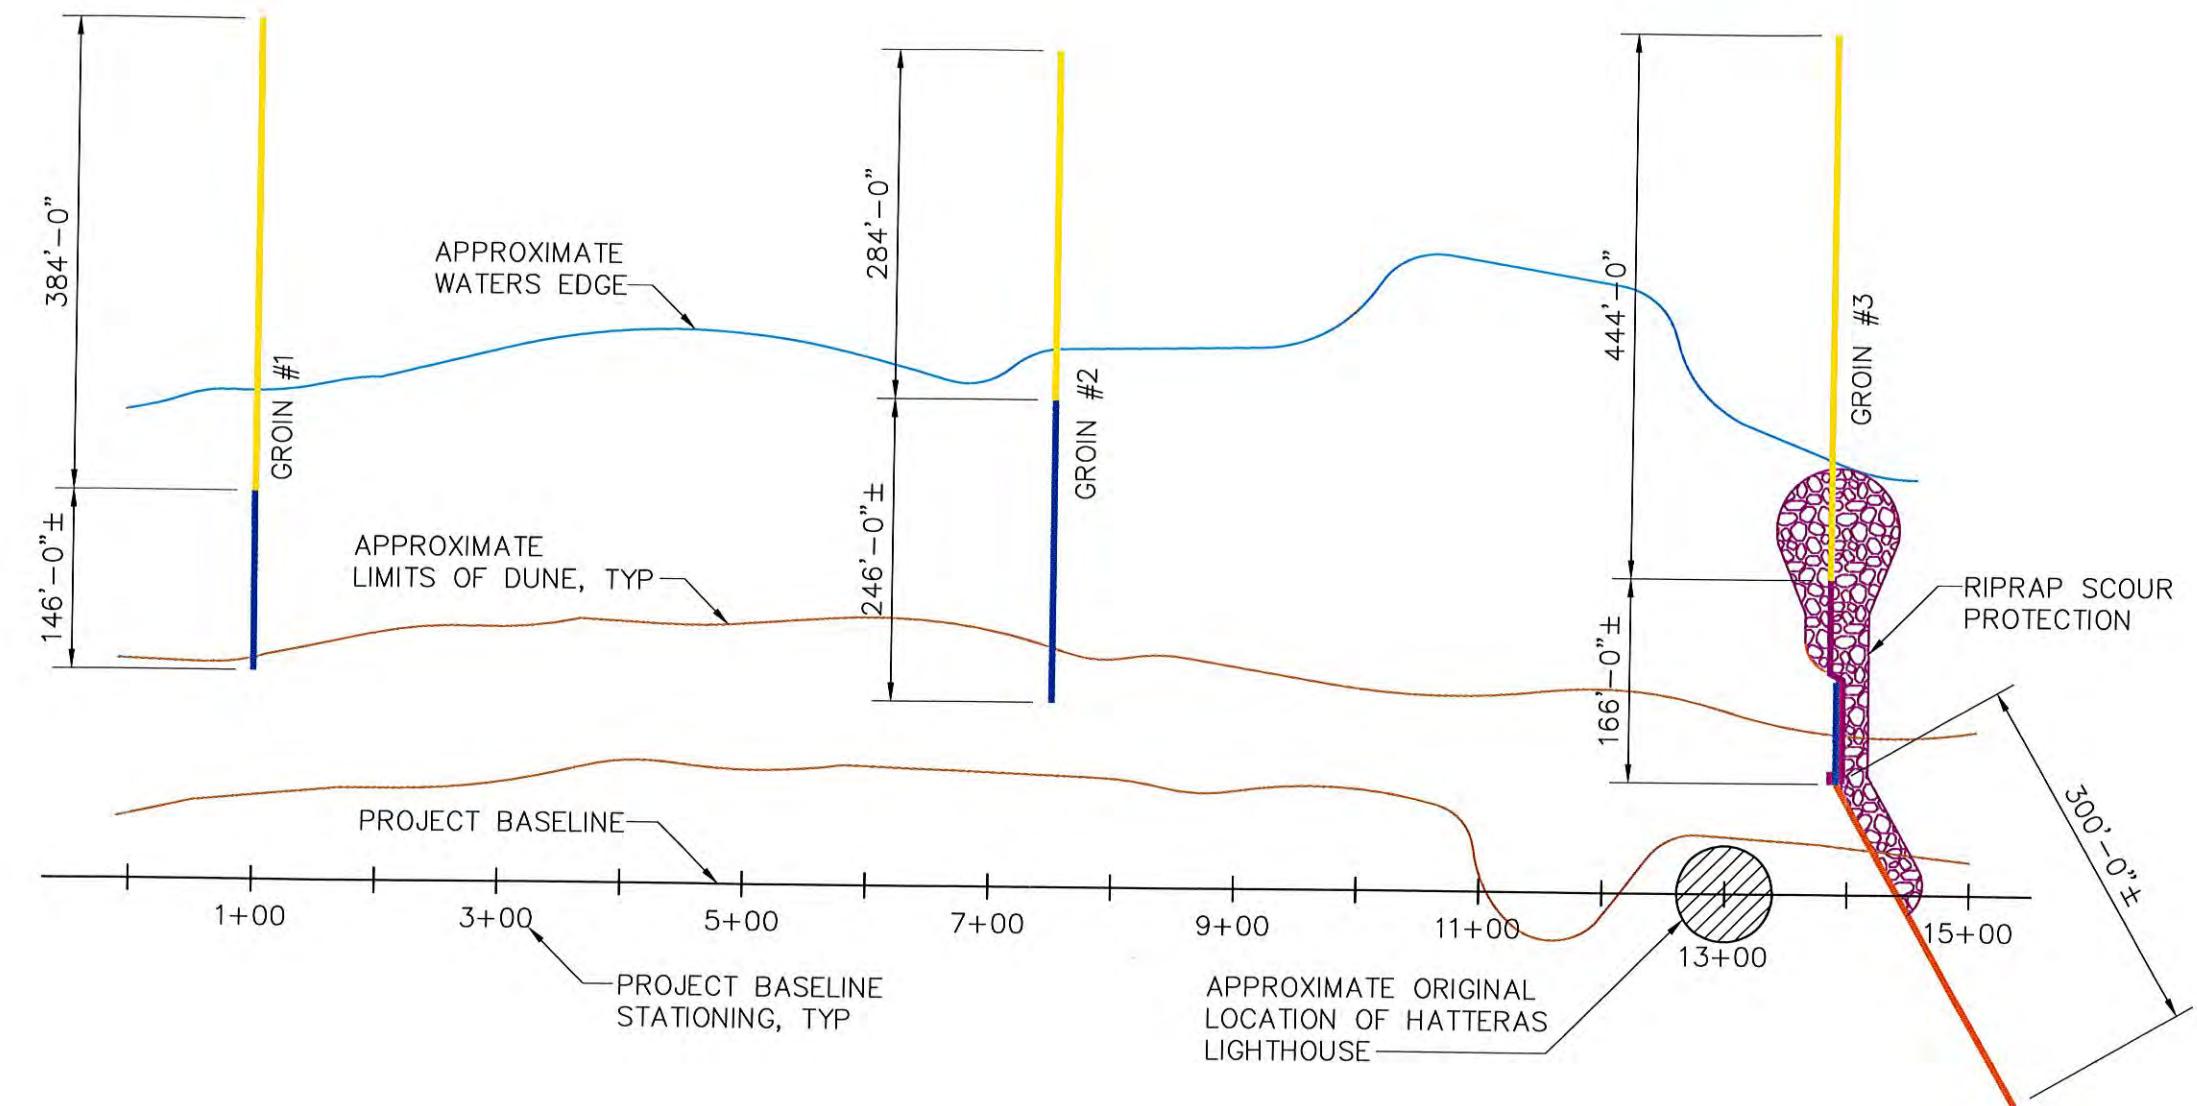
FIGURE 2.9

M&N estimates that at Groin 1, approximately 146 linear feet of the original 530 linear feet, is usable. The 146 feet consist of the buried portion of the original concrete sheet pile bulkhead. M&N could not confirm this length since it was buried. The remaining 384 feet of the original 530 feet of groin was almost completely gone or deemed unusable to resist the design wave forces. The estimated value of the 146 ft of usable groin is approximately \$223,000. The estimated cost to repair in kind with an 18 inch thick precast concrete sheet pile repair or PZ-27 A690 steel sheet pile repair each being 29 feet in height of the remaining 384 ft in plan of groin would be approximately \$496,000. For the new construction, we assumed that mobilization and demobilization will occur twice in case of severe weather. Since the cost of repairs of \$496,000 is greater than 50% of the existing value of \$223,000, the project would be considered a replacement, and a CAMA permit would be required. Figure 2.9 in Appendix A illustrates

the length of usable groin, and the amount of groin that would require replacement for Groins 1, 2, and 3. All opinions of probably costs can be found in Appendix C.

M&N estimates that at Groin 3, approximately 466 linear feet of the 910 linear feet of groin, is usable. The landside PZ-27 sheets and the newer PZ-40 sheets installed in 1994 still have adequate section to resist the storm wave forces. The remaining 444 feet of the original 910 feet of groin was almost completely gone or deemed unusable to resist the design wave forces. The estimated value of the 466 ft of usable groin is approximately \$1,136,000. The estimated cost to repair in kind with a PZ-40 A690 sheet pile repair of the remaining 444 ft of groin would be approximately \$1,281,000. For the new construction, we assumed that mobilization and demobilization will occur twice in case of severe weather. Since the cost of repairs of \$1,281,000 is greater than 50% of the existing value of \$1,136,000, the project would be considered a replacement and a CAMA permit would be required.
