Alcoa Badin picture document April 4, 2025

# SEDIMENTATION/CONSTRUCTION STORMWATER INSPECTION REPORT

County: Stanly Project #: N/A Project: Alcoa Badin

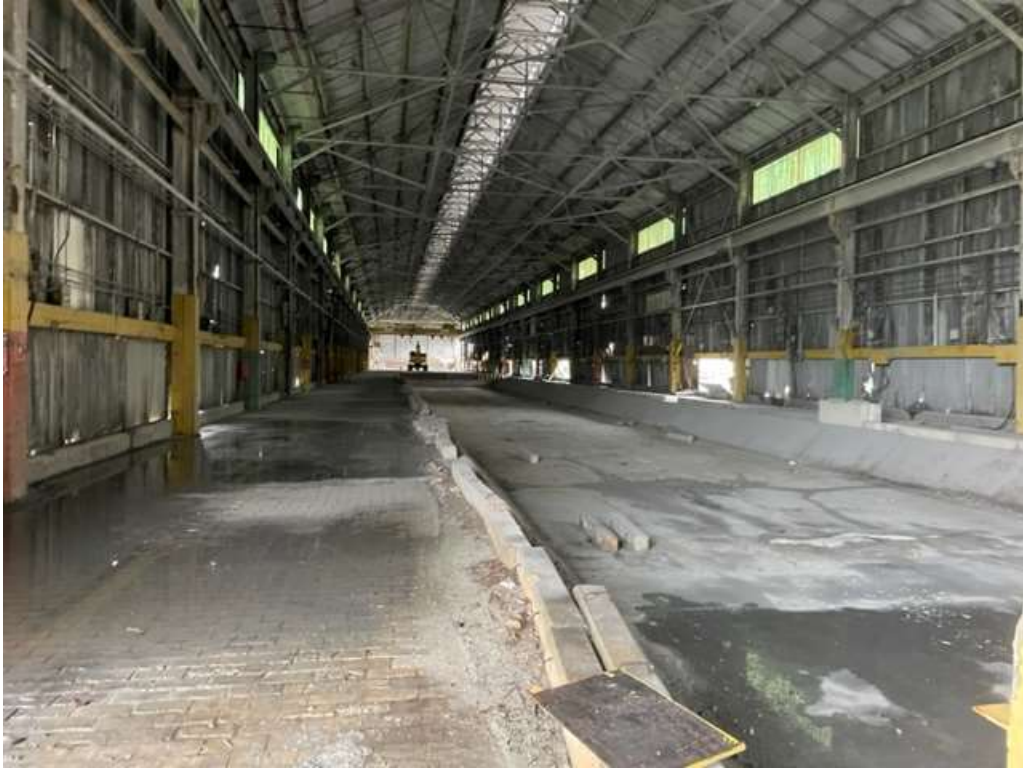
Inside the south side of Building 1

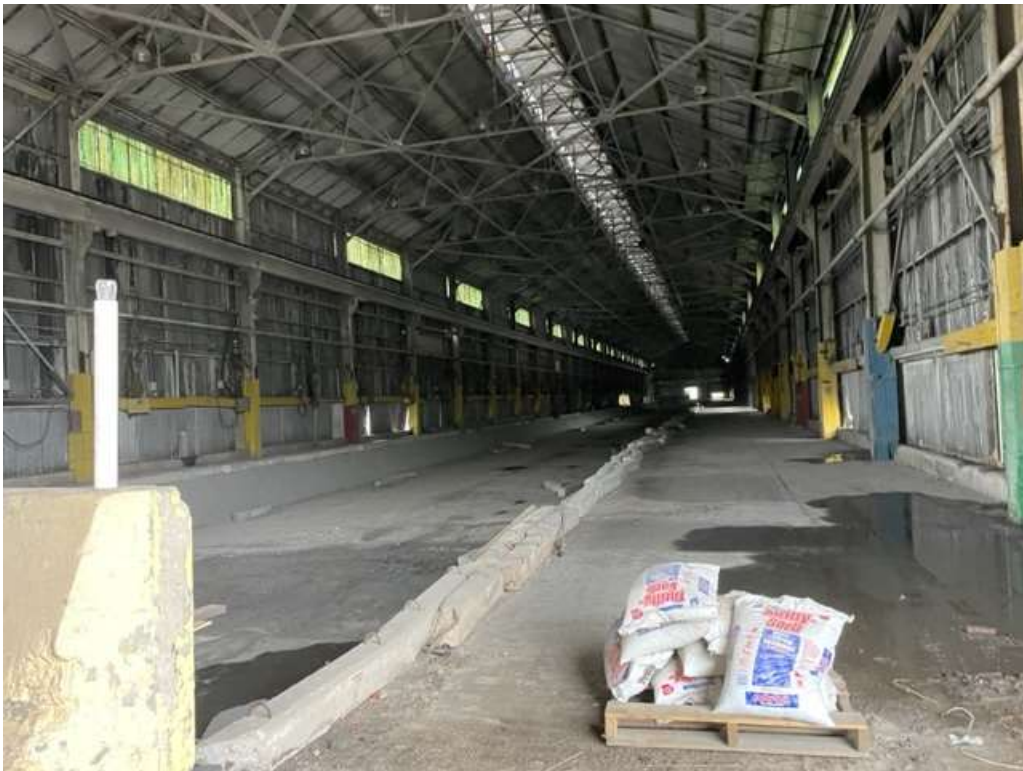
North side of Building 1

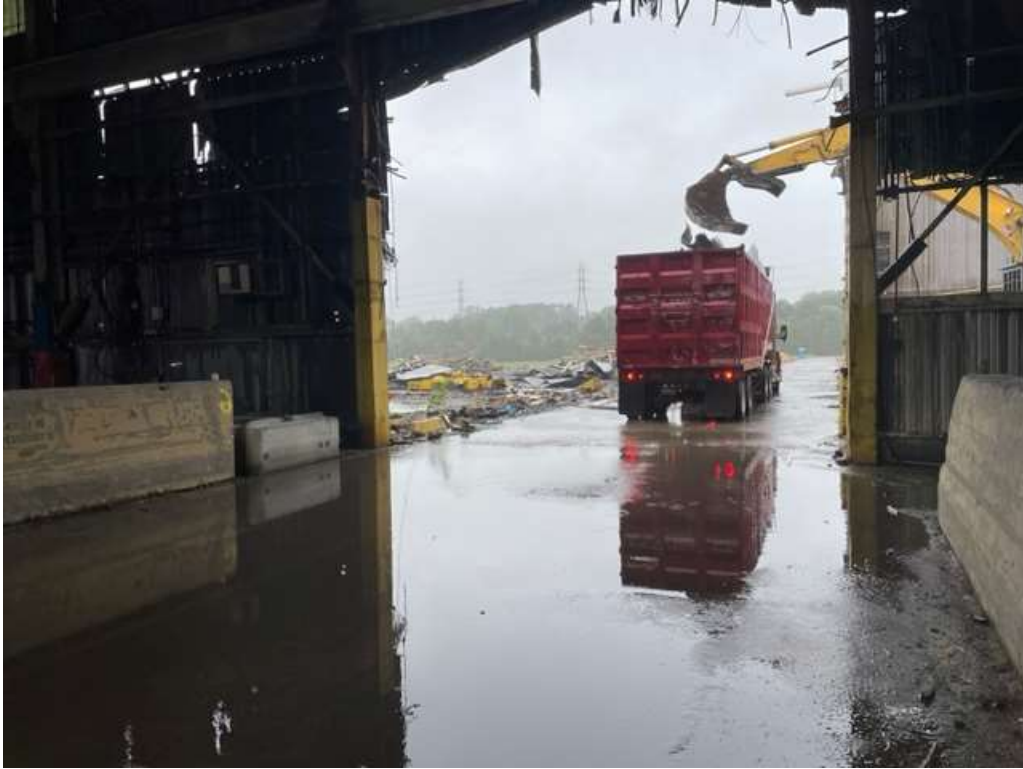
Scrap metal from Building 2 being loaded out.

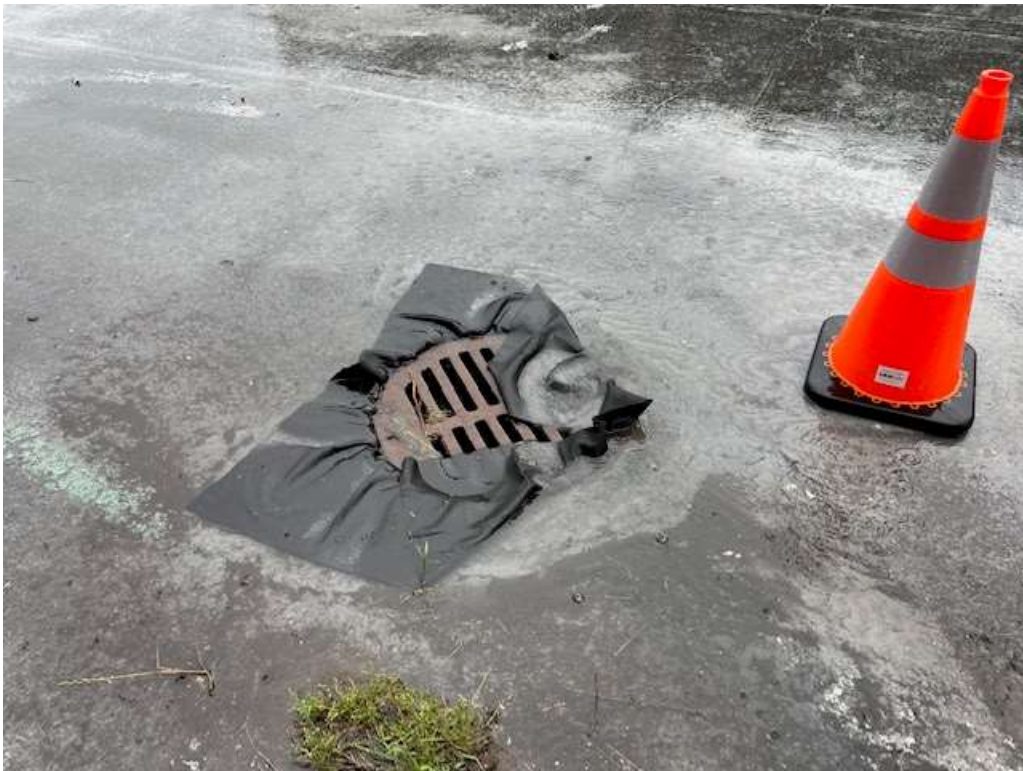
Silt sacks installed in yard inlets.

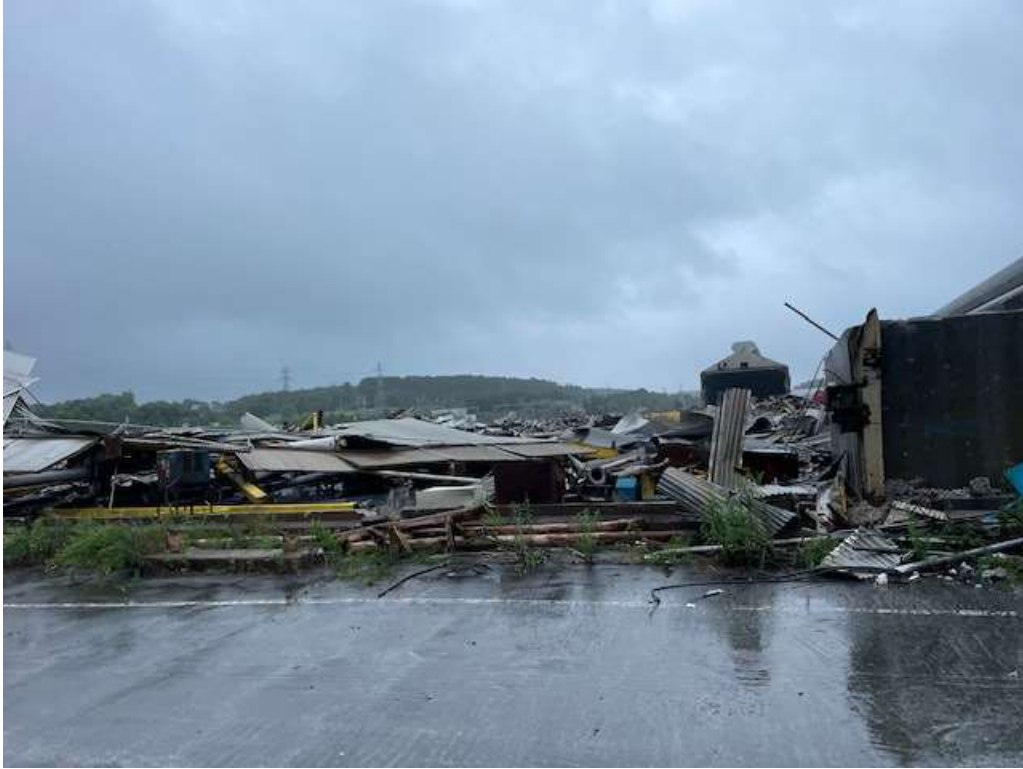
Demolished building materials on the south side of the project.

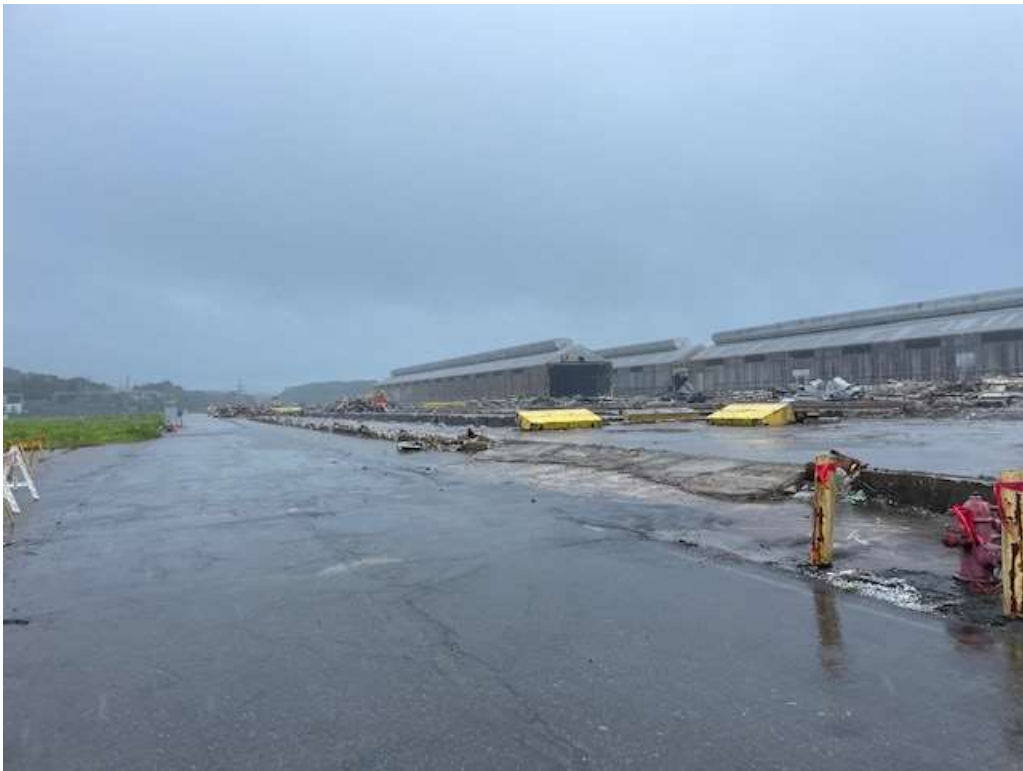
A view of the southwest side of the project.

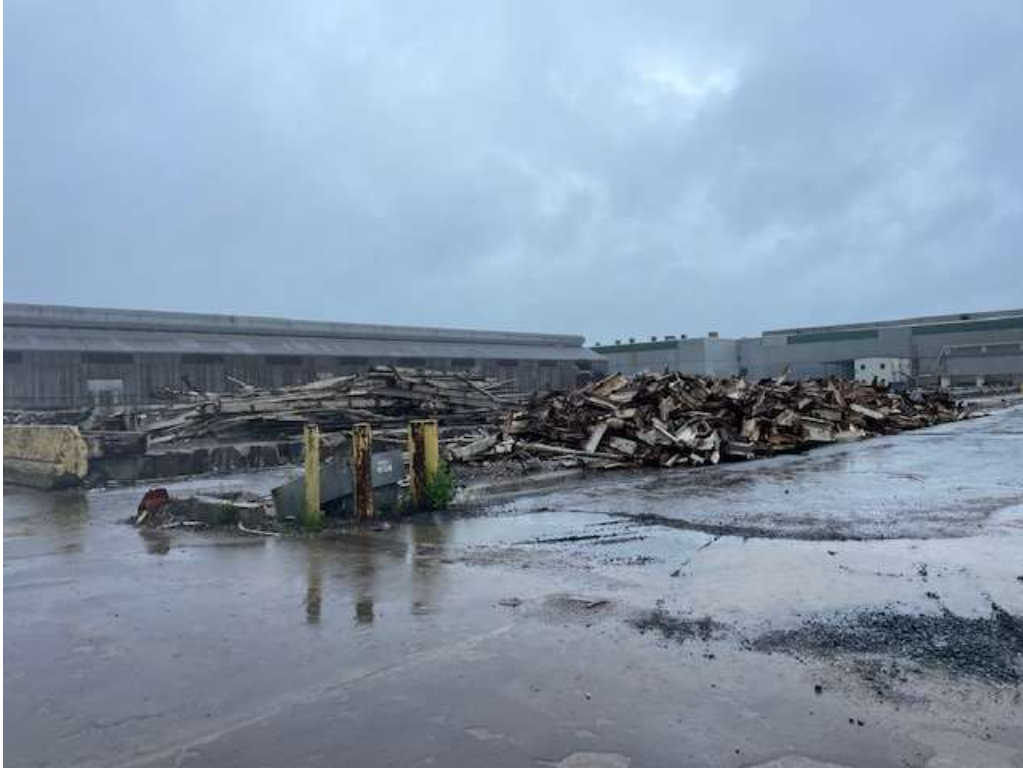
A view of the project from the west facing south.

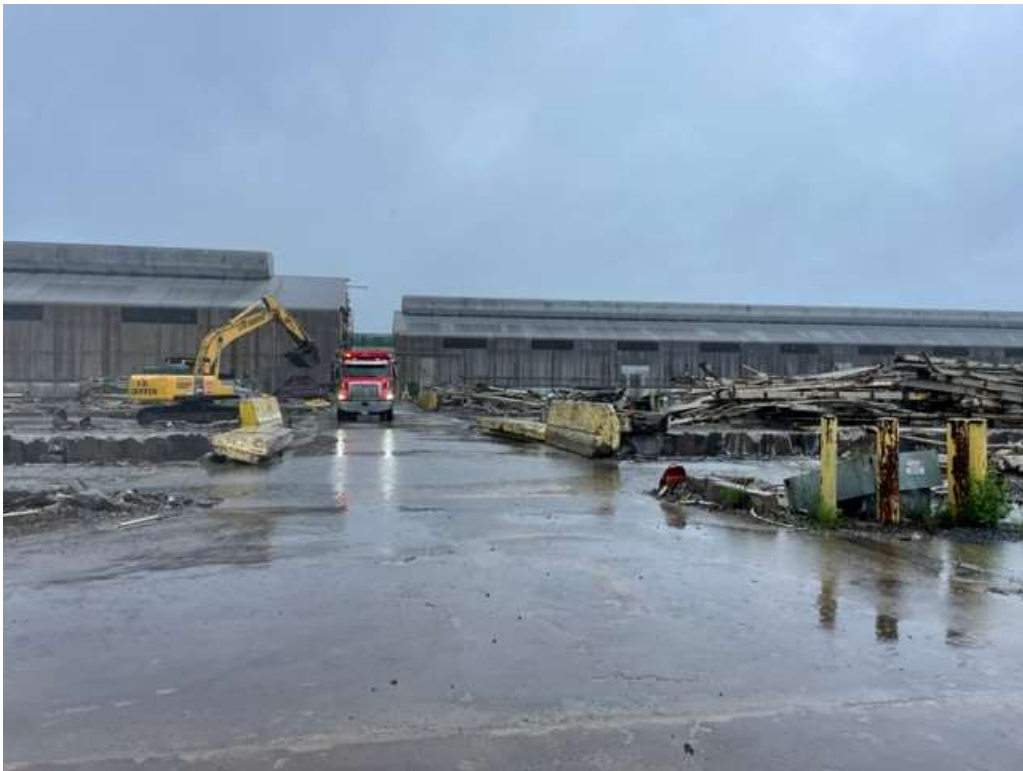
A view from the west looking east.

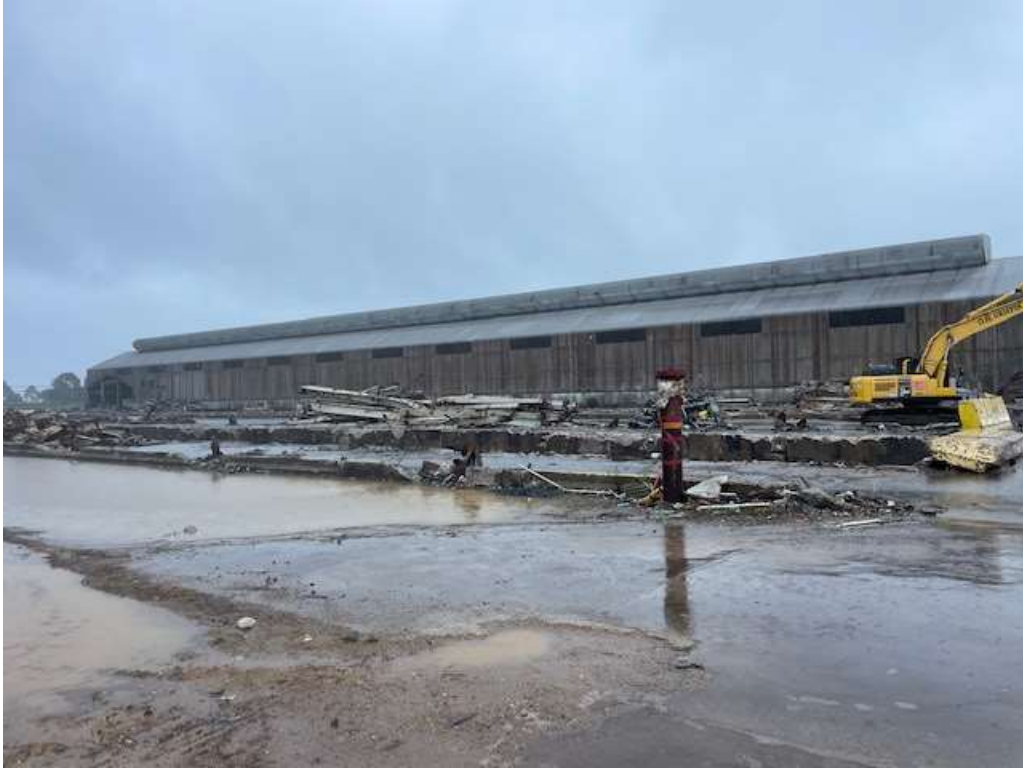
A view from the west facing north.

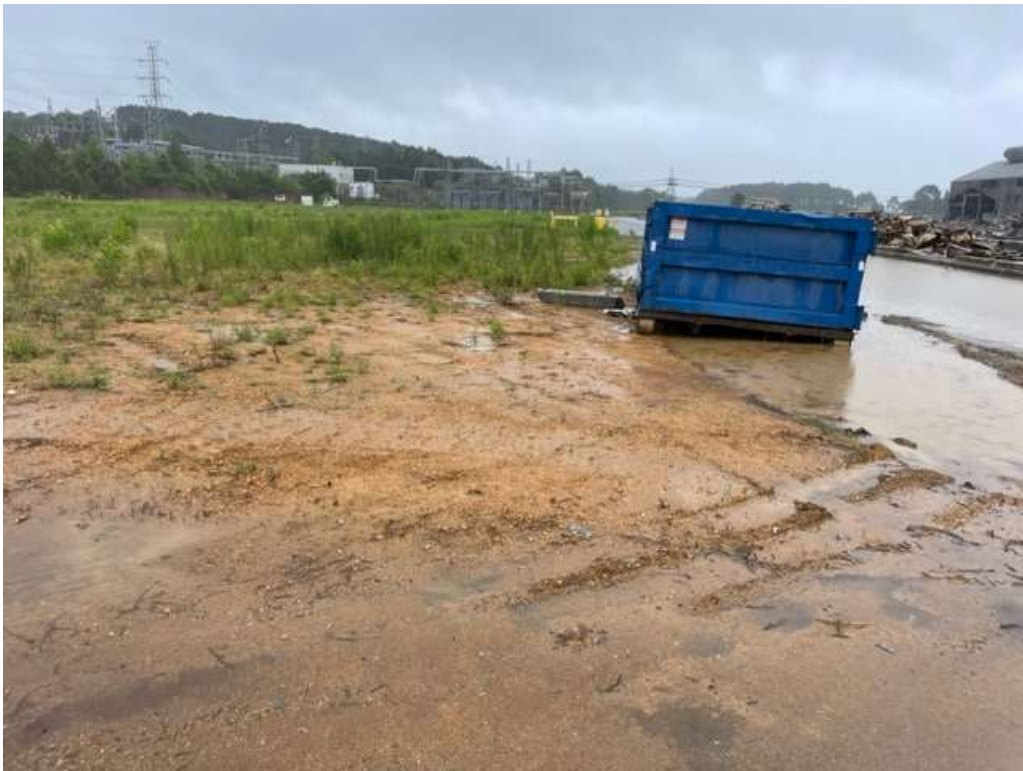
The only exposed sediment was from hauling traffic and was well less than a half acre in size. Building 2 was being demolished at the time of inspection and Building 1 was still intact.

Exposed sediment from hauling traffic.

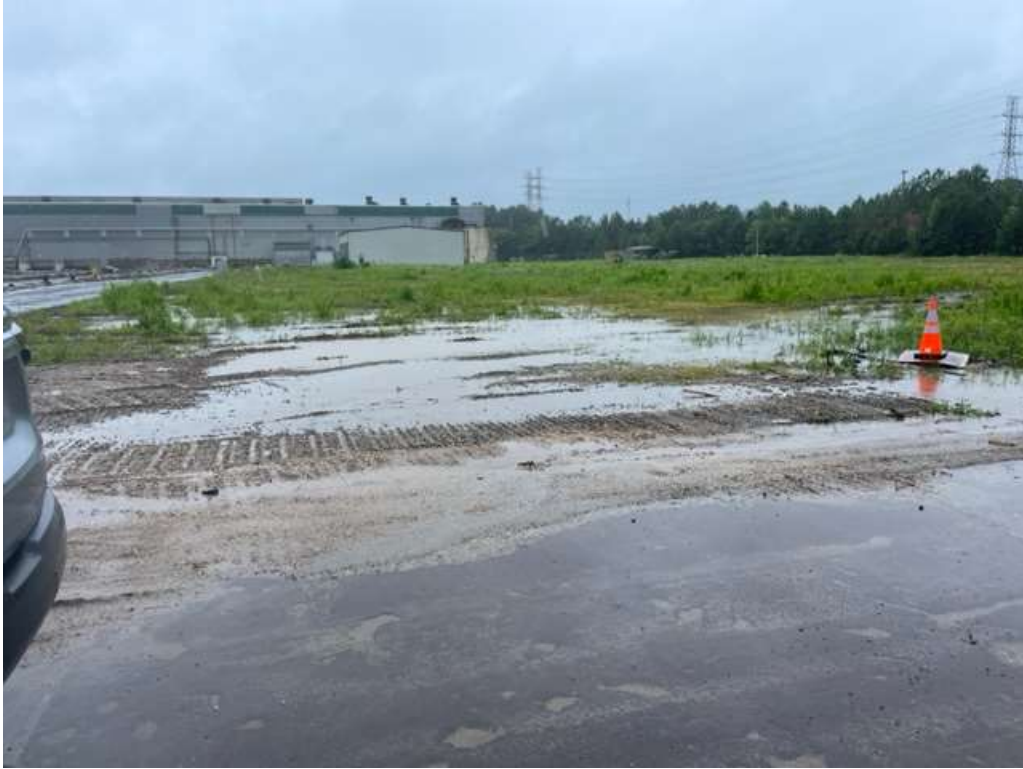
Exposed sediment from hauling traffic.

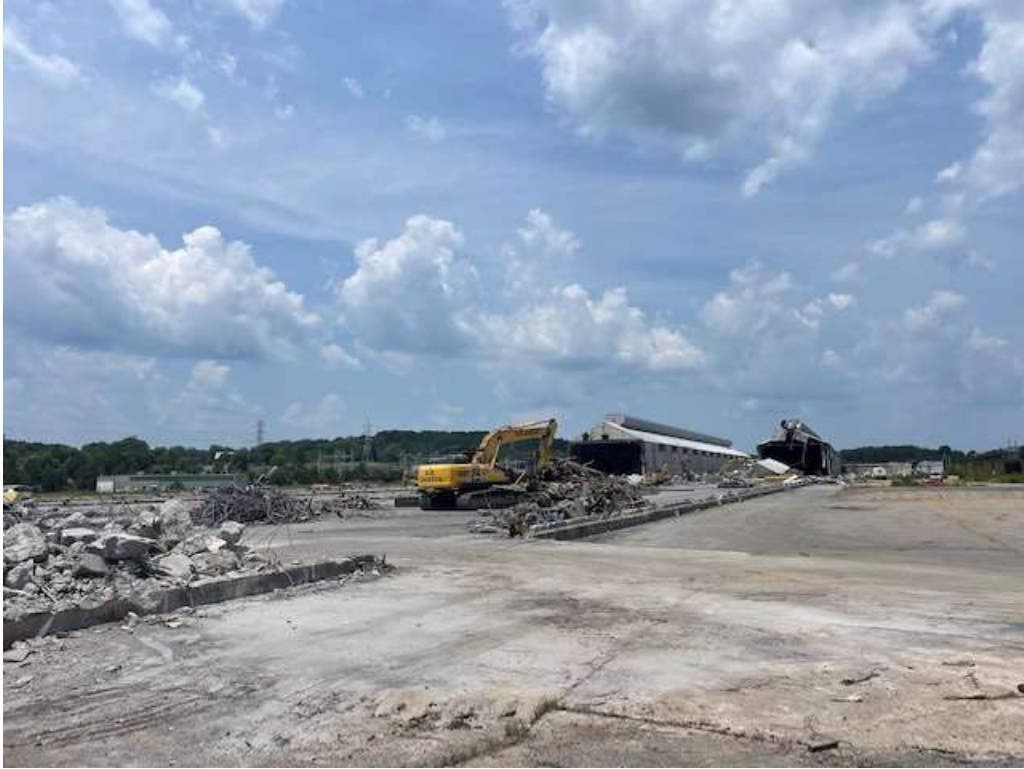
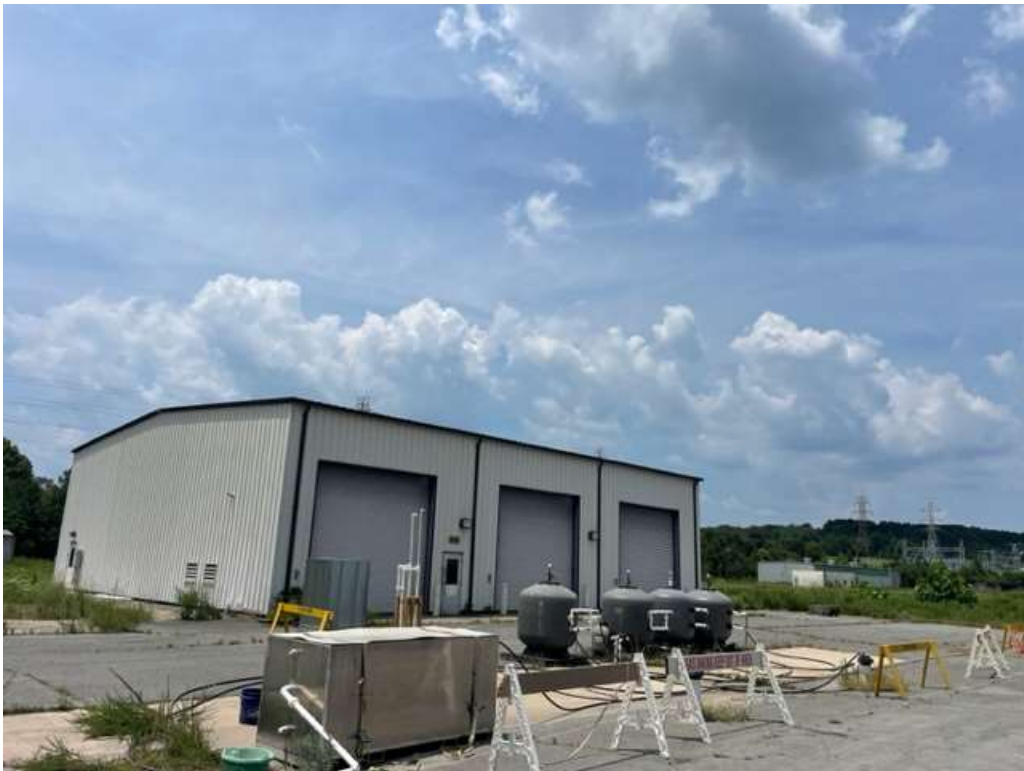
Stormwater remediation system

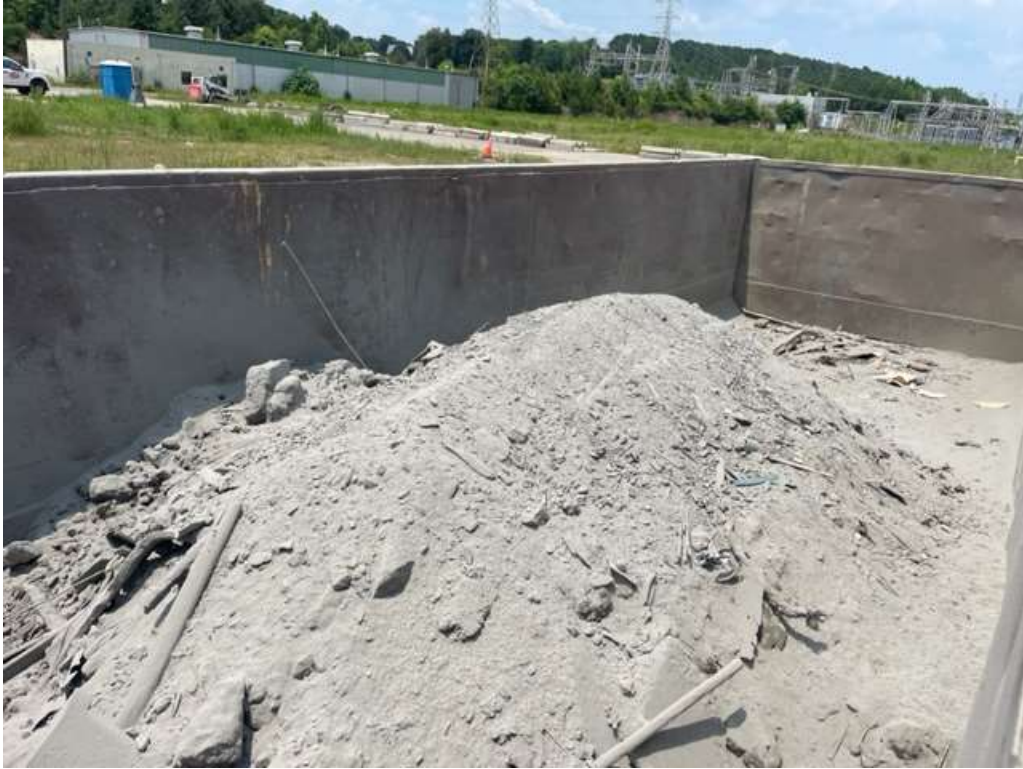
The only exposed sediment was from hauling traffic and was less than 200 square feet. Building 2 was being demolished at the time of inspection and Building 1 was still intact. Dust was observed from cleaning the concrete, but the dust was all contained on site and the superintendent stops work if dust is blown toward the rail line.

Concrete dust sweepings

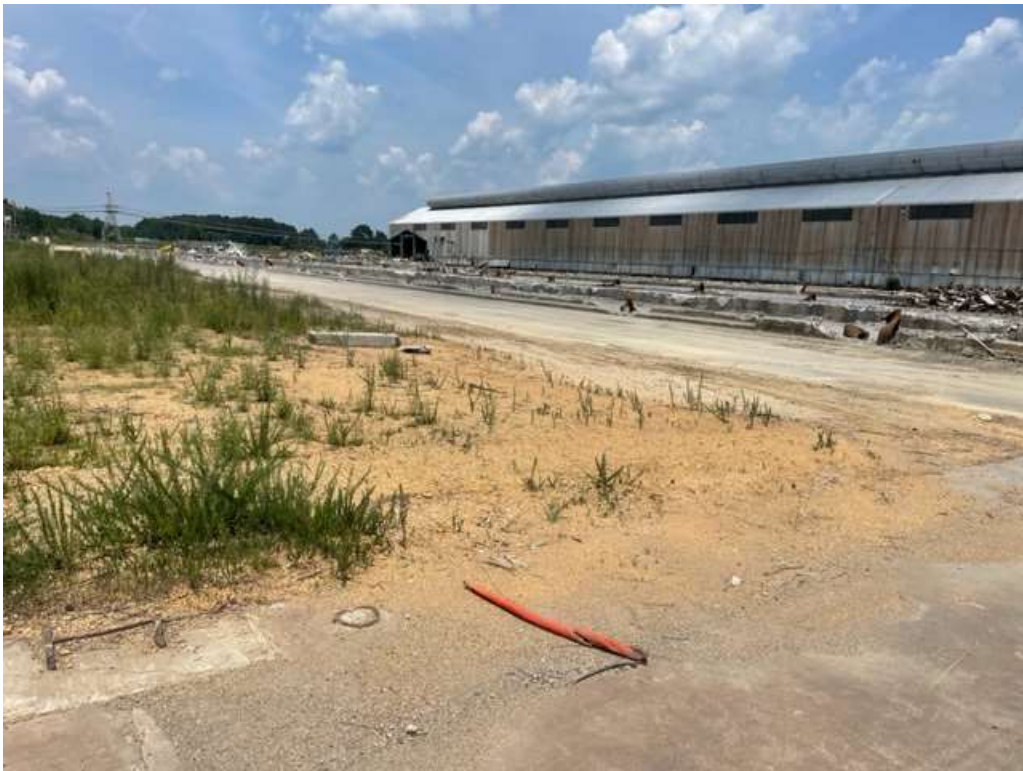
The only exposed sediment along the haul road.

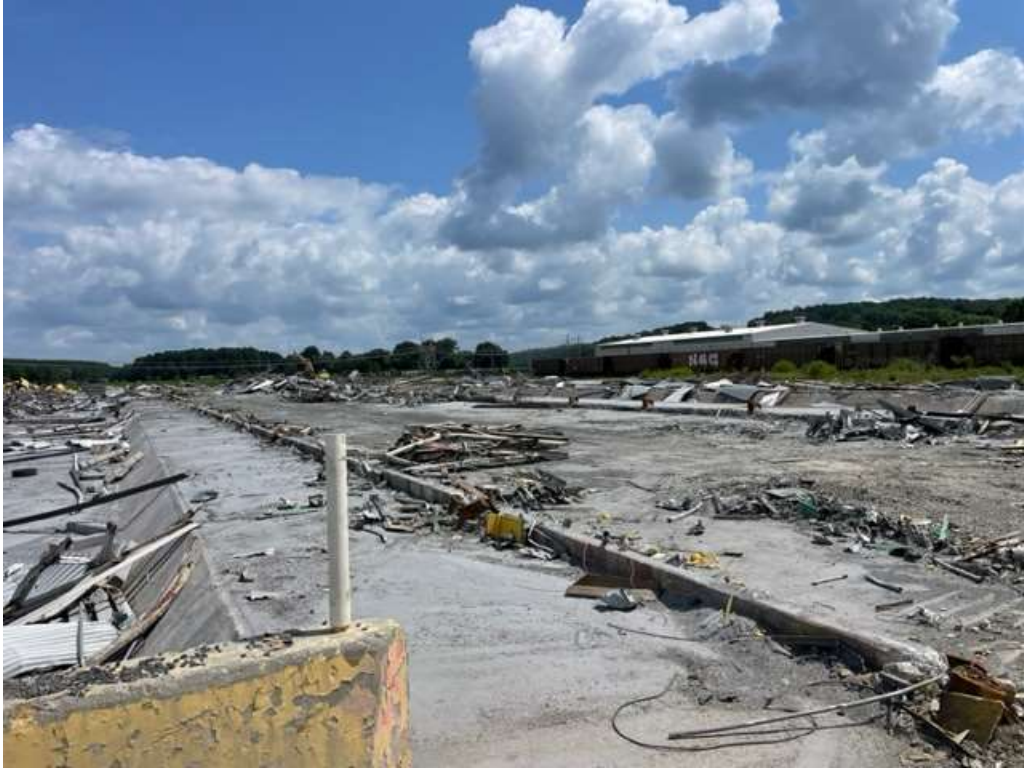
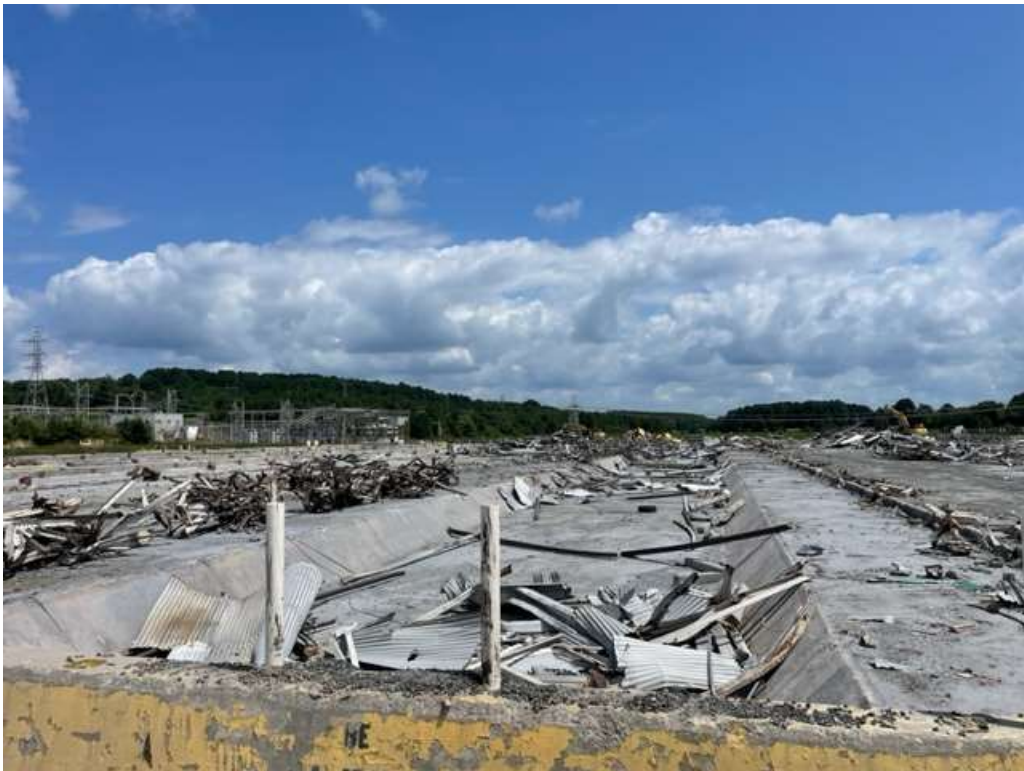
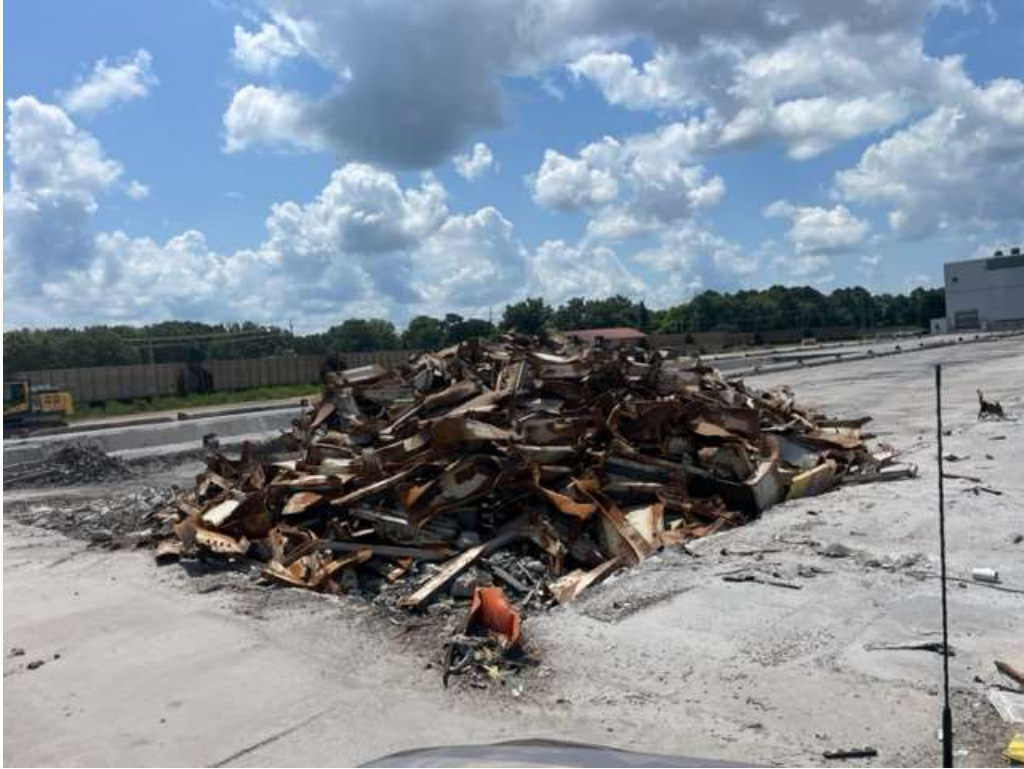
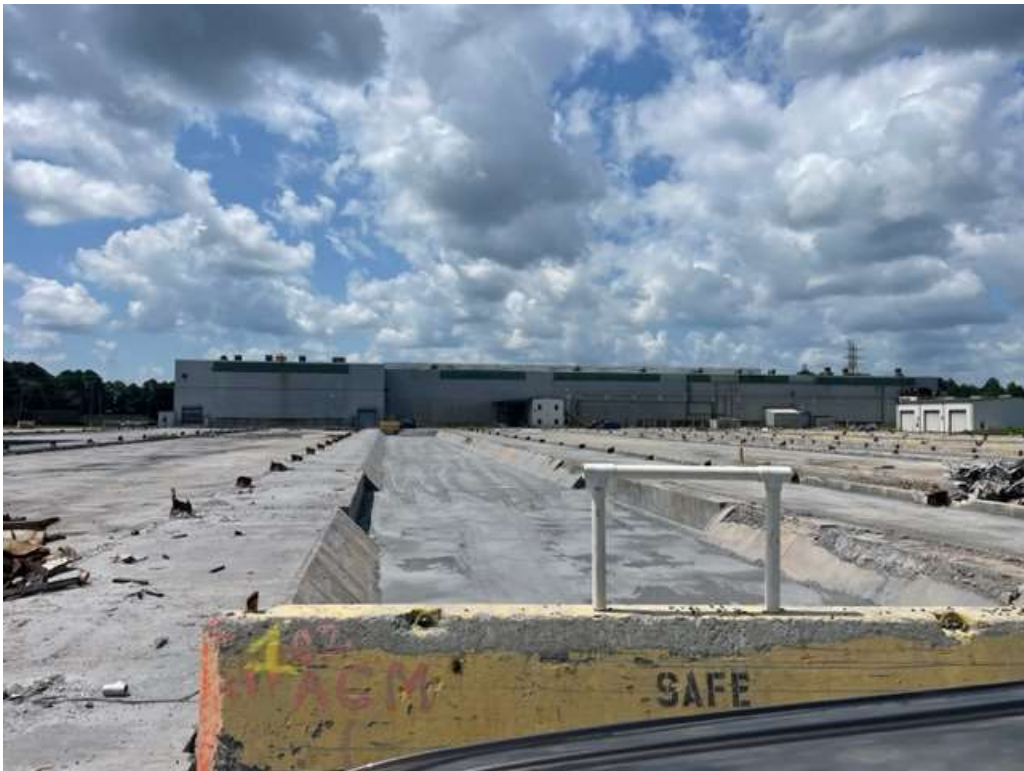
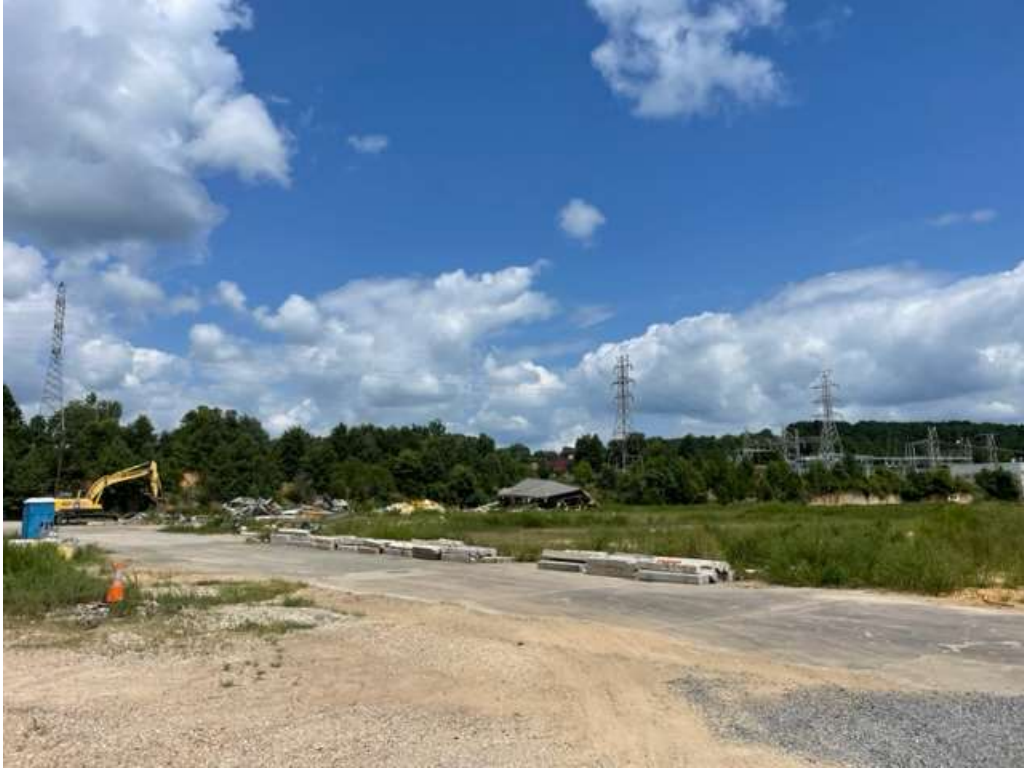
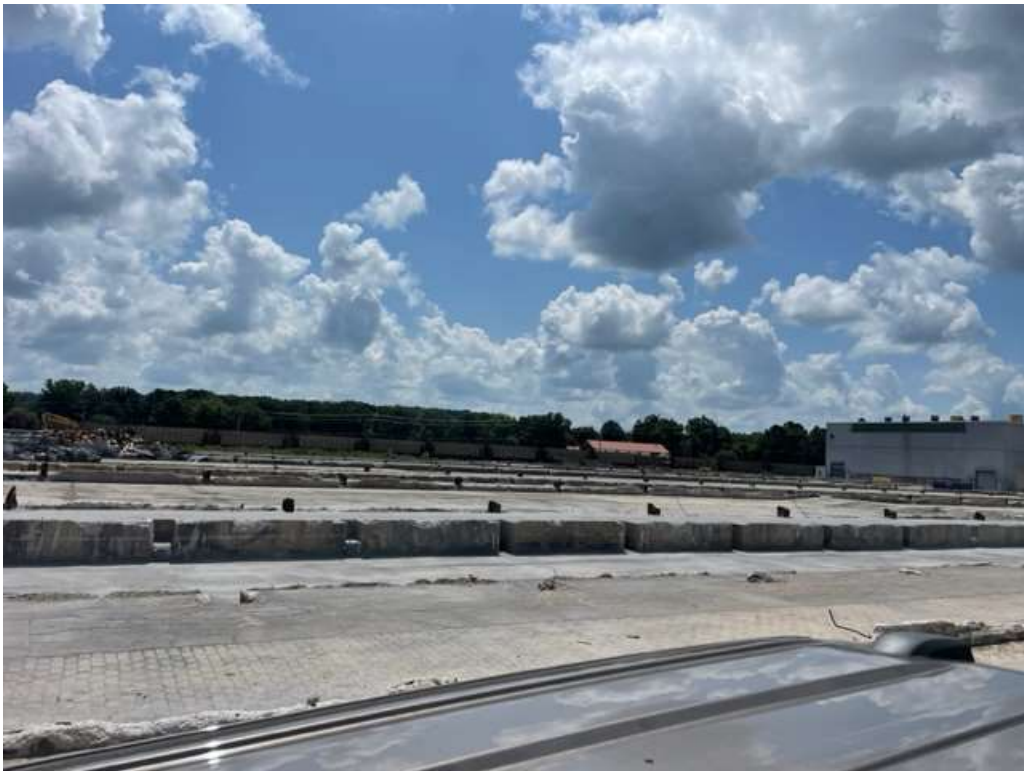
The only exposed sediment was from hauling traffic and was less than 200 square feet. All large buildings have been demolished and one small sheet metal building was being torn down at the time of inspection. The C&D waste, concrete waste and scrap metal were being removed and properly disposed. A couple of the concrete runs on the south side have been cleaned of dust and residue.

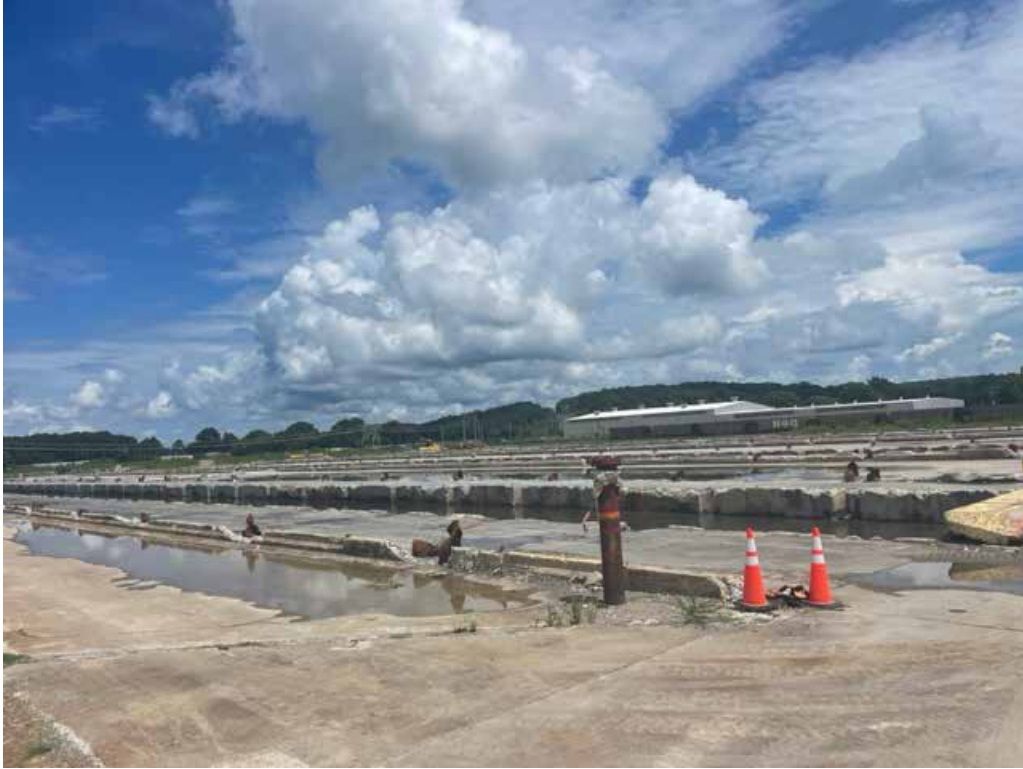
All buildings have been removed.

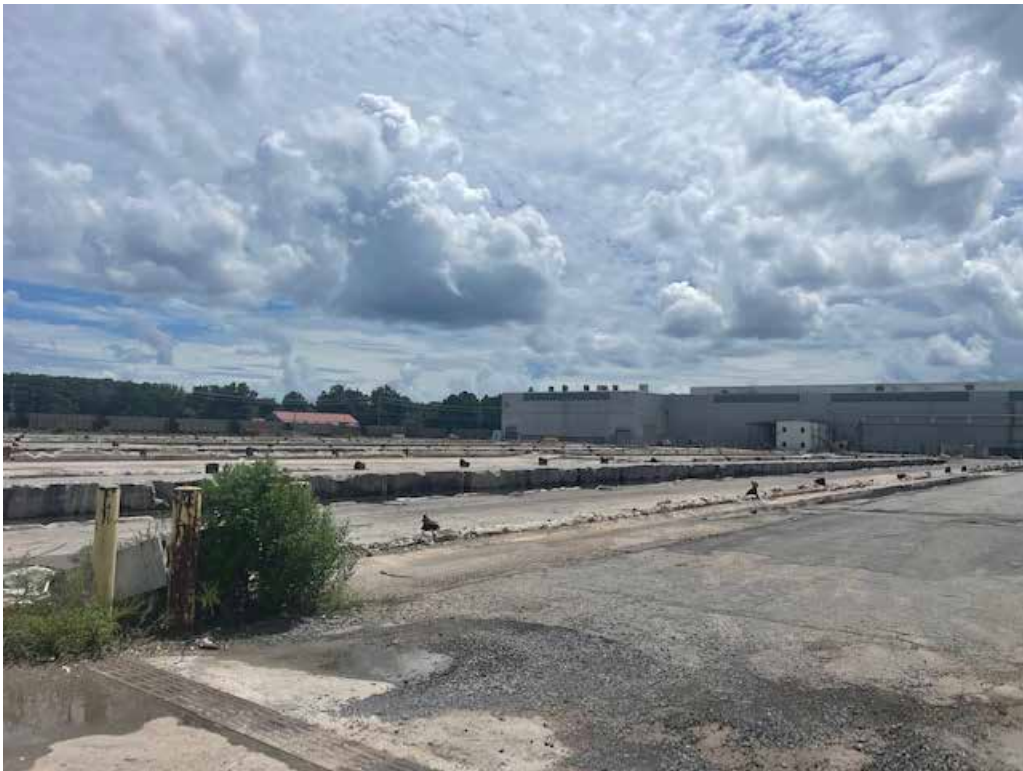
All buildings have been removed.

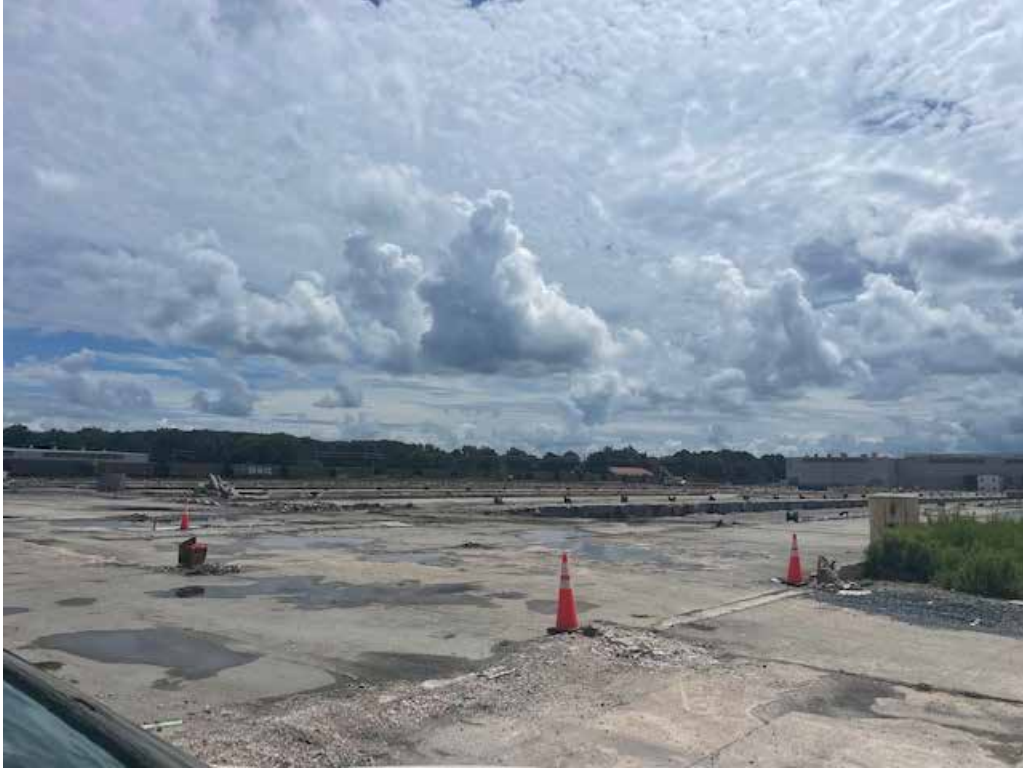
All buildings have been removed.

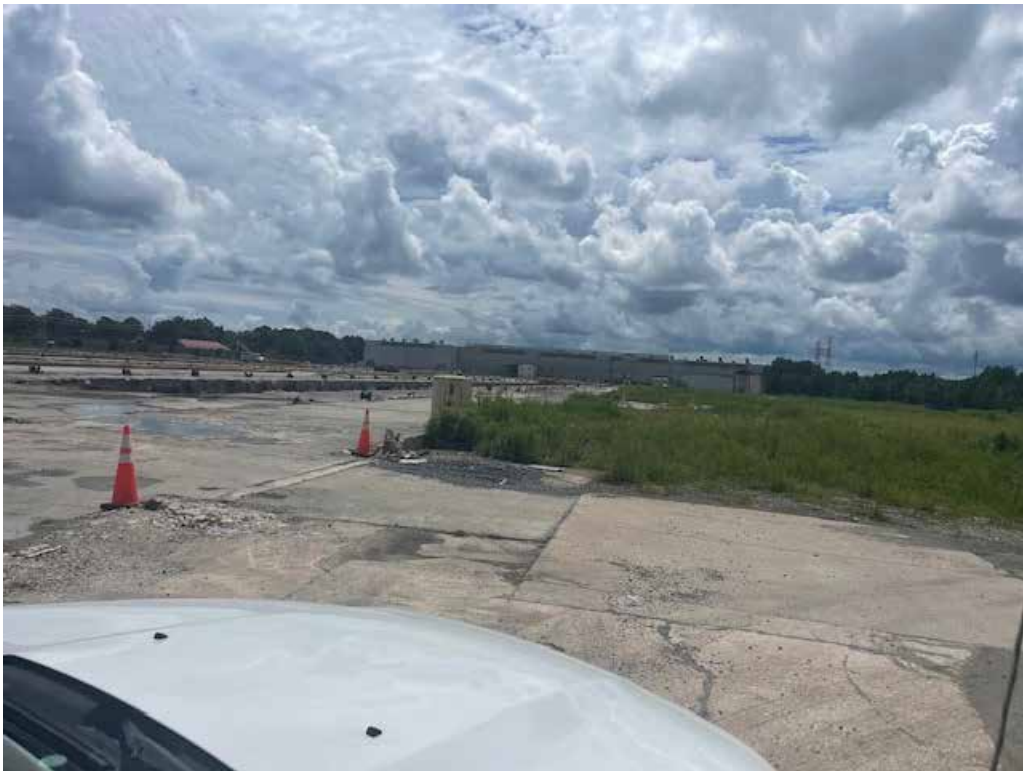
All buildings have been removed.
