# SAFETY INSPECTION REPORT

| NAME<br><b>DAN RIVER PRIMARY ASH POND</b> | | COUNTY<br><b>ROCKINGHAM</b> | NO.<br><b>237</b> | INSPECTED BY<br><b>S. LEONARD / M. GANTT</b> | DATE<br><b>2/3/14</b> | |
| OWNER<br><b>DUKE ENERGY</b> | | ADDRESS | | | PHONE | |

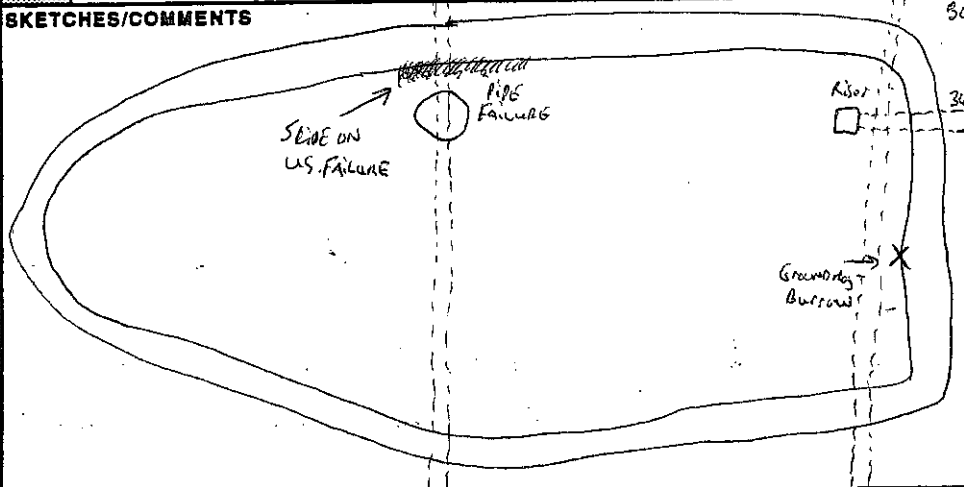
| REMARKS<br>RECEIVED CALL ABOUT FAILURE OF STORM DRAIN (48") UNDER DAM & IMPOUNDMENT AREA. WATER & ASH FLOWING INTO DAN RIVER. ALSO CONDUCTED ANNUAL INSPECTION TODAY.<br>LAKE IMPOUNDMENT HAS DRAINED & CONTINUES TO LEACH OUT OF ASH | | | ACTION<br><input type="checkbox"/> None <input checked="" type="checkbox"/> Maintenance <input type="checkbox"/> Monitoring <input type="checkbox"/> Minor repair <input checked="" type="checkbox"/> Engineering | | RECOMMENDATIONS<br><input type="checkbox"/> Inspection letter <input type="checkbox"/> Deficiency letter <input type="checkbox"/> RE notice <input type="checkbox"/> Engineering study <input type="checkbox"/> Inspection by RE <input type="checkbox"/> Inspection by DSE <input type="checkbox"/> Dam safety order <input type="checkbox"/> Enforcement <input type="checkbox"/> Periodic reinspection <input type="checkbox"/> Other reinspection | |

| AREA | PROBLEMS | COMMENTS |
|---|---|---|
| DRAINS / OTHER OUTLETS | <input type="checkbox"/> 1. None<br><input type="checkbox"/> 2. No bottom drain<br><input type="checkbox"/> 3. Bottom drain inoperable<br><input type="checkbox"/> 4. Subsurface drain dry<br><input type="checkbox"/> 5. Subsurface drain muddy flow<br><input type="checkbox"/> 6. Subsurface drain obstructed<br><input type="checkbox"/> 7. No animal guard<br><input type="checkbox"/> 8. Other | TYPE:<br><br>NO OTHER DRAINS ASSOCIATED WITH DAM. HOWEVER, THERE ARE 2 STORM WATER CULVERTS RUNNING UNDER DAM & IMPOUNDMENT AREA. (1) 48" C/P/RCP AND (1) 36" RCP. |
| SKETCHES/COMMENTS<br> <p>EXACT LOCATION UNKNOWN BUT APPEARS TO BE IN THIS VICINITY.</p> <p>48" C/P/RCP    36" RCP</p> <p>STORM WATER    STORM WATER</p> | | |

| | <input checked="" type="checkbox"/> 1. None <input type="checkbox"/> 11. Cracks<br><input type="checkbox"/> 2. Trees <input type="checkbox"/> 12. Spalling<br><input type="checkbox"/> 3. High bushes <input type="checkbox"/> 13. Deteriorated joints<br><input type="checkbox"/> 4. Burrows <input type="checkbox"/> 14. Displaced joints<br><input type="checkbox"/> 5. Puts <input type="checkbox"/> 15. Exposed reinforcement<br><input type="checkbox"/> 6. Livestock damage <input type="checkbox"/> 16. Other<br><input type="checkbox"/> 7. Depressions<br><input type="checkbox"/> 8. Unlevel<br><input type="checkbox"/> 9. Misalignment<br><input type="checkbox"/> 10. Has overtopped | | COVER: <input checked="" type="checkbox"/> Vegetation <input checked="" type="checkbox"/> Gravel <input type="checkbox"/> Concrete <input type="checkbox"/> Asphalt <input type="checkbox"/> Other<br><br>1. NO PROBLEMS. IT IS ANTICIPATED THAT A SECTION ON WEST SIDE WILL NEED TO BE EXCAVATED TO REACH PIPE FAILURE IN POOL AREA (AREA WHERE SLIDE IS LOCATED). | | | |
