SUBJECT: Plan For Remedial Action for Triangle Quarry

Rock Slide of January 7, 1992

SUBJECT: Wake Stone Corporation Triangle Quarry

Summary of January 7, 1992 Blast and Factors Causing Rock

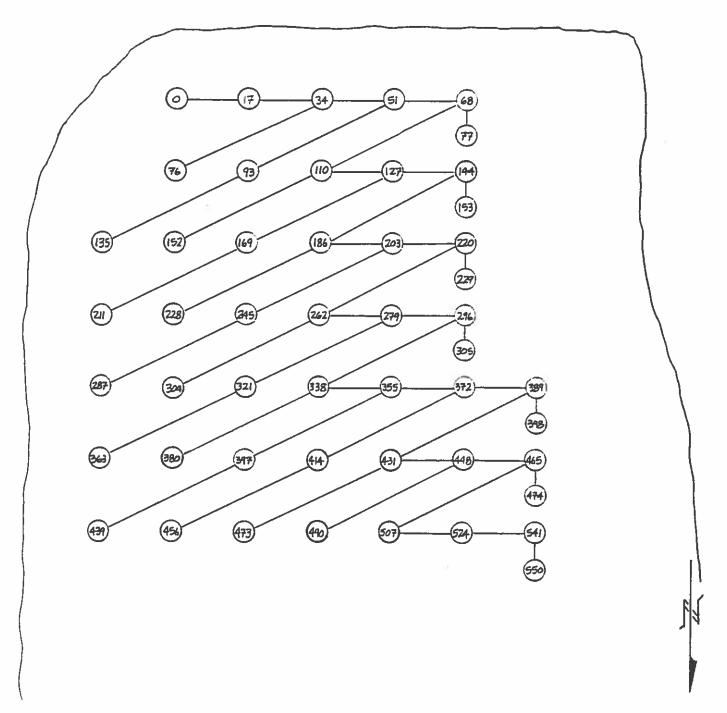
SHOT DESIGN FOR JANUARY 7, 1992 SHOT

This blast pattern was typical of several previous shots that had been successfully executed along the same western ridge of our pit. It consisted of fifty holes arranged on an eight feet spacing by eight feet of burden pattern (8'x 8' hole spacing). Refer to the enclosed blast design drawing. The shot had seven rows of holes delayed with non-electric caps wired in a pattern to force the rock to move in a southeast direction.

When the pit foreman designed the shot he saw the necessity to add additional rows of holes to the north end. This is a common occurrence when designing any blast as we not only want to control the shot rock, but we also need to consider what the remaining wall or face will look like for the next shot that will be drilled. In this case, the ridge was narrow so the additional holes were drilled in order to guarantee drill accessibility for the next shot. The extra burden generated by the additional three rows of holes slowed the movement of the stone in the desired direction causing it to impede complete movement to the southeast. When this happened, the force of the blast was directed to the area of least burden, resulting in the blasted material sliding down the slope into Crabtree Creek.

A second variable which contributed to the slide was the hardness of the rock in the shot. Normally, the rock on the east and south sides of this ridge is hard, with the rock on the west being deeply weathered. This weathered rock is soft and will react to the impact from the blast much differently than hard rock. It tends to absorb the energy from the blast and does not move as readily as hard rock. With hard rock there is an opposite situation in that it tends to fracture more readily and is therefore more likely to move in the direction desired. This makes it possible to direct the movement of the shot rock by using time delay caps and wiring patterns tailored to the particular shot.

On the previous shots along the western ridge, we were successful in forcing the hard rock to move in a southeast direction, leaving a high ridge of soft rock along the western side that we would excavate with a hydraulic shovel. As you could see from your inspection on January 8th, there was no weathered rock in the muck pile. Instead, the material was all hard. This hard rock reacted to the force of the blast differently than had the previous shots. This factor, combined with the size of the blast as discussed earlier, lead to the material fracturing more than anticipated and moving to the west down the slope and into Crabtree Creek.

As per your request, I visited your Triangle Quarry to look at the blast data from the shot on 01/07/92. This was a seven row shot which automatically creates a problem, but after discussions with you and the blasting crew it is very understandable why they felt the need to have the shot with this configuration.

The bench that was blasted was only 48 feet at the widest point and the drill crew felt the need to bring the shot back to an area that would be wide enough to ensure good access for the drills on the next blast. This shot did achieve the goal of having good access, but allowed part of the blasted rock to roll into Crabtree Creek, which runs parallel with bench being blasted.

Shot data:
50 holes 4 nuch diameter
8×8 PAHERN
Side OF Shot Toward CREEK
had 25 FEET burden
