Review of Erosion and Sedimentation Program Delegation to the North Carolina Department of Transportation, Division of Highways

February 20, 2008

North Carolina Department of Environment and Natural Resources Division of Land Resources Land Quality Section The Land Quality Section reviewed the program delegation to the Department of Transportation, Division of Highways (DOT) on January 14-16, 2008. The format was revised this year to focus on contract construction and design-build projects, with twenty-four hour notice given to the project staff of the review. The review and the results reported here are in accordance with requirements of the Sedimentation Control Commission (SCC) delegation to the DOT.

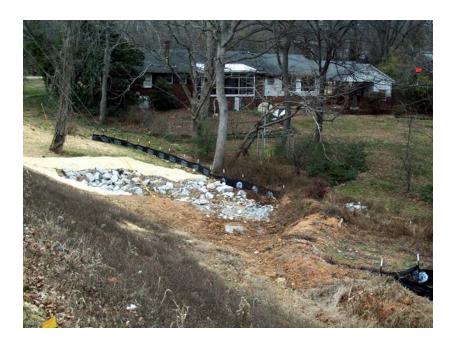
<u>SR 1129</u>— Groometown Road in Greensboro is being widened. The storm drainage outfall into Sedgefield Lake was checked, along with the edge of the lake. No sedimentation damage was observed. The project was been well protected.

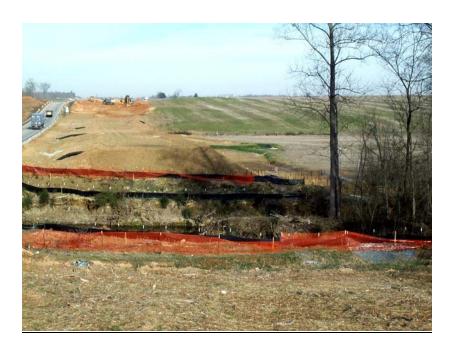
<u>US 601</u>— Project being built to new standards with baffles in all basins and some skimmer basins. A couple basins needed to be adjusted in location. Contractor had built basins with incorrect spillway elevations, and this was being corrected with sandbags on some basins. Road grader had bladed out diversion berms to slope drains along new roadbed.

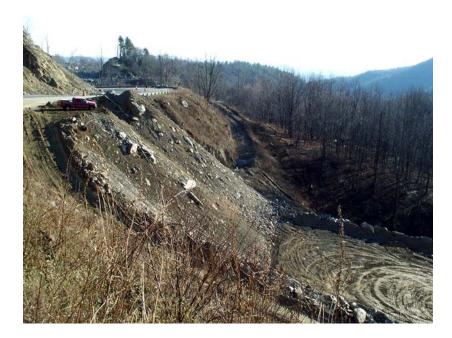
<u>US 321</u>— Massive cuts blasted from rock, and massive fills consisting of boulders characterize project. Numerous small waste areas are located along the project. An active waste area was the only location with poor management. Diversions were needed across haul road, and better sediment controls in ditch below waste area entrance. Falling/sliding rock a major safety concern on project.

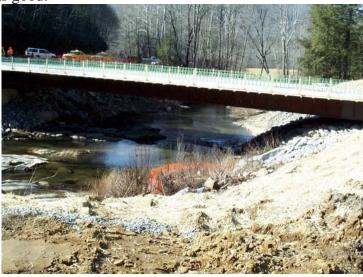
<u>SR 2804</u>— Ground cover was fair to good, with much of the banks in rock. There was little erosion. A stone bench for a crane had been removed from the Broad River. Sand in the stream had been dug out to reopen pool where the bench had been. Special silt fence should be reinstalled before fill for ramp to river is excavated. The overall effectiveness of the sedimentation and erosion control measures was good.

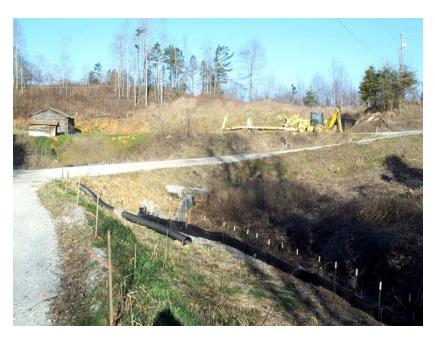
SR 1135, Shook Cove Road—This project involves the widening and paving of an existing gravel road in mountainous Jackson County. A small stream classified as trout waters runs at the base of a fill slope. A trout waiver was not issued for this project until plans were revised to provide a permanent buffer zone between the toe of the fill slope and the stream. About 250-300 feet of the stream is to be relocated using natural channel design. The road will be widened toward the stream using rock fill. The work area had been cleared this fall and grassed for the winter. Special silt fence was located along the toe of the slope. The site was well maintained.
