*Review of
Erosion and Sedimentation Program
Delegation to the North Carolina Department
of Transportation, Division of Highways*

November 30, 2010

NCDENR
*North Carolina Department of Environment
and Natural Resources
Division of Land Resources
Land Quality Section*

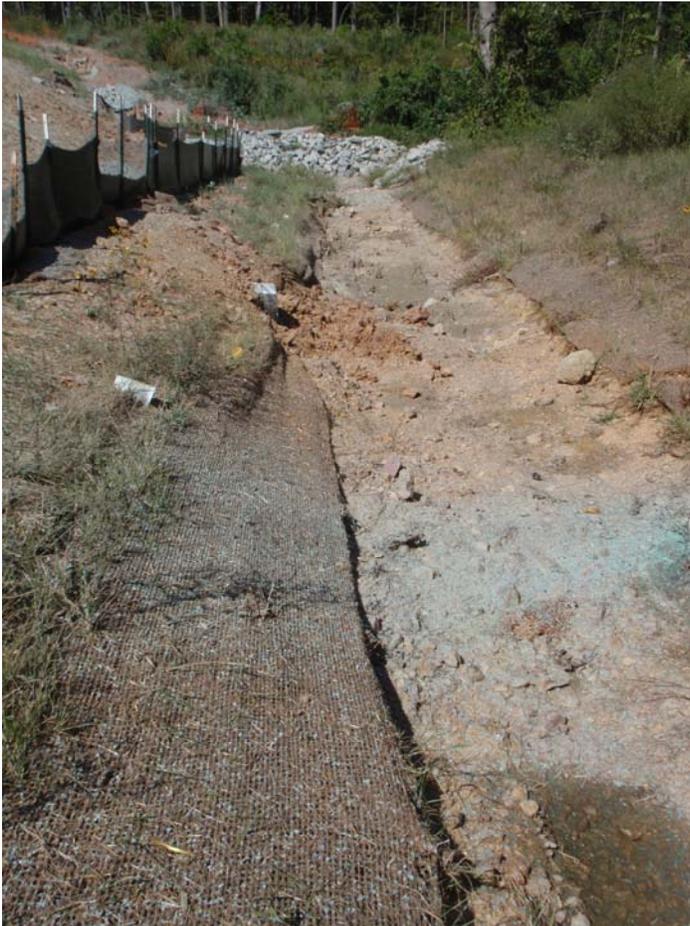
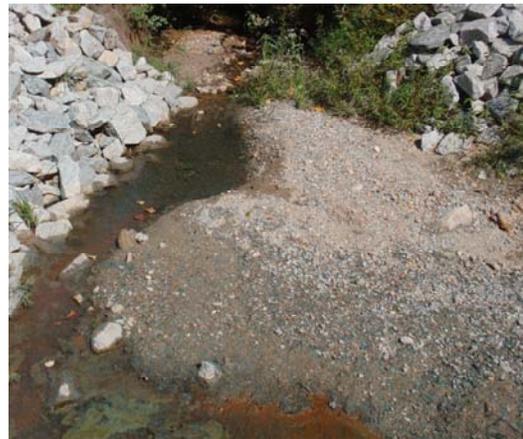
SR 4126, Bridford Parkway

SR 4126, Bridford Parkway—The plan failed to adequately handle off-site stormwater coming onto the project. Revised measures were needed to handle the off-site water separately from runoff from the graded roadbed. One lateral base channel at the toe of a fill slope was classified as an intermittent stream, and it was dry during the review. The channel bed was eroding because DWQ had directed that the coir matting lining the channel should be removed. A delta of sediment from the channel had formed in the receiving stream.

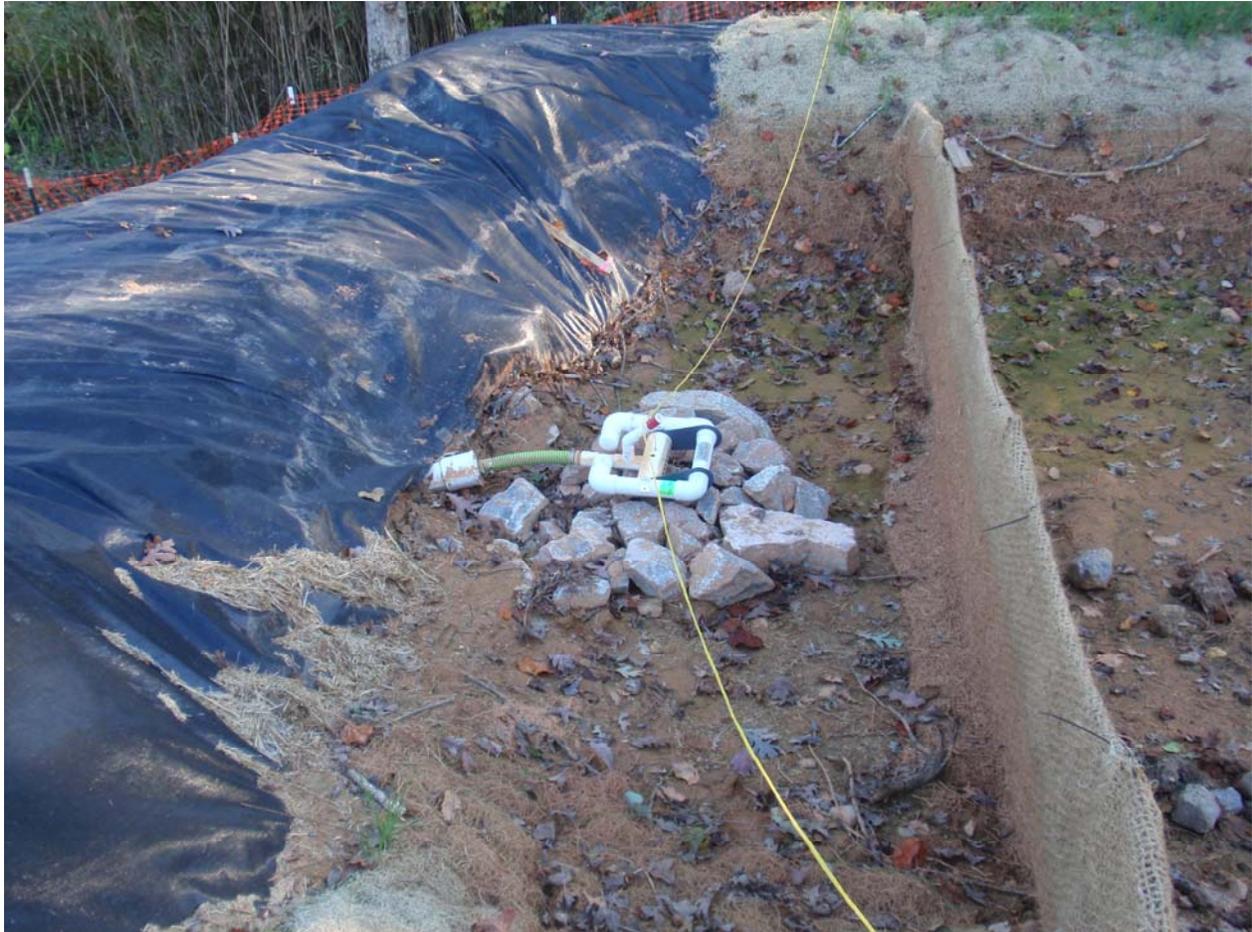
Timber Drive Extension, Wake County

Skimmer Installation

The PVC barrel pipe on floating skimmers should be at least 6 feet long. The orifice plate should be checked as part of period self-monitoring and self-inspection. Fabric lining of spillways should be carefully shingled (overlapped) and pinned.

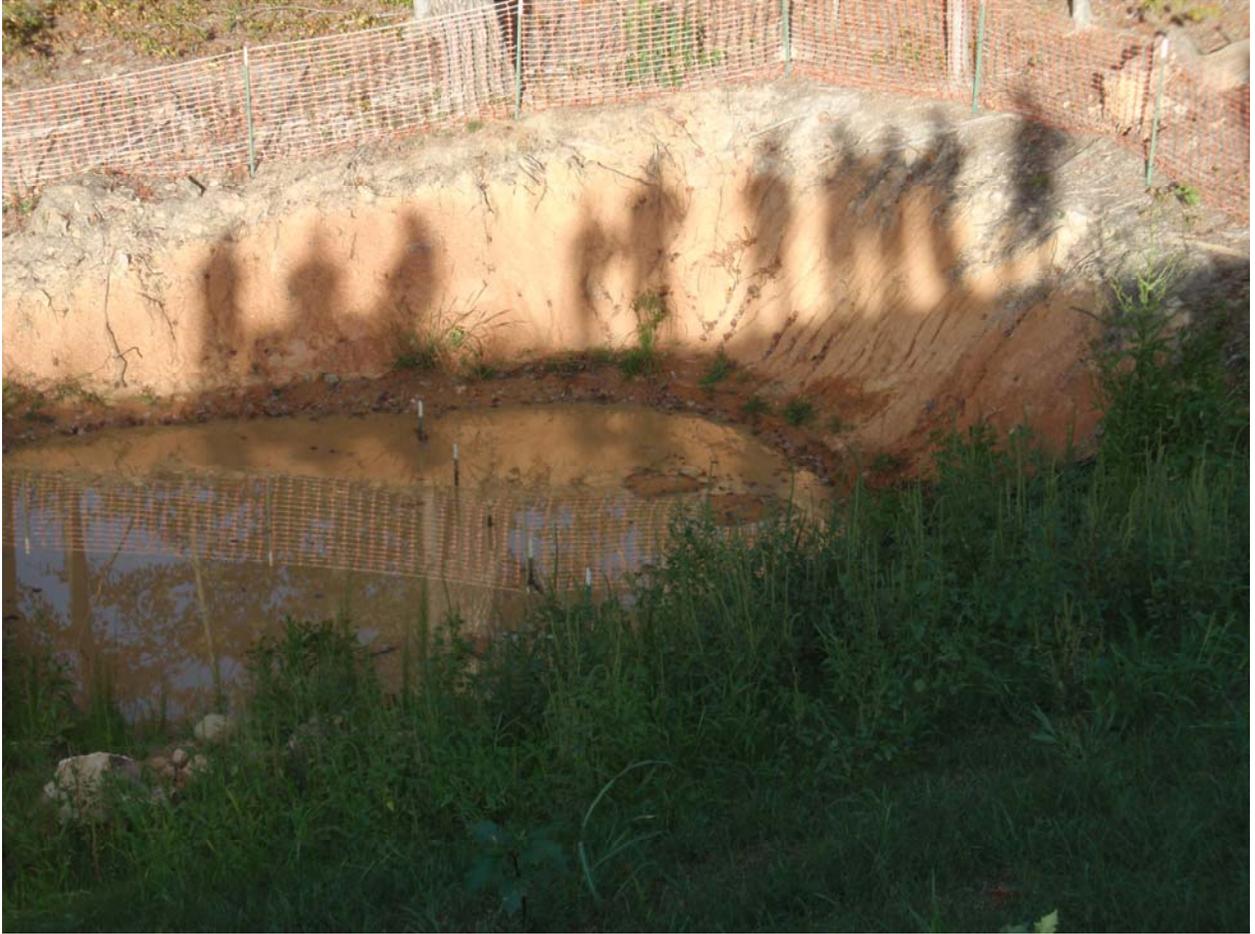
US 311, Randolph County

US 311—Ground cover had not been established on the slopes of sediment traps. Stabilization of highway graded slopes and fills was good. The project had been issued an ICA in the past.

Basin stabilization

The interior slopes of sediment traps and basins should be no steeper than 1.5:1 and the slopes should be stabilized with vegetation. Matting is recommended for slopes steeper than 2:1.

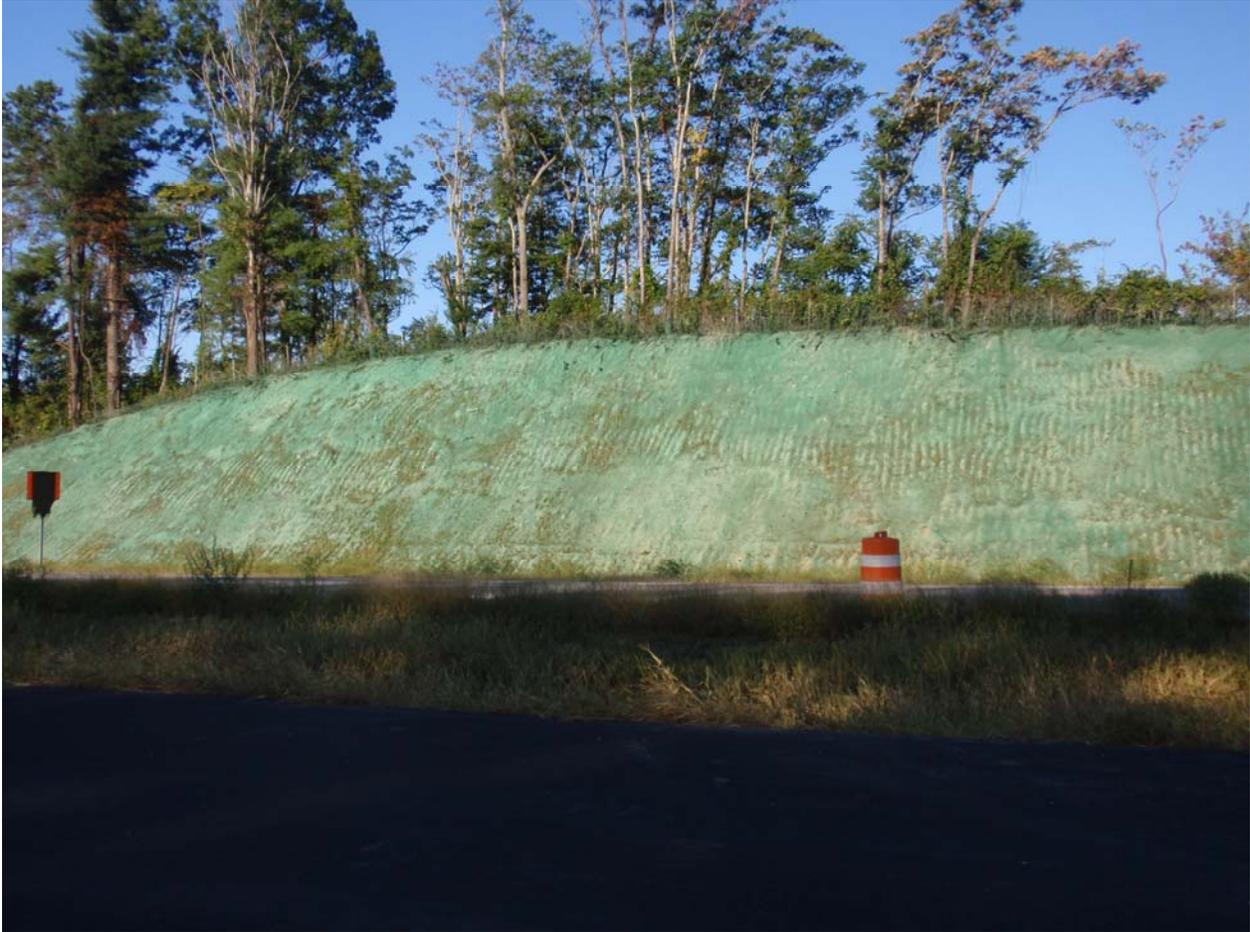
NC 225, Henderson County, poor preparation

Graded slopes and fills need adequate seedbed preparation.

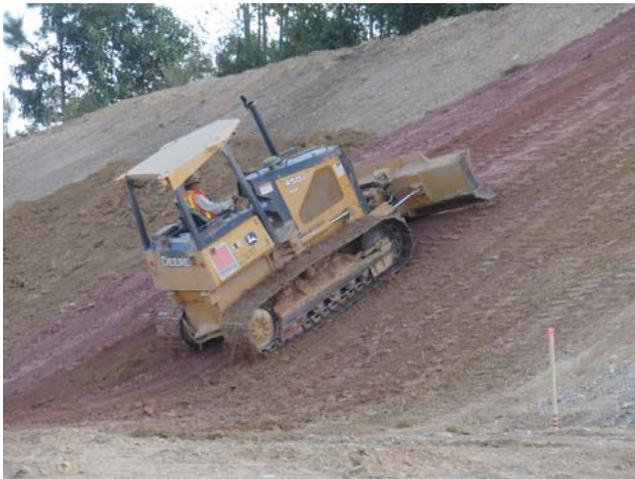
US 311, Randolph County, good preparation

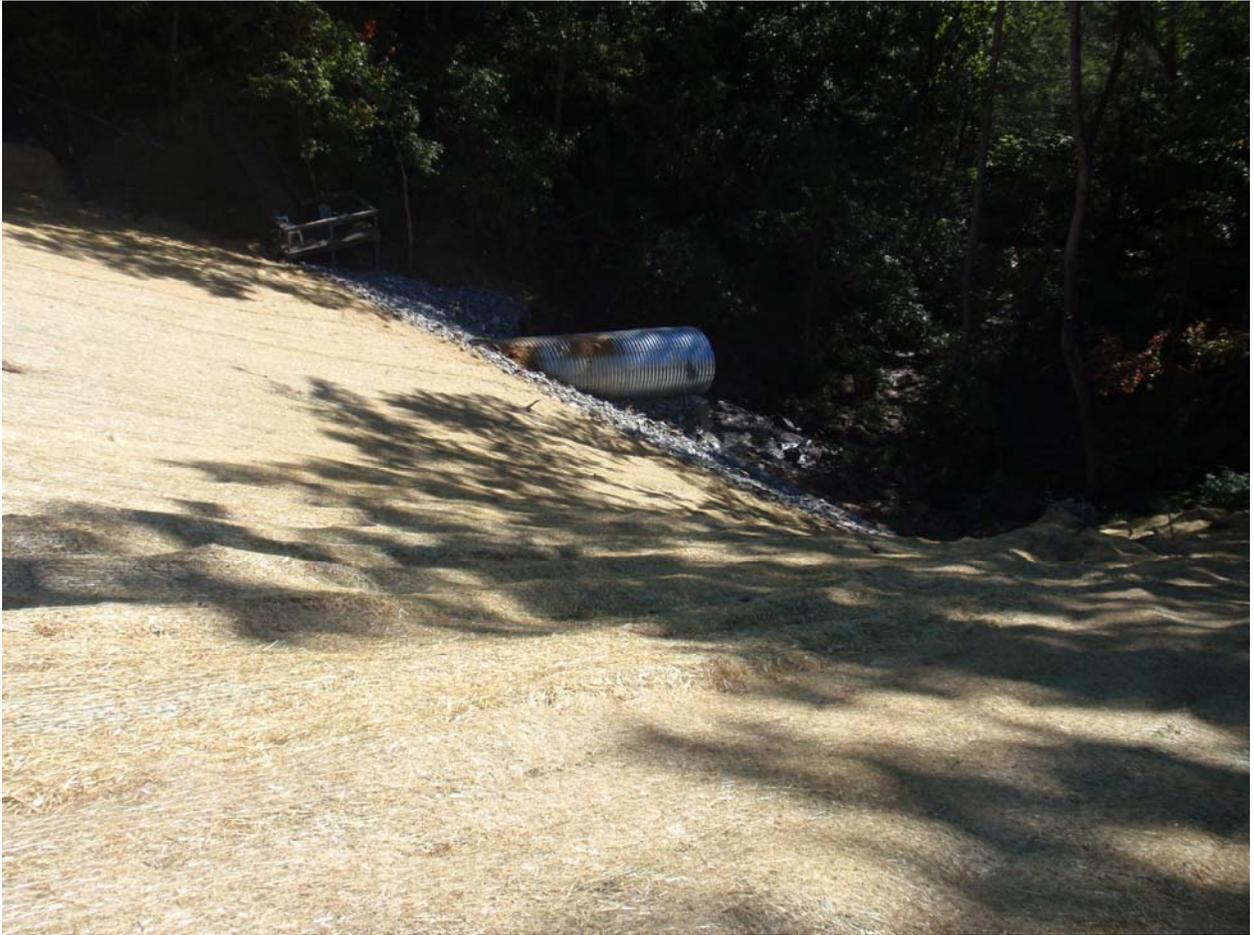
NC 225, Henderson County

NC 225—This project was in good condition during the review. A slope had failed earlier in the project, filling a private pond below the project with sediment. The measures shown on the original plan could not be installed as shown, because of the steep topography. The plan had been heavily revised by REU staff from the area and the central office.

Several basins shown on plans in steep terrain could not be constructed as drawn. If the proposed contours of the basins had been drawn, it would have shown that the basins could not be constructed

without large graded slopes. Drawing proposed basin contours is recommended in steep terrain.
