***Review of  
Erosion and Sedimentation Program  
Delegation to the North Carolina Department  
of Transportation, Division of Highways***

***November 29, 2011***

***NCDENR  
North Carolina Department of Environment  
and Natural Resources  
Division of Land Resources  
Land Quality Section***

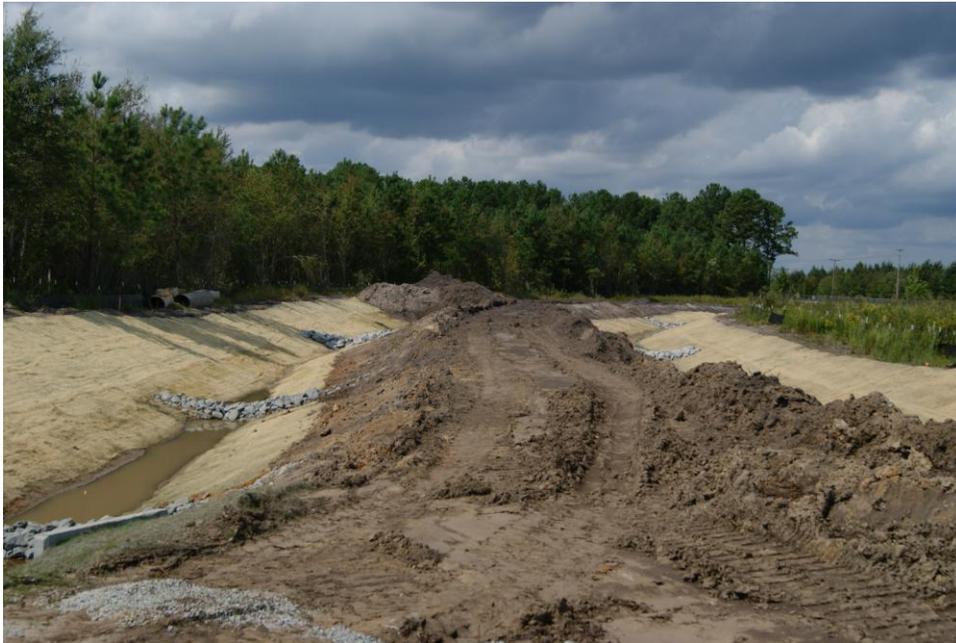
Rail Line from NCRR to GTP — The plans were adequate and changes had been documented on the plans. Both the self inspections required in the SPCA and the Water Quality inspections were being performed. The grading of the railroad bed should be completed before the side slopes are graded. Sediment controls measures should be left in until the side slopes and railroad bed are stabilized. Most of the sediment control measures had been removed once the side slopes had been stabilized but grading continued on the railroad bed in places with the possibility of off-site sediment. There needs to be some means to access the site once the tracks are placed. Site needed entrance and exit pads. There had been no offsite sedimentation but the potential was high.

*Railroad grade for  
Global Transpark*

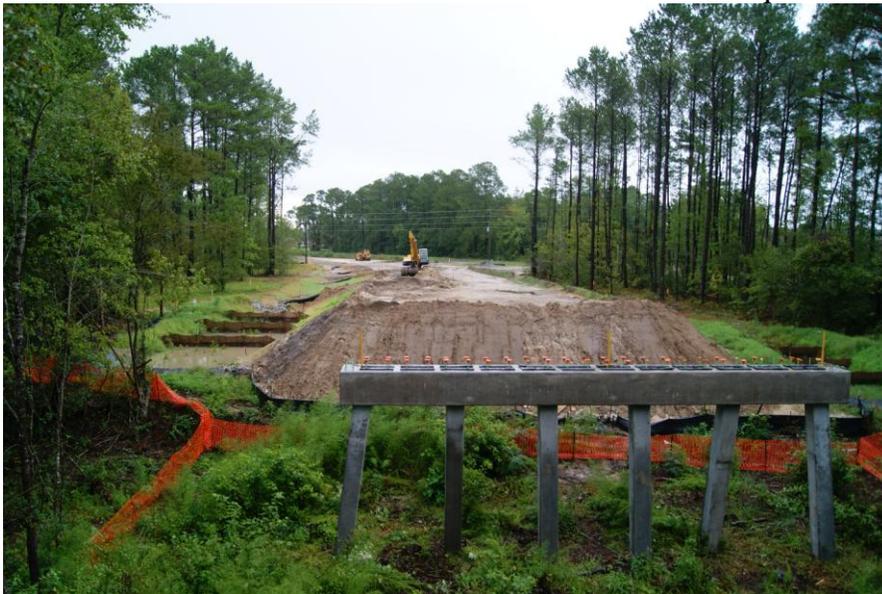
Future I-140, Wilmington Bypass — The plans were adequate and changes had been documented on the plans. Both the self inspections required in the SPCA and the Water Quality inspections were being performed. At one area on the site, measures for the clearing and grubbing phase had been removed and the measures for the final phase had been installed but site was not graded to drain to the final phase measures. A rock check dam was the only sediment control in this area. Fortunately there had been no offsite. Ground cover at the site was adequate. The site was not in compliance.

*Bridge approach on  
Wilmington Bypass*

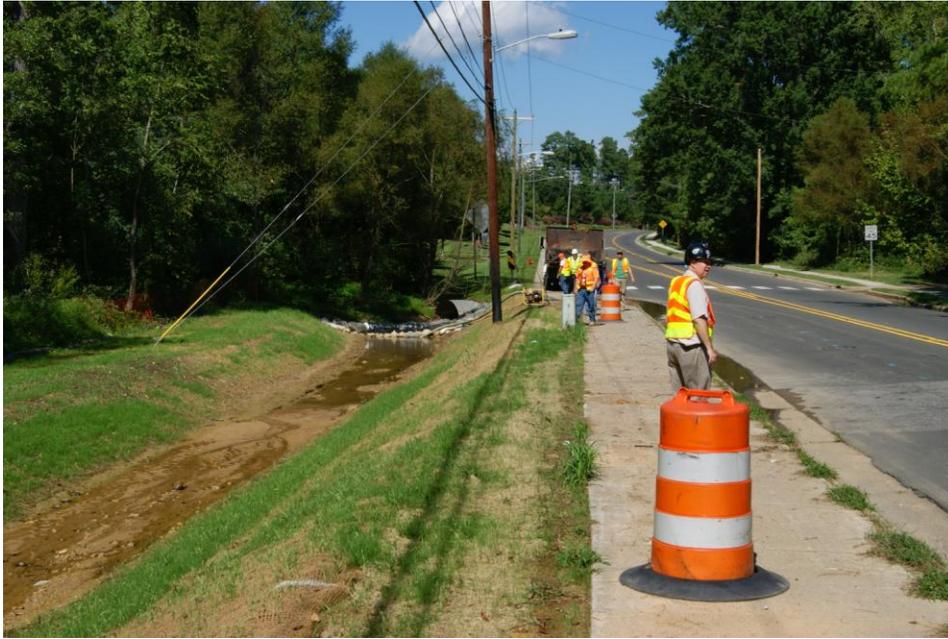
SR 1321, Hillendale Road— The plans were adequate and changes had been documented on the plans. Both the self inspections required in the SPCA and the Water Quality inspections were being performed. Measures were mostly in and functioning. Ground cover is adequate in some areas but not adequate in other areas of the project. There was a soil stock pile that was not shown on the plans.

*Stream channel relocation on Hillendale Road*

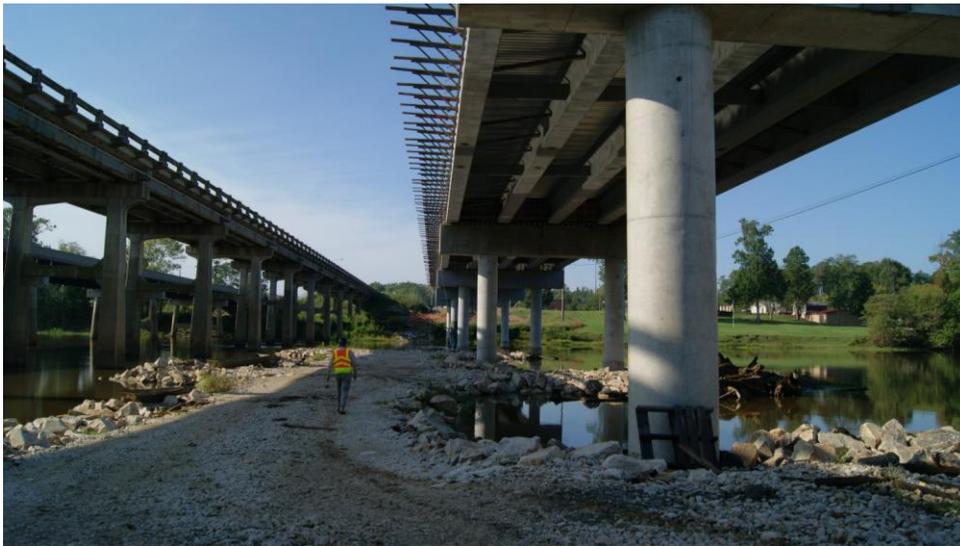
US 401 Bridge over Cape Fear River— The plans were adequate and changes had been documented on the plans. Both the self inspections required in the SPCA and the Water Quality inspection was being performed. Measures were in and functioning with mixed results. Maintenance of some of the measures was needed. Ground cover was adequate except in several place along the back slope of the stream restoration channel. There had been no offsite sediment.

*US 401 Bridge over Cape Fear River*

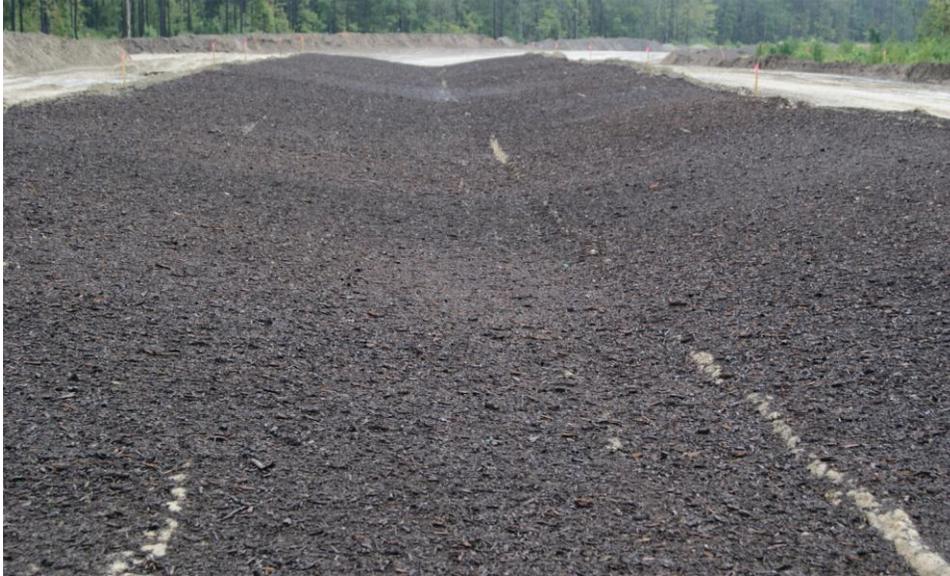
I-295, Fayetteville Outer Loop— The plans were adequate and changes had been documented on the plans. Both the self inspections required in the SPCA and the Water Quality inspection were being performed. Measures were in and functioning. Slope had been seeded and mulched but ground cover had not come up in several. Reseeding and mulching was in progress. Areas near wetlands had been cleared but not grubbed and were heavily mulched. There was no off-site sedimentation and the site was in compliance.

*Mulching of median*

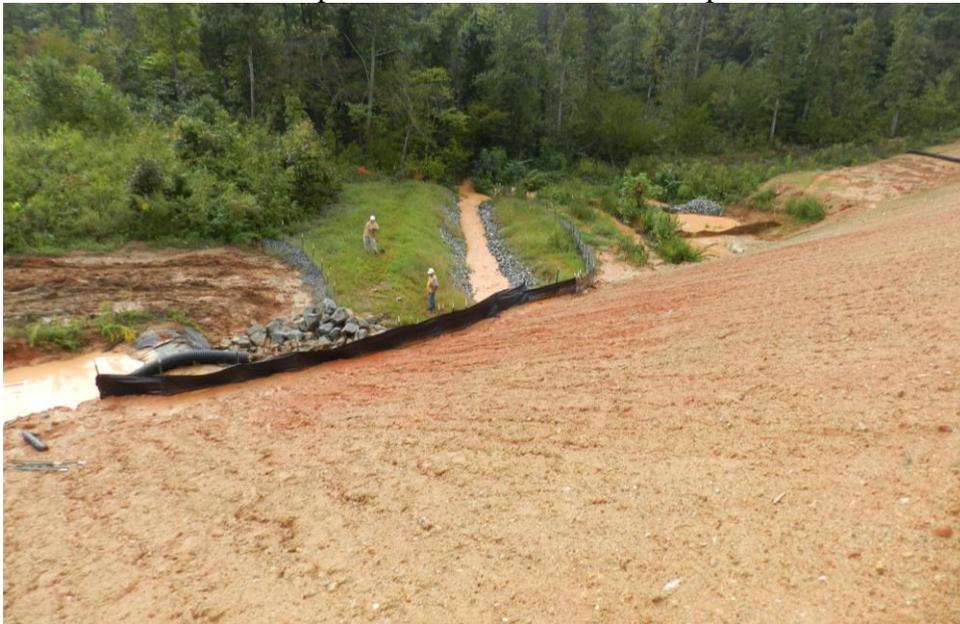
US 421—Sedimentation control measures were in place, but were not completely effective. Ground cover had not been provided on slopes in a timely manner. It appeared that the large areas had been prepared for seeding, but a rainy and wet period had set in before the seeding contractor had mobilized to the site. Stream turbidity was severe. Slight to moderate stream sedimentation was anticipated based on the level of suspended sediment in the streams.

*Fill slopes and creek on US 421*

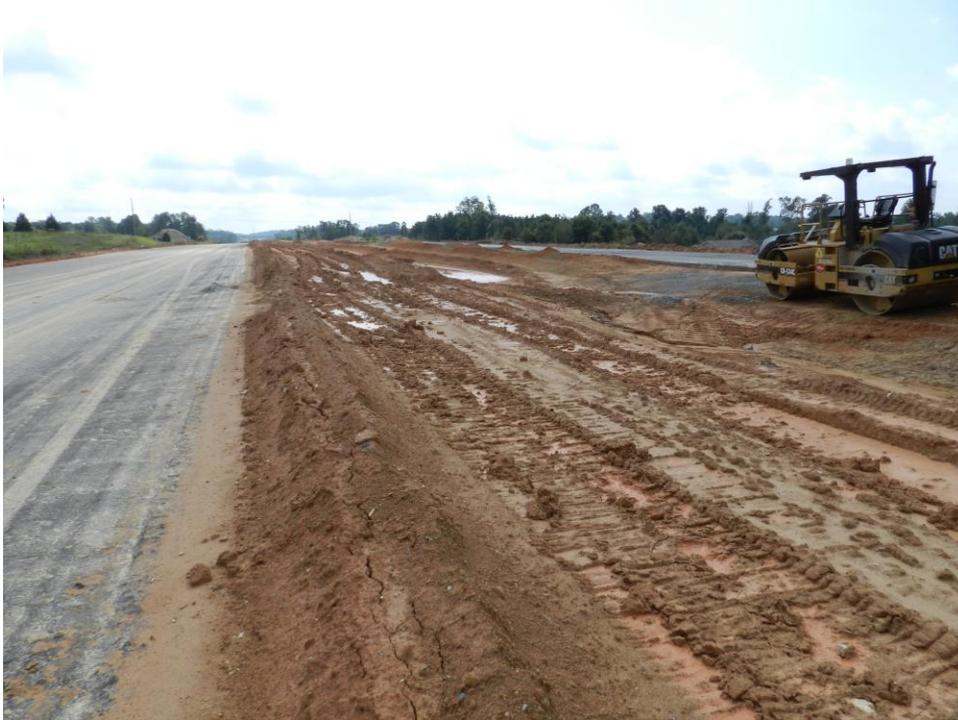
US 311—The project was generally in good condition. The median was being used as a haul road during paving operations. This kept the soil in the median bare and contributed to sedimentation of the median inlets. Slight stream sedimentation was observed.

*Haul road in  
median of US 311*

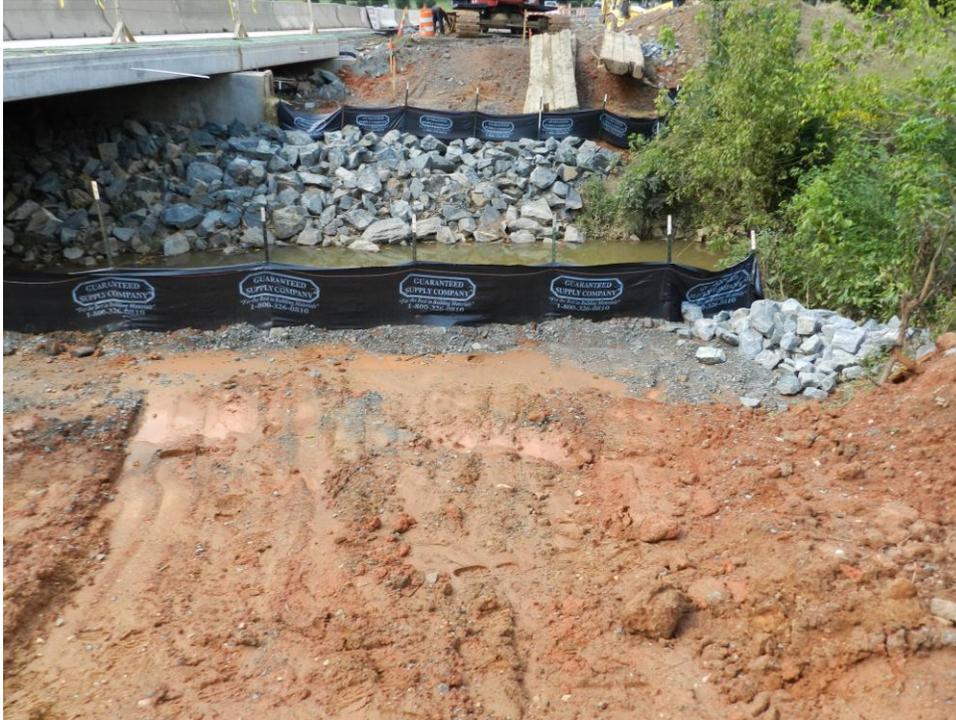
Lebanon Road— This project included replacing a bridge on a two lane road. One side of the road widening had been done and permanently stabilized. The other side was under construction. No stream sedimentation was observed. The project was in good condition.

*Lebanon Road  
bridge site*

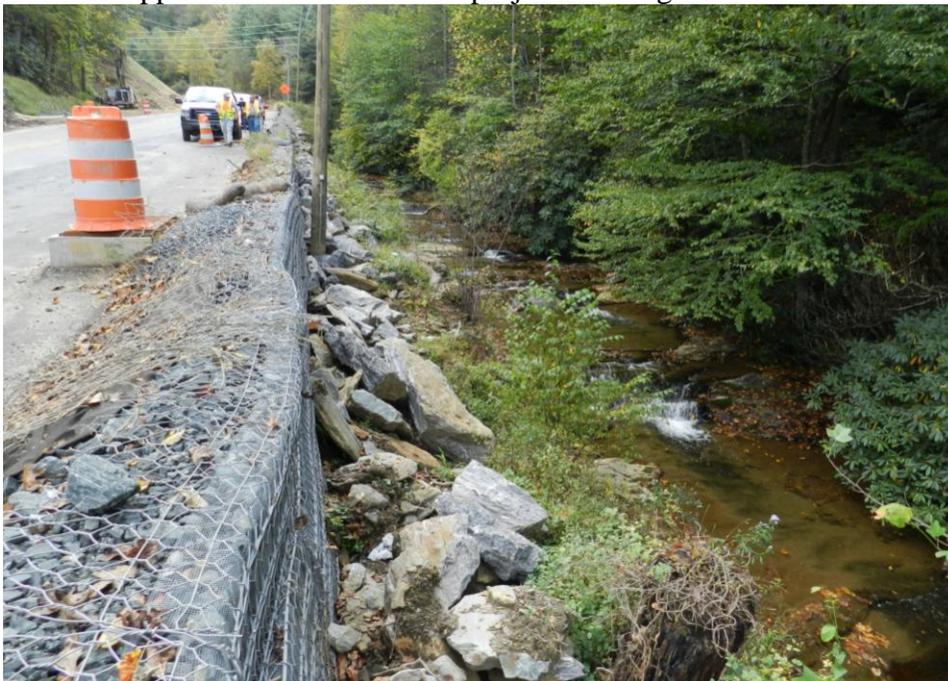
NC 16—The highway is being widened along a stream and the New River. No sedimentation damage was observed, despite the close proximity to the streams. New seeding of cut slopes needed a heavier application of mulch. The project was in good condition.

*NC 16 widening  
along stream*

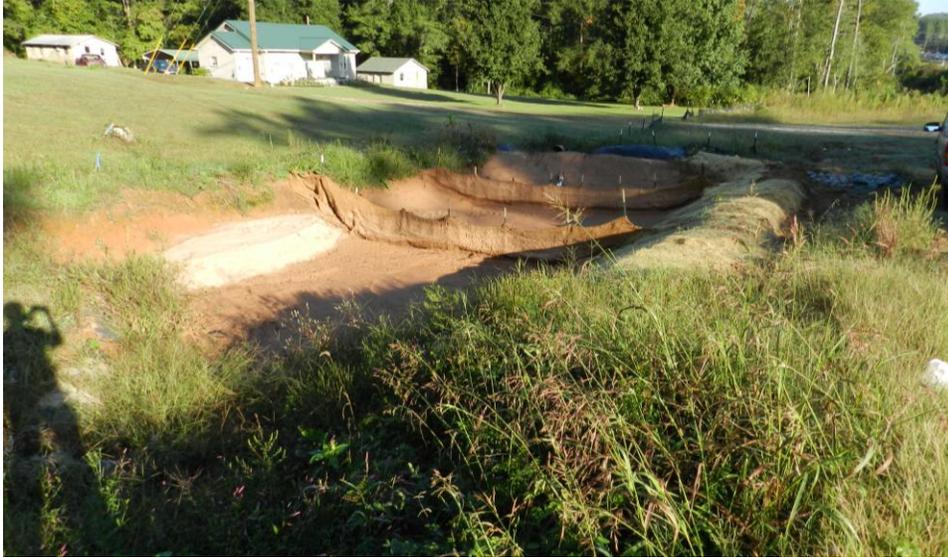
US 221—The location and design of some of the sediment basins did not fit the existing topography and available right-of-way. Two basins were observed to have been overwhelmed with more stormwater runoff than they could effectively handle. Maintenance of measures was behind. It appeared that additional equipment and personnel were needed to catch up on the maintenance of sediment control measures. Slight stream sedimentation was observed.

*Sediment basin on US 221 that had sediment pass through the basin.  
Note sand behind first baffle and silt on geotextile fabric spillway.*

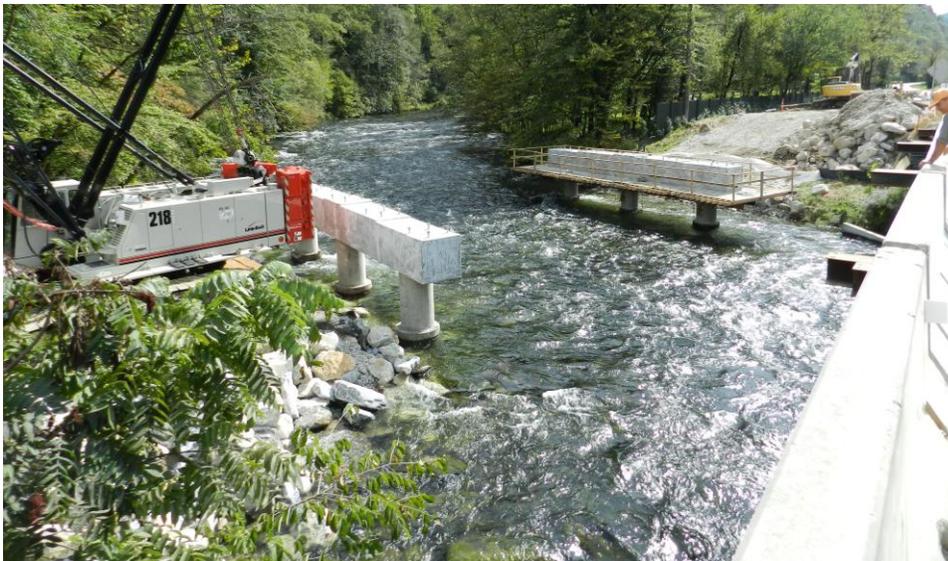
US 19 Bridge over Nantahala River—This is a very visible project on a river heavily used for recreation. The measures were well installed and very effective. Care had been taken to remove loose riprap from the river as the bridge columns were completed. The project was in good condition.

*US 19 Bridge over Nantahala River*

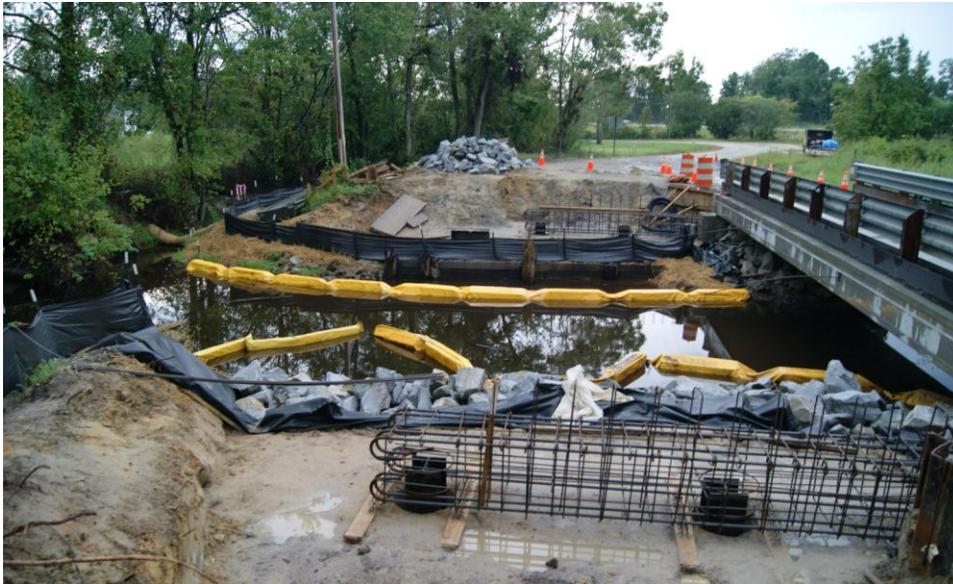
SR 1214, Fish Pond Road— The plan was adequate and changes had been documented. The Measures for the bridge were in and functioning. Rest of the project had not started.

*Fish Pond Road Bridge, with turbidity curtains*

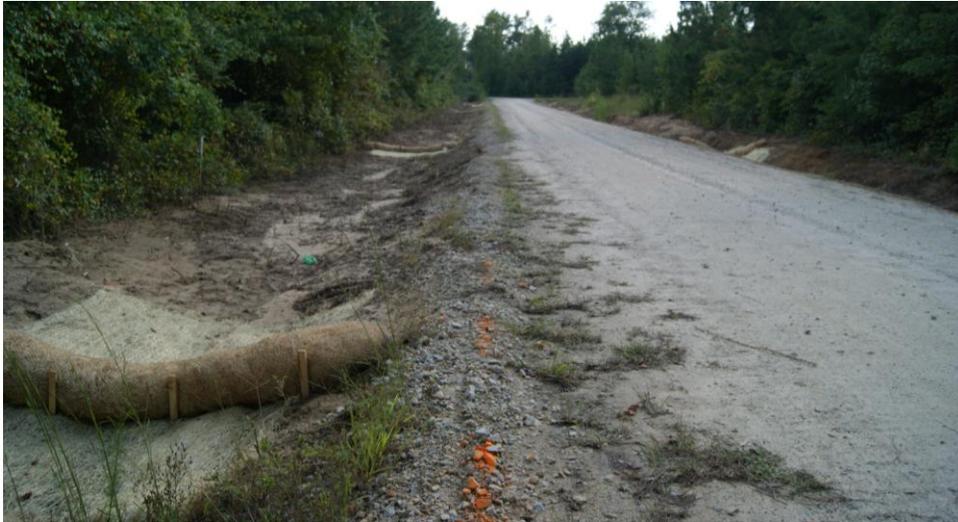
*SR 1123, Creeksville  
Church Road*

SR 1123, Creeksville Church Road— Ground cover could be applied sooner. There was slight offsite sedimentation. Right-of-way was not adequate, however the site was in compliance.

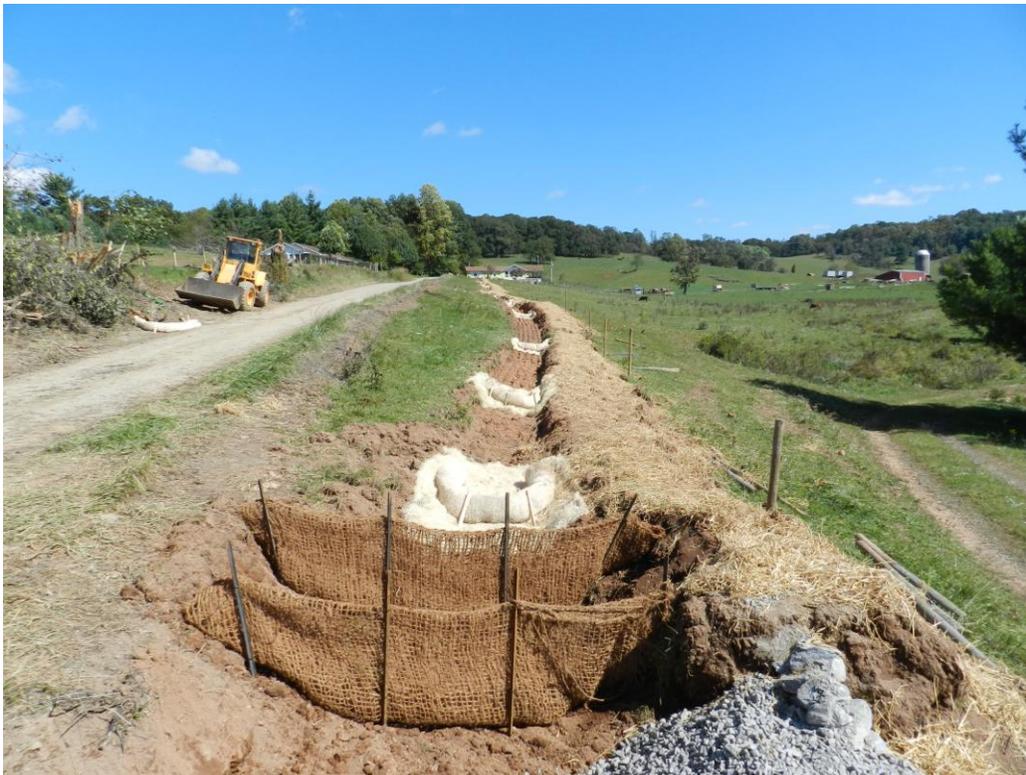
SR 1134, Harold Road— The project is a secondary road that is being widened and paved beside the Little River. The day before the review the project was issued an ICA by the Roadside Environmental Technician for blasting damage to the buffer zone of the river. Portable “Jersey” barrier had been substituted for blast mats, but only a small portion of the buffer had been protected. The river bank had been cleaned up, seeded and matted. Reforestation would need to take place in the winter. Sediment control measures had vertical sides and needed to be regarded. Seeding of cuts had not been done within 30 days of disturbance, as required by the erosion control plan.

*Measures along  
Harold Road*

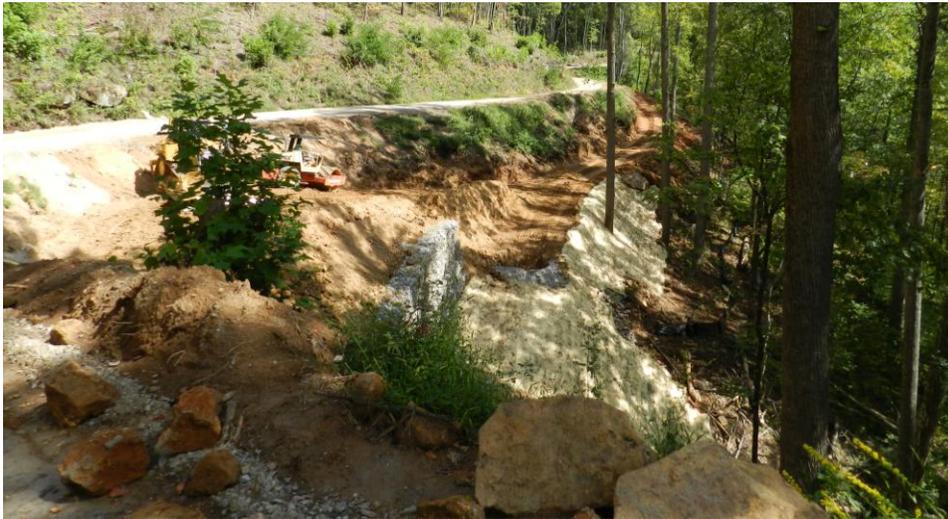
*SR 1521-A, Onion Mountain Road*

SR 1521-A, Onion Mountain Road—A narrow gravel road is being widened and paved around a winding mountain-side. The plans were an older style “straight-line” schematic layout, that does not show curves in the road. The spacing between straw or excelsior wattles was needed on the plan. Hydro-seeding of cut slopes needed an adequate application of mulch, such as bonded fiber matrix for flexible growth medium. The fill slope was being widened with a aid of a gabion wall. During work, the project was vulnerable to sediment loss. Protection depended upon getting each day’s work complete and provided with temporary ground cover.

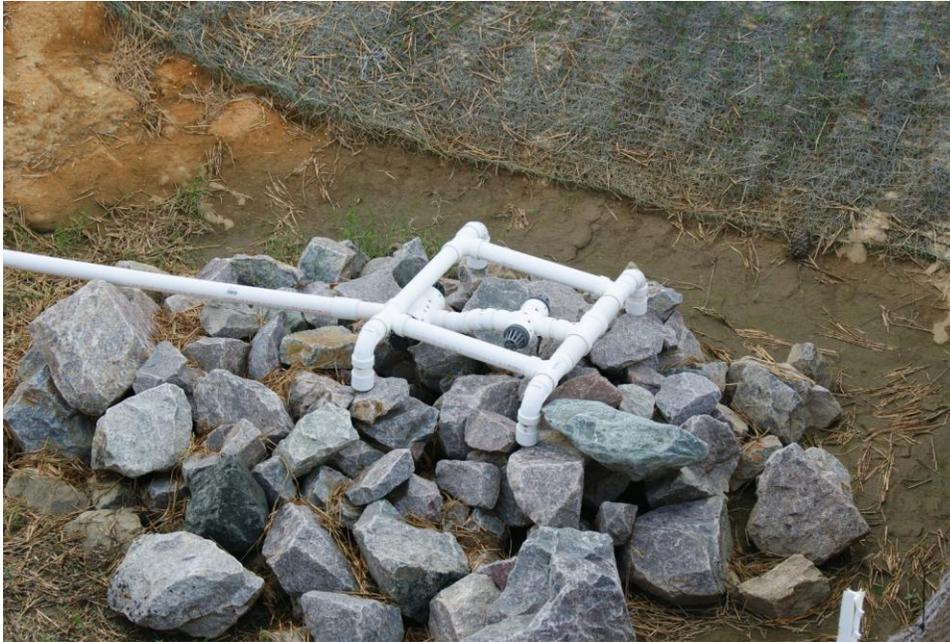
Some of the skimmers used by NC DOT contractors appeared to dewater at a rapid rate. Checking the flow rate of skimmers with a simple method such as a bucket and stopwatch is suggested when basins are observed to rapidly dewater.

*Skimmer with large inlet openings*

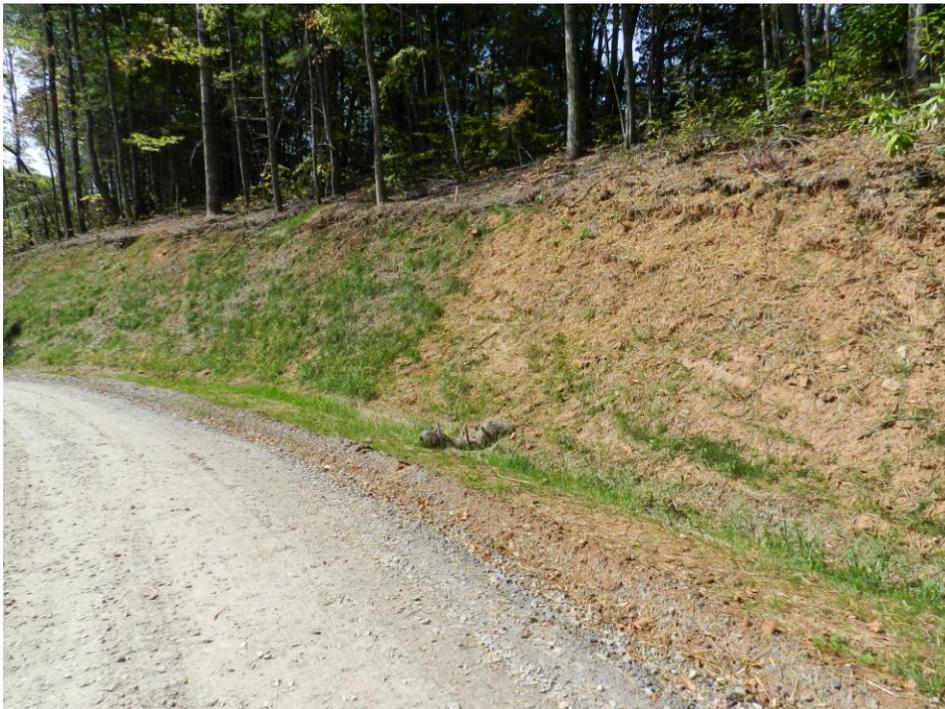
Steep cut slopes had been hydroseeded. Blown straw mulch had not been tacked, and had fallen or blown off the slopes. Some grass had sprouted, but temporary ground cover was inadequate. The use of tack over straw should be mandatory. Matting, BFM or FGM should be required on slopes steeper than 2:1.

*SR 1521-A, Onion Mountain Road.  
Note two stages of ground cover on cut slope.*

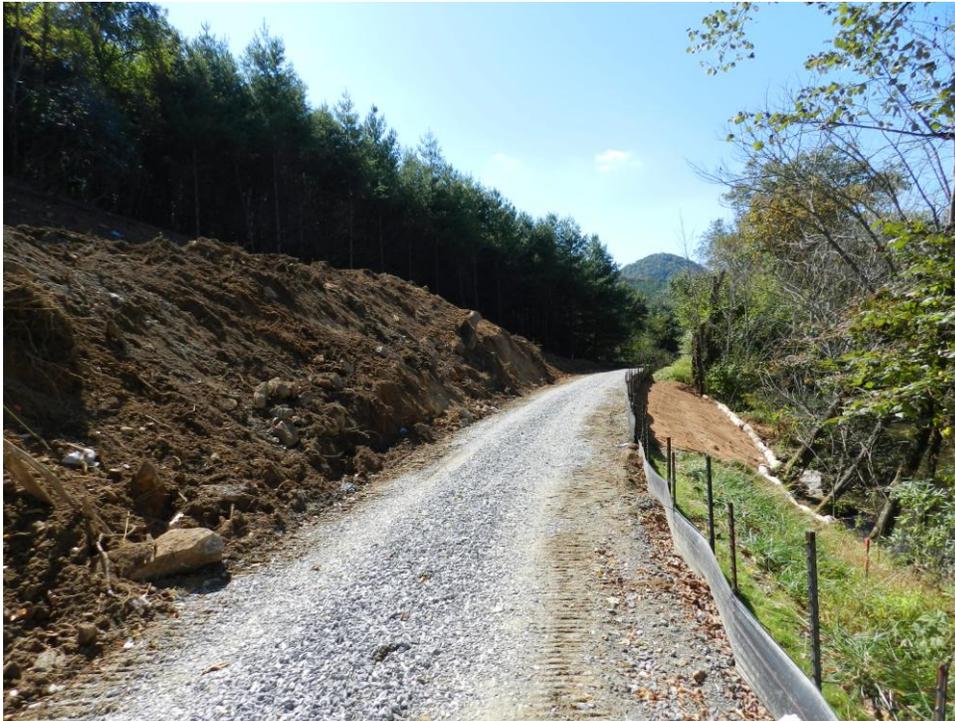
Blasting damage to vegetation in the stream buffer zone has been noted in three annual reviews, including this year. The blasting contract objected to the use of blast mats due to the vertical slopes. Portable concrete barrier was substituted along the river bank, but it only protected a small portion of the blast area. Soil and rock were thrown down to the river. Only the area with adequate protection should have been blasted. NC DOT has a set of general conditions that apply to work in the buffer zone of trout waters. District and county maintenance engineers need to adhere to these conditions.

*SR 1134, Harold Road in Alleghany County. Note repaired river bank on right.*
