October 27, 2015

Town of Wake Forest
Attention: Holly Miller, PE
301 S. Brooks Street
Wake Forest, NC 27587-2901

Subject: Sedimentation and Erosion Control Local Program Review

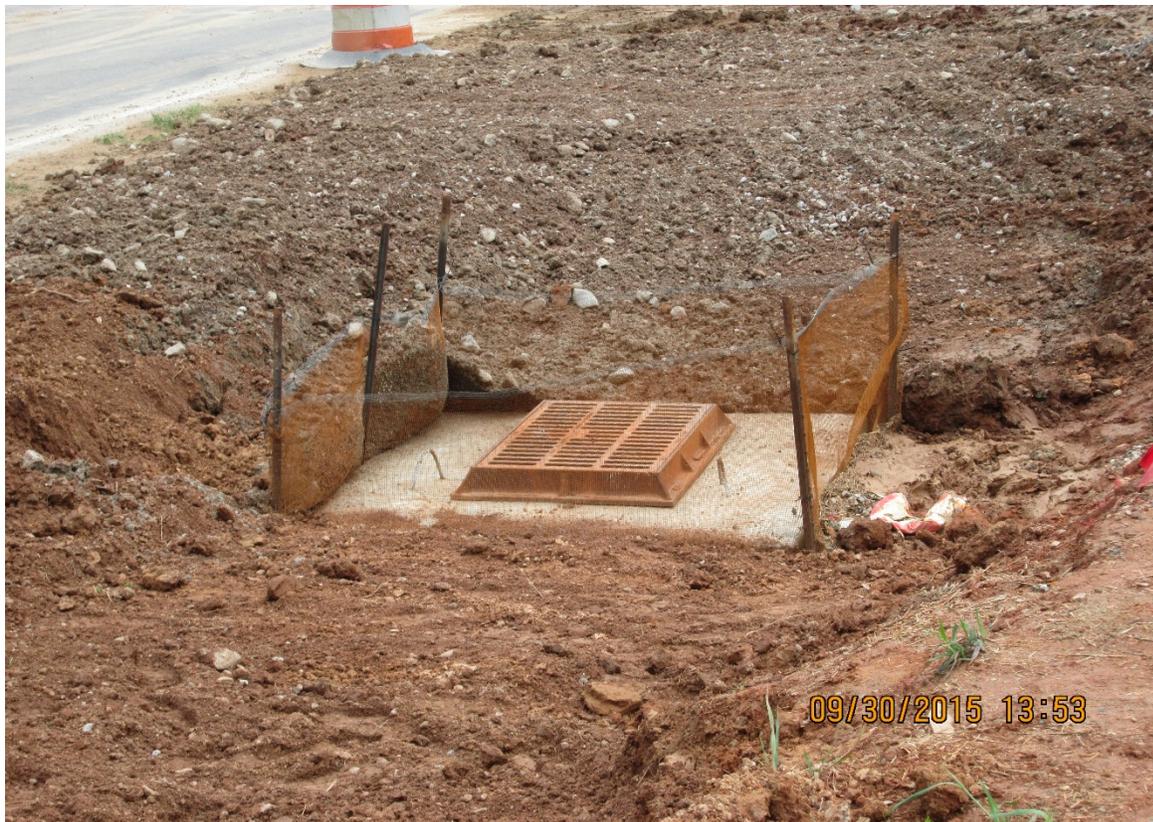
Site 1 – Inlet protections needs to be maintained and provided with clean stone.

- 1) Remove sediment from Jenkins Street. Install clean stone and extend existing construction entrance, and provide additional construction entrance where fire truck/trailers are currently accessing and parking on site.
- 2) Provide clean stone at inlets.
- 3) Remove stockpile located within 50 feet of two inlets, provide silt fence around stockpile at new location and stabilize.
- 4) Tie baffle into basin slopes, stabilize basin slopes, and connect skimmer to riser.

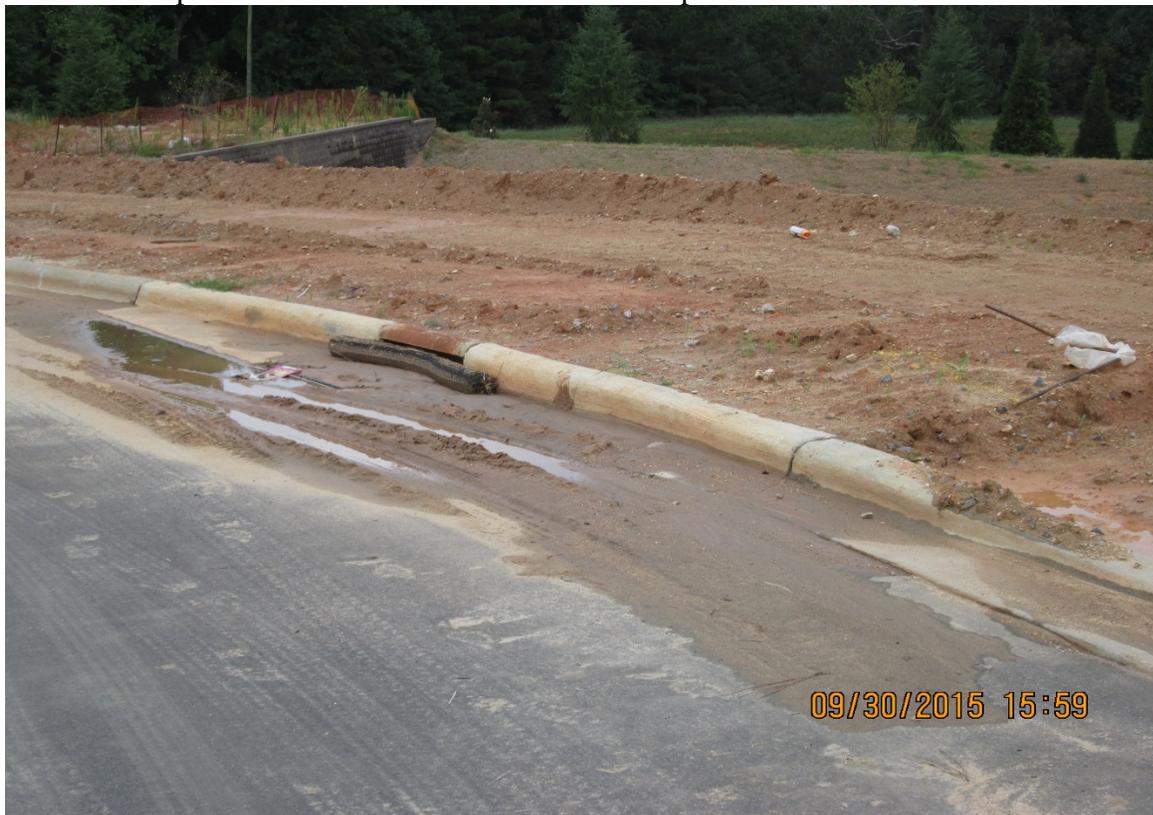
Site 2 – Curb inlet needs to be maintained and sediment removed from street.

- 1) North and West Borrow Areas - Repair/maintain perimeter silt fence. Stabilize diversions entering basins. Provide groundcover on stockpiles and overseed borrow areas to achieve dense vegetation.
- 2) Main Site – Maintain/repair perimeter silt fence. Maintain silt fence outlet, inlet protection, sediment basins, and repair eroded areas onsite. Re-install baffles in sediment basin that is being short circuited. Remove sediment from interior roads near curb inlets and exterior roadside ditch and re-stabilize.

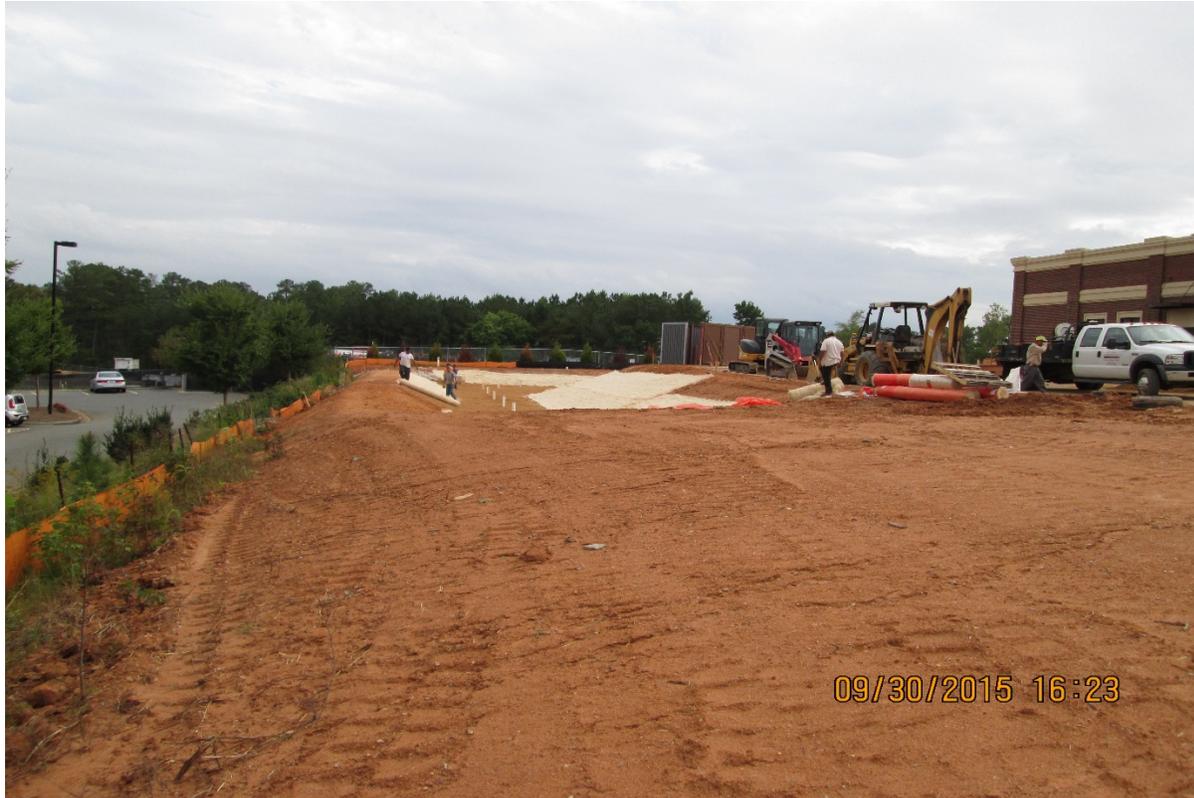
Site 3 – Sediment basin being converted to permanent Stormwater BMP.

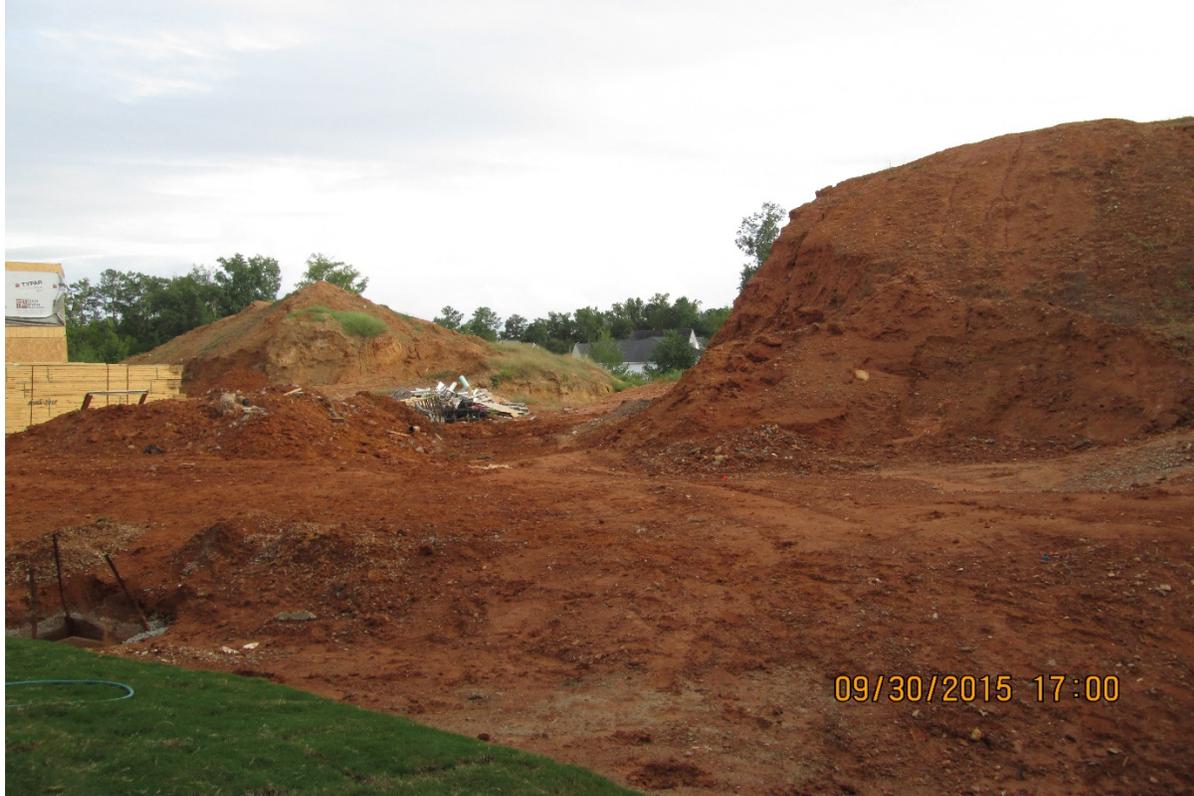
Site 4 – Yard inlet needs maintains and stockpiles need groundcover.

- 1) Provide adequate ground cover on all bare and inactive areas.
- 2) Repair, install, and maintain inlet protection and silt fence throughout site.
- 3) Provide channel liner and check dams in all ditch lines.
- 4) Revise plan for additional waste area that has been installed on site. These slopes are too steep and signs of slope failure are evident. Waste area is located adjacent to Neuse River Riparian Buffer and dirt clods from stockpile are in buffer already.
- 5) Stabilize all inactive stockpiles with temporary vegetation immediately. Sparse weeds were growing on stockpile.
