**YEAR 1 (2015) MONITORING REPORT**  
**ABBEY LAMM**  
**STREAM AND WETLAND MITIGATION SITE**  
**ALAMANCE COUNTY, NORTH CAROLINA**  
**FULL DELIVERY CONTRACT NO. 5790**

**CAPE FEAR RIVER BASIN**  
**CATALOGING UNIT 03030002**

**Data Collection – March-October 2015**

**November 2015**

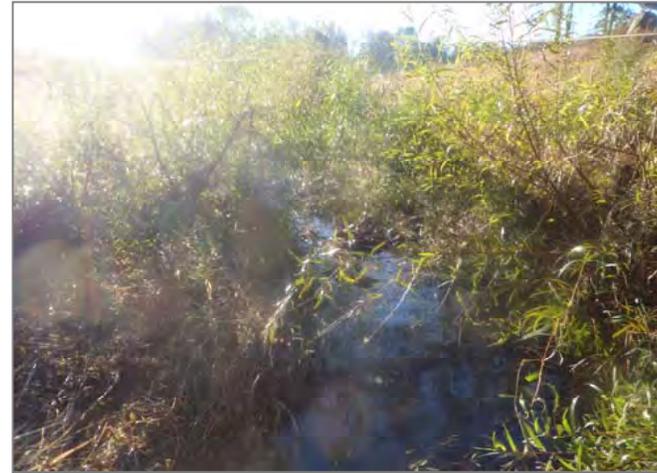
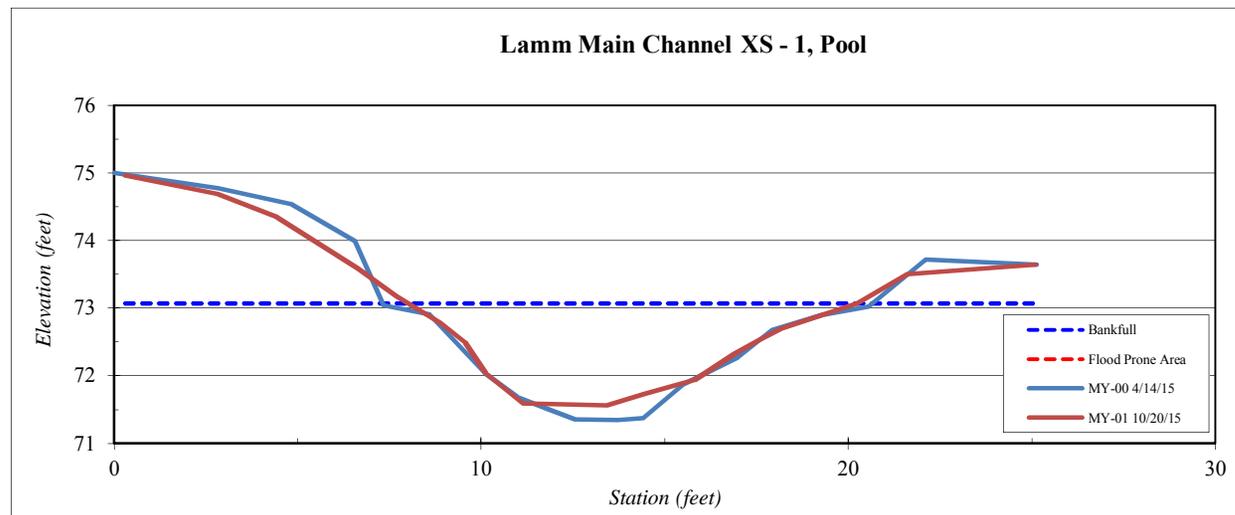
<b>Site</b>	Abbey Lamm
<b>Watershed:</b>	Cape Fear, 0303002
<b>XS ID</b>	Main Channel XS - 1, Pool
<b>Feature</b>	Pool
<b>Date:</b>	10/20/2015
<b>Field Crew:</b>	Perkinson, Keith

SUMMARY DATA	
<b>Bankfull Elevation:</b>	73.1
<b>Bankfull Cross-Sectional Area:</b>	10.8
<b>Bankfull Width:</b>	12.2
<b>Flood Prone Area Elevation:</b>	NA
<b>Flood Prone Width:</b>	NA
<b>Max Depth at Bankfull:</b>	1.5
<b>Mean Depth at Bankfull:</b>	0.9
<b>W / D Ratio:</b>	NA
<b>Entrenchment Ratio:</b>	NA
<b>Bank Height Ratio:</b>	1.0

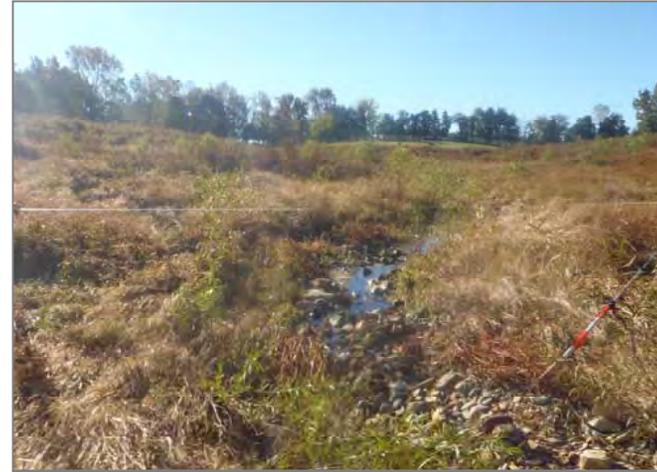
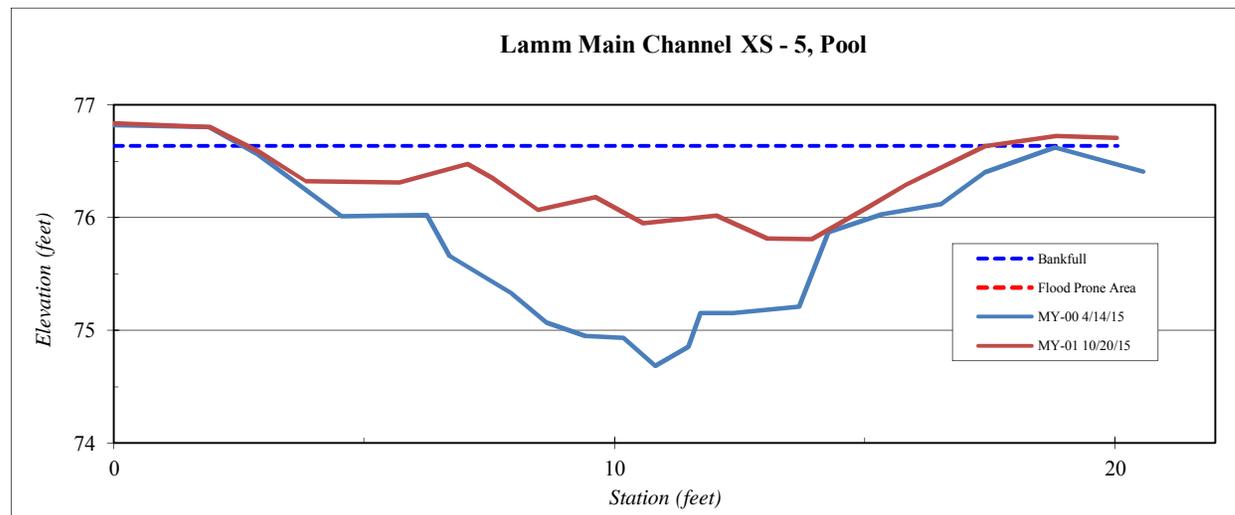
<b>Site</b>	Abbey Lamm
<b>Watershed:</b>	Cape Fear, 0303002
<b>XS ID</b>	Main Channel XS - 5, Pool
<b>Feature</b>	Pool
<b>Date:</b>	10/20/2015
<b>Field Crew:</b>	Perkinson, Keith

SUMMARY DATA	
<b>Bankfull Elevation:</b>	76.6
<b>Bankfull Cross-Sectional Area:</b>	6.6
<b>Bankfull Width:</b>	14.8
<b>Flood Prone Area Elevation:</b>	NA
<b>Flood Prone Width:</b>	NA
<b>Max Depth at Bankfull:</b>	0.8
<b>Mean Depth at Bankfull:</b>	0.4
<b>W / D Ratio:</b>	NA
<b>Entrenchment Ratio:</b>	NA
<b>Bank Height Ratio:</b>	1.0

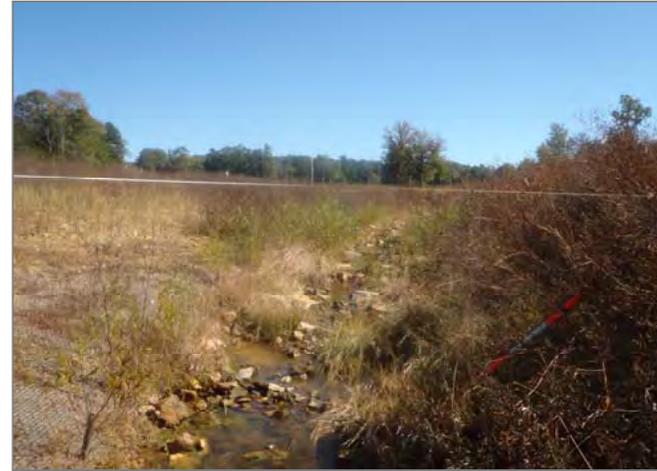
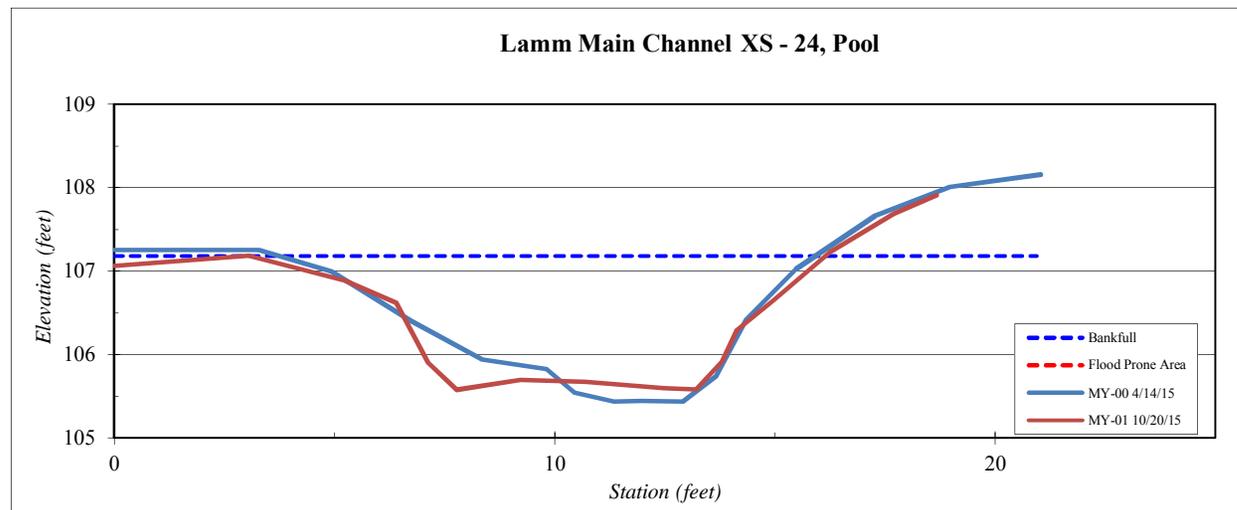
<b>Site</b>	Abbey Lamm
<b>Watershed:</b>	Cape Fear, 0303002
<b>XS ID</b>	Main Channel XS - 24, Pool
<b>Feature</b>	Pool
<b>Date:</b>	10/20/2015
<b>Field Crew:</b>	Perkinson, Keith

SUMMARY DATA	
<b>Bankfull Elevation:</b>	107.2
<b>Bankfull Cross-Sectional Area:</b>	12.9
<b>Bankfull Width:</b>	13.1
<b>Flood Prone Area Elevation:</b>	NA
<b>Flood Prone Width:</b>	NA
<b>Max Depth at Bankfull:</b>	1.6
<b>Mean Depth at Bankfull:</b>	1.0
<b>W / D Ratio:</b>	NA
<b>Entrenchment Ratio:</b>	NA
<b>Bank Height Ratio:</b>	1.0

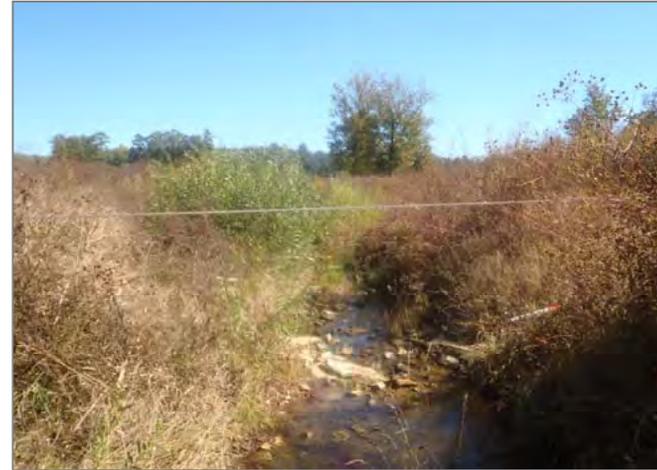
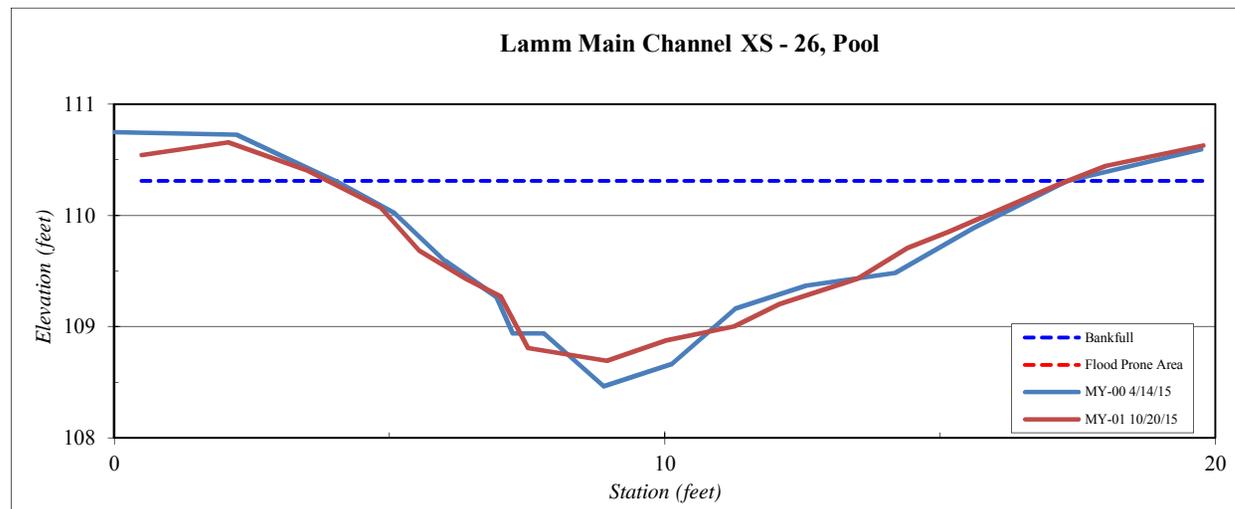
<b>Site</b>	Abbey Lamm
<b>Watershed:</b>	Cape Fear, 0303002
<b>XS ID</b>	Main Channel XS - 26, Pool
<b>Feature</b>	Pool
<b>Date:</b>	10/20/2015
<b>Field Crew:</b>	Perkinson, Keith

SUMMARY DATA	
<b>Bankfull Elevation:</b>	110.3
<b>Bankfull Cross-Sectional Area:</b>	11.8
<b>Bankfull Width:</b>	13.4
<b>Flood Prone Area Elevation:</b>	NA
<b>Flood Prone Width:</b>	NA
<b>Max Depth at Bankfull:</b>	1.6
<b>Mean Depth at Bankfull:</b>	0.9
<b>W / D Ratio:</b>	NA
<b>Entrenchment Ratio:</b>	NA
<b>Bank Height Ratio:</b>	1.0

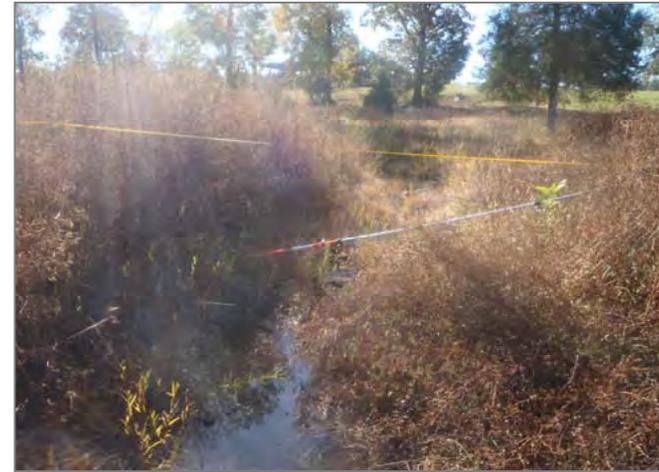
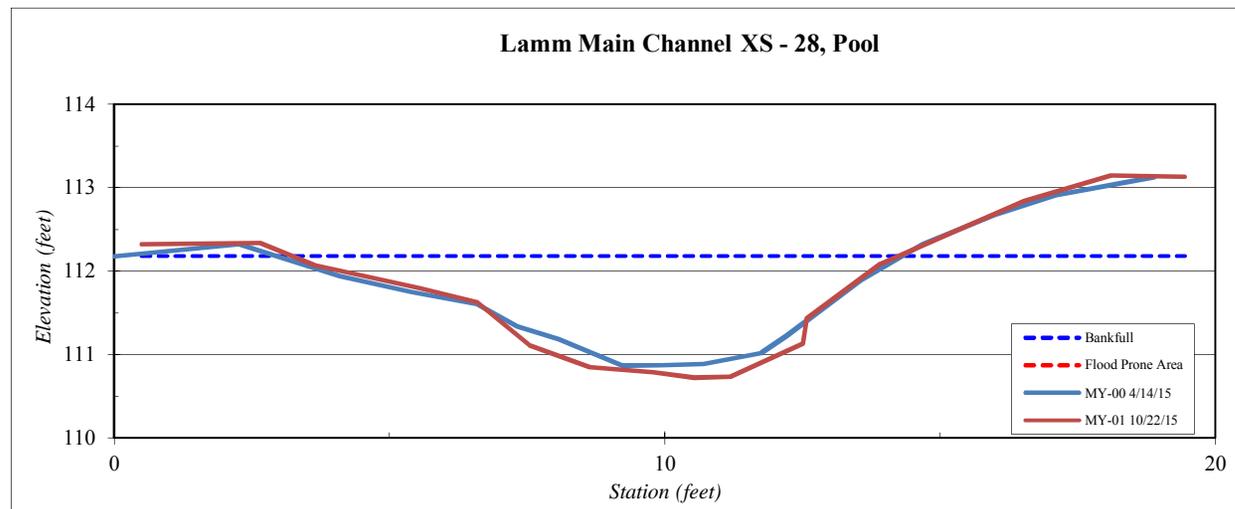
<b>Site</b>	Abbey Lamm
<b>Watershed:</b>	Cape Fear, 0303002
<b>XS ID</b>	Main Channel XS - 28, Pool
<b>Feature</b>	Pool
<b>Date:</b>	10/20/2015
<b>Field Crew:</b>	Perkinson, Jernigan

SUMMARY DATA	
<b>Bankfull Elevation:</b>	112.2
<b>Bankfull Cross-Sectional Area:</b>	8.9
<b>Bankfull Width:</b>	11.0
<b>Flood Prone Area Elevation:</b>	NA
<b>Flood Prone Width:</b>	NA
<b>Max Depth at Bankfull:</b>	1.5
<b>Mean Depth at Bankfull:</b>	0.8
<b>W / D Ratio:</b>	NA
<b>Entrenchment Ratio:</b>	NA
<b>Bank Height Ratio:</b>	1.0

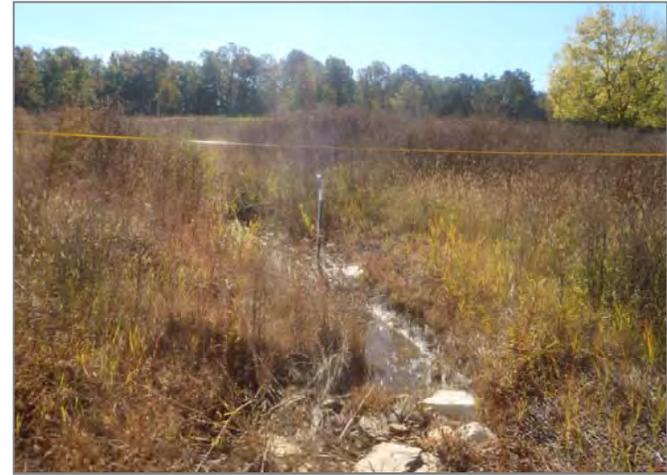
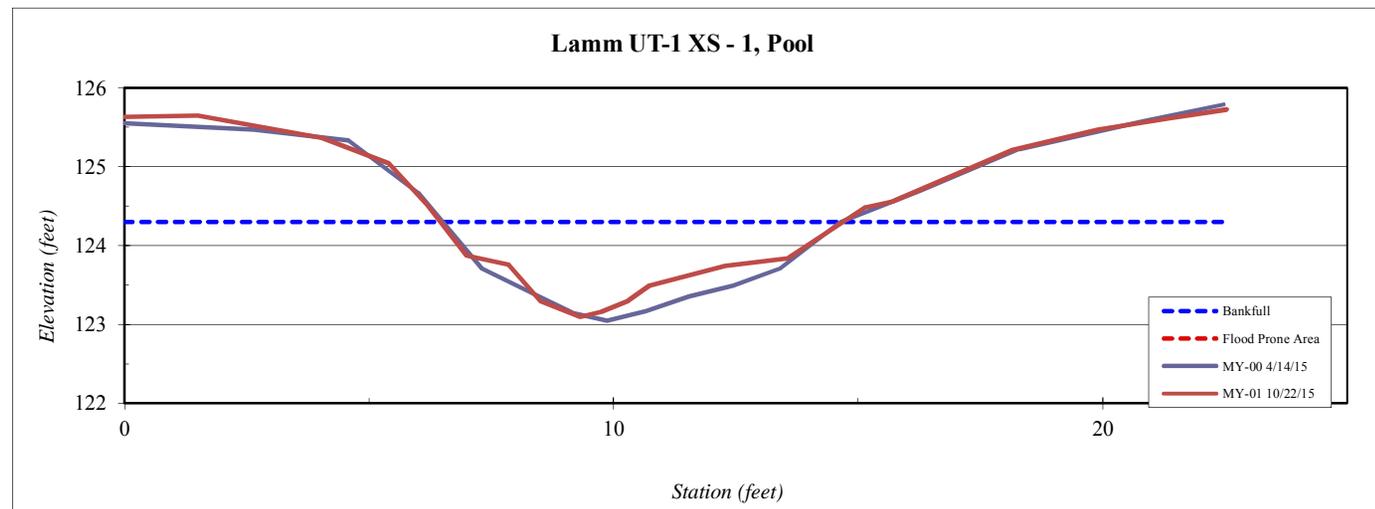
<b>Site</b>	Abbey Lamm
<b>Watershed:</b>	Cape Fear, 0303002
<b>XS ID</b>	UT 1 XS - 1, Pool
<b>Feature</b>	Pool
<b>Date:</b>	10/22/2015
<b>Field Crew:</b>	Perkinson, Jernigan

SUMMARY DATA	
<b>Bankfull Elevation:</b>	124.3
<b>Bankfull Cross-Sectional Area:</b>	5.4
<b>Bankfull Width:</b>	8.2
<b>Flood Prone Area Elevation:</b>	NA
<b>Flood Prone Width:</b>	NA
<b>Max Depth at Bankfull:</b>	1.2
<b>Mean Depth at Bankfull:</b>	0.7
<b>W / D Ratio:</b>	NA
<b>Entrenchment Ratio:</b>	NA
<b>Bank Height Ratio:</b>	1.0

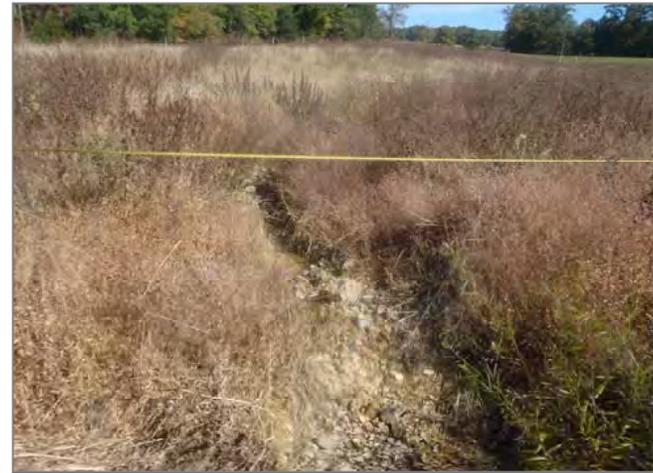
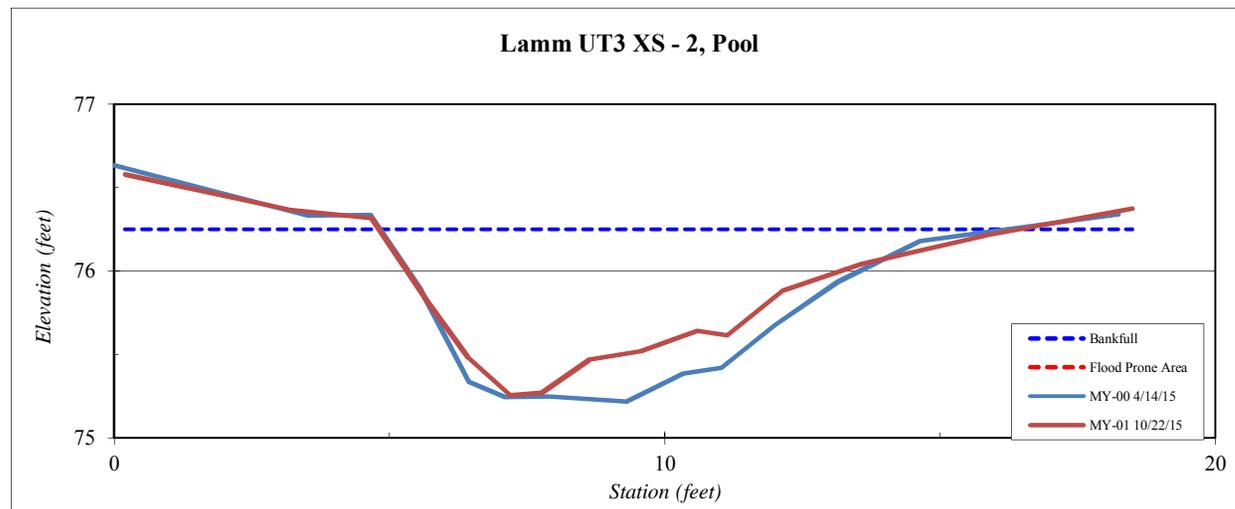
<b>Site</b>	Abbey Lamm
<b>Watershed:</b>	Cape Fear, 0303002
<b>XS ID</b>	UT 3 XS - 2, Pool
<b>Feature</b>	Pool
<b>Date:</b>	10/20/2015
<b>Field Crew:</b>	Perkinson, Jernigan

SUMMARY DATA	
<b>Bankfull Elevation:</b>	76.3
<b>Bankfull Cross-Sectional Area:</b>	5.6
<b>Bankfull Width:</b>	11.6
<b>Flood Prone Area Elevation:</b>	NA
<b>Flood Prone Width:</b>	NA
<b>Max Depth at Bankfull:</b>	1.0
<b>Mean Depth at Bankfull:</b>	0.5
<b>W / D Ratio:</b>	NA
<b>Entrenchment Ratio:</b>	NA
<b>Bank Height Ratio:</b>	1.0

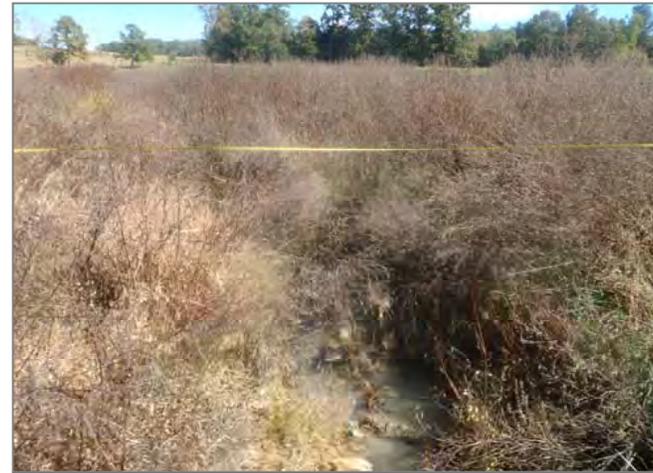
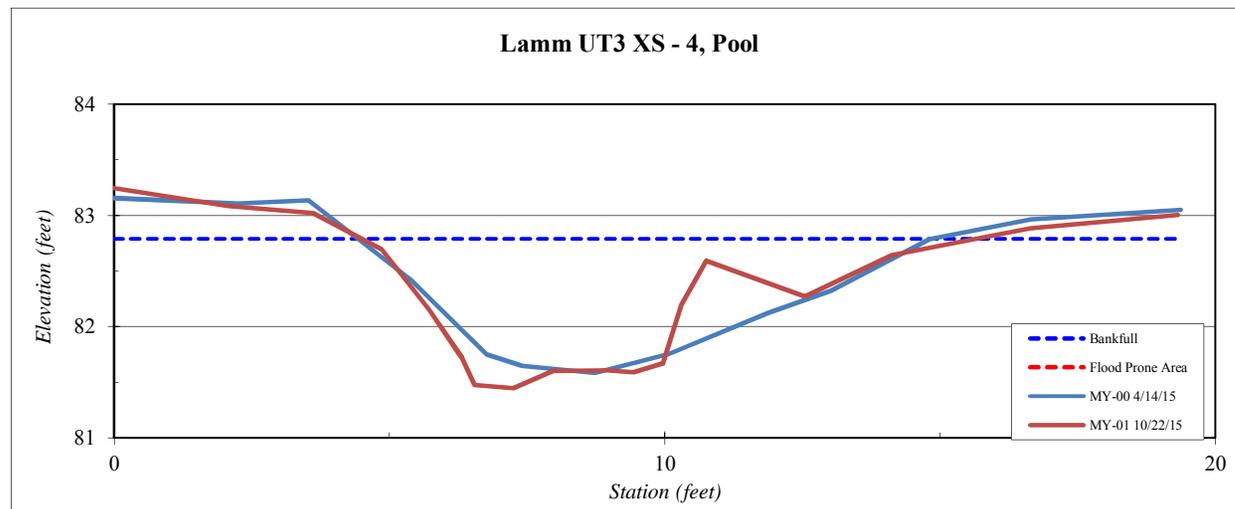
<b>Site</b>	Abbey Lamm
<b>Watershed:</b>	Cape Fear, 0303002
<b>XS ID</b>	UT 3 XS - 4, Pool
<b>Feature</b>	Pool
<b>Date:</b>	10/20/2015
<b>Field Crew:</b>	Perkinson, Jernigan

SUMMARY DATA	
<b>Bankfull Elevation:</b>	82.8
<b>Bankfull Cross-Sectional Area:</b>	7.1
<b>Bankfull Width:</b>	11.2
<b>Flood Prone Area Elevation:</b>	NA
<b>Flood Prone Width:</b>	NA
<b>Max Depth at Bankfull:</b>	1.3
<b>Mean Depth at Bankfull:</b>	0.6
<b>W / D Ratio:</b>	NA
<b>Entrenchment Ratio:</b>	NA
<b>Bank Height Ratio:</b>	1.0

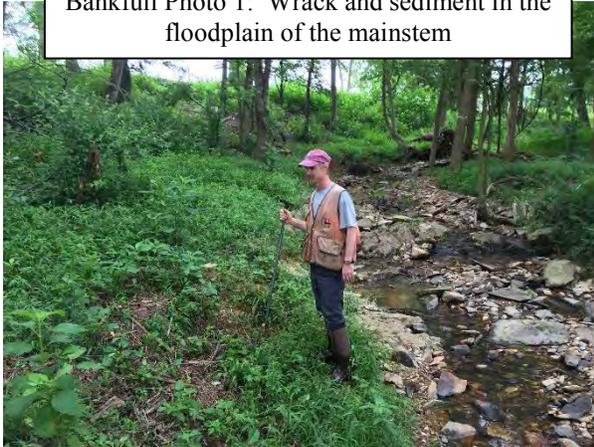
Bankfull Photo 1: Wrack and sediment in the floodplain of the mainstem

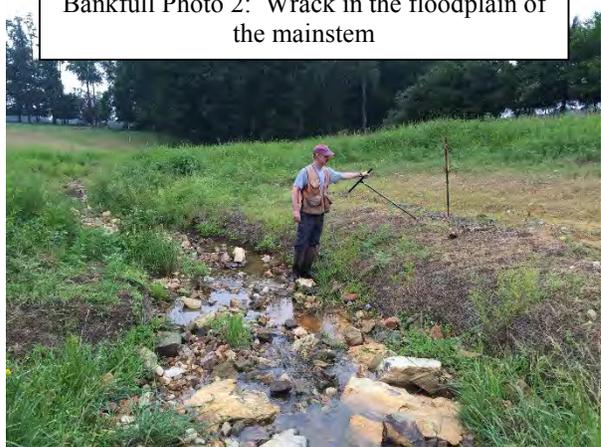
Bankfull Photo 2: Wrack in the floodplain of the mainstem

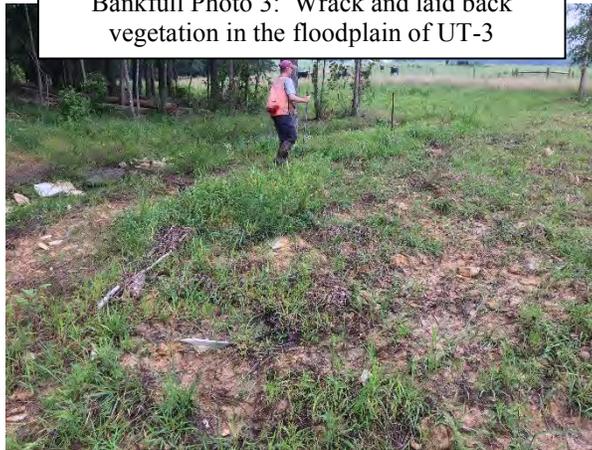
Bankfull Photo 3: Wrack and laid back vegetation in the floodplain of UT-3
