YEAR 2 (2016) MONITORING REPORT
ABBEY LAMM
STREAM AND WETLAND MITIGATION SITE
ALAMANCE COUNTY, NORTH CAROLINA
FULL DELIVERY CONTRACT NO. 5790

CAPE FEAR RIVER BASIN
CATALOGING UNIT 03030002

Data Collection – March-October 2016

December 2016

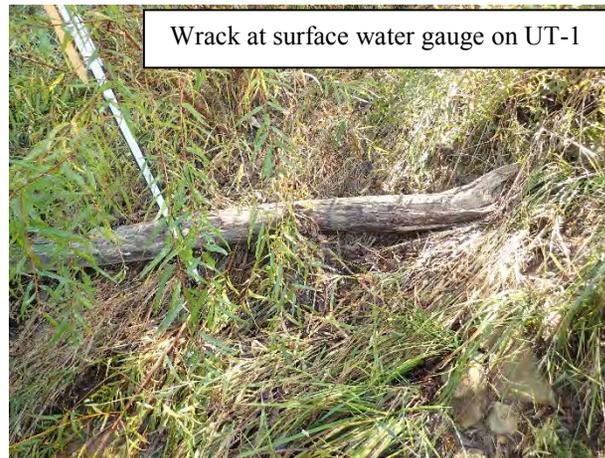
Wrack at surface water gauge on UT-1

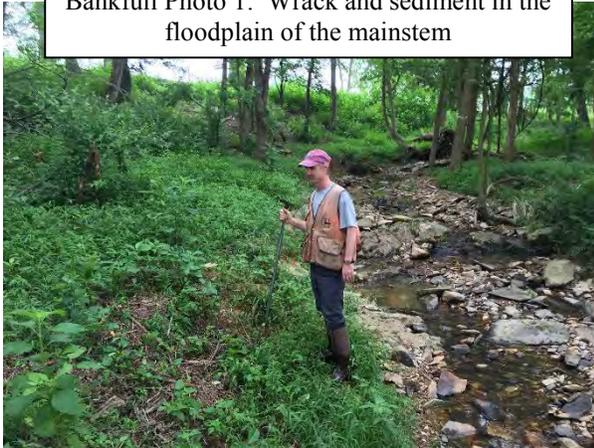
Bankfull Photo 1: Wrack and sediment in the floodplain of the mainstem

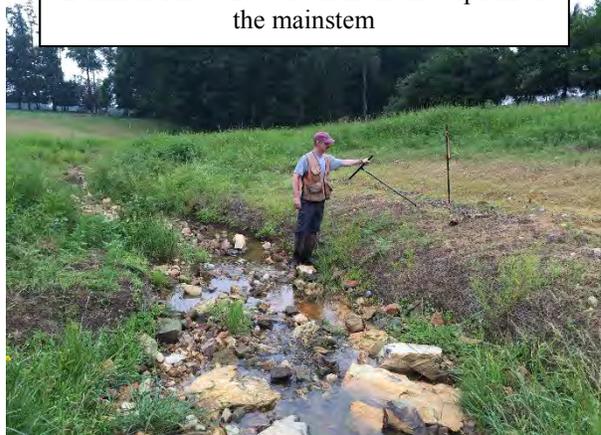
Bankfull Photo 2: Wrack in the floodplain of the mainstem

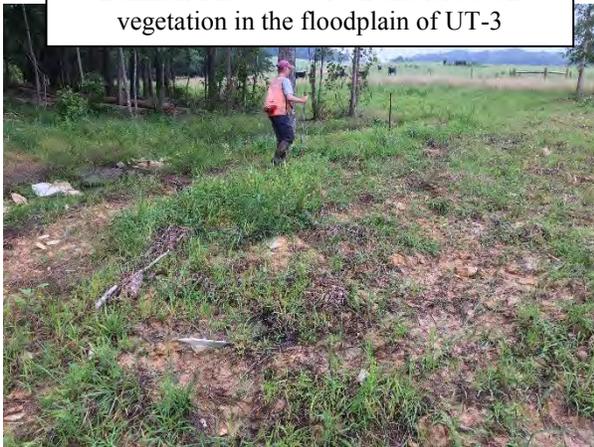
Bankfull Photo 3: Wrack and laid back vegetation in the floodplain of UT-3

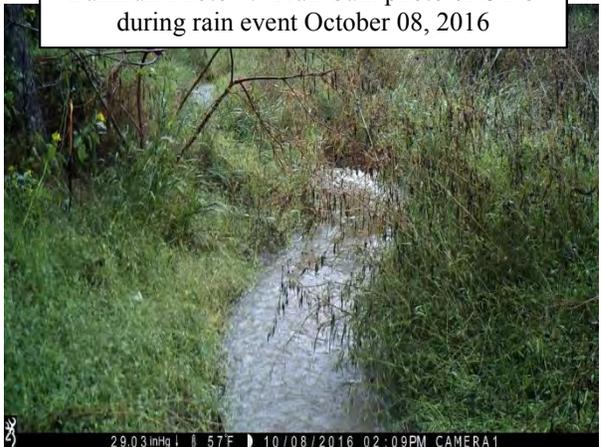
Bankfull Photo 4: Trail Cam photo of UT-3 during rain event October 08, 2016
