# ***YEAR 3 MONITORING REPORT***

## **ADKIN BRANCH STREAM RESTORATION PROJECT PHASE 1 – WASHINGTON AVE. TO LINCOLN ST.**

Lenoir County, North Carolina  
EEP IMS No. 7

Construction Completed: April 2011  
Morphology Data Collected: July 2013  
Vegetation Data Collected: July 2013  
Submitted: November 27, 2013

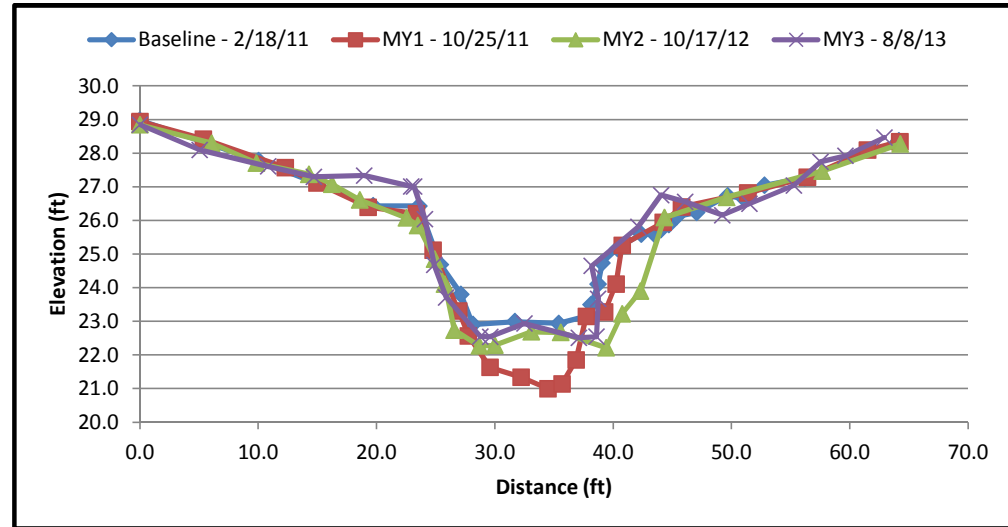
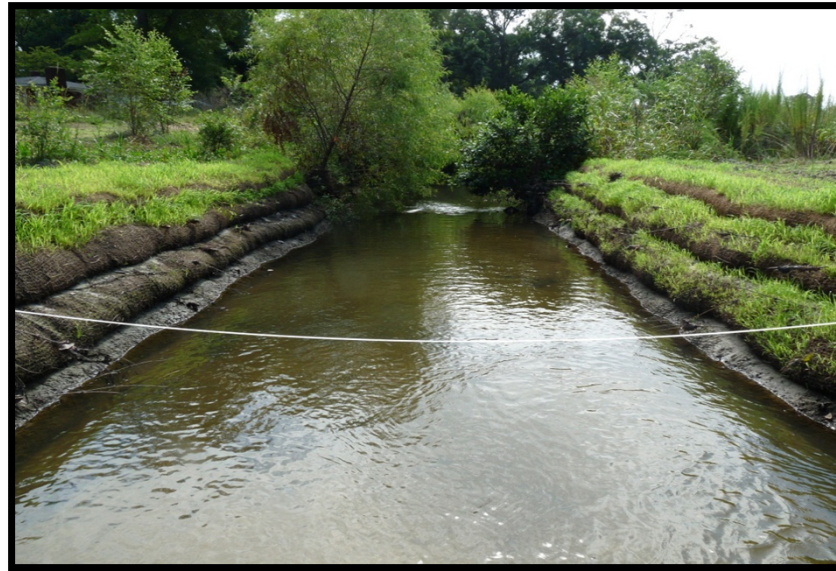
throughout the upcoming monitoring periods to determine whether the condition necessitates repair in the future. Cross section 7 displays changes in geometry due to the installation of soil lifts as part of the Hurricane Irene repair plan. The repaired banks shown now for Year 3 have been restored to the geometry recorded in the baseline report.

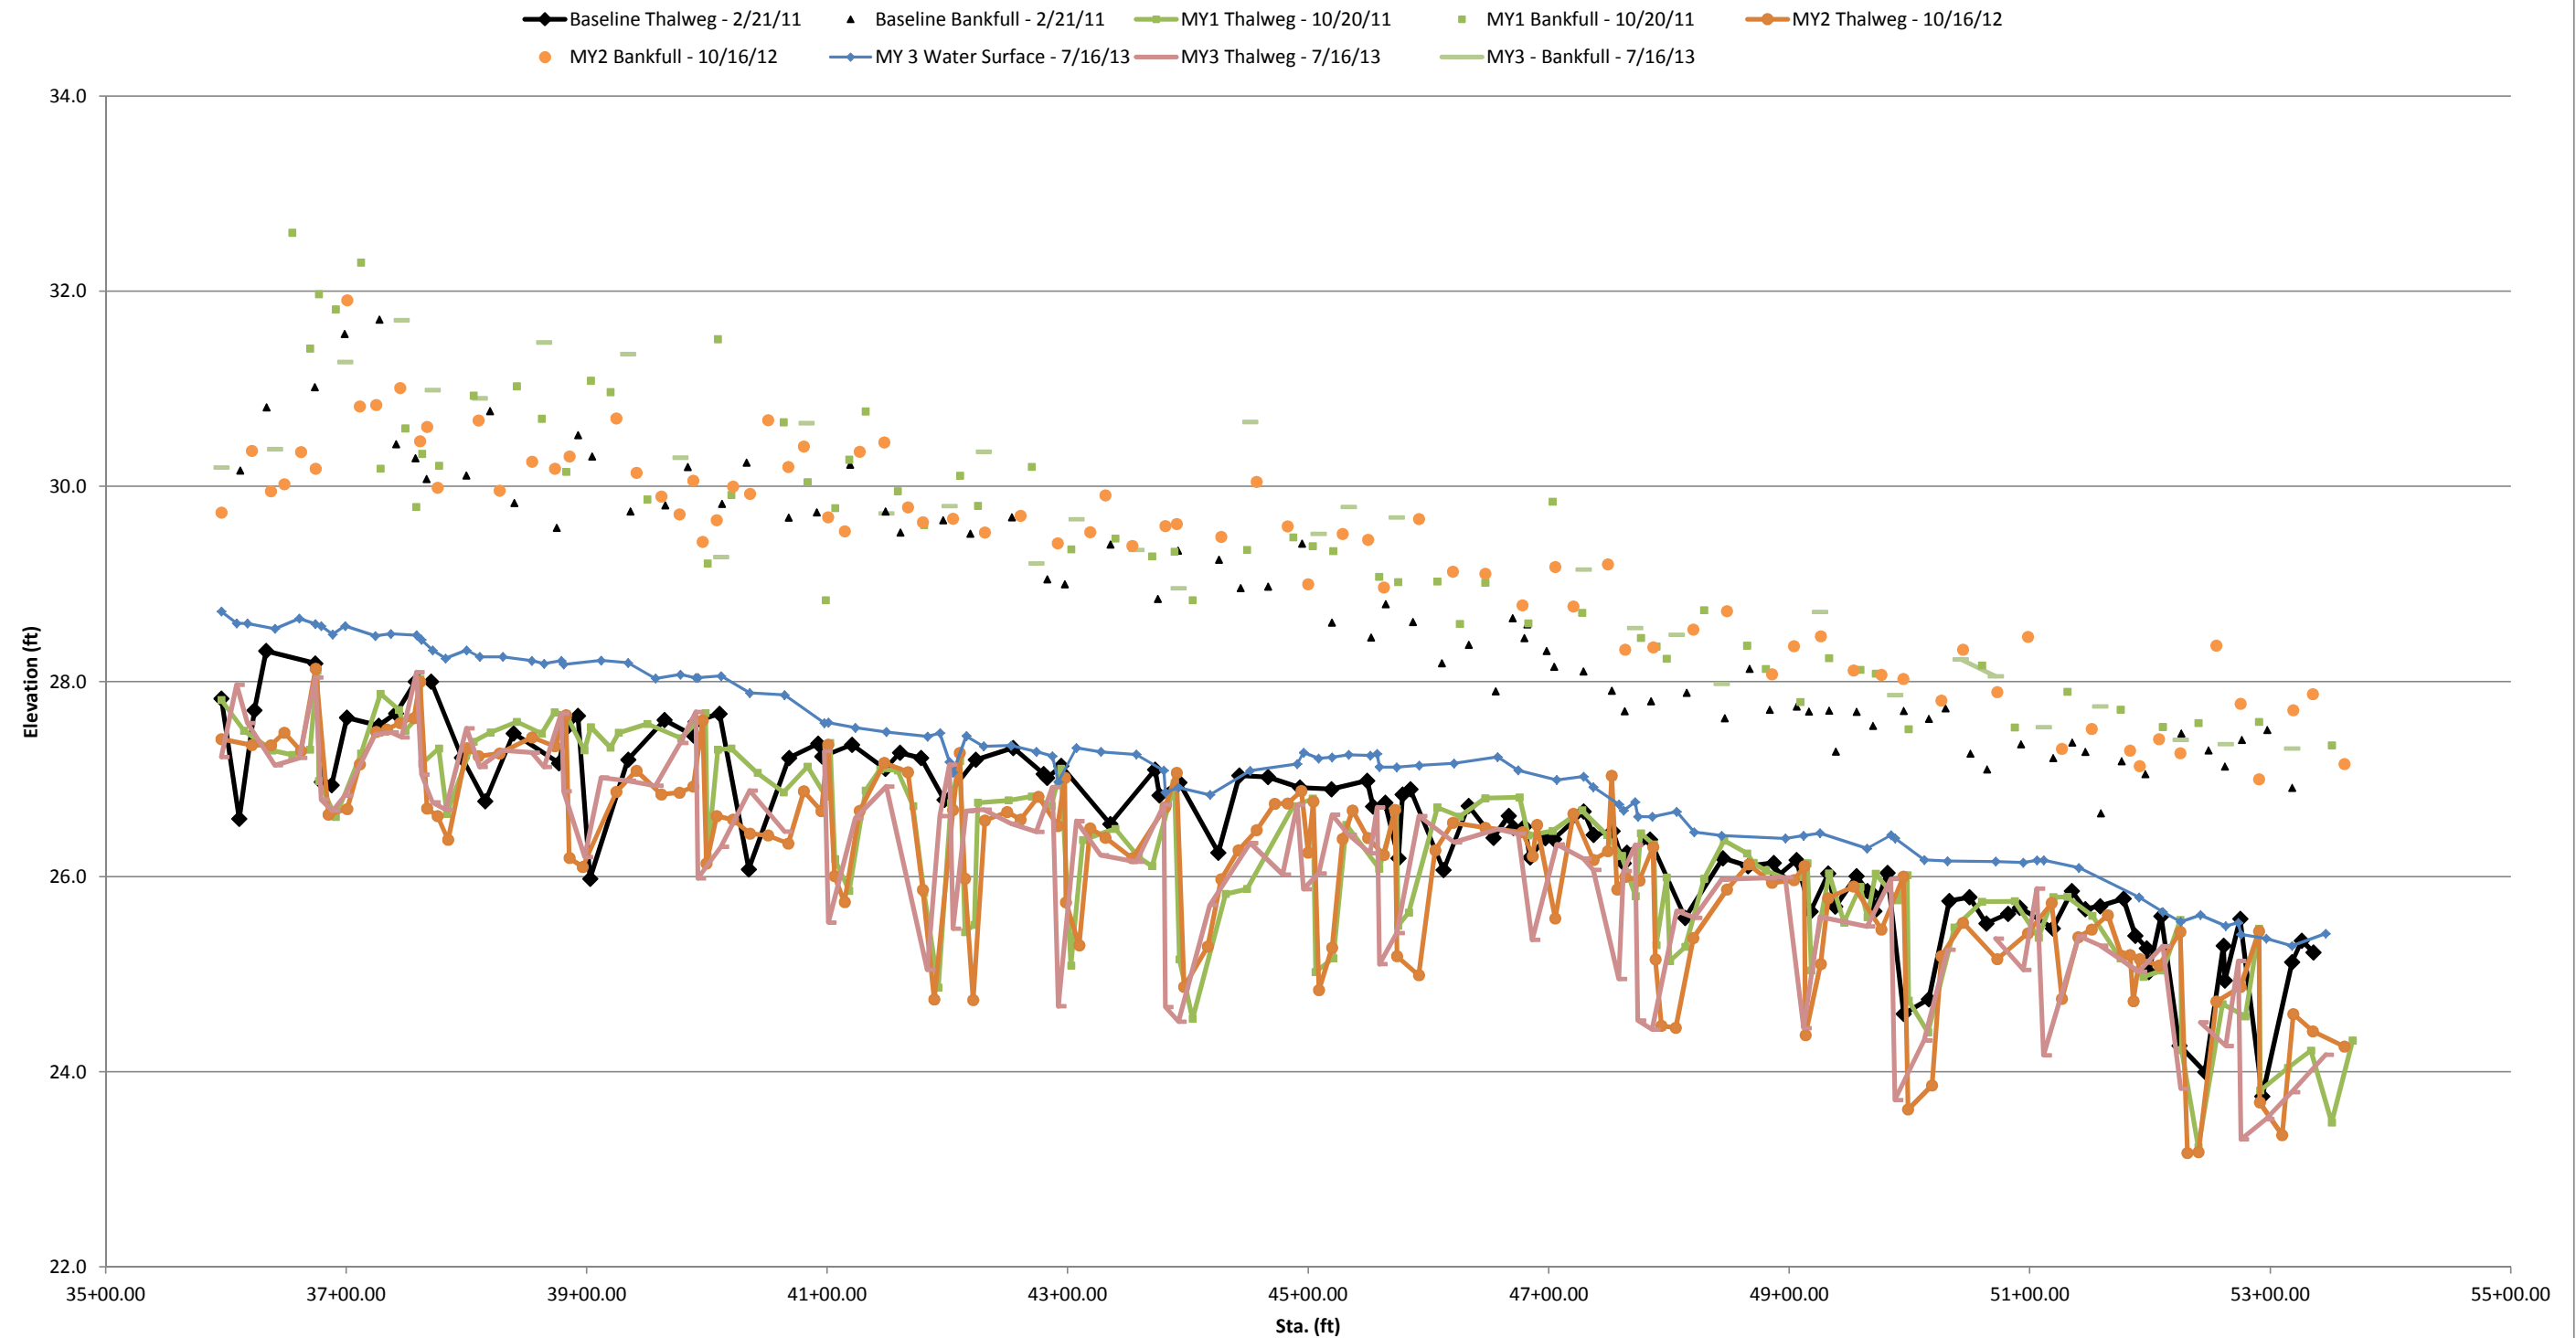
Figure 5.1 Reach 1 (Washington Ave. to Gordon St.) - Longitudinal Profile

Reach 1: Significant stream bed scour was observed from station 41+00 to 46+00. This scour likely occurred during the storm events associated with Hurricane Irene in late August, 2011. Several of the existing pools deepened and/or lengthened as a result of the storm events, but the log structures maintained grade control and the overall stability of the channel was not compromised. Only minor shifting of pools and riffles was observed throughout the remainder of the profile, which is expected in a sand bed system. The majority of stream banks and structures throughout the project were stable and functioning as intended. There was no evidence of trends

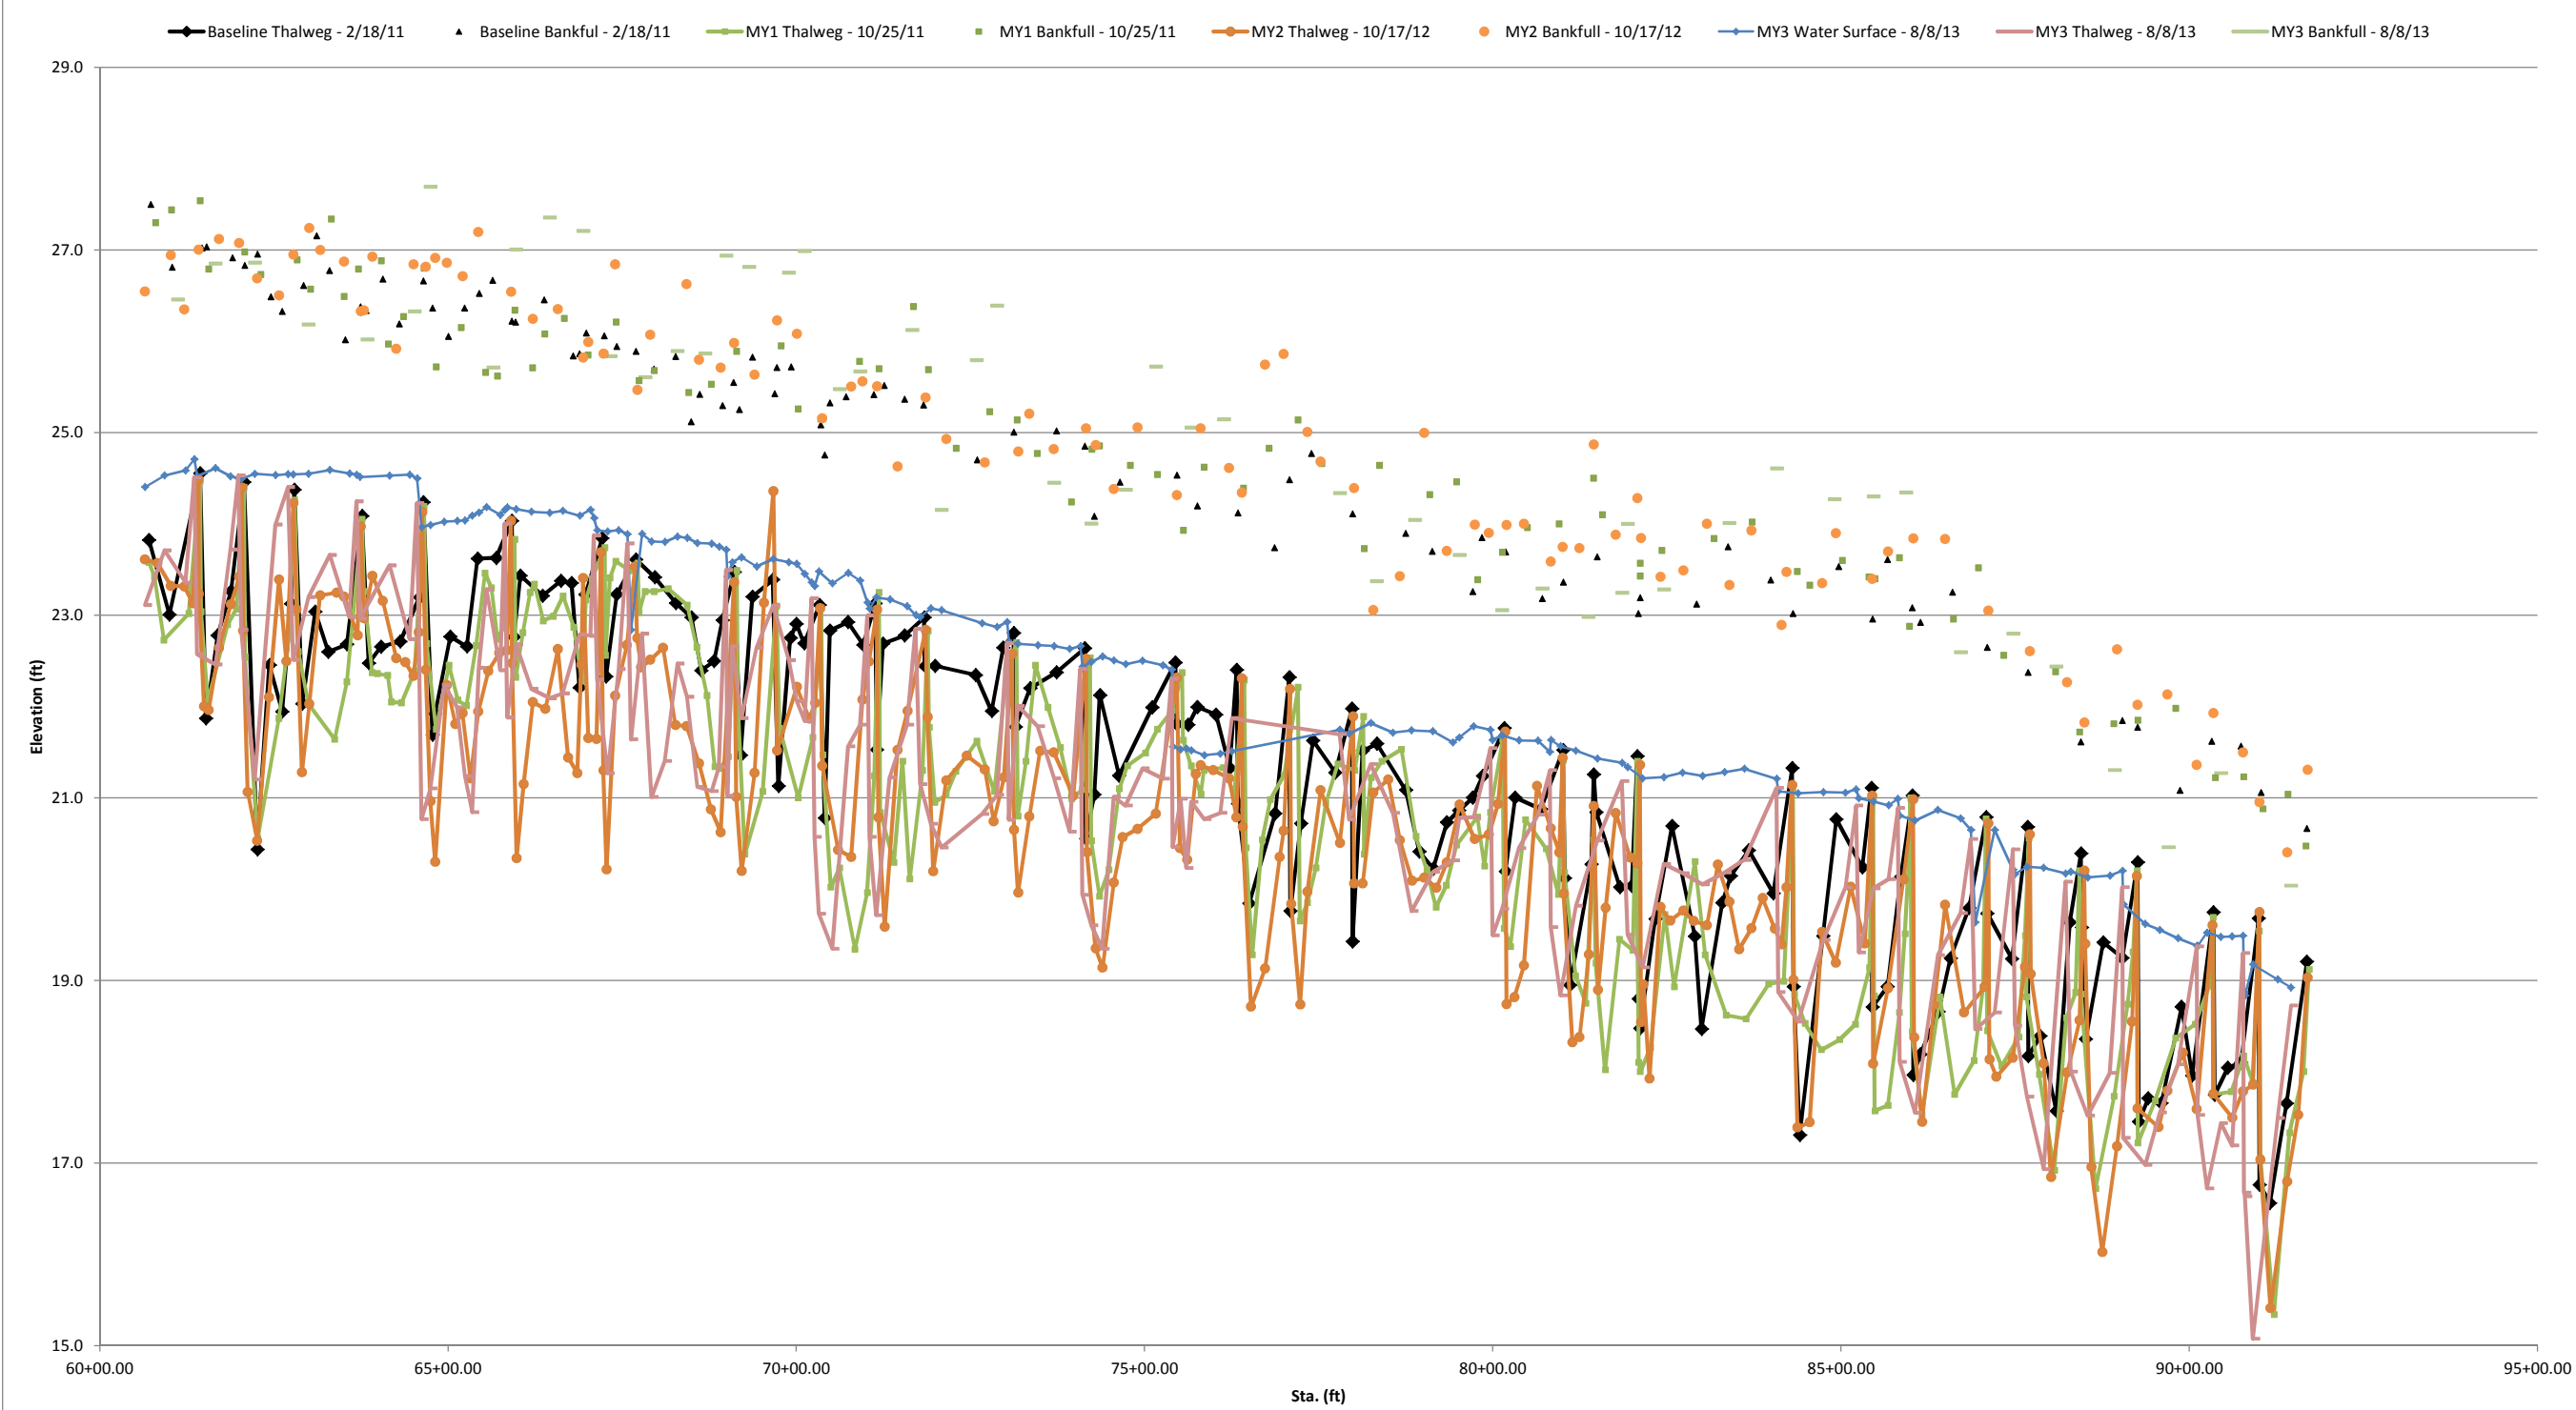
Figure 5.2 Reach 2 (Gordon St. to Lincoln St.) - Longitudinal Profile

Reach 2: The profile along Reach 2 provides evidence of the fluctuating nature of a sand bed system. Some pools became deeper and longer (station 65+00 to 69+00) while others filled in and shortened (station 82+50 to 86+00). Overall, Reach 2 was somewhat unstable due to erosion along approximately 45 percent of the stream banks within the Reach. Erosion was attributed to a lack of vegetation and several large storm events, including Hurricane Irene, that have resulted in severe shear stress along the exposed sandy banks. A Repair Plan was developed to correct the eroded stream banks which included the use of soil lifts, bank grading, and erosion control matting. The Repair Plan was implemented in the Spring/Summer of 2013. Fluctuation in channel bed features is expected to continue throughout the monitoring period; however, the overall stream reach should stabilize once woody vegetation establishes along the stream banks. A beaver dam was observed at Station 69+60 and appears to have formed on top of rip rap that

was placed in the channel by local residents. Rip rap was also observed in the channel near station 81+25. The soil lifts that were installed in January and February, 2011 are stable with well established willow cuttings along the stream banks.

Reach 2: The profile along Reach 2 provides evidence of the fluctuating nature of a sand bed system. Some pools became deeper and longer while others filled in and shortened. In general, the unstable sections of Reach 2 that were documented in the Year 2 Monitoring Report have been repaired as part of construction activities completed in September of 2013. The majority of the plans consisted of installed soil lifts along eroded banks, which are now shown in the CCPV. Fluctuation in channel bed features is expected to continue throughout the monitoring period, but the overall stream reach should stabilize once woody vegetation establishes along the stream banks.

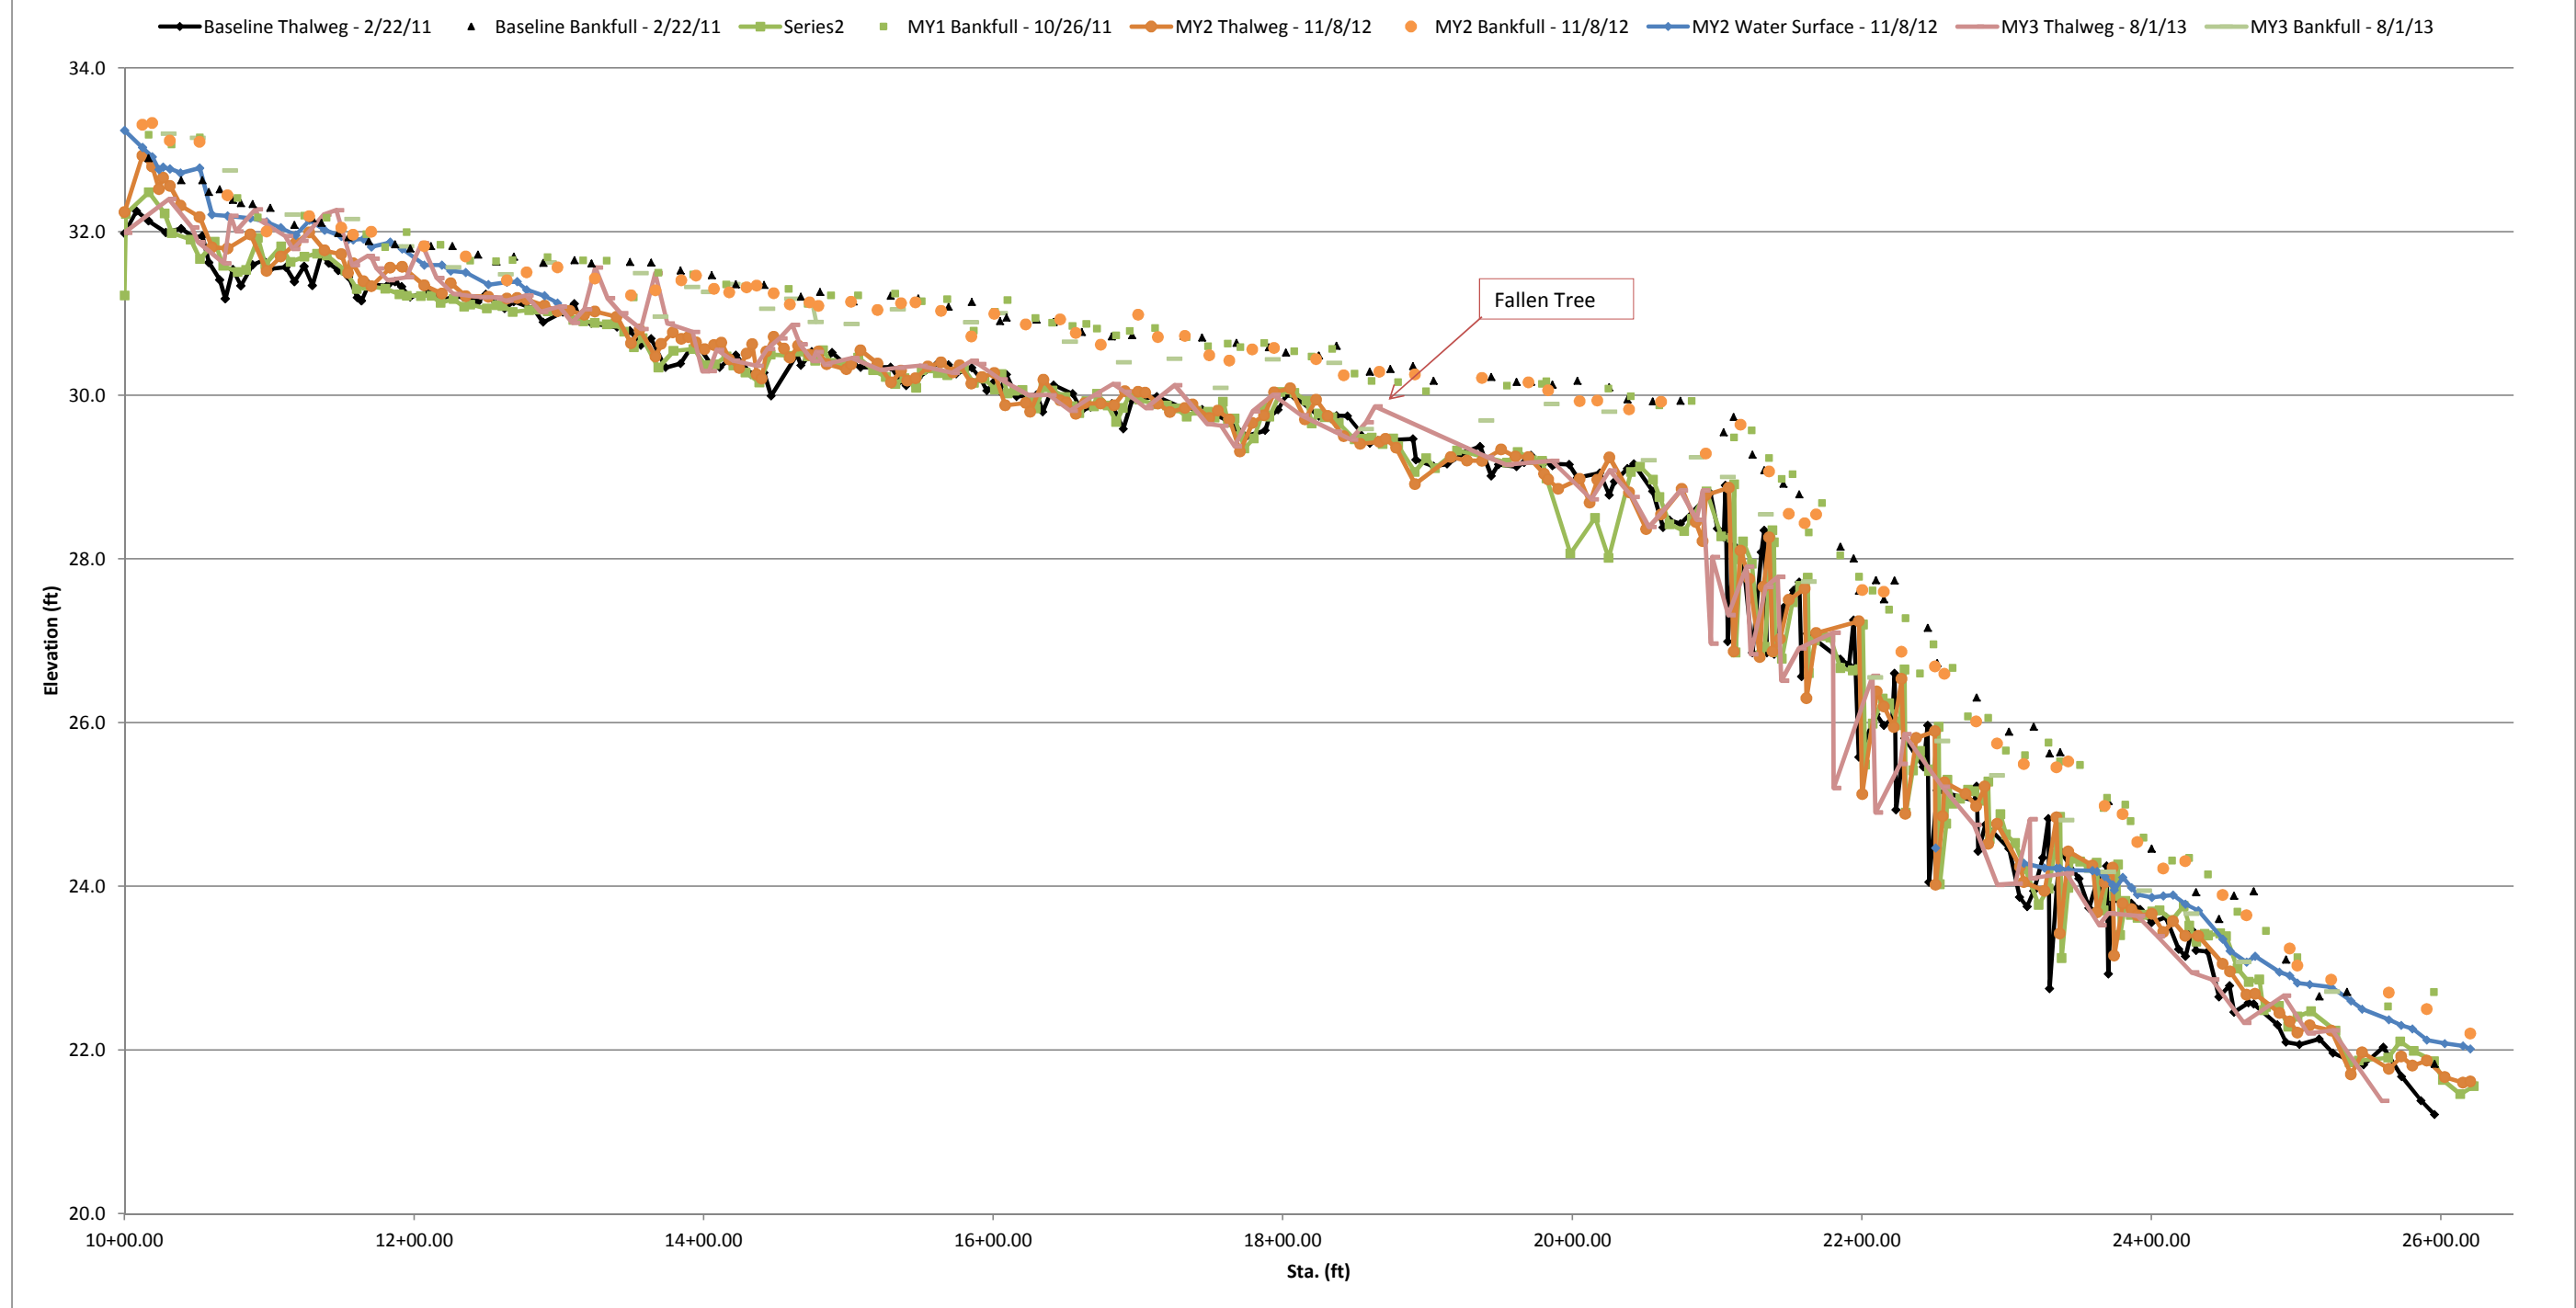
Figure 5.3 Reach 3 (UT to Adkin Branch) - Longitudinal Profile

Reach 3: Reach 3 experienced aggradation between Stations 10+00 and 12+35 due to dense herbaceous vegetation forming in the channel and trapping sediment. However, the stream remains stable and flood waters are accessing the adjacent stormwater wetlands as intended. Only minor shifting of pools and riffles was observed throughout the remainder of the profile, which is expected in a sand bed system. The majority of stream banks and structures throughout the project were stable and functioning as intended. There was no evidence of trends toward significant change in channel pattern. Cross sectional data indicated that the channel width to depth ratio was lowering as the channel matures.
