FINAL
YEAR 1 (2014) ANNUAL MONITORING REPORT
BEAR CREEK (PHILLIPS SITE) RESTORATION PROJECT

Chatham County, North Carolina
EEP Project No. 26 (Contract No. 5715)
DWR Project No. 0713-94
SCO No. 09-07726-01A

Data Collection – May-October 2014

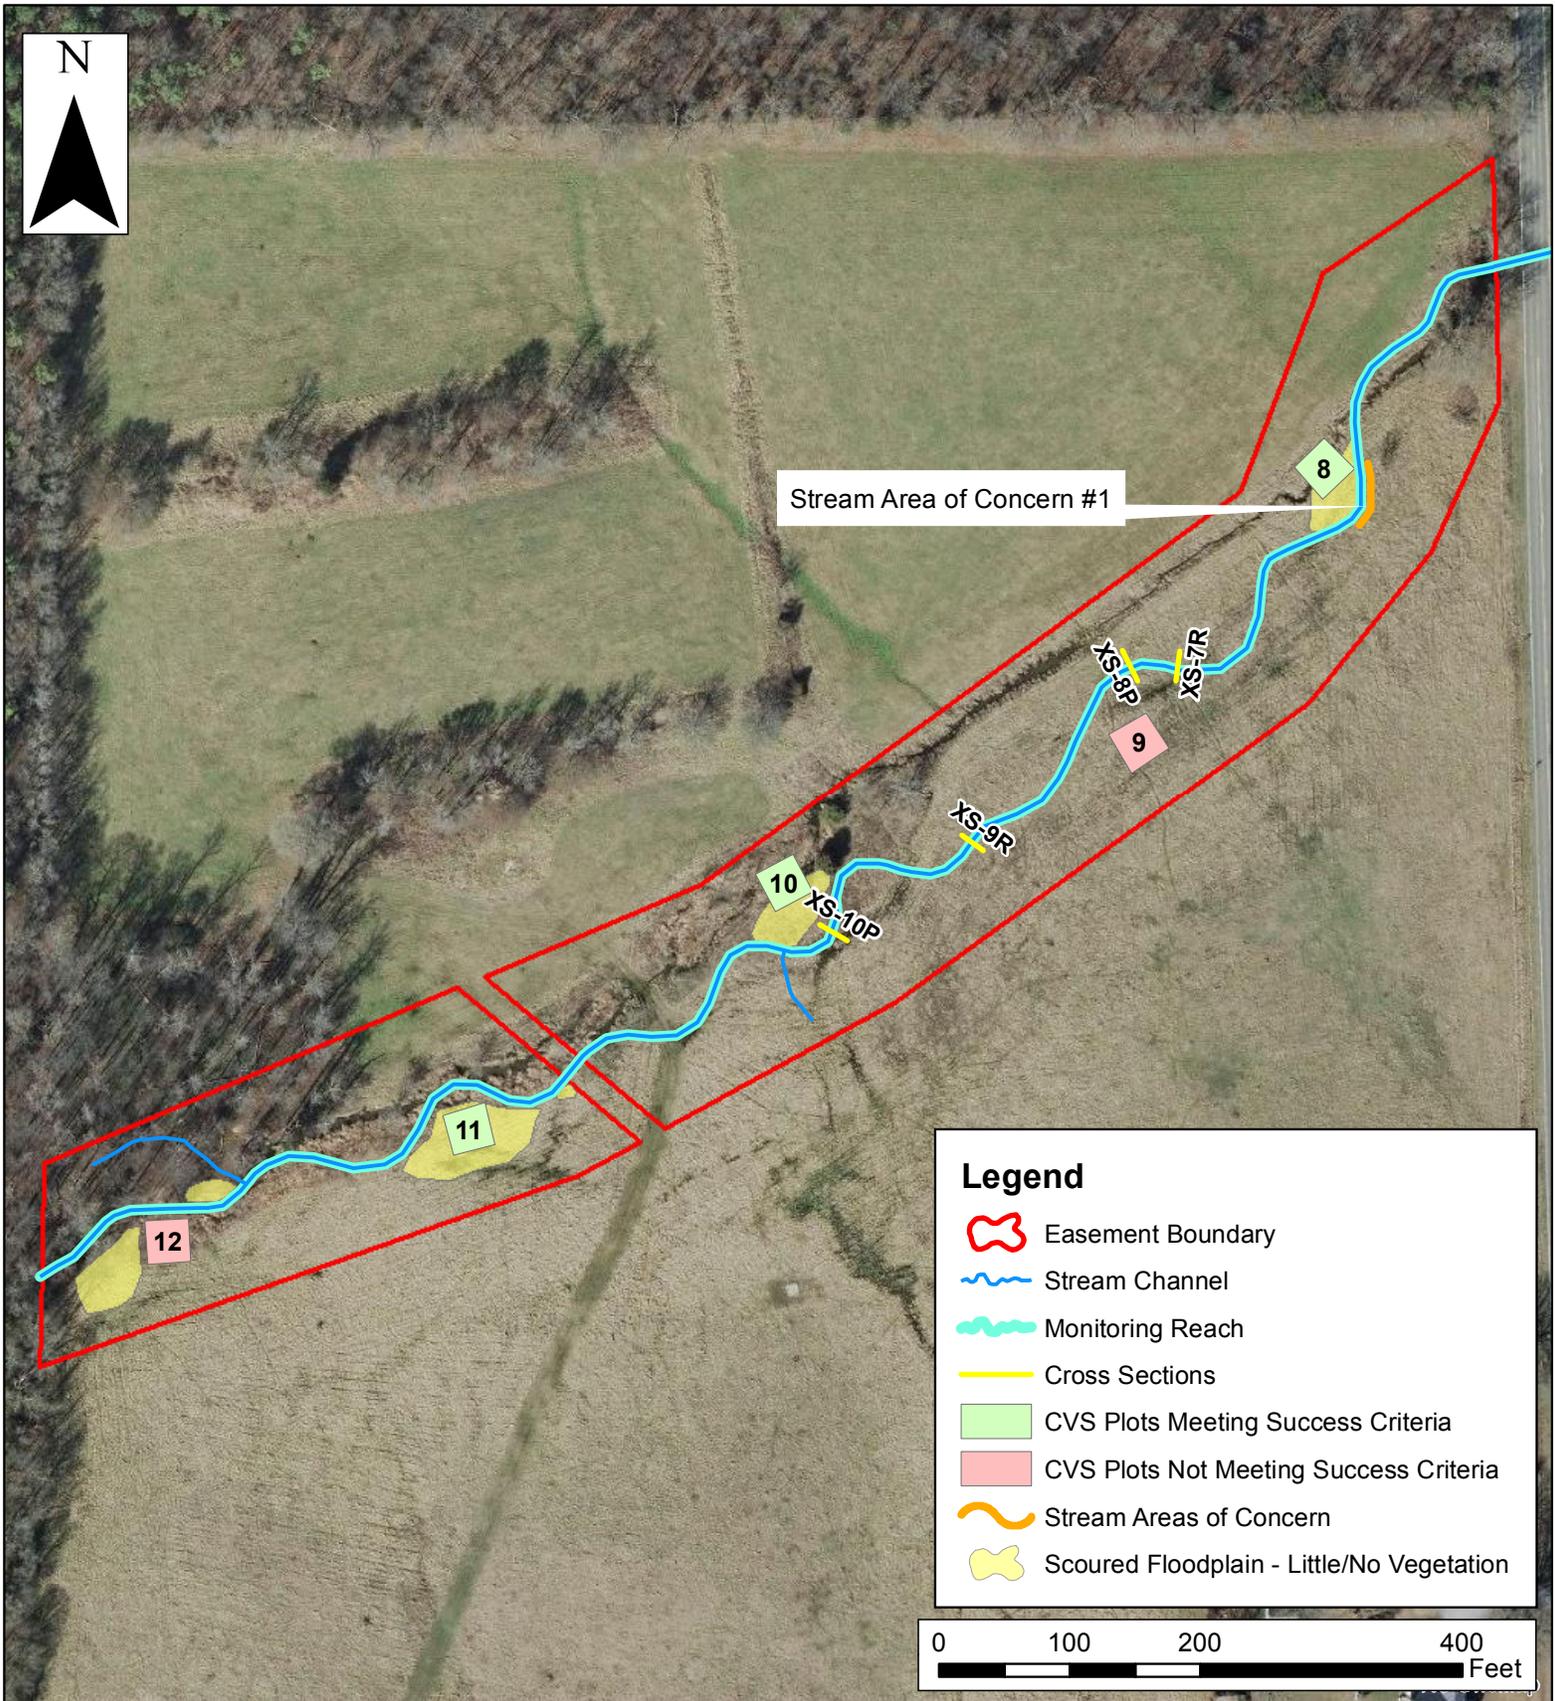
2A

During monitoring year 1 (2014), two stream areas of concern were observed. An outer bend on the Unnamed Tributary to Bear Creek has been severely scoured (Area of Concern #1). The bank appears unstable and is void of all vegetation. One additional area of concern is the upstream culverted crossing on Bear Creek (Area of Concern #2). Rain events since construction have caused a significant amount of debris to block the culverts. Efforts to remove debris manually have been unsuccessful. During storm events the stream is bypassing the culvert and scouring the crossing. These areas of concern are depicted on Figures 2A-2B in Appendix B.

monitored include species composition and species density. Visual observations of the percent cover of shrub and herbaceous species will also be documented by photograph. Vegetation plot information can be found in Appendix C. MY1 (2014) stem count measurements indicate an average of 314 planted stems per acre (excluding livestakes) across the Site, which is slightly below success criteria for monitoring year 1 (2014). Additionally, six of the twelve vegetation monitoring plots met success criteria. The lack of vegetation survival can be attributed to poor soils in the graded floodplain throughout the site. Also, just after construction was complete, several large rain events caused flooding that scoured the floodplain, leaving it bare. Vegetation is slowly establishing, but there are still many bare areas. These scoured areas have been depicted on Figures 2A-2B in Appendix B.

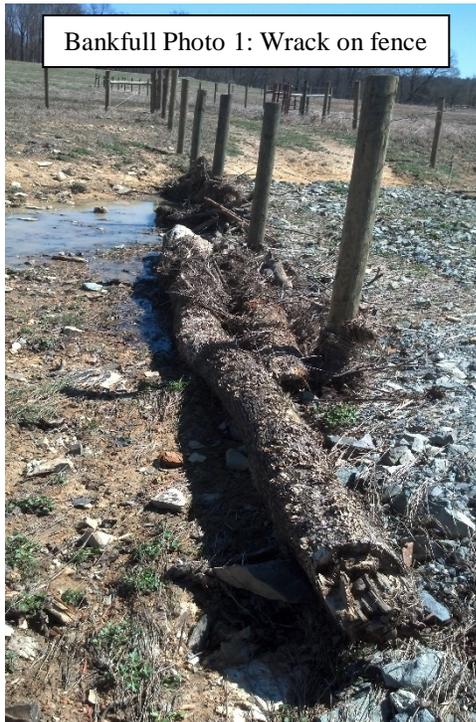
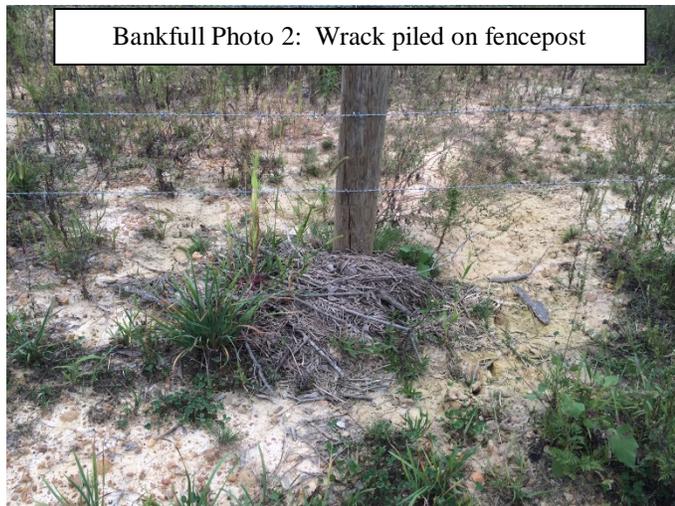
Date of Data Collection	Date of Occurrence	Method	Photo (if available)
March 13, 2014	March 7, 2014	Wrack on floodplain and crest gauge data indicate a bankfull event after 1.59 inches* of rain in one day.	1
August 22, 2014	May 15, 2014	Crest gauge data indicate a bankfull event after 2.08 inches* of rain in one day.	--
September 23, 2014	September 4, 2014	Wrack on floodplain and crest gauge data indicate bankfull event after 1.95 inches rain* in three days.	2
