**FINAL**  
**YEAR 4 (2017) ANNUAL MONITORING REPORT**  
**BEAR CREEK (PHILLIPS SITE) RESTORATION PROJECT**

Chatham County, North Carolina  
DMS Project No. 26 (Contract No. 5715)  
DWR Project No. 0713-94  
SCO No. 09-07726-01A

**Data Collection – January-August 2017**

RE: Bear Creek (Phillips) Monitoring (DMS Project # 26, Contract #5715)  
Final MY4 (2017) Annual Monitoring Report

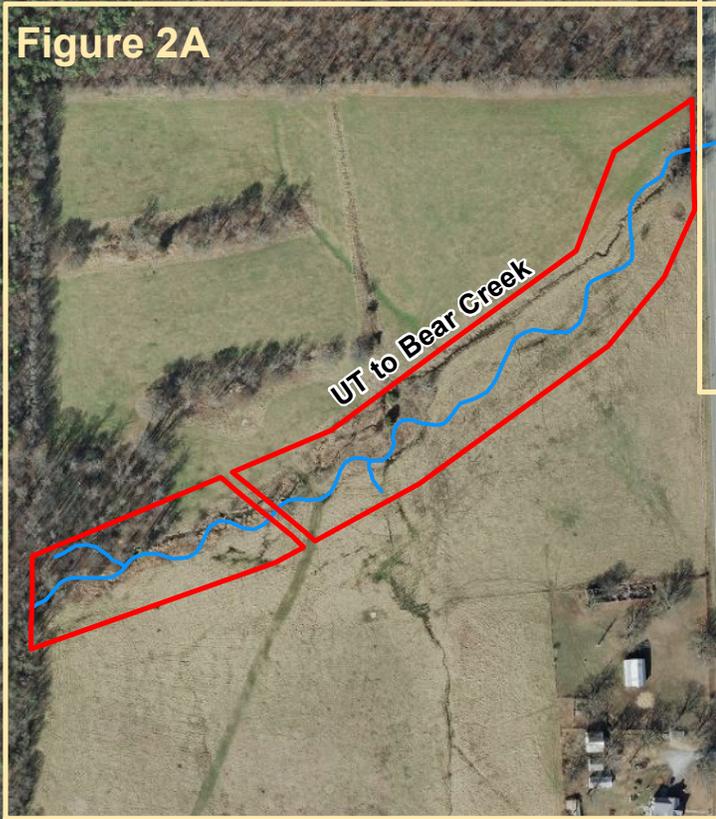
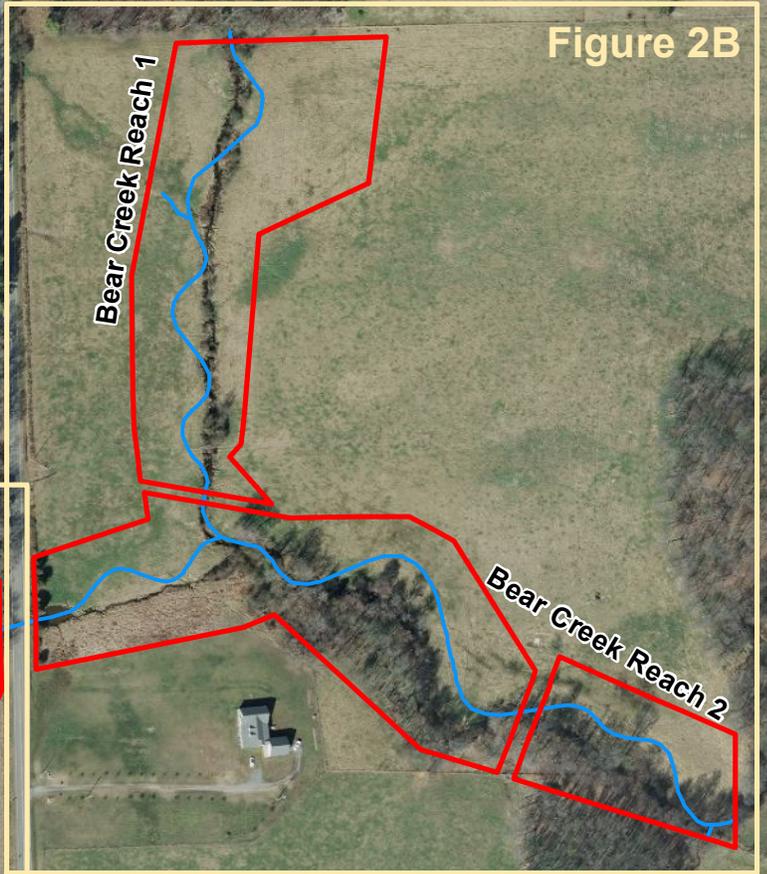
Two stream areas of concern were observed during monitoring year 4 (2017). Area of Concern #1 was observed during the previous three monitoring years, and it remains concerning during monitoring year 4 (2017). The right bank of the Unnamed Tributary to Bear Creek has failed causing the water to leave the stream channel and scour a new, smaller channel during heavy flow events. The bank and new channel appear unstable and are void of vegetation. Area of Concern #2 consists of bank scour in the inner bend of a pool caused by instream vegetation that has changed the flow path causing it to undercut the stream bank. These areas of concern are depicted on Figure 2A in Appendix B and will be closely monitored throughout the remainder of the monitoring period.

Shortly after construction was complete, several large rain events caused flooding that scoured the floodplain, leaving it bare. Vegetation has established throughout much of the floodplain, but there are still some bare areas. These scoured areas have been depicted on Figures 2A-2B in Appendix B.

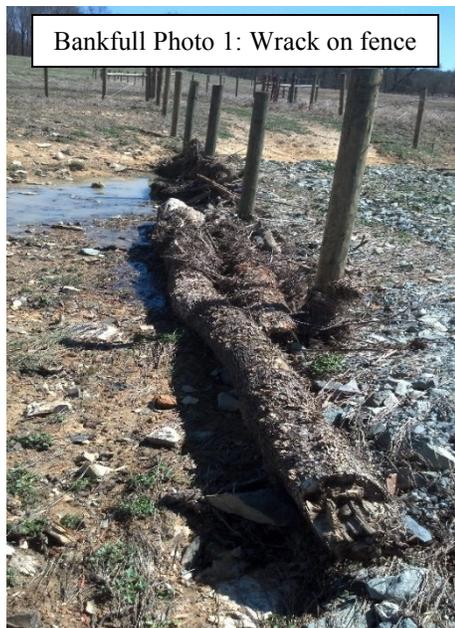
Bankfull Photo 1: Wrack on fence

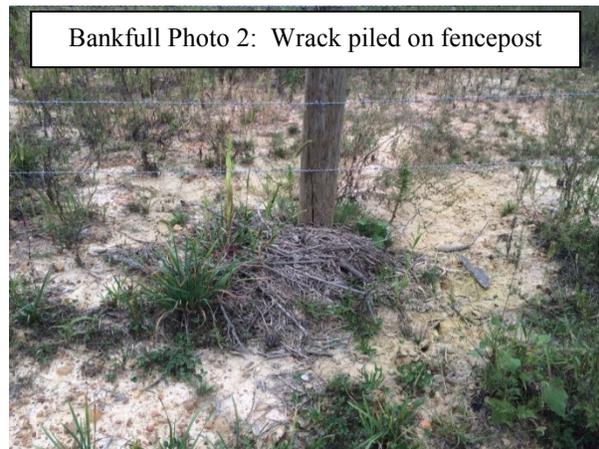
Bankfull Photo 2: Wrack piled on fencepost

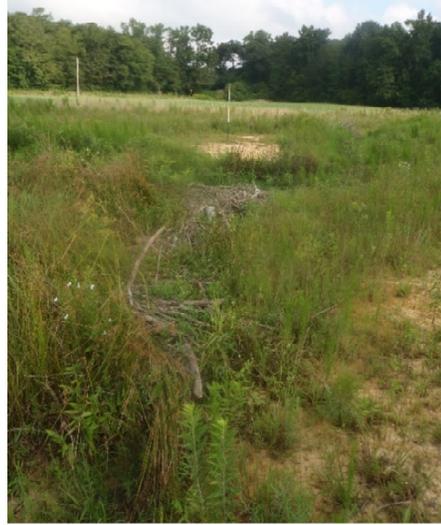
Bankfull Photo 5: Wrack in floodplain
