STREAM MITIGATION AS-BUILT REPORT

Beaver Creek Surry County, North Carolina

N.C. Wetlands Restoration Program
_____NCDENR_DWQ

February 2003

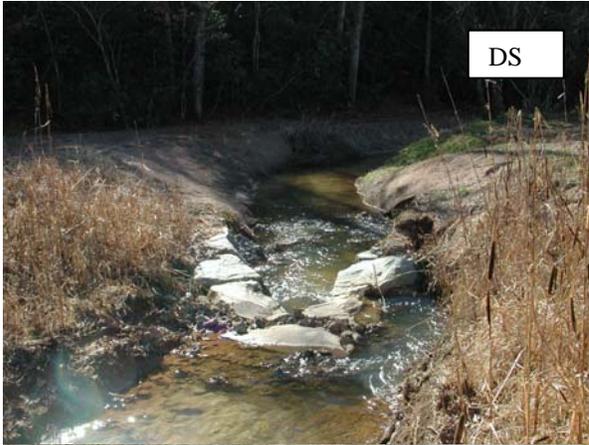
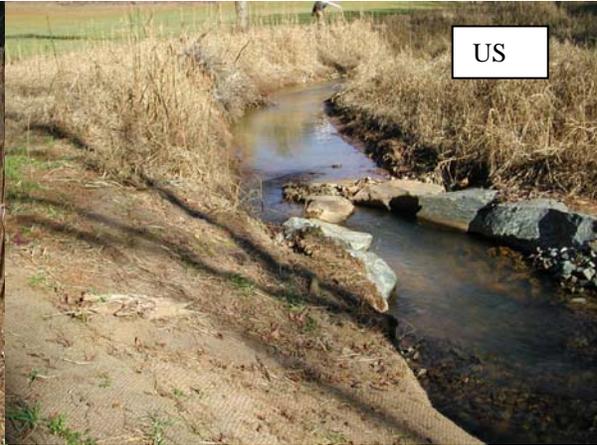
Problem Area 1: Station 39+10, Cross-Vane Failure
