**FINAL
Beaverdam Mitigation Project
Harnett County, North Carolina**

**Cape Fear River Basin No. 03030004
DENR-EEP Contract No. D06029-B**

Year 3 Monitoring Report

December 2010

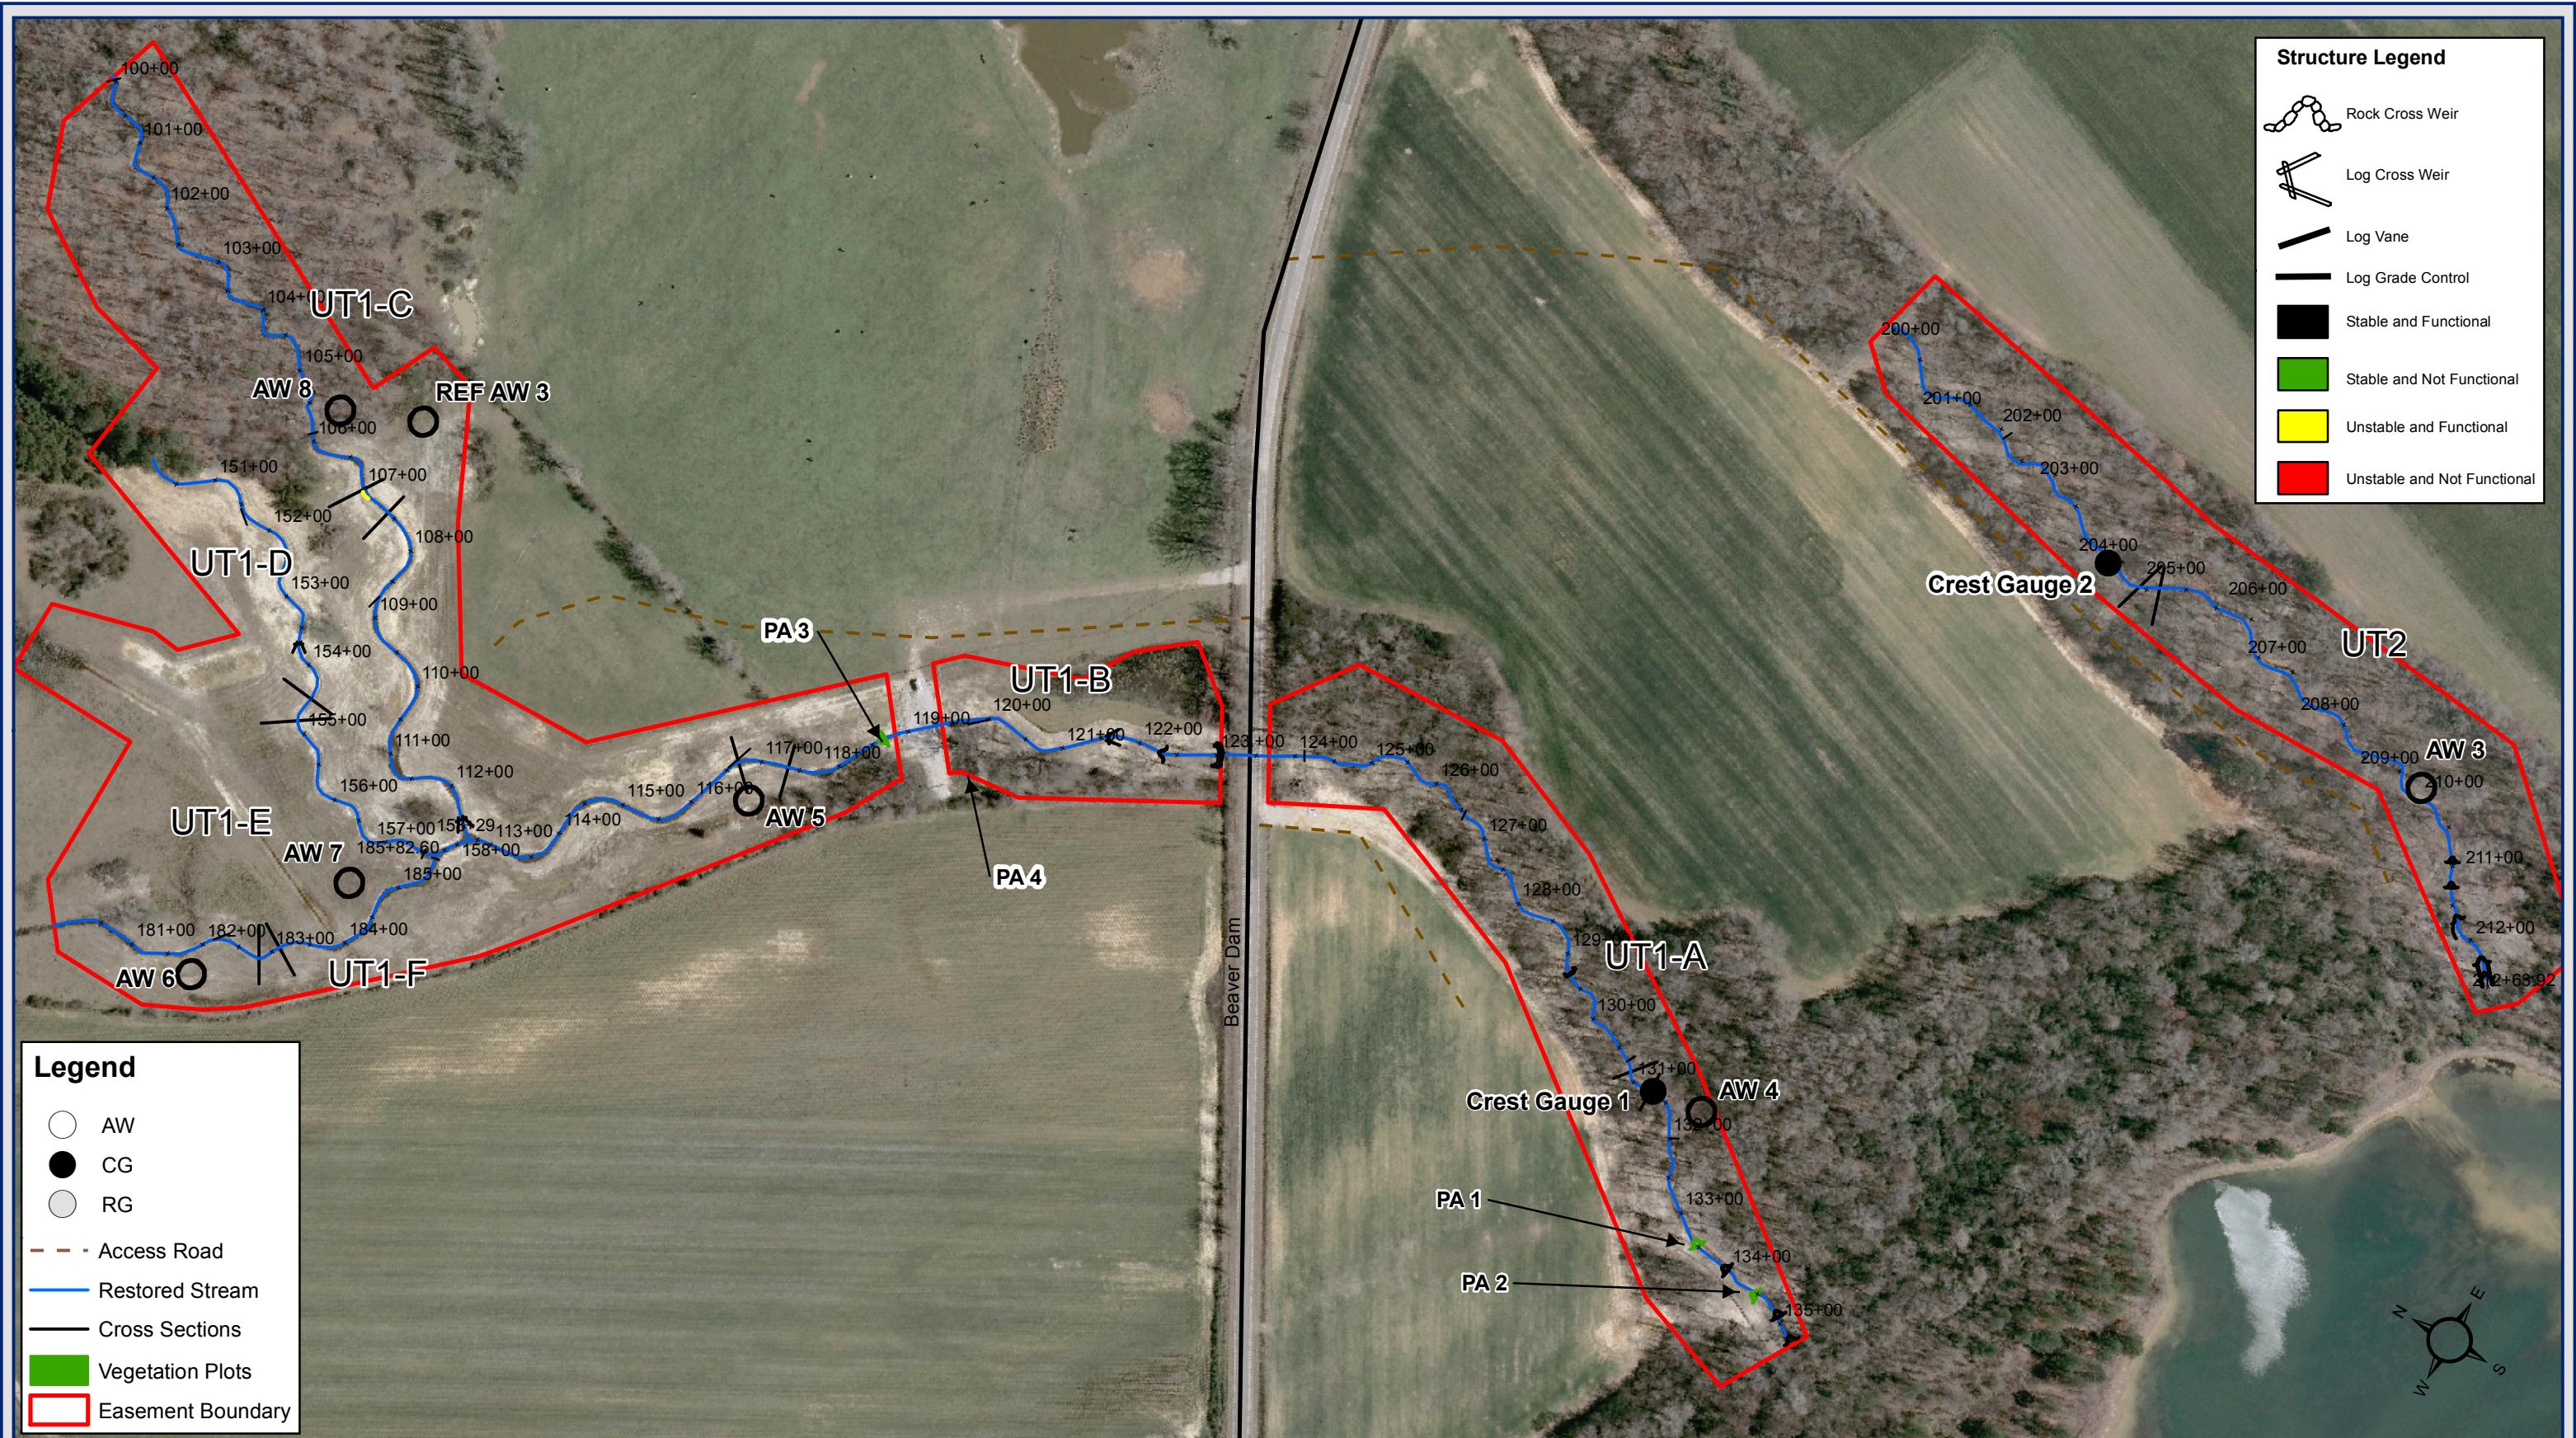
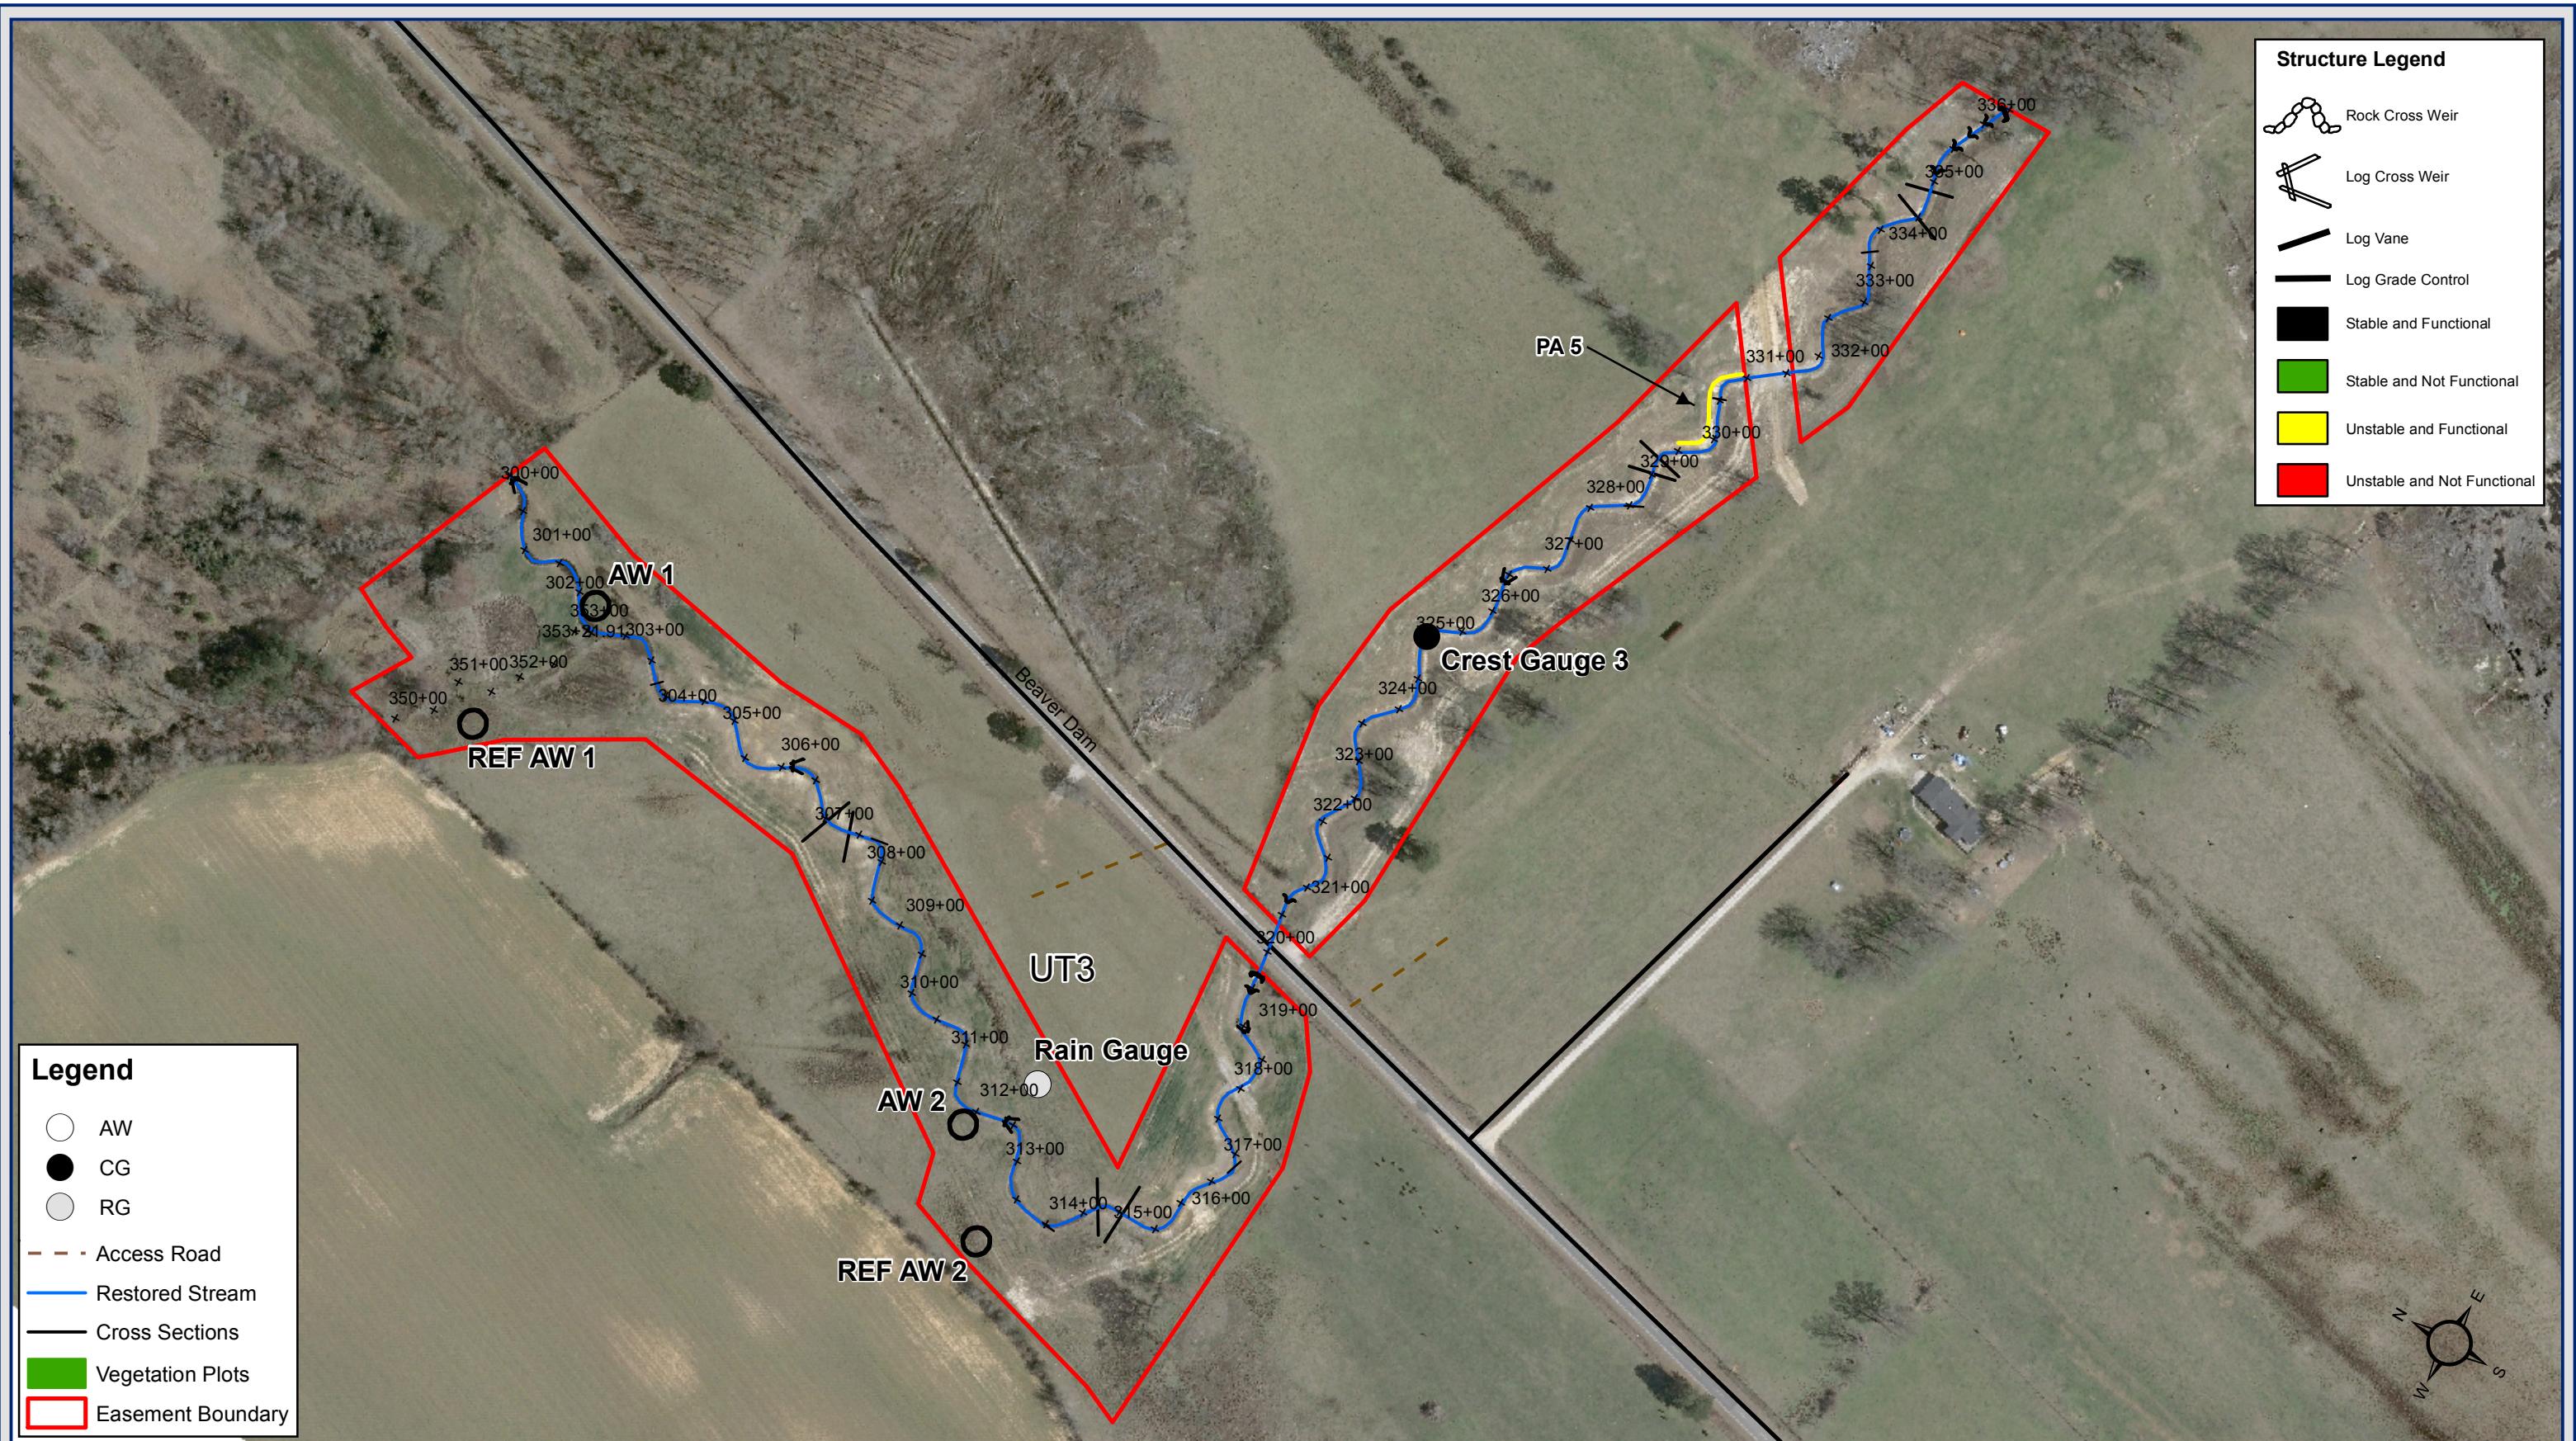
SOA	Feature	STA	Description
SOA1	Rock A-vane	UT1-A 133+30	Minor piping around header rock, No repair needed, will continue to monitor
SOA2	Rock A-vane	UT1-A 134+50	Minor piping around header rock, No repair needed, will continue to monitor
SOA3	Rock A-vane	UT1-B 118+70	Minor piping around header rock, No repair needed, will continue to monitor
SOA4	Right Bank Fencing	UT1-B 119+50	Easement fencing is down at stream crossing, Repair is recommended.
SOA5	Left bank	UT3 329+50 - 331+00	Rills and erosion on left bank, Re-seed with a permanent seed, will continue to monitor
