**Beaverdam Mitigation Project  
Harnett County, North Carolina**

**Cape Fear River Basin No. 03030004  
DENR-EEP Contract No. D06029-B**

**Year 4 Monitoring Report**

**January 2012**

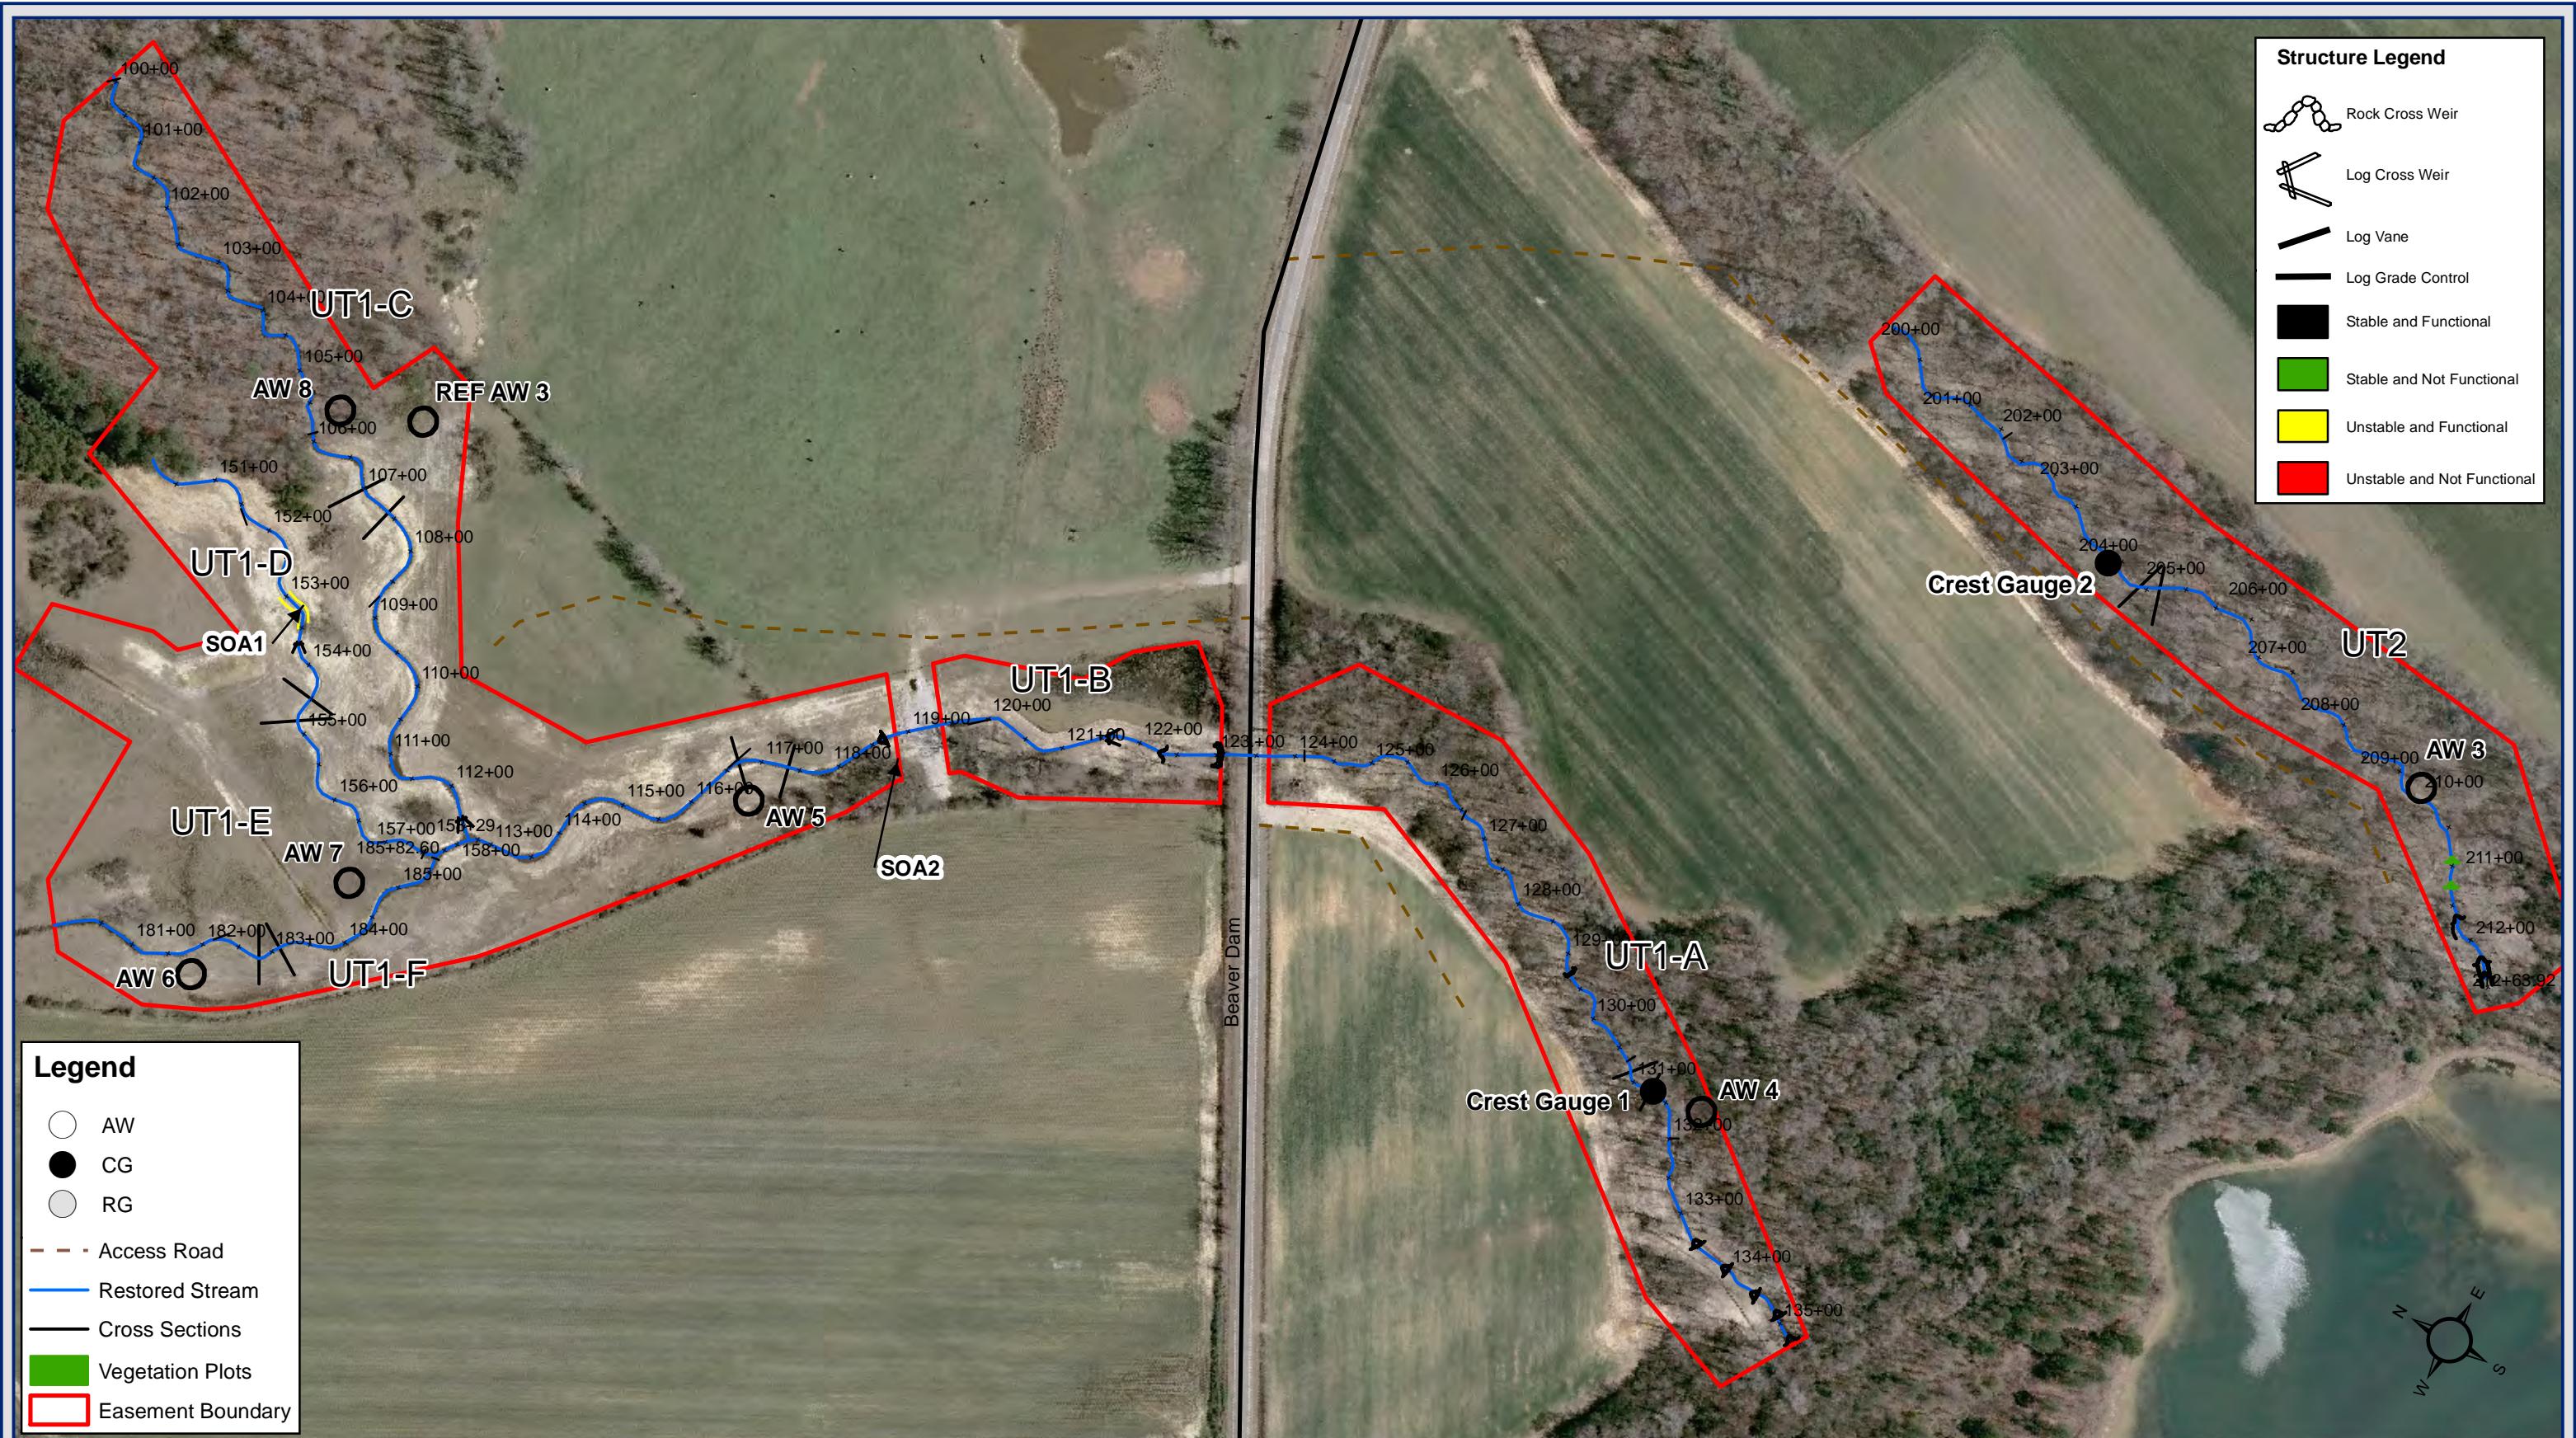
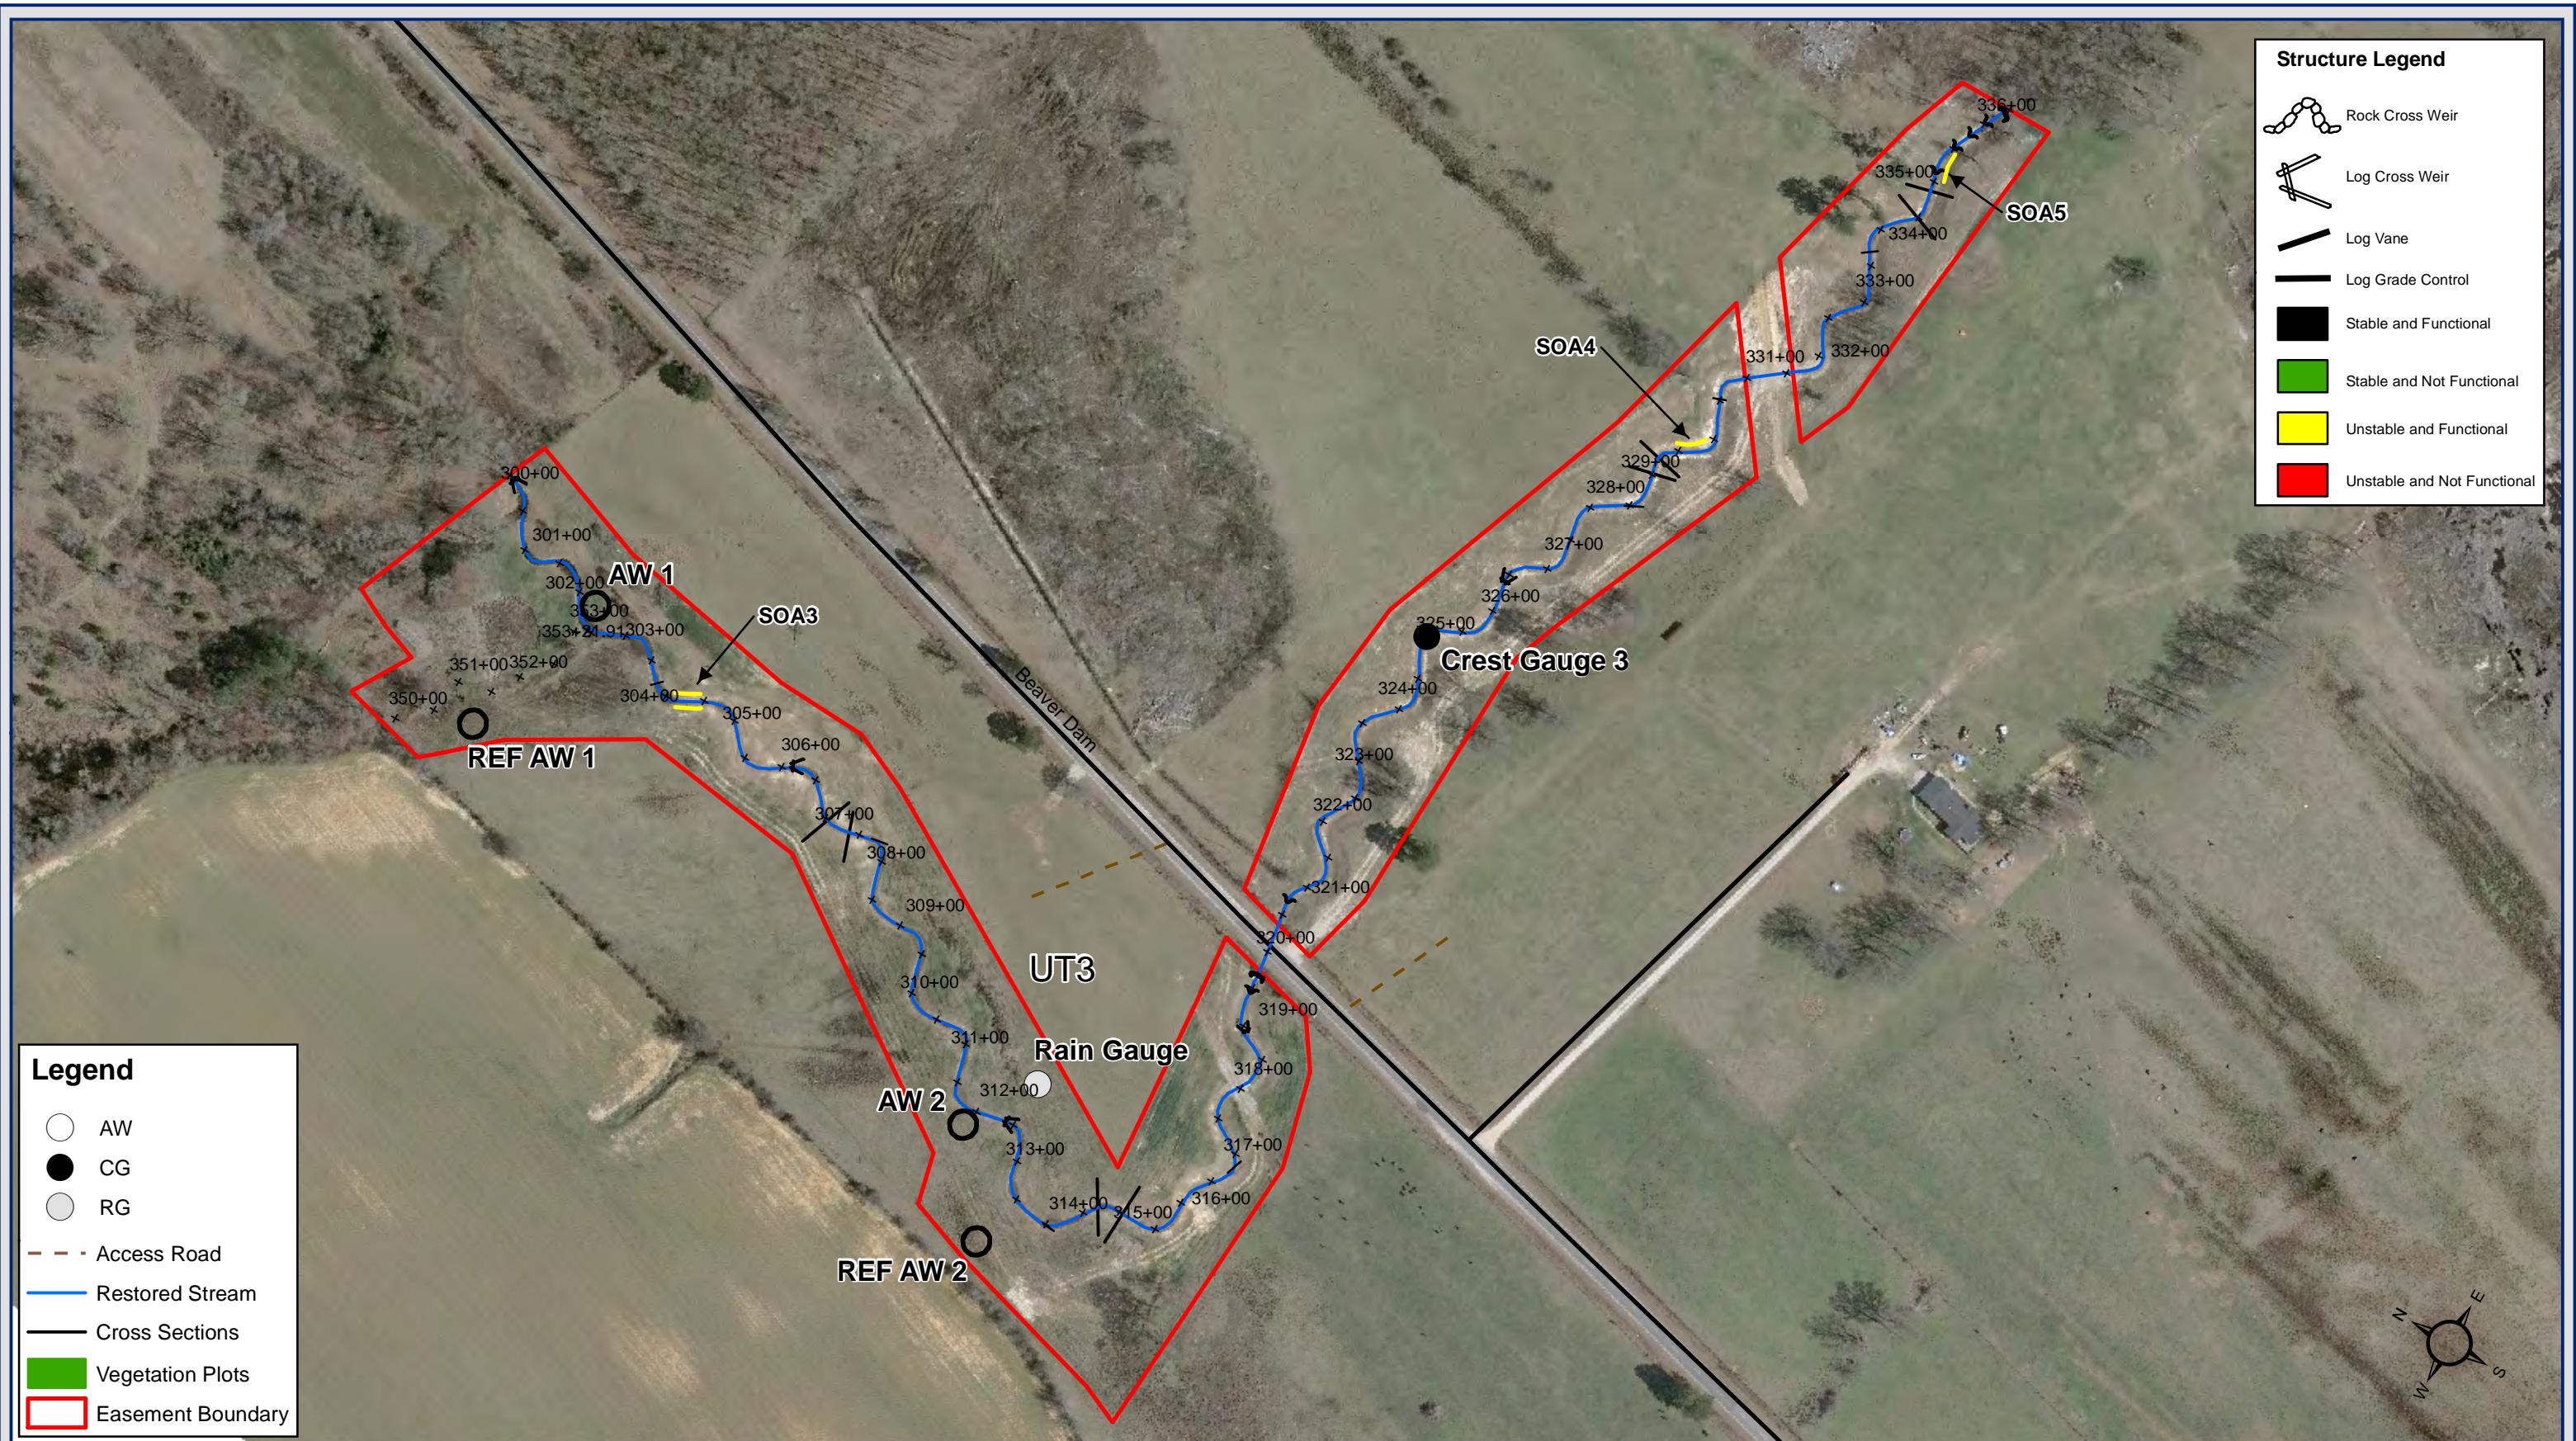
Figure 6b  
Beaverdam Mitigation Project  
2011 Stream Current Conditions Map

SOA	Feature	STA	Description
SOA1	Left/Right Banks	UT1-A 153+00 - 153+30	Sparse vegetation on left and right banks, Re-seed with a permanent seed, will continue to monitor
SOA2	Right Bank Fencing	UT1-B 118+90	Easement fencing is loose at stream crossing allowing potential cattle access, Repair and reinforcement is recommended.
SOA3	Left/Right Banks	UT3 304+30 - 304+50	Sparse vegetation on left and right banks, Re-seed with a permanent seed, will continue to monitor
SOA4	Left Bank	UT3 329+50 - 329+80	Sparse vegetation on left bank, Re-seed with a permanent seed, will continue to monitor
SOA5	Right Bank	UT3 335+10 - 335+40	Localized erosion on right bank, Re-seed with a permanent seed, will continue to monitor

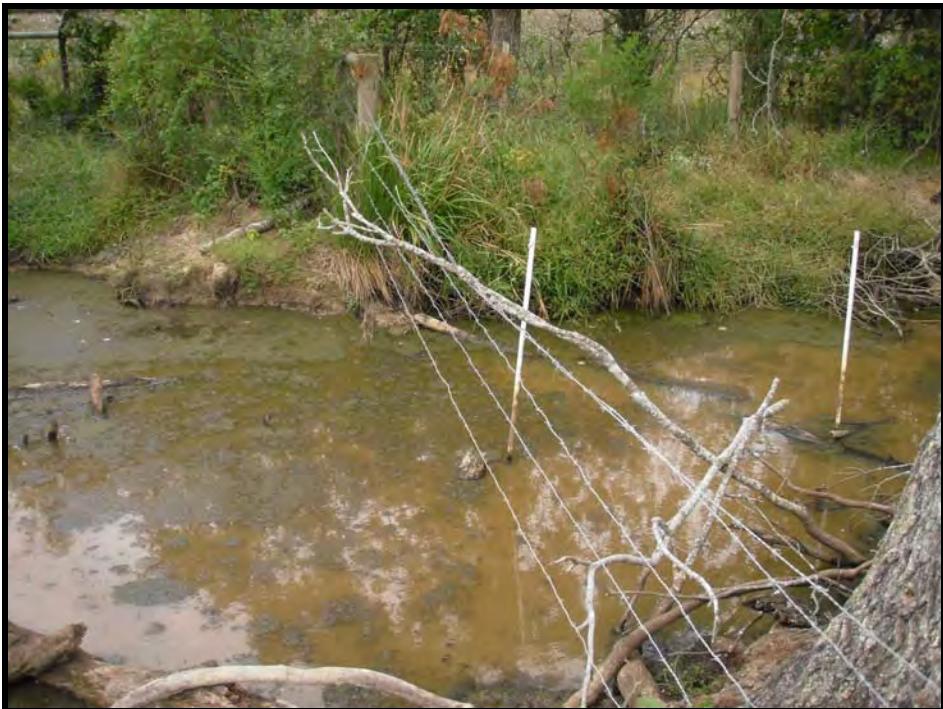
SOA2 – Easement fencing is loose at Sta. 118+90 (UT1-B)

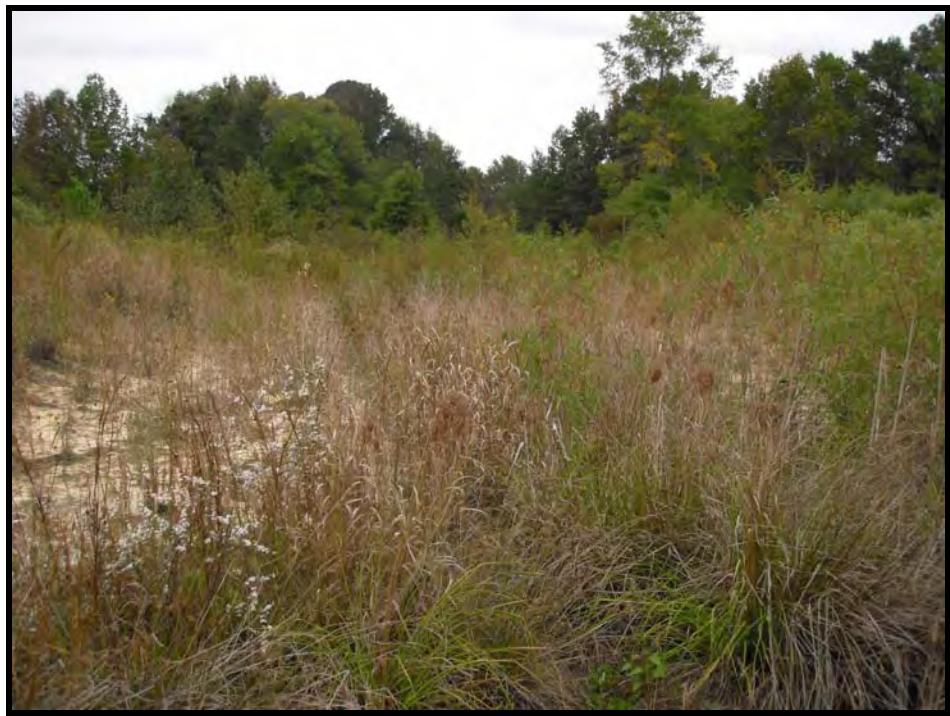
SOA3 – Sparse vegetation on left and right banks at Sta. 304+30 – 304+50 (UT3)
