Year 1 Monitoring Report

Bohemian Mitigation Project

DMS Project #: 100108 | Contract #: 7863 | DWR # 2019-1403 | RFP: 16-007703

Randolph & Guilford Counties, North Carolina
Cape Fear River Basin
Randleman Lake Watershed
HUC 03030003

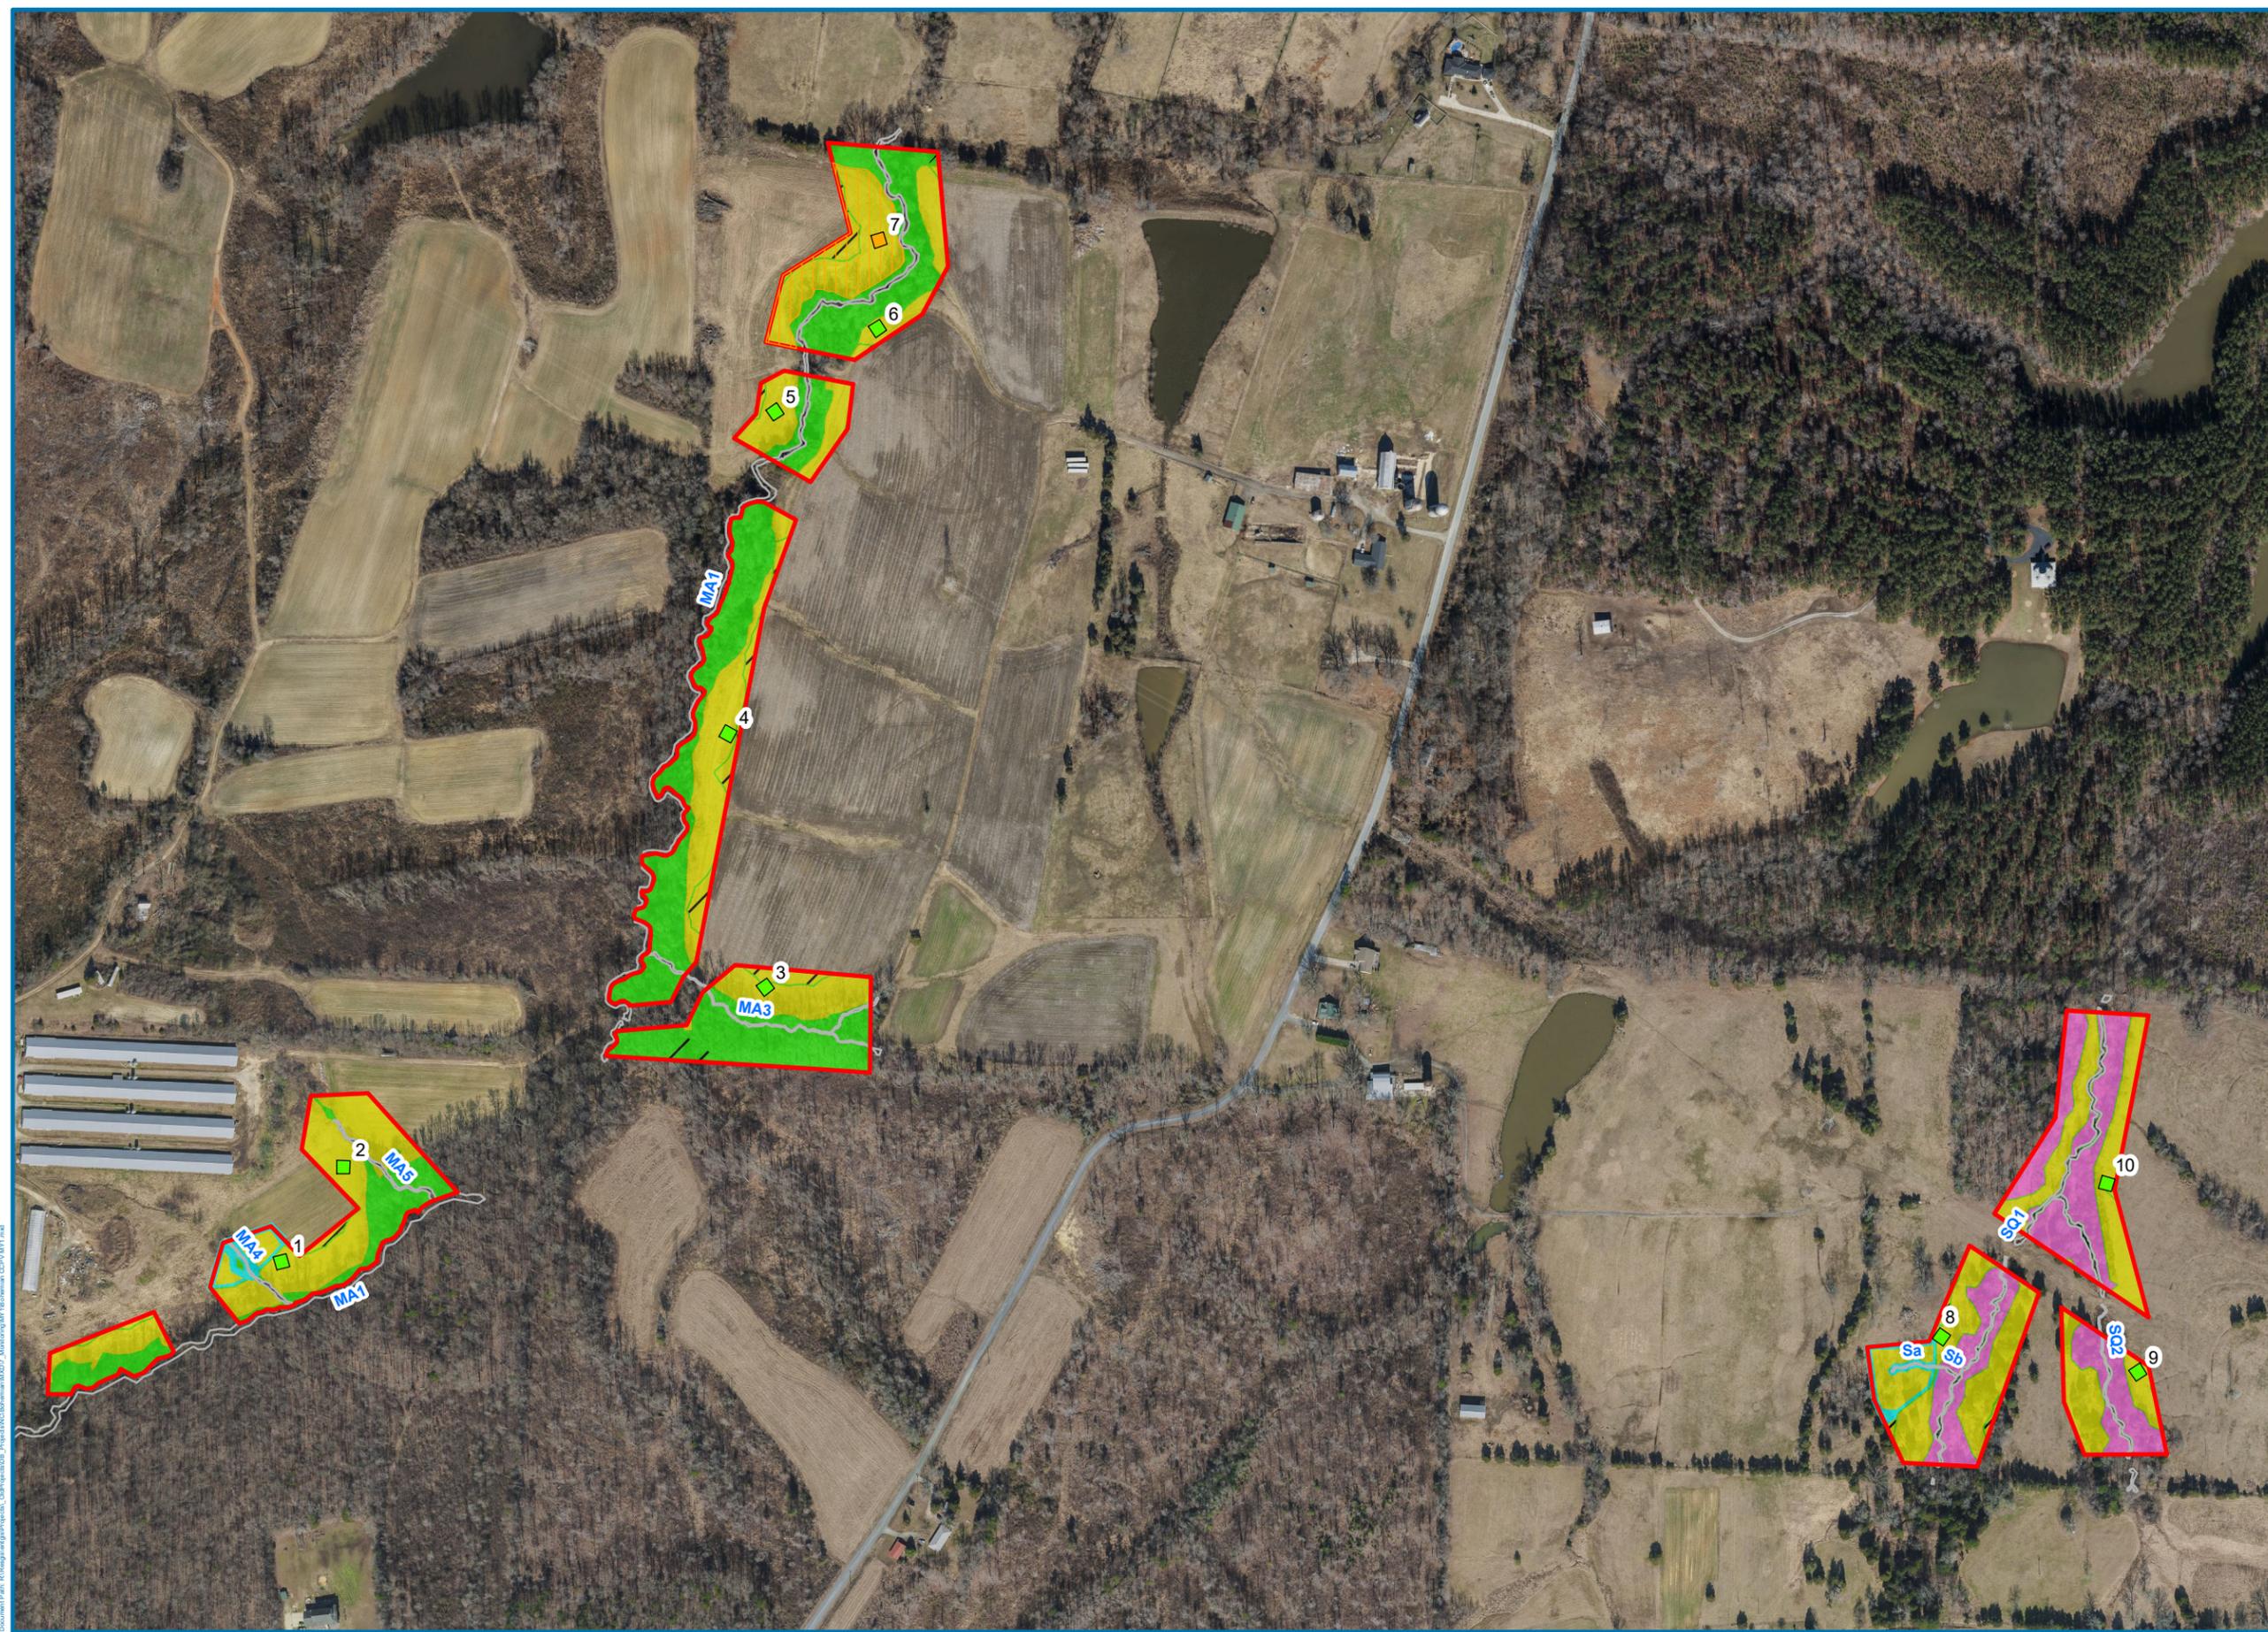
Figure 2
Current Conditions Plan View
MY1 2020
Bohemian Mitigation Project
Guilford and Randolph Counties, North Carolina

Visual assessment of vegetation outside of the monitoring plots indicates that the herbaceous vegetation is becoming well established throughout the project and no invasive species were observed. The fence has been installed, is in good condition, and is maintaining cattle exclusion. Additionally, there were no signs of encroachment or concentrated flow in the easement area.

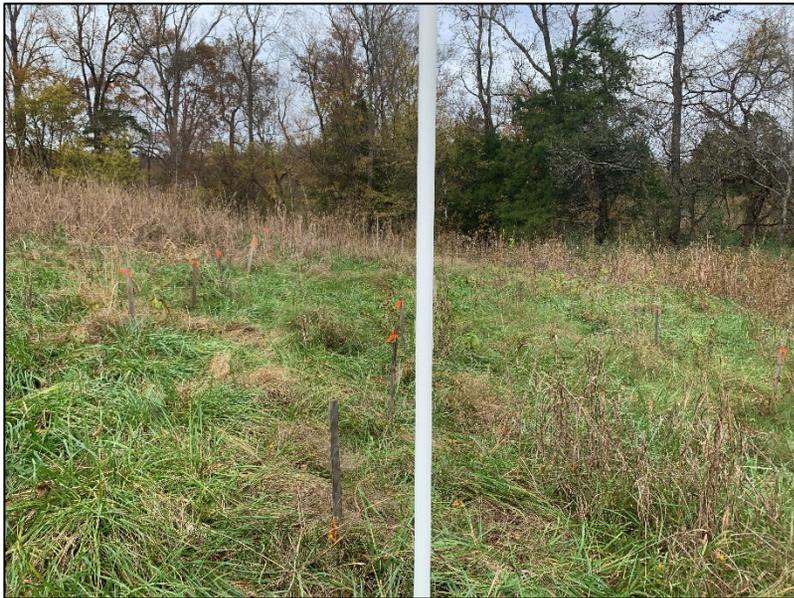
Vegetation Plot 7 (11/10/2020)

2. Section 1.6 – Does RES have a theory as to why vegetation in and around veg plot 7 had such high mortality (herbaceous competition, poor soil, late planting date, etc.)? If so, please briefly discuss this and what actions may be considered to ensure the supplemental planting's success.

RES believes the high mortality can be attributed to the growing season (May) planting. RES experienced similar mortality across all four Randleman Group B sites. RES will ensure that supplemental planting is completed during this dormant season.

Monitoring of the 10 fixed vegetation plots was completed on November 10, 2020. Vegetation tables are in **Appendix B** and associated photos are in **Appendix C**. Year 1 monitoring data indicates that all plots but one (Vegetation Plot 7) are exceeding the success criteria of 260 planted stems per acre. Planted stem densities ranged from 162 to 1,052 planted stems per acre with a mean of 749 planted stems per acre across all plots. A total of 17 native species were documented within the plots. Volunteer species were found in only one plot. The average tree height observed was 1.8 feet. The area in and around Vegetation Plot 7 (1.33 acres) will be supplemental planted with bareroot species this dormant season.
