**Bold Run
Stream/Buffer Restoration
Monitoring Report
EEP Project # 439
Monitoring Year - 01**

January 2008

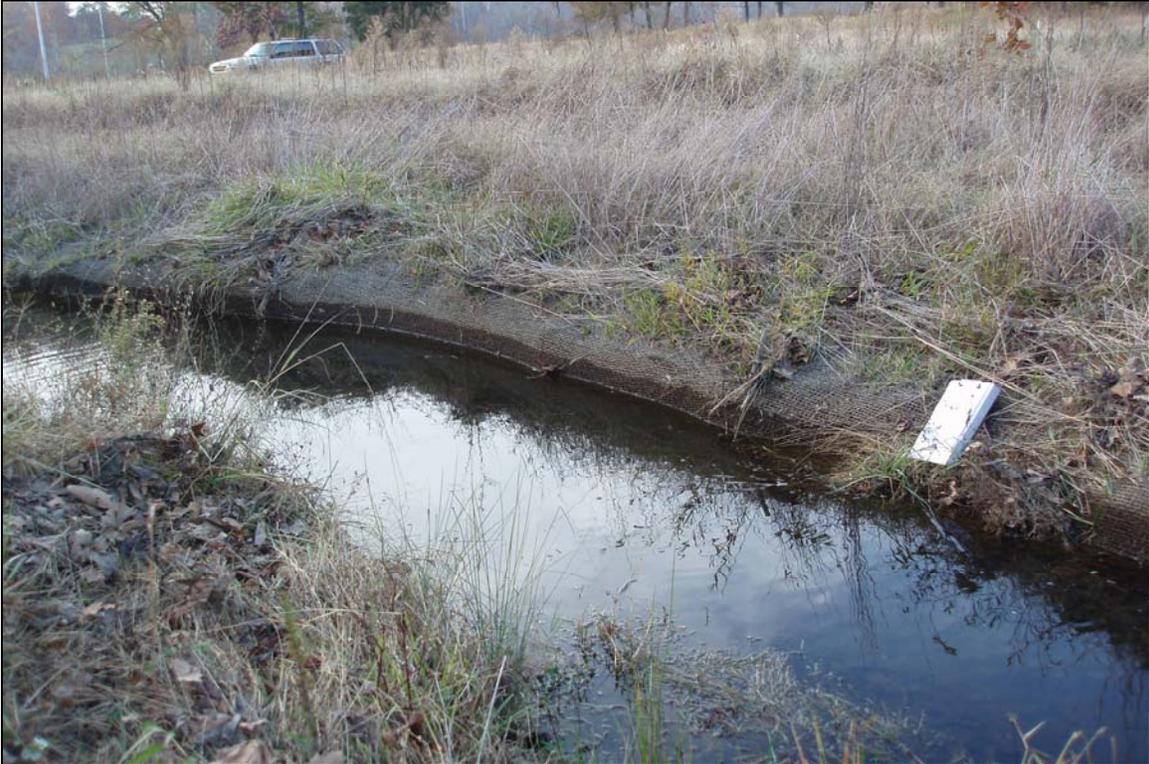
Table A6. Vegetation Problem Areas Project Name and Number: Bold Run - 439			
Feature Issue	Station numbers	Suspected Cause	Photo #
Bare Bank	14+75	Unknown	VP1

VP1 –Poorly vegetated banks and exposed coir matting. Photo taken near Station 14+75. 11/19/07 - MY 01

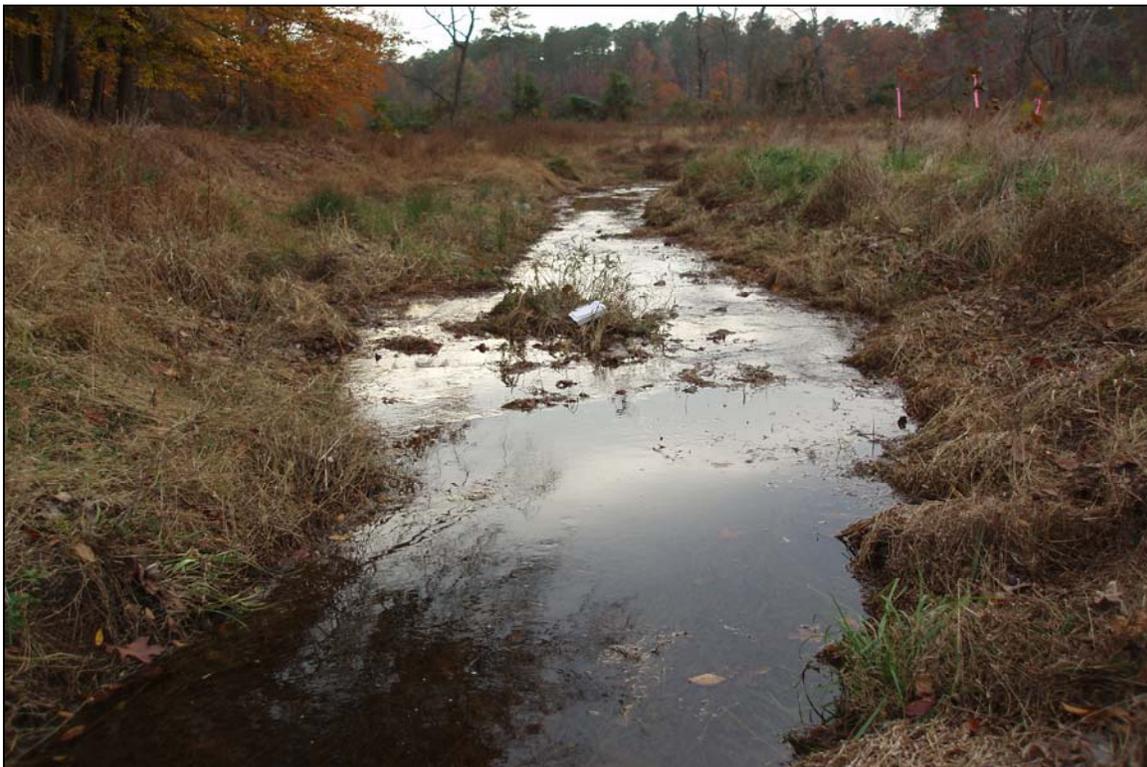
Table B1. Stream Problem Areas			
Project Name and Number: Bold Run - 439			
Feature Issue	Station numbers	Suspected Cause	Photo #
Aggradation/Bar Formation	22+90	aggradation - - due to widened stream	SP1
Bed Degradation	13+85	unknown	SP2
	21+10	unknown	
Bank Scour	14+50	unknown	SP3
	21+10	unknown	
	24+10	unknown	
Engineered Structures - piping	19+85	poor head stone placement, structure still functional	SP4

SP1 – Aggradation due to overly wide as-built cross-section. Photo taken near Station 23+00 looking downstream. 11/19/07 - MY 01

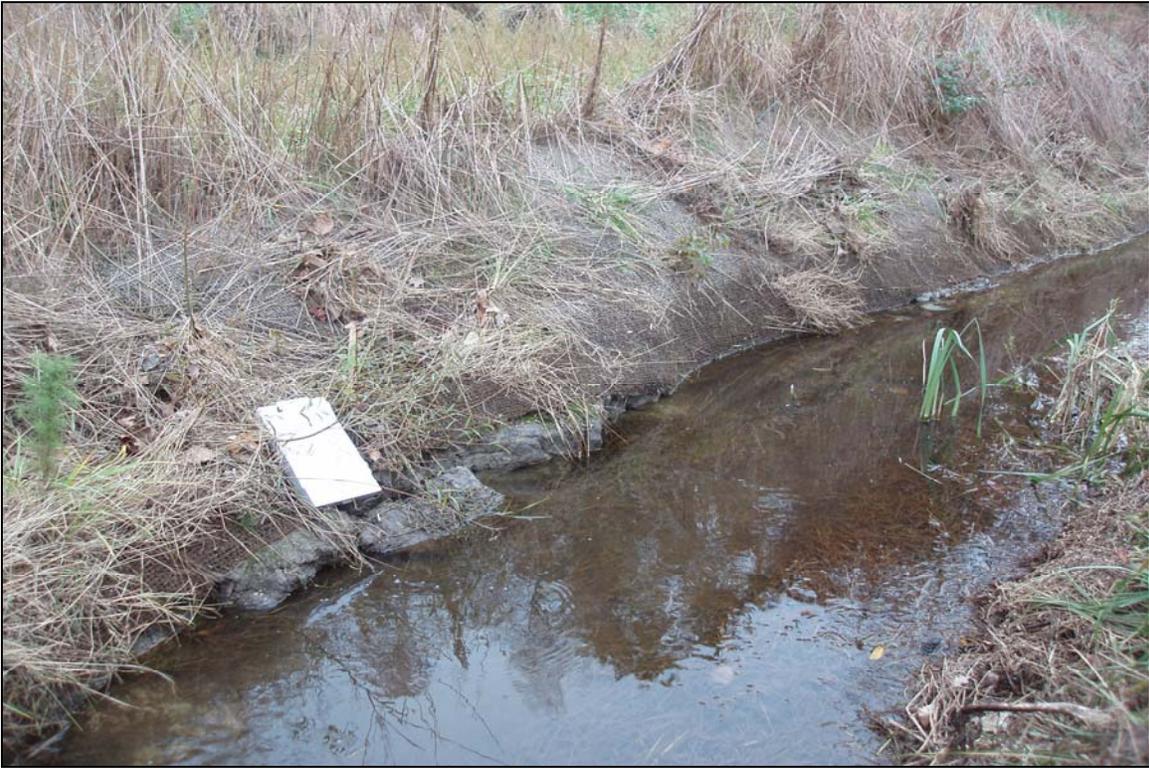
SP2 – Bed degradation on the left with erosion downstream. Photo taken near Station 21+25. 11/19/07 - MY 01

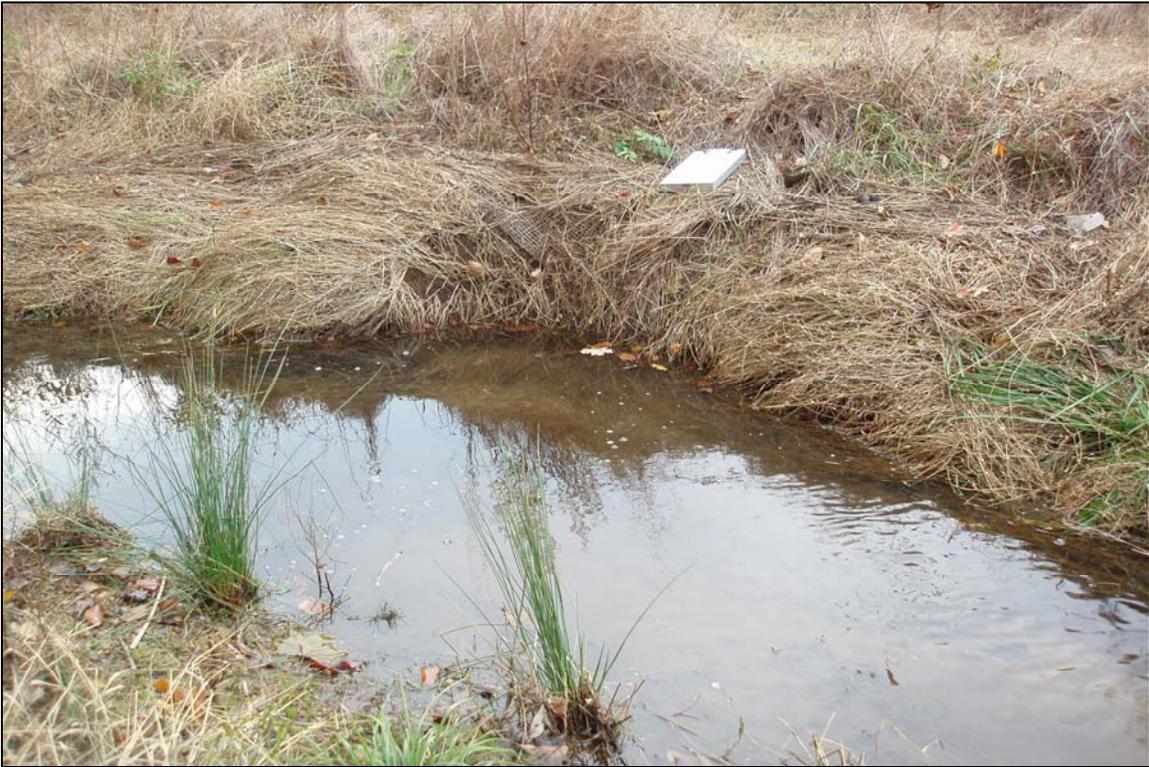
SP3 – Bank erosion under coir matting. Photo taken near Station 24+10. 11/19/07 - MY 01

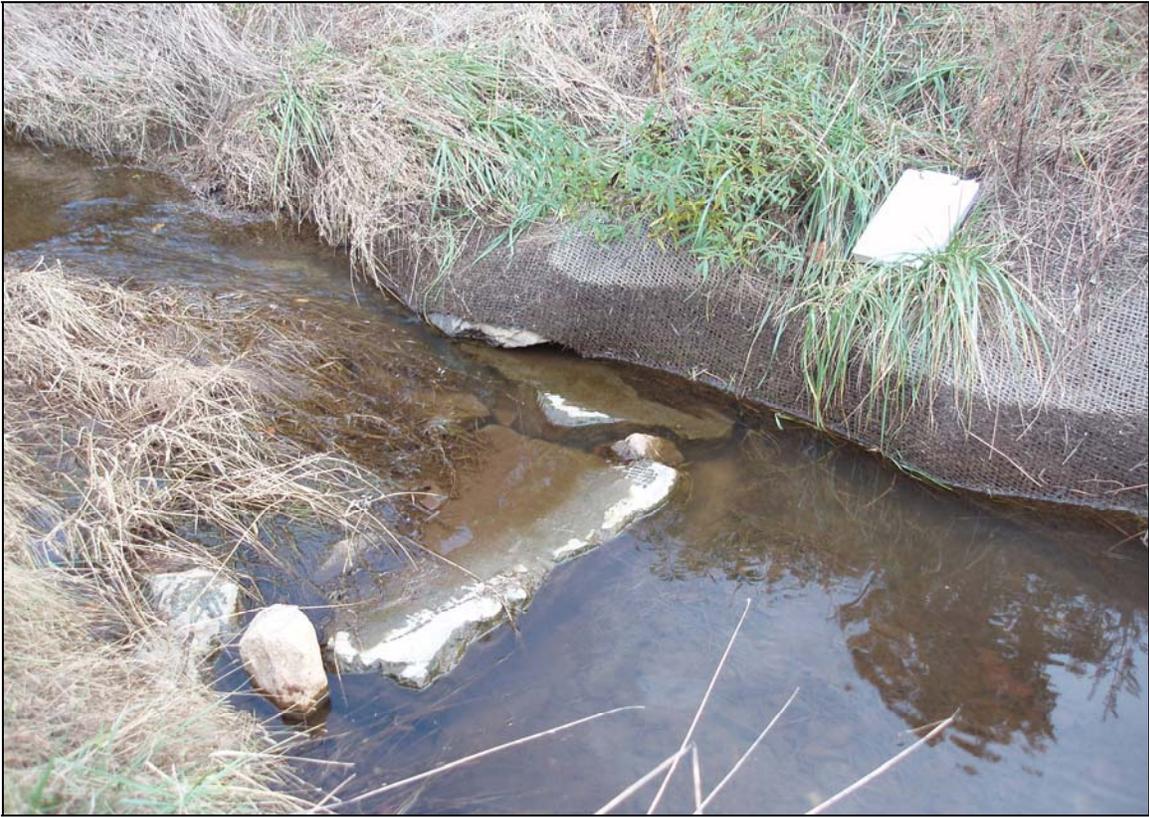
SP4 – Cross vane not built correctly with piping at low flow. Photo taken near Station 19+85. 11/19/07 – MY 01
