MONITORING YEAR 1 AND 2 REPORT
BOWLIN-PEAK CREEK MITIGATION SITE

Ashe County, North Carolina

EEP Project Number: 92606
Contract Number: D06082; Task Order: 06NW01-1

Period Covered: March 2008 - June 2009

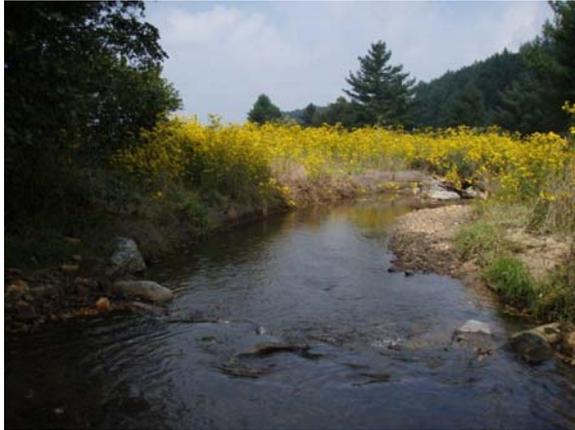
PA1, eroding left bank: 08 Sep 2008.

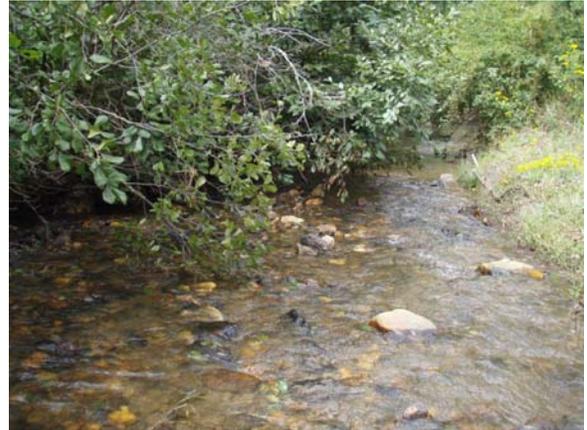
The small center bar at station 12+44 was present only for the MY1 survey. Its formation is probably a result of sediment moving through the project site as the stream channel adjusted to a more steady state after construction. The center bar at station 19+89 was present prior to construction. The center bar was low in elevation with a stable riffle and stable stream banks adjacent to it. The stream channel is overly wide in this section due to historic gravel mining. It has not changed over time and should not cause further instability. No remedial action is needed and should just be watched over time.

PA2, center bar: 08 Sep 2008.

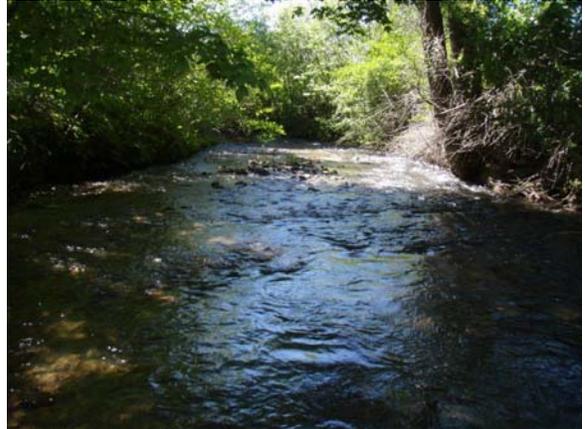
PA3, center/transverse bar: 20 May 2009.

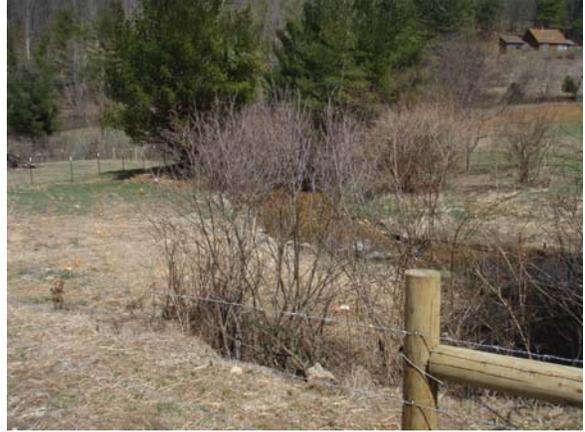
PS-5, bearing 45°: 26 Mar 08. Note: stream channel moved to the right.

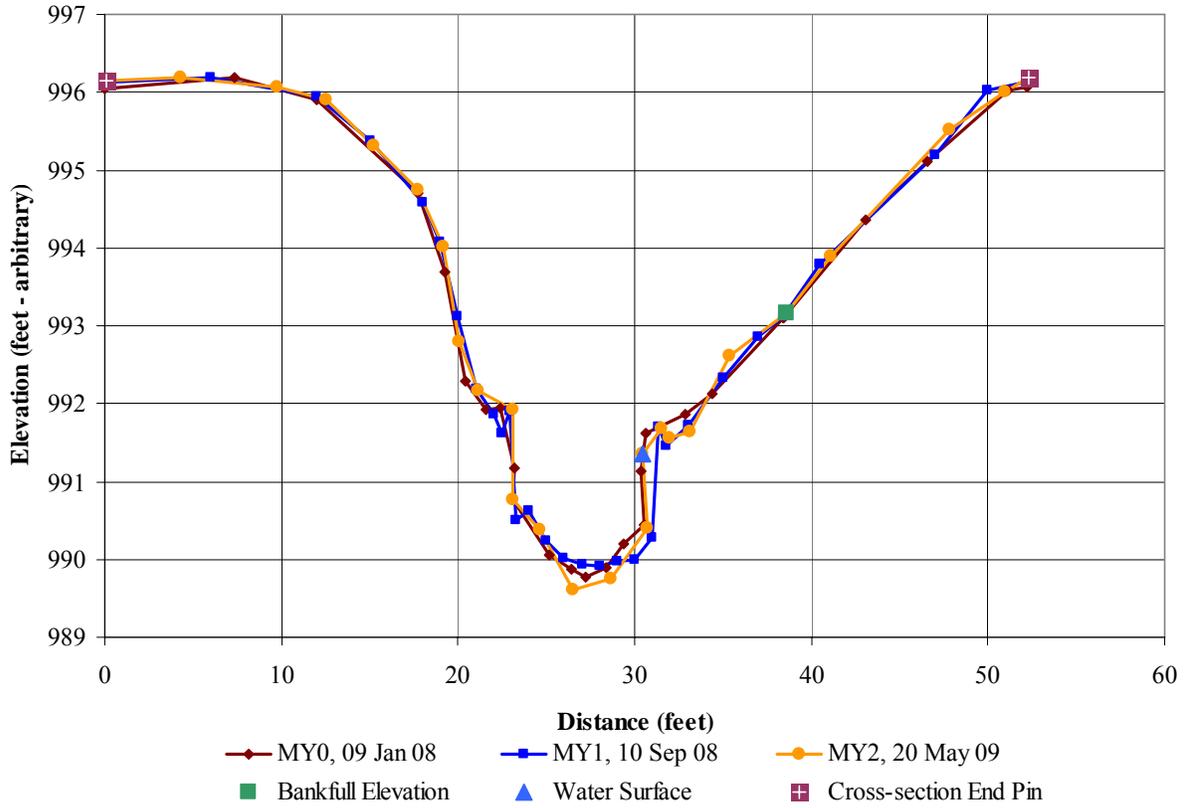
Cross-section 2, Pool
Bowlin-Peak Creek/Project Number:92606

- Cross-section 2 transects a pool and the downstream portion of a log cross-vane. The annual cross-section overlay (Appendix B.5) suggests the right bank migrated approximately 0.8 ft to the right from the as-built condition to MY1 and then migrated back to its original position in MY2. The bank did not actually move. The discrepancy is just a function of not surveying the exact same points every year.
