BROCK STREAM ENHANCEMENT

FINAL AS-BUILT & BASELINE MONITORING REPORT

Jones County, North Carolina SCO Project Number 050650601-A EEP Project Number 92333

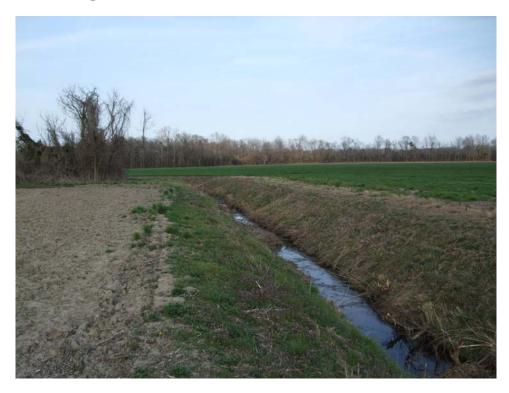
Photo B1 – Pre-construction stream channel looking downstream near station 14+00 (3/10/09)

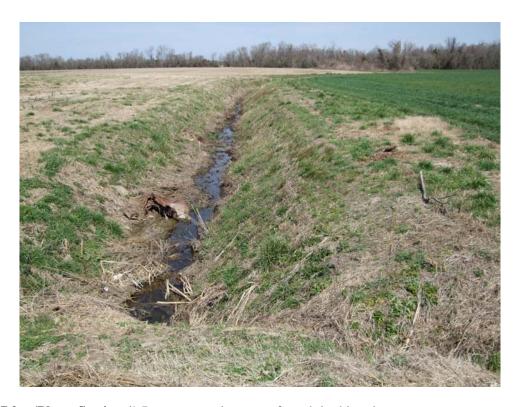
Photo B2 – (**Photo Station 1**) Pre-construction, top of reach looking downstream to permanent cross-section 11+00 (3/10/2009)

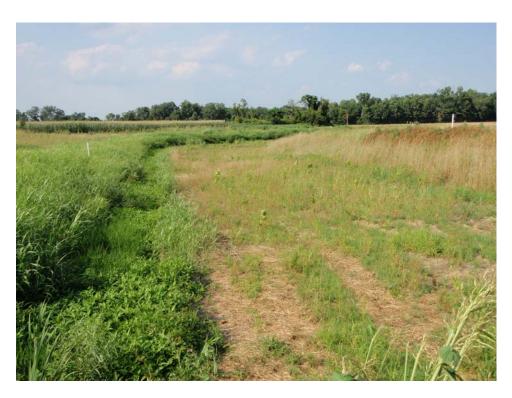
Photo B3 – (**Photo Station 1**) Post-construction, top of reach looking downstream to cross-section 11+00 (marked by PVC pipes) (7/2/2009 Year 0)

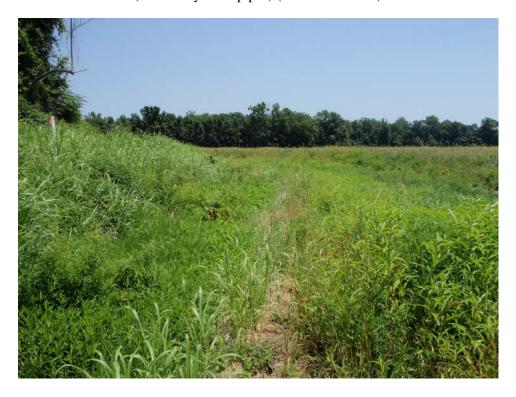
Photo B4 – (**Photo Station 4**) Stream channel looking downstream at cross-section 15+00 (7/2/2009 Year 0)

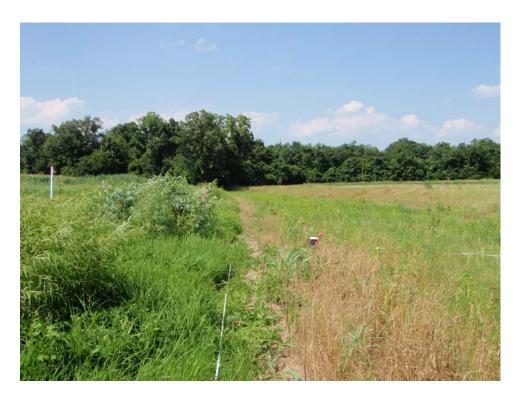
Photo B5 – (**Photo Station 10**) Stream channel looking downstream at cross-section 23+00 (marked by PVC poles just downstream of Veg Plot 4) (7/2/2009 Year 0)

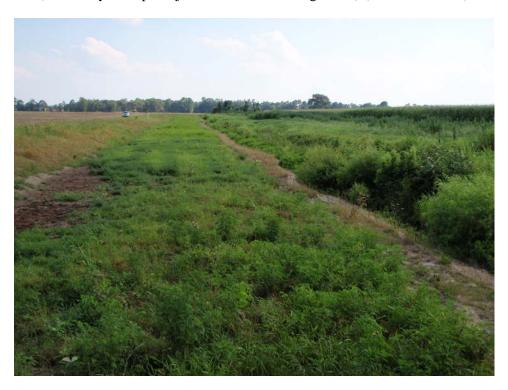
Photo B6 – (Photo Station 13) Lower end of stream enhancement looking upstream (7/2/2009 Year 0)

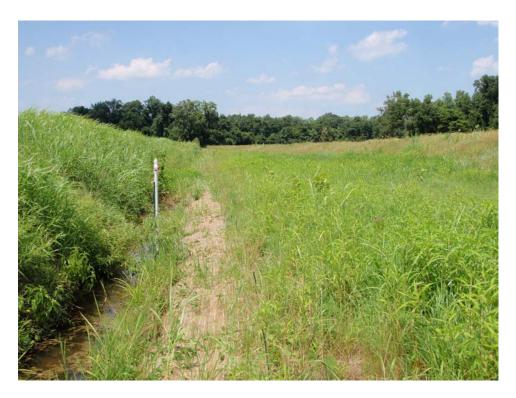
Photo B7 – (Photo Station 7) – Crest gauge looking downstream (7/2/2009 Year 0)

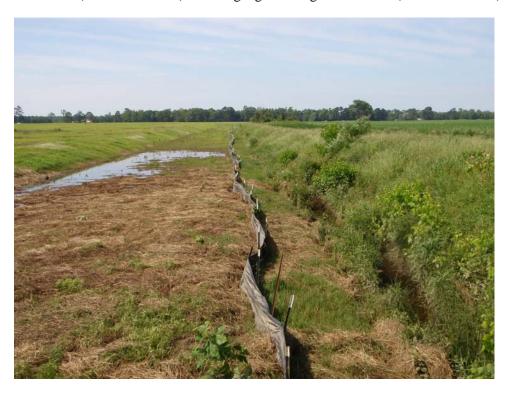
Large rain events onsite occurred in the middle of April and first half of May 2009. Bankfull flow is evidenced by the wrack lines of straw observed at the downstream end of the project reach on May 13,

Photo B8 – Evidence of bankfull flow (wrack lines of straw and sediment on plants). Lower end of stream enhancement looking upstream (5/13/2009 Year 0)
