# Brown Creek Tributaries Restoration Project Final Year 5 Monitoring Report

Anson County, North Carolina

DMS Project ID No. 95351, DEQ Contract No. 004641

Report Prepared and Submitted by Michael Baker Engineering, Inc.

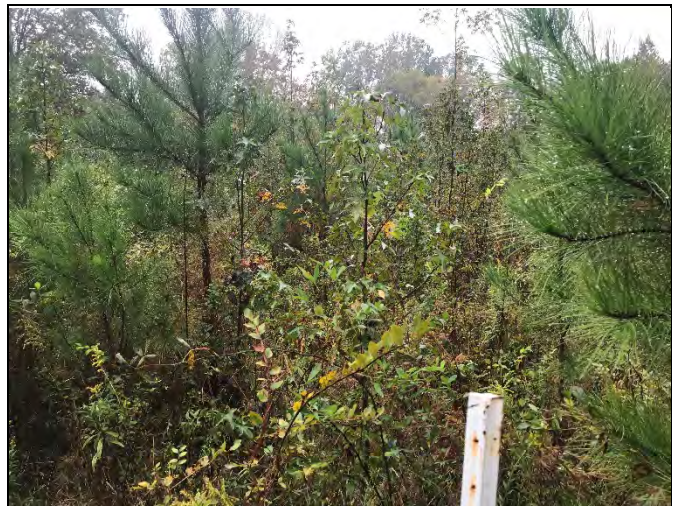
Vegetation Plot 9 – UT4-R3

Vegetation Plot 10 – UT4-R2  
(pines/sweetgum to be thinned)

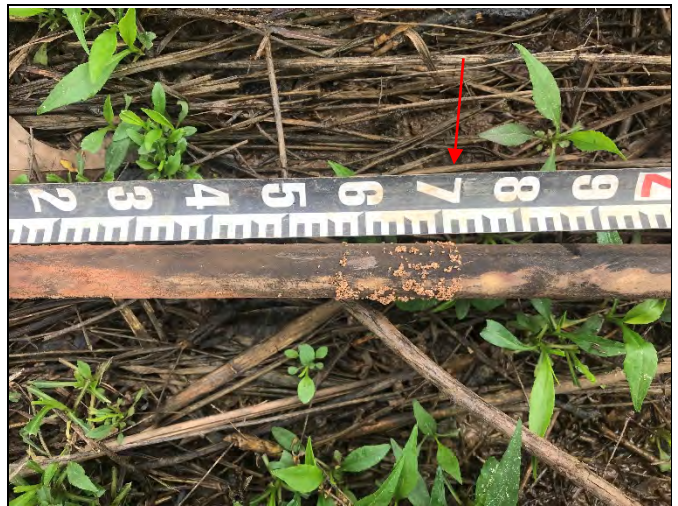
Crest Gauge Reach HC-R1: Overbank event of 1.72'  
(photo from 4/12/19)

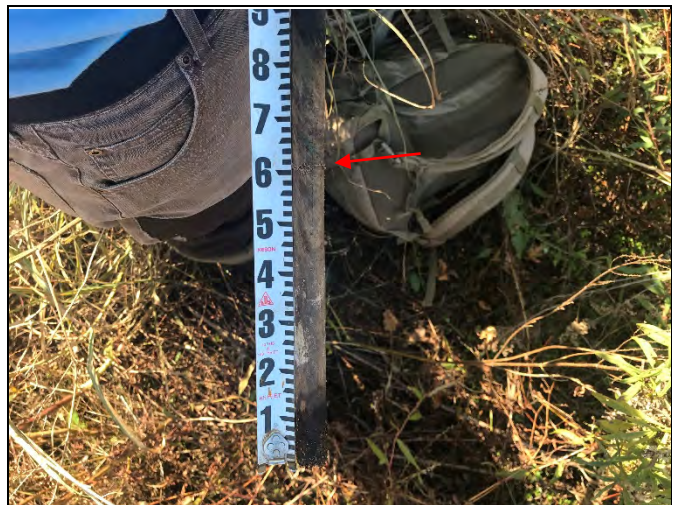
Crest Gauge Reach UT4-R2: Overbank event of 0.58'  
(photo from 10/16/19)

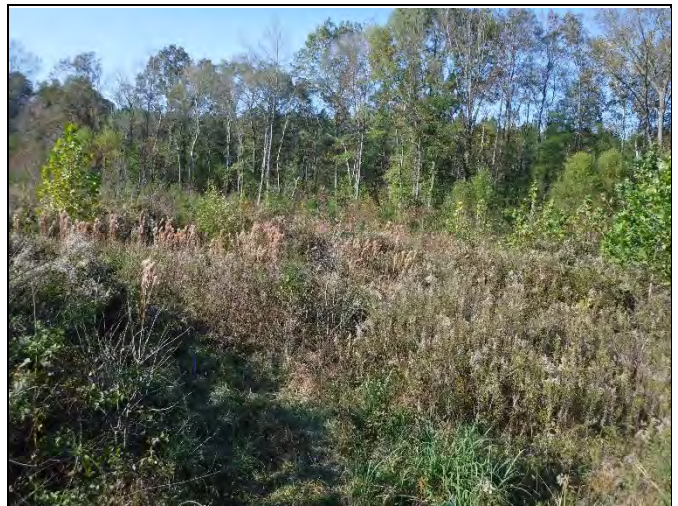
There were however a few Vegetation Problem Areas (VPAs) documented on the project during Year 5 monitoring. First, there were five areas of scattered Chinese privet (*Ligustrum sinsense*) observed and documented on site: two areas in the upper easement of HC-R1, one along HC-R3, and one each on UT4-R4b and UT4-R5b. The areas total approximately 0.80 acres but contain only scattered privet, not dense thickets, and still contain numerous planted species within them. These areas will be fully treated in 2020.

Privet (*Ligustrum sinense*) on Reach HC-R3  
(photo from 11/7/19)

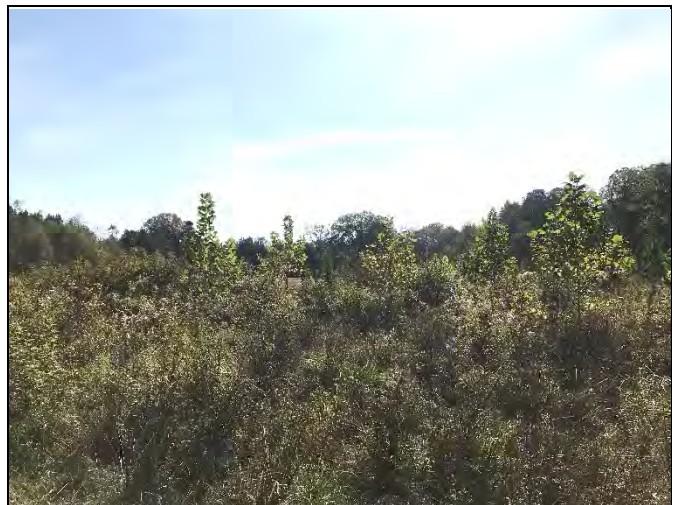
The other VPAs are two areas of low stem densities observed in portions of the floodplain along HC-R2 and UT4-R2 totally approximately 0.37 acres (see photographs in Appendix B). These are sub-sections of larger areas that had been noted as having thin densities in the past and have previously been supplementally planted. Most of the additional plantings have successfully established and appear to be growing well. However, these smaller sub-sections have each experienced high mortality. The area on HC-R2 clearly appears to have had difficulty due to very wet conditions from runoff flow coming from a wet swale in the adjacent pasture leading to extended periods of saturation and ponding throughout the year (see swale in aerial photo in Figure 2A). Although scattered, short plants were found here (and Vegetation Plot 2 located within it passed in MY5), the area as a whole appears to have a low stem density as compared to the surrounding areas. As such, additional 3 and/or 5-gallon container plants of more water-tolerant species will be supplementally planted in this area in the winter of 2019-2020. The area on UT4-R2 has no obvious explanation for its high mortality, though the area is a little drier than the more successful adjacent areas nearer the stream. Regardless, an additional supplemental planting of 3 and/or 5-gallon container plants will be conducted in this area in the winter of 2019-2020.

Low stem density on HC-R2 (photo from 11/7/19)

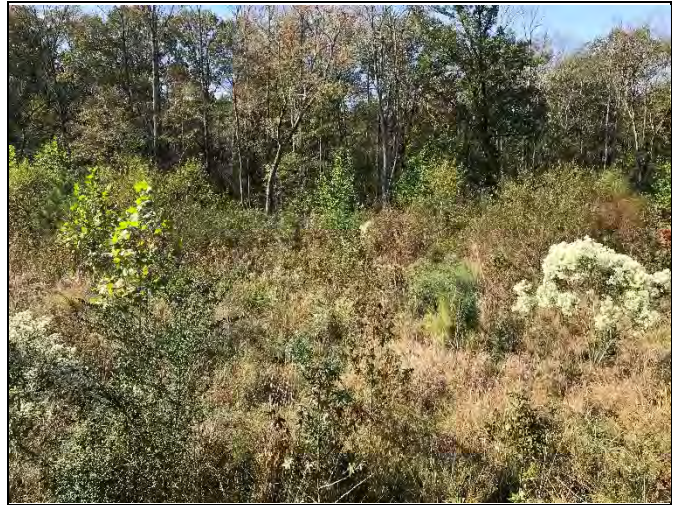
Previously, there were two VPAs identified for the project in the Year 4 monitoring report. The first was an area of low stem vigor observed in the upper section of HC-R1. Applications of fertilizer were made in the spring of 2019 to the short stems, which along with an additional growing season, has resulted in substantial plant growth in this area as shown in the photographs found in Appendix B. Fertilizer will again be added in 2020 to further boost growth rates. The second VPA was an area of low stem density (0.24 acres) found along UT4-R4b. This area was supplementally planted in January 2019 with approximately 50 bareroot stems and 10 1-gallon containers of an equal mix of tulip poplar (*Liriodendron tulipifera*), river birch (*Betula nigra*), white oak (*Quercus alba*), and sycamore (*Platanus occidentalis*). An assessment of the area in November of 2019

Previously reported low-vigor area on upper HC-R1  
(photo from 11/7/19)

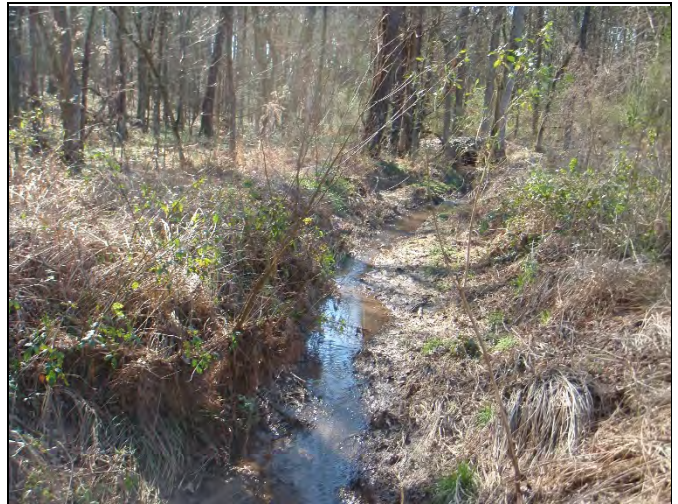
A stream flow camera located on UT4-R4b provides some further documentation of seasonal flow and shows water in the channel throughout the late winter and early spring of 2019, confirming the results collected from the in-stream flow gauge found in the same location. However, once again, the flow camera experienced technical difficulties resulting in the loss of photographs. It will be replaced in early 2020 with a newer model camera and relocated to a new position to better document seasonal flow in the channel.

Flow camera showing flow in riffle on Reach UT4-R4b  
(photo from 3/29/19)
