# Brown Creek Tributaries Restoration Project Final Year 6 Monitoring Report

Anson County, North Carolina

DMS Project ID No. 95351

Monitoring Year: 6 of 7

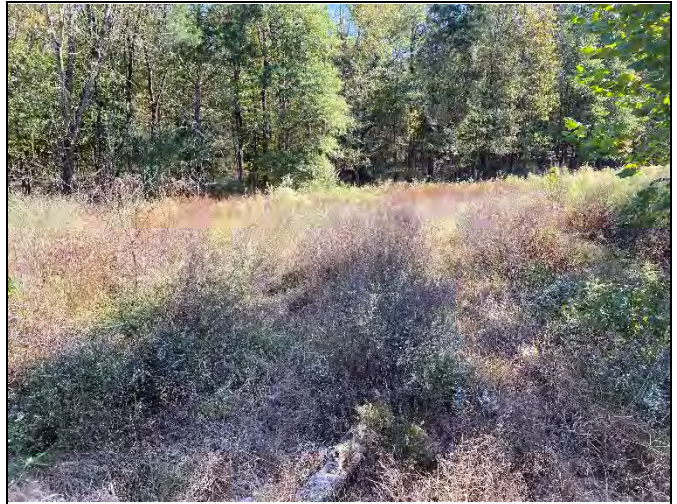
Pipe culvert crossing between UT4-R1a and R1b (path is mostly vegetated and stable)

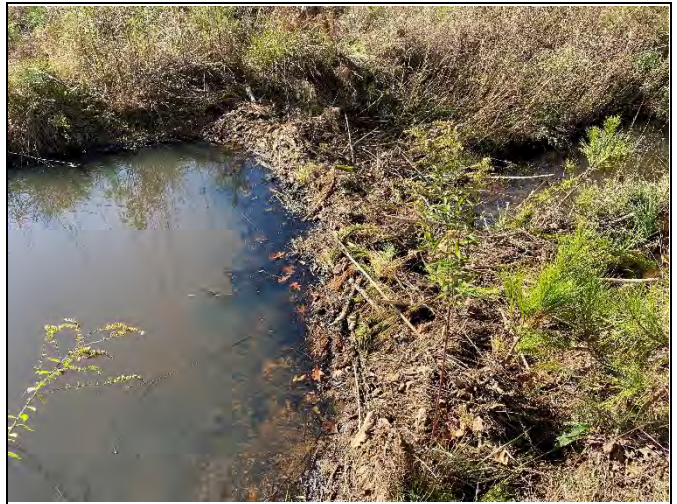
Several beaver dams were discovered on both portions of the project during the November 2020 site inspections. Five were found on Hurricane Creek in HC-R1 and R2, while another three were found on UT4 in UT4-R2 and UT4-R5b (see photographs in Appendix B). A few of the dams were in locations where some beaver activity had been noted in the past and a couple of small dams previously removed, but all of these were built since the summer of this year. Before that, field inspections had revealed the reaches to be clear of dams. A beaver wildlife specialist has already been contacted, and Baker will arrange for the beaver to be removed and the dams taken out as soon as possible. Fortunately, it seems much of the vegetation used for several of the dams was the adjacent black willow, which is present in abundance and naturally regrows well. Nevertheless, once the dams are removed a more thorough assessment of the impact to vegetation will be made.

First beaver dam on lower UT4-R2

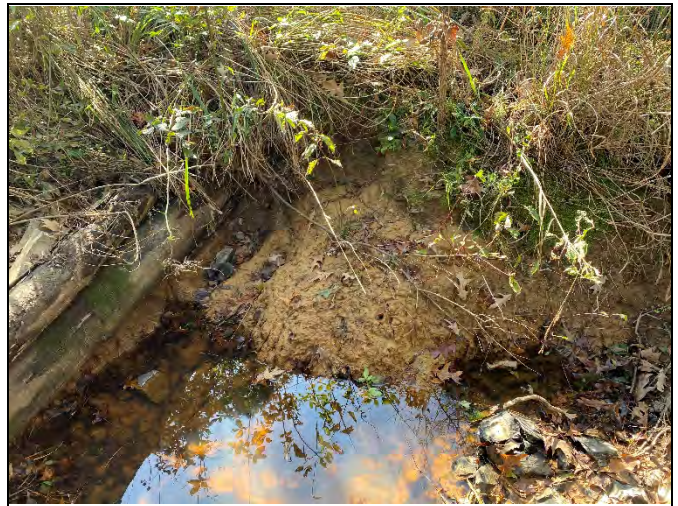
<b>Table 5b. Stream Problem Areas (SPAs)</b>				
<b>Brown Creek Tributaries Restoration Project: DMS Project ID No. 95351</b>				
<b>SPA #</b>	<b>Feature Issue</b>	<b>Reach ID, Station Number</b>	<b>Suspected Cause</b>	<b>Photo in Photo Log</b>
1	Localized Bank Scour	UT4-R2, Station 36+75	Exceptionally high seasonal flows	see Appendix B
2	Localized Bank Scour	UT4-R2, Station 36+00	Exceptionally high seasonal flows	see Appendix B
3	Localized Bank Scour	UT4-R1b, Station 18+50	Exceptionally high seasonal flows	see Appendix B
<b>Notes:</b>

Close-up of SPA #1: UT4-R2

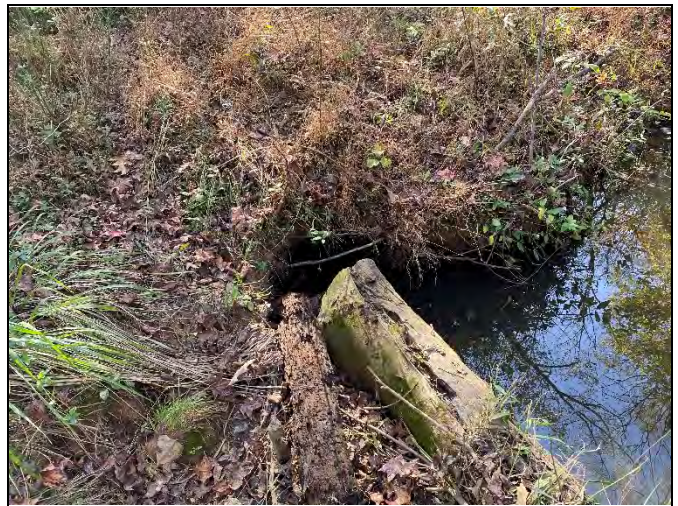
SPA #3: UT4-R1b

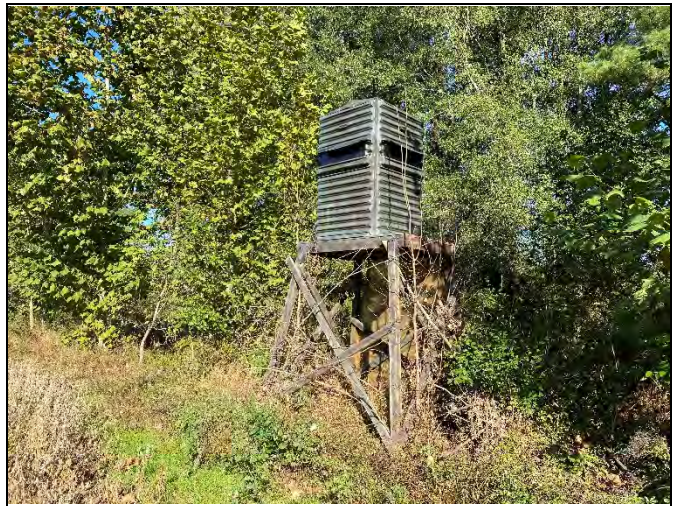
Hunting stand just inside CE on UT4-R5b

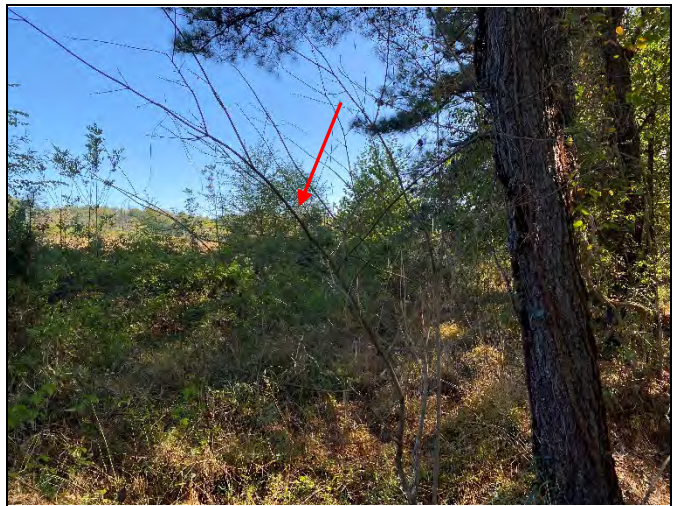
Several areas of previously identified invasive Chinese privet (*Ligustrum sinsense*) were also treated in April of 2020. The areas of scattered privet totaled approximately 0.78 acres and were found along HC-R1, HC-R3, UT4-R4b, and UT4-R5b as shown in the CCPV. However, additional scattered resprouts were observed during November 2020 field inspections, and a Vegetation Problem Area is reported for Year 6 consisting of four areas totaling 0.86 acres of privet. Much of these areas overlap with previously treated areas. In some cases, new resprouts were observed, in others it appears some privet that was previously treated has survived. These areas will be fully treated in 2021 and will continued to be monitored.

UT4-R5b: Sprayed privet (dead/bare branch and stem)

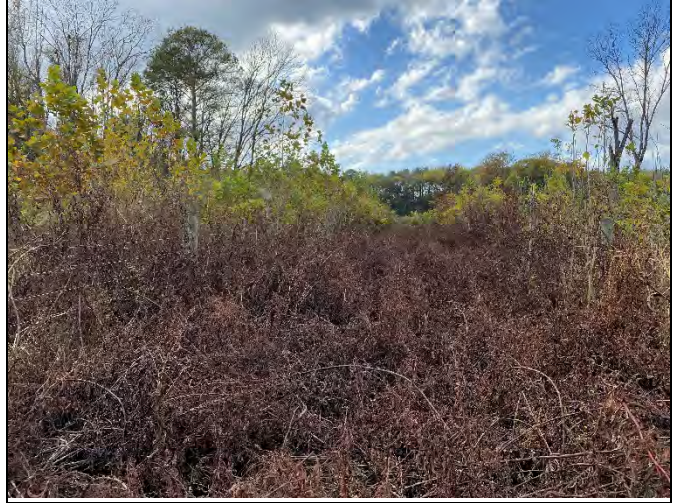
**Response: The crossing gates have been closed at every field visit during the monitoring year. The crossing gives no indication of having been used for livestock in a considerable time as it is completely overgrown with thick herbaceous vegetation (as shown in the additional project photos). Additionally, several young trees were observed growing in the crossing and no manure was observed.**

Crossing at HC-R2 (looking West towards the rock ford overgrown with vegetation)

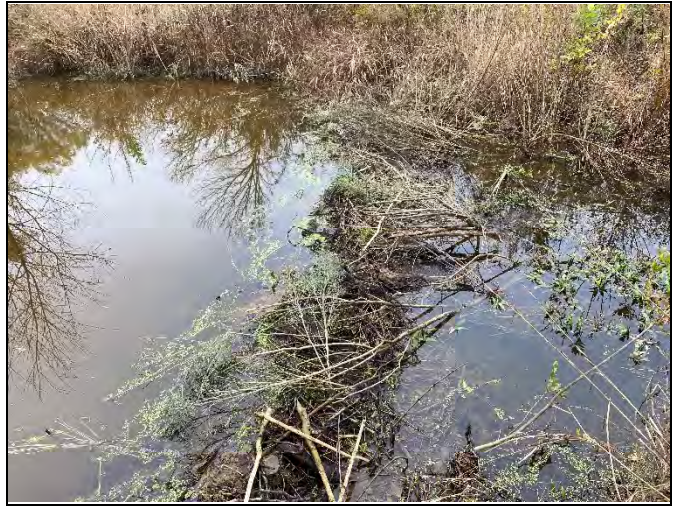
Beaver dam on HC-R2

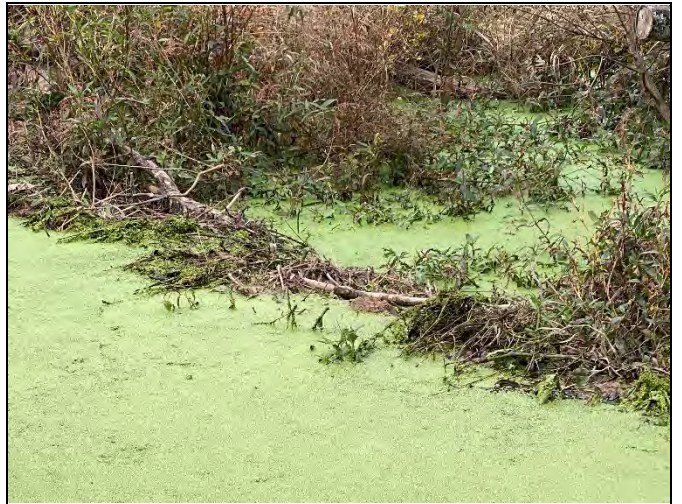
Beaver dam on HC-R1

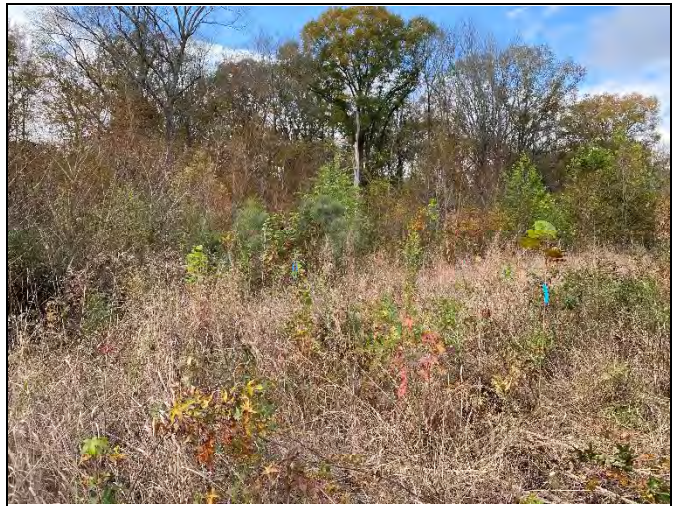
The Year 6 visual inspection monitoring also observed that the planted acreage performance categories were functioning well overall with no bare or eroding areas to report (Appendix B). Two areas previously identified in the Year 5 report as having low stem densities were supplementally planted in February of 2020. The first was an area approximately 0.19 acres in size within the right floodplain of HC-R2. It was replanted with 40, 3-gallon size trees consisting of a roughly equal mix of swamp chestnut oak (*Quercus michauxii*), overcup oak (*Q. lyrata*), pin oak (*Q. palustris*), water oak (*Q. nigra*), sycamore (*Platanus occidentalis*), and black gum (*Nyssa sylvatica*). The second area was approximately 0.35 acres in size within the left floodplain of lower UT4-R2, and it was replanted with 60, 3-gallon size trees consisting of an equal mix of the same species. Site inspections in November of 2020 reveal that these replants appear to have had a high survival rate in their first year and the readily identifiable stems appeared to be vigorous and growing.

Previously identified area of short stem / low vigor trees on upper HC-R1 is still relatively short but is clearly improving (tall grass hides many stems)
