**MONITORING YEAR 0
ANNUAL REPORT
FINAL**

BUG HEADWATERS MITIGATION SITE

Wilkes County, NC
Yadkin River Basin
HUC 03040101

DMS Project No. 100084
NCDEQ Contract No. 7617
DMS RFP No. 16-007406
USACE Action ID No. 2018-01788
DWR Project No. 2018-1273
Data Collection Dates: April 2021

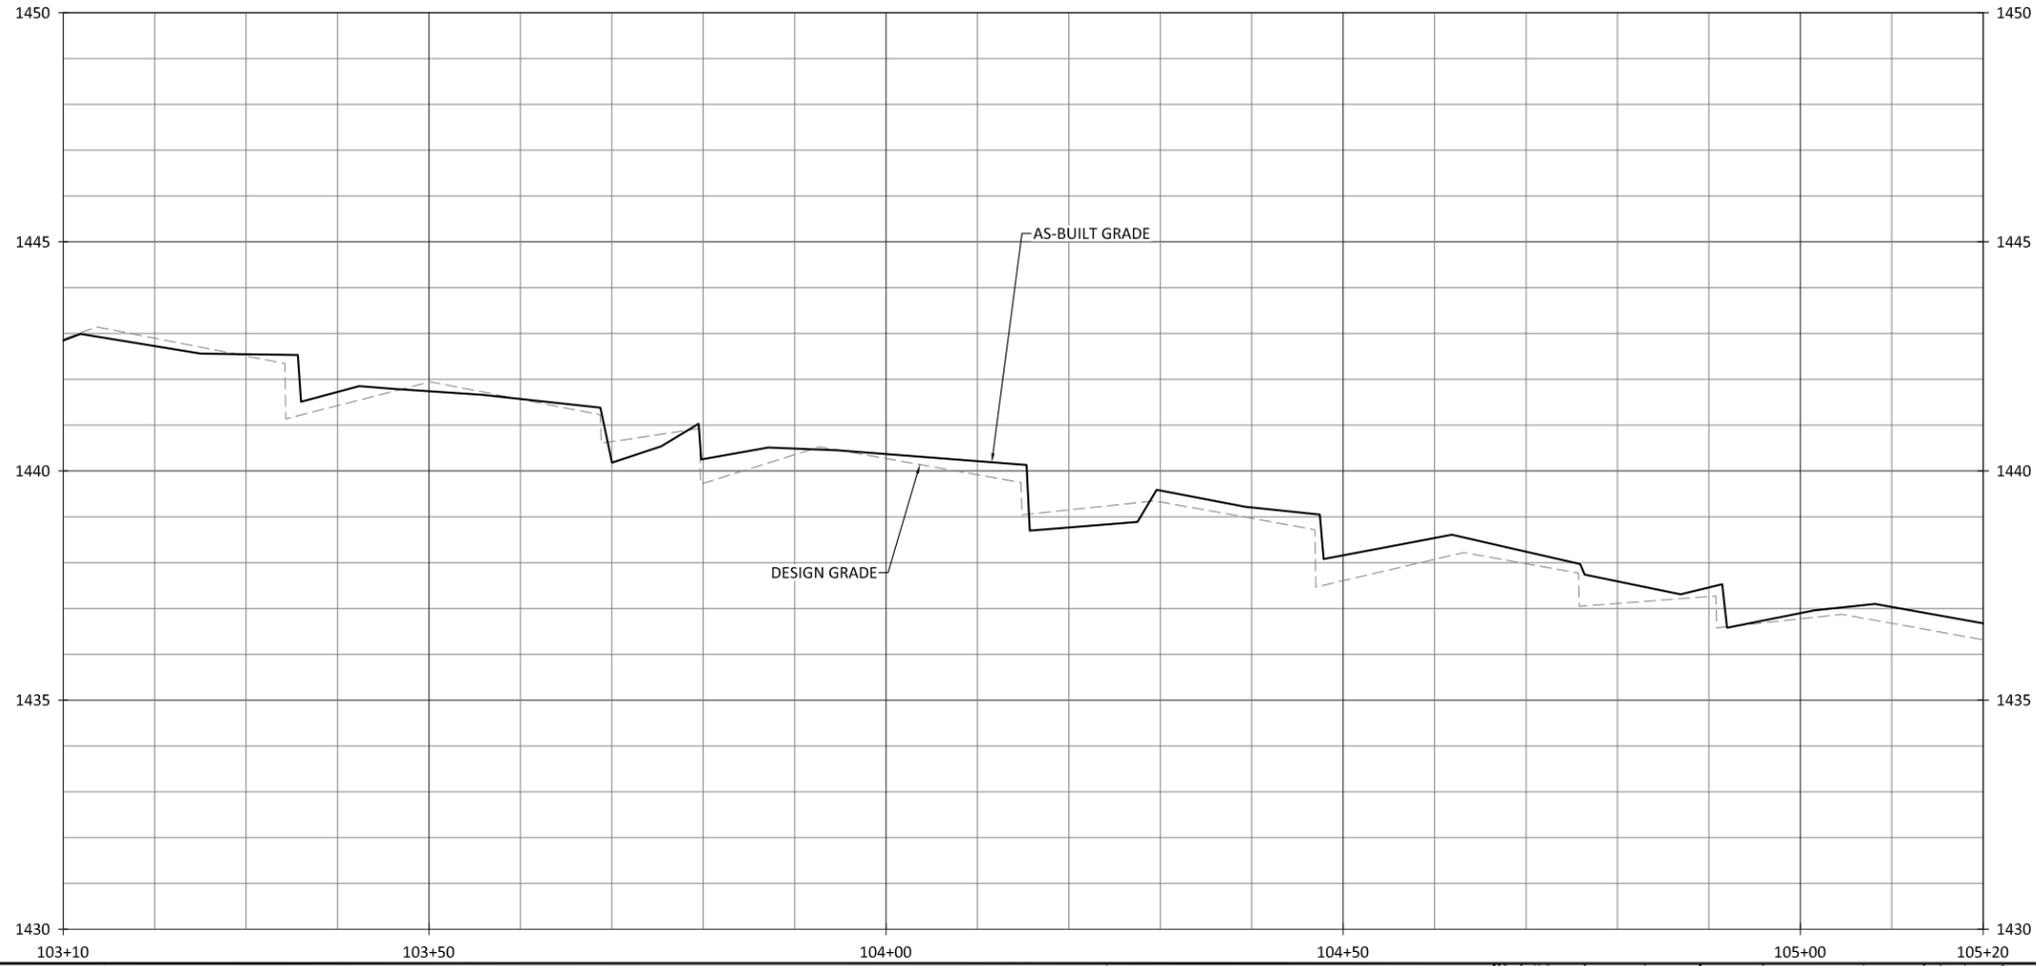
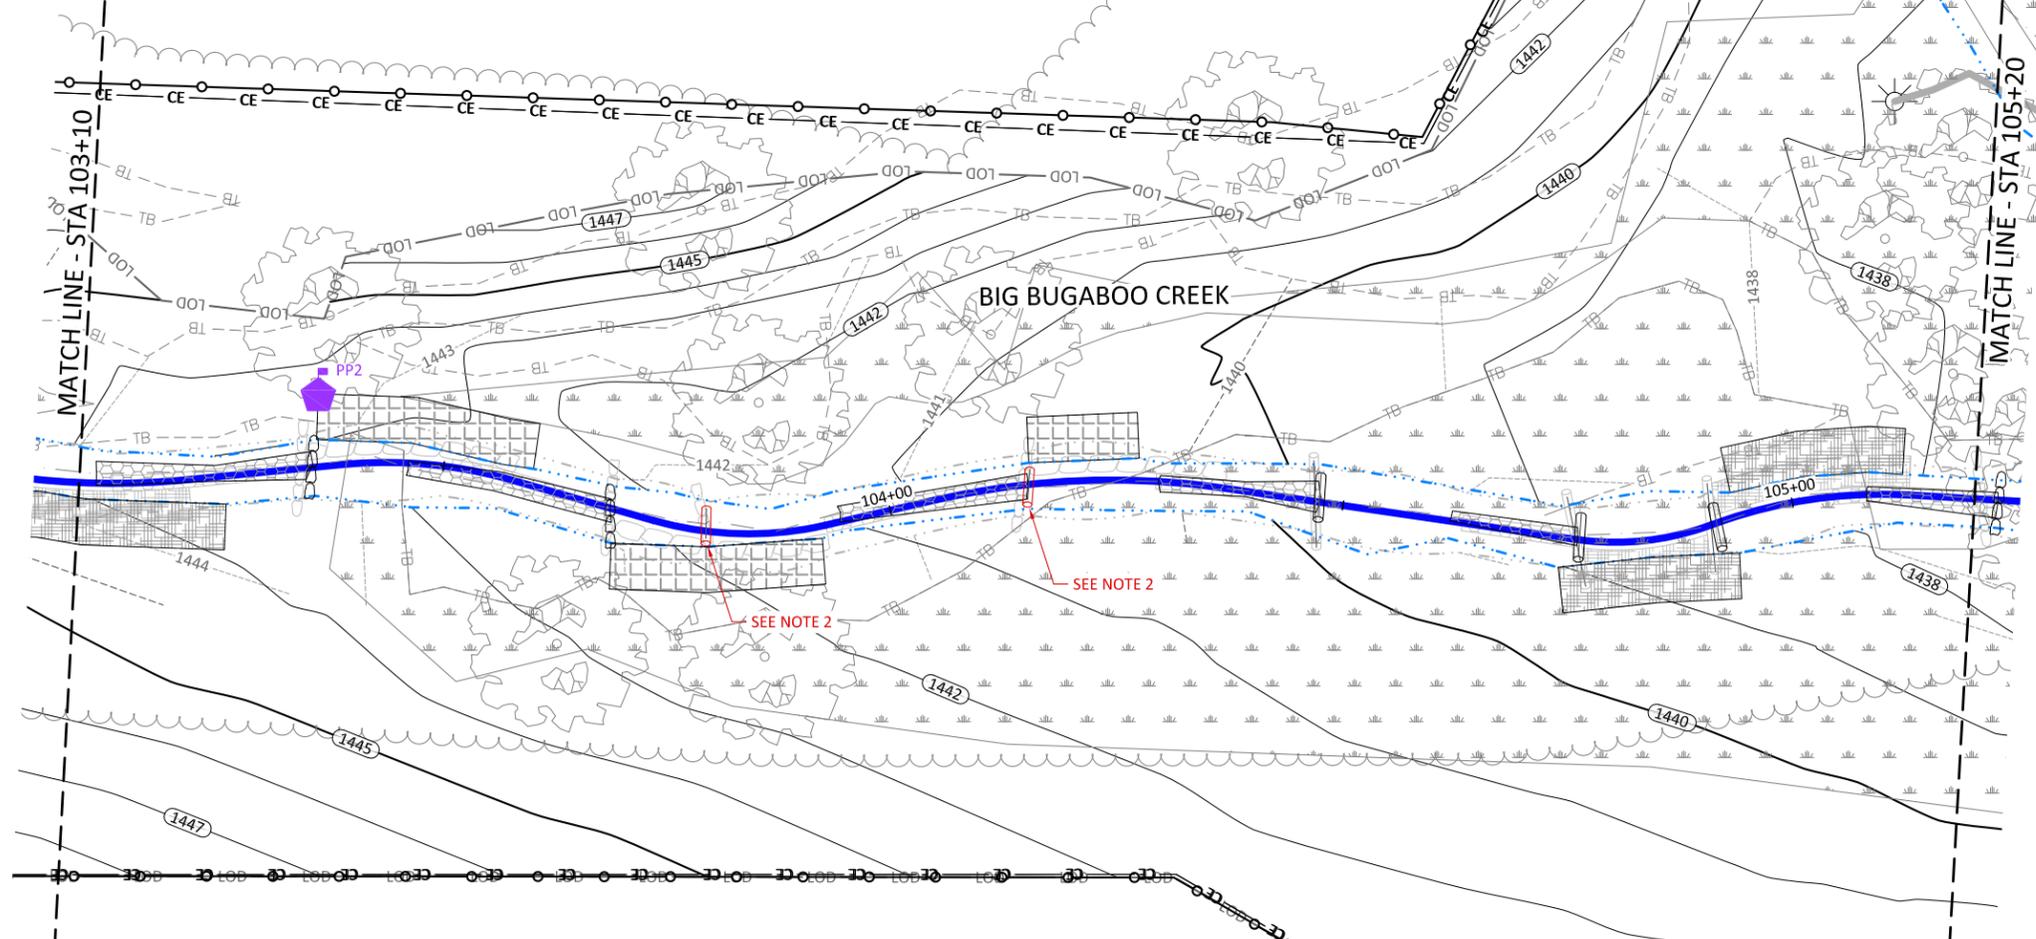
1.01

- NOTES:
1. DEVIATIONS FROM THE DESIGN WILL BE SHOWN IN RED.
 2. STA 103+80 & STA 104+15 BOULDER SILL REPLACED WITH LOG SILL DUE TO NO NATIVE BOULDERS ON SITE

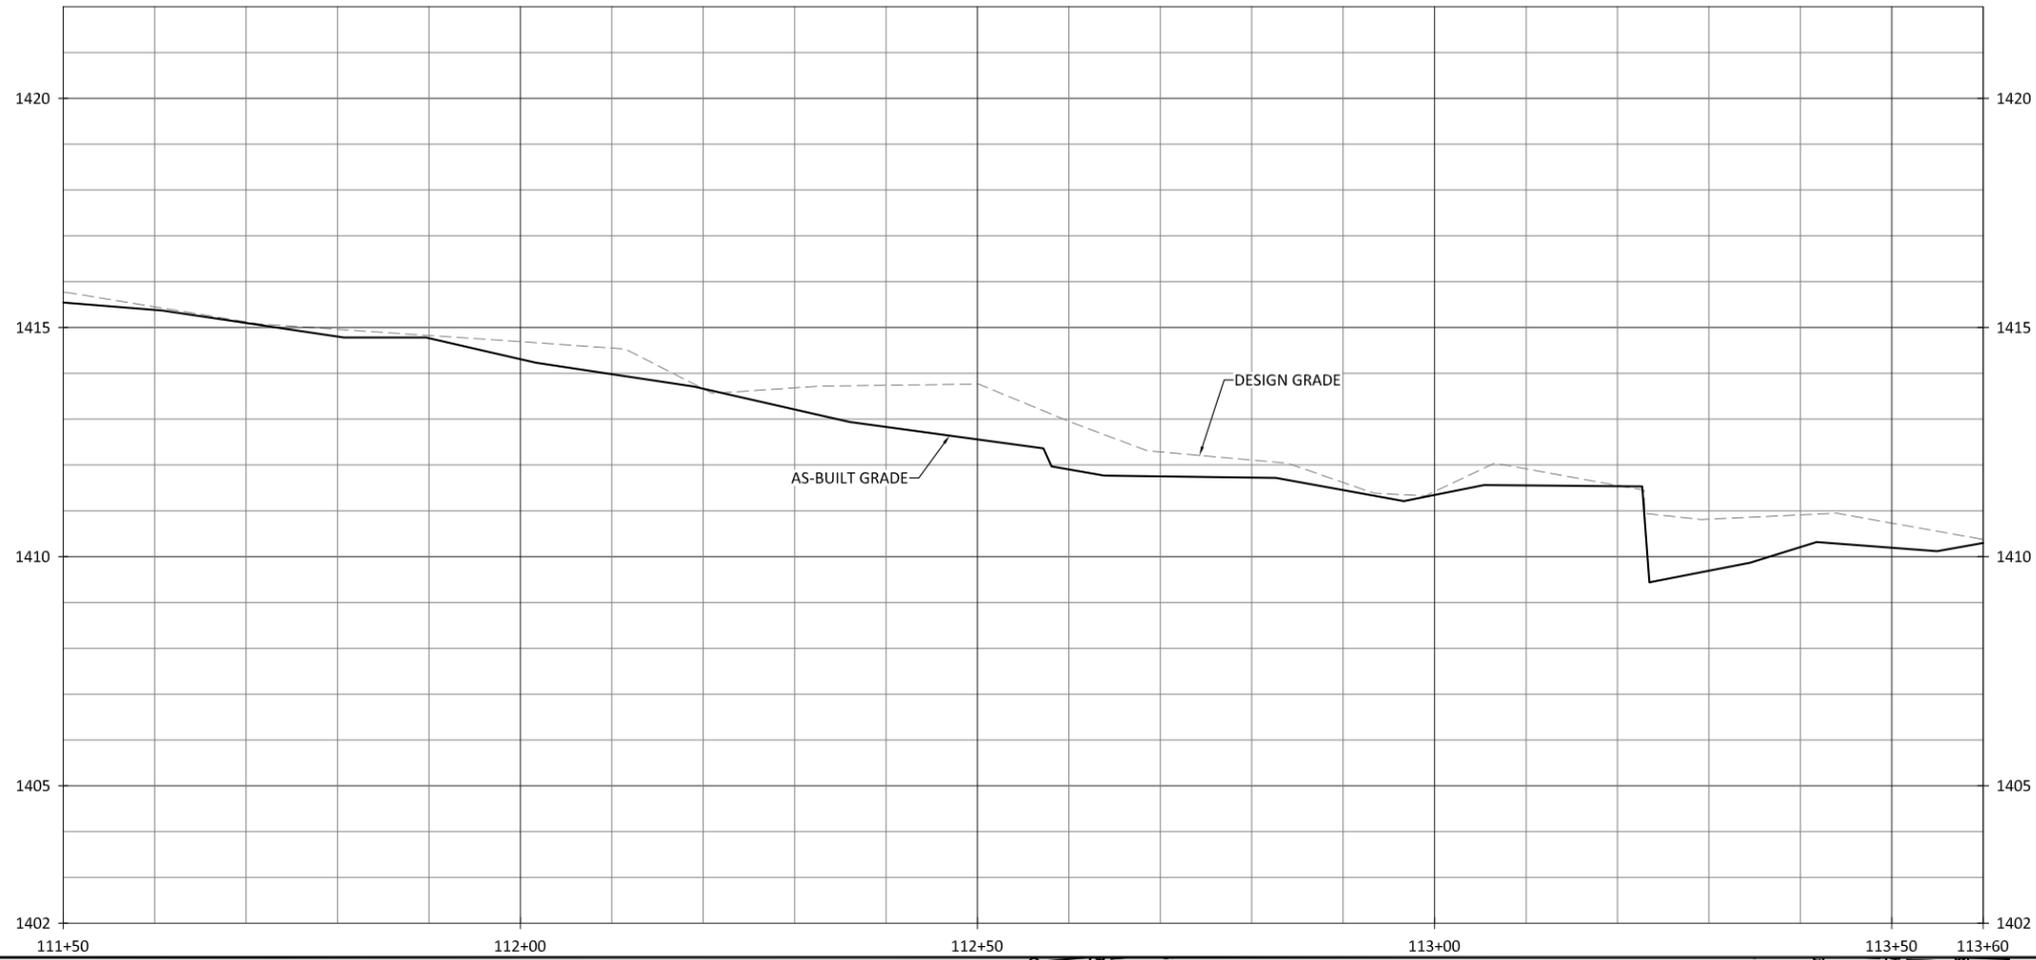
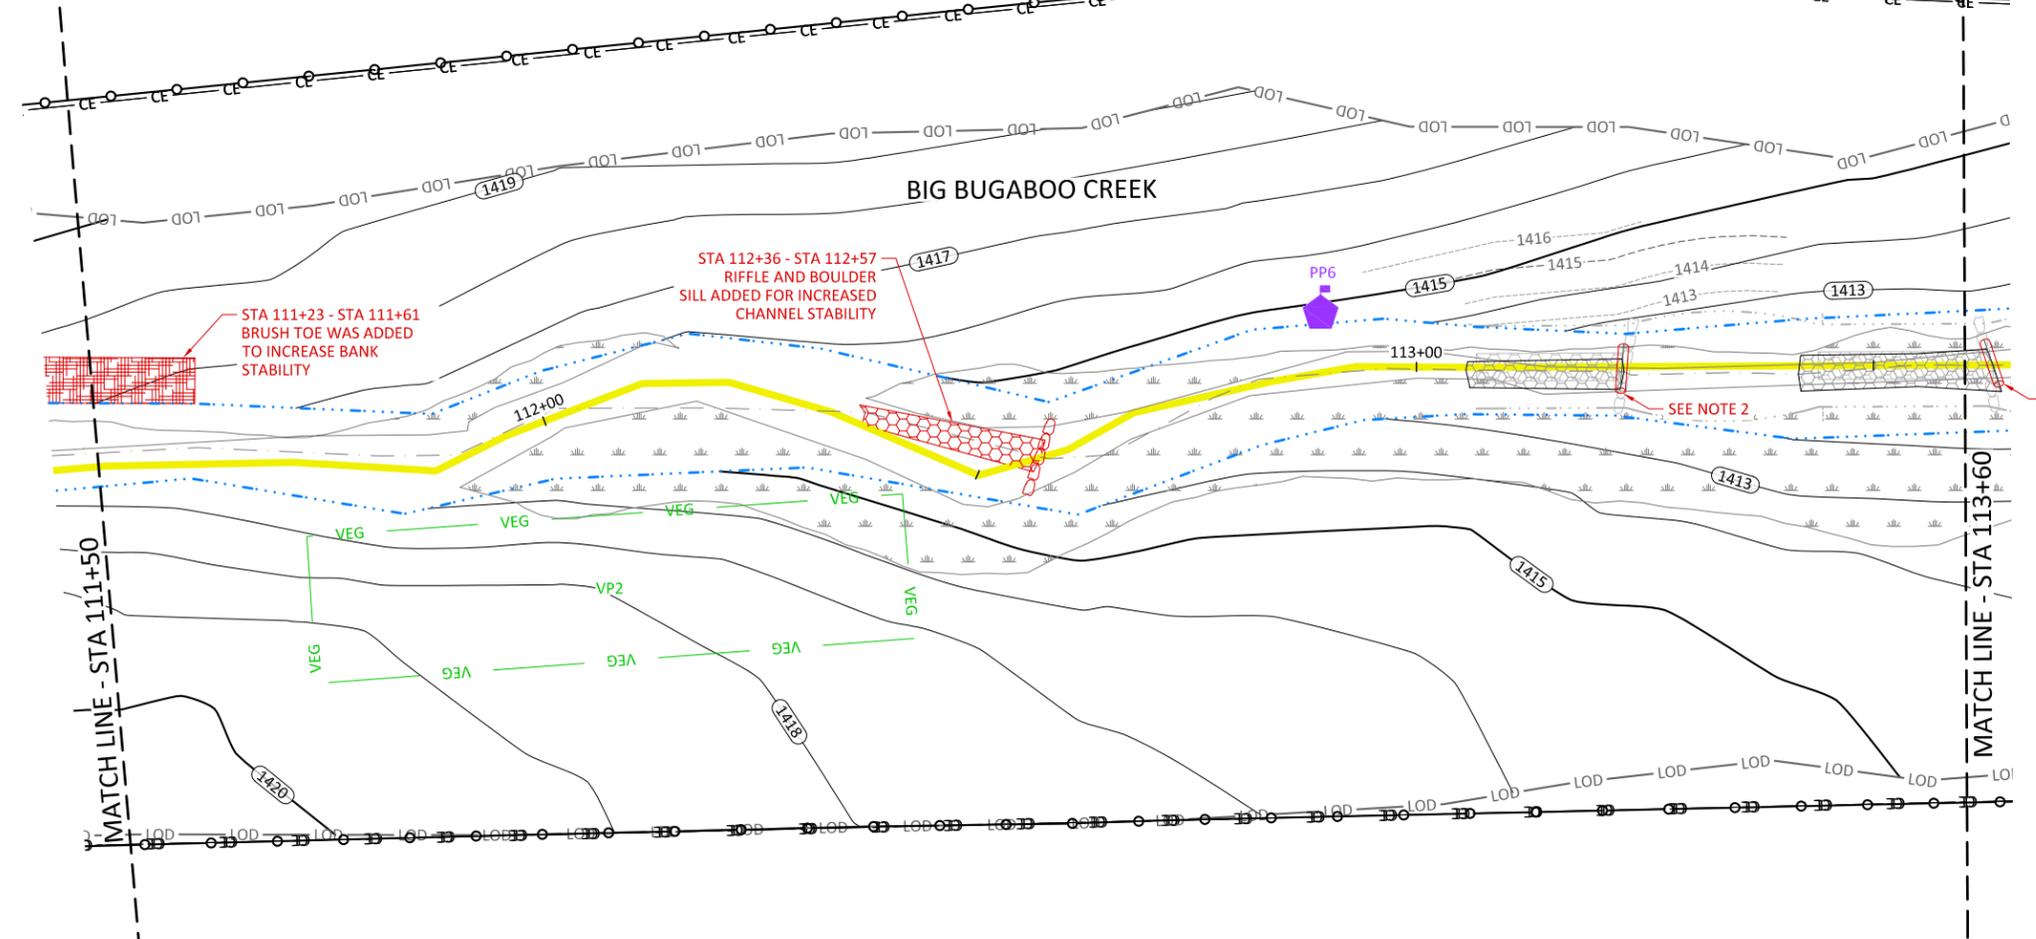
1.05

- NOTES:
1. DEVIATIONS FROM THE DESIGN WILL BE SHOWN IN RED
 2. 113+23 & STA 113+63 BOULDER SILL REPLACED WITH LOG SILL DUE TO NO NATIVE BOULDERS ON SITE

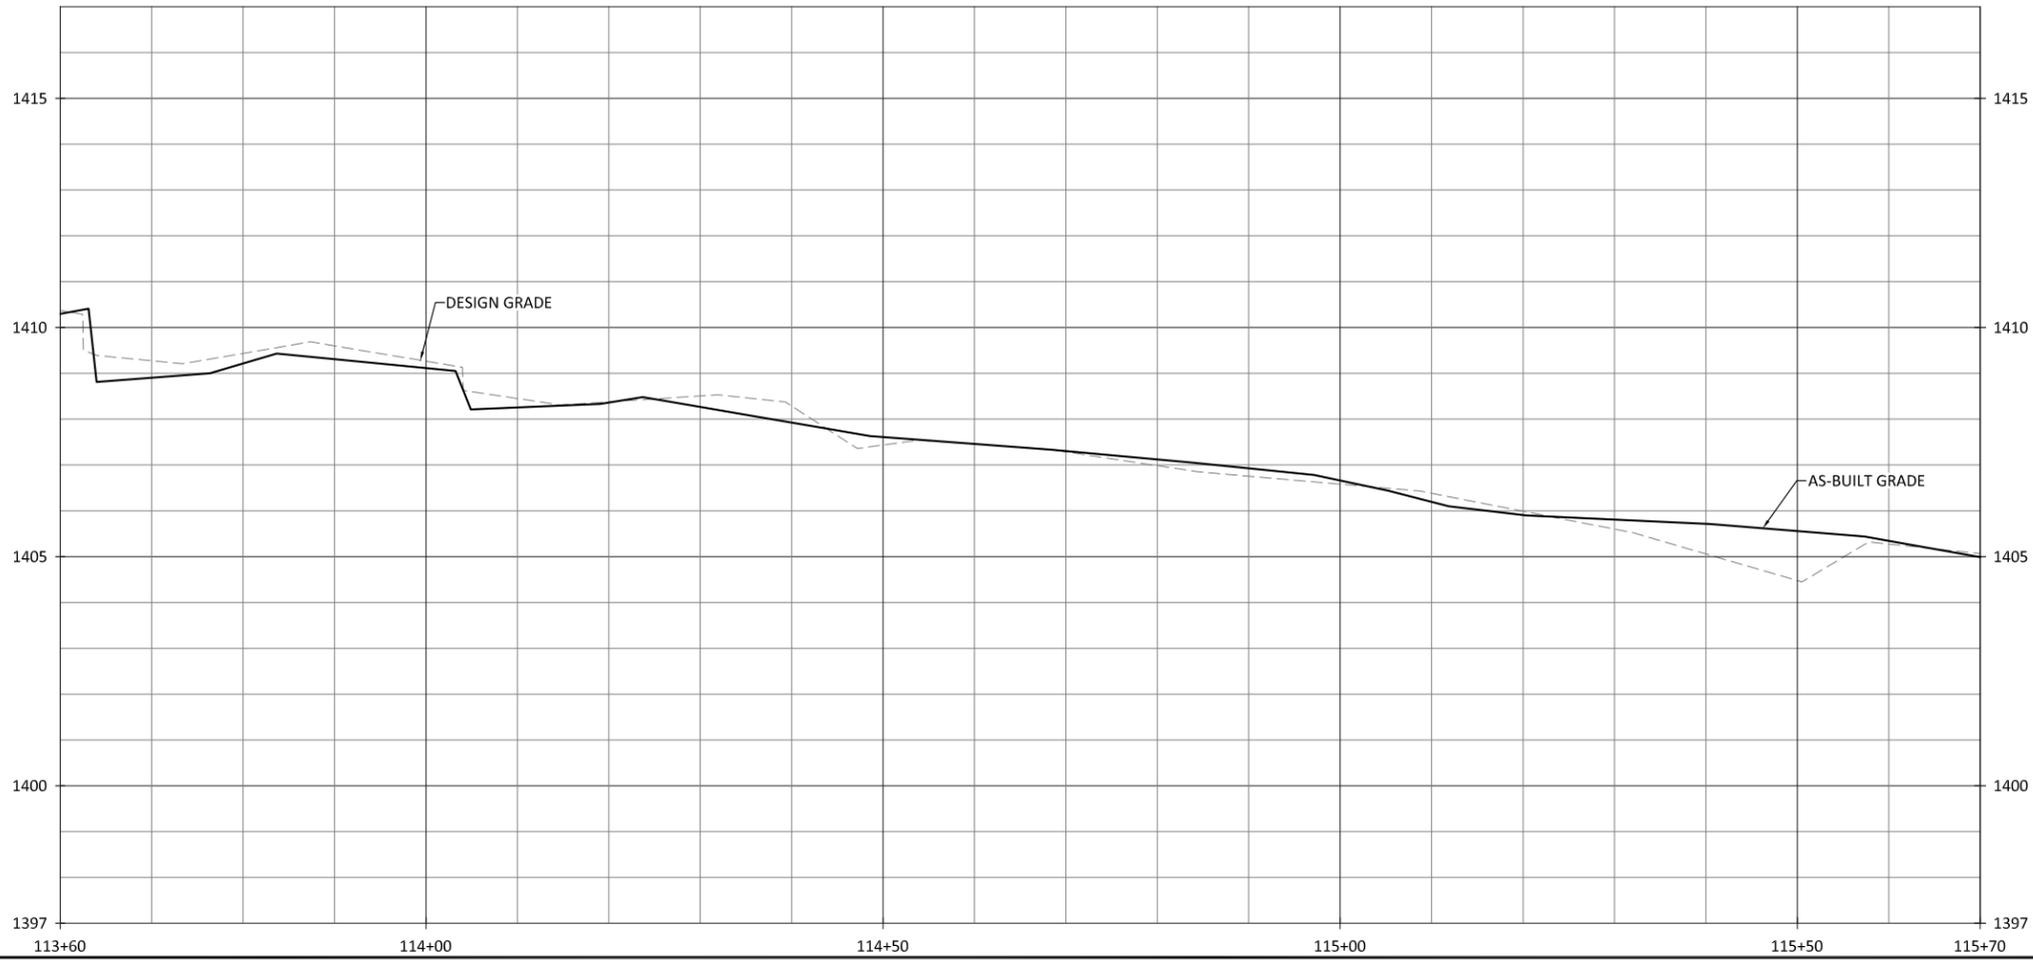
1.06

- NOTES:**
1. DEVIATIONS FROM THE DESIGN WILL BE SHOWN IN RED.
 2. STA 114+24 - STA 114+49 & STA 114+68 - STA 114+84 RIFFLE ADDED FOR INCREASED CHANNEL STABILITY
 3. STA 114+49 - STA 114+66 & STA 114+85 - STA 115+05 BRUSH TOE ADDED FOR INCREASED CHANNEL STABILITY

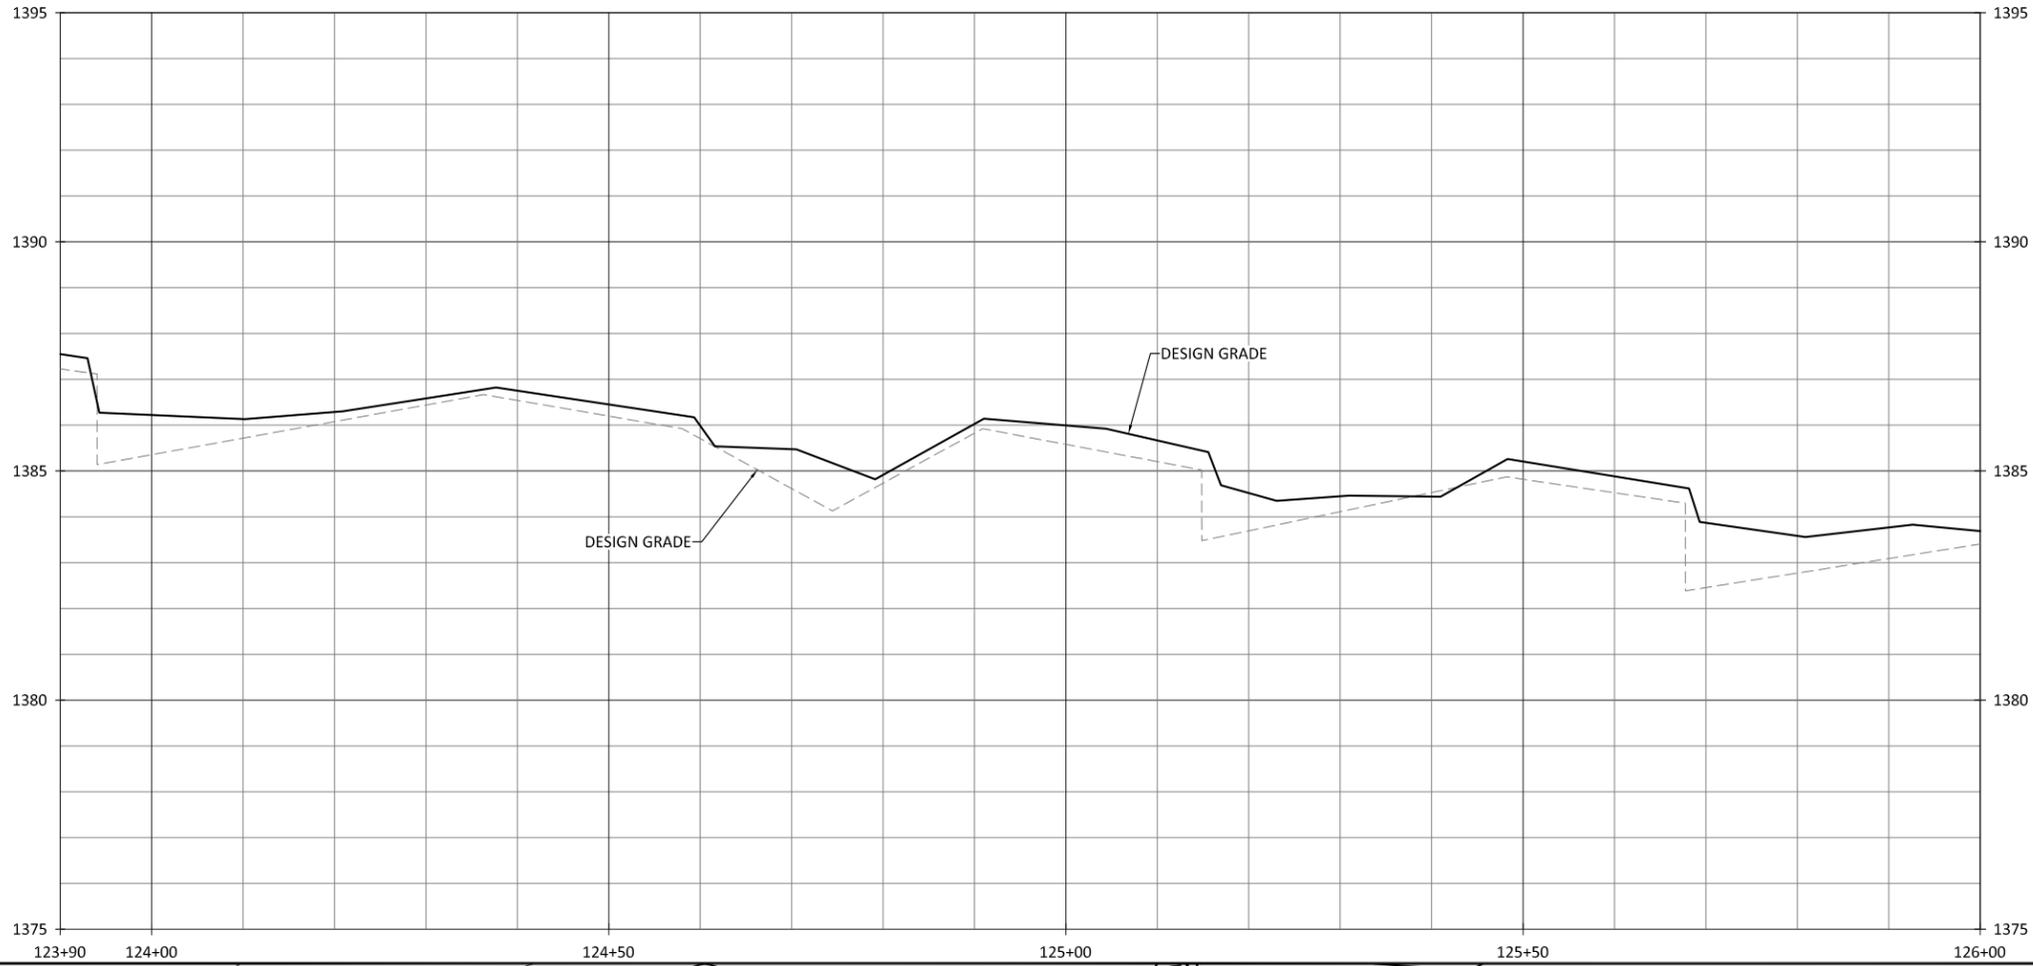
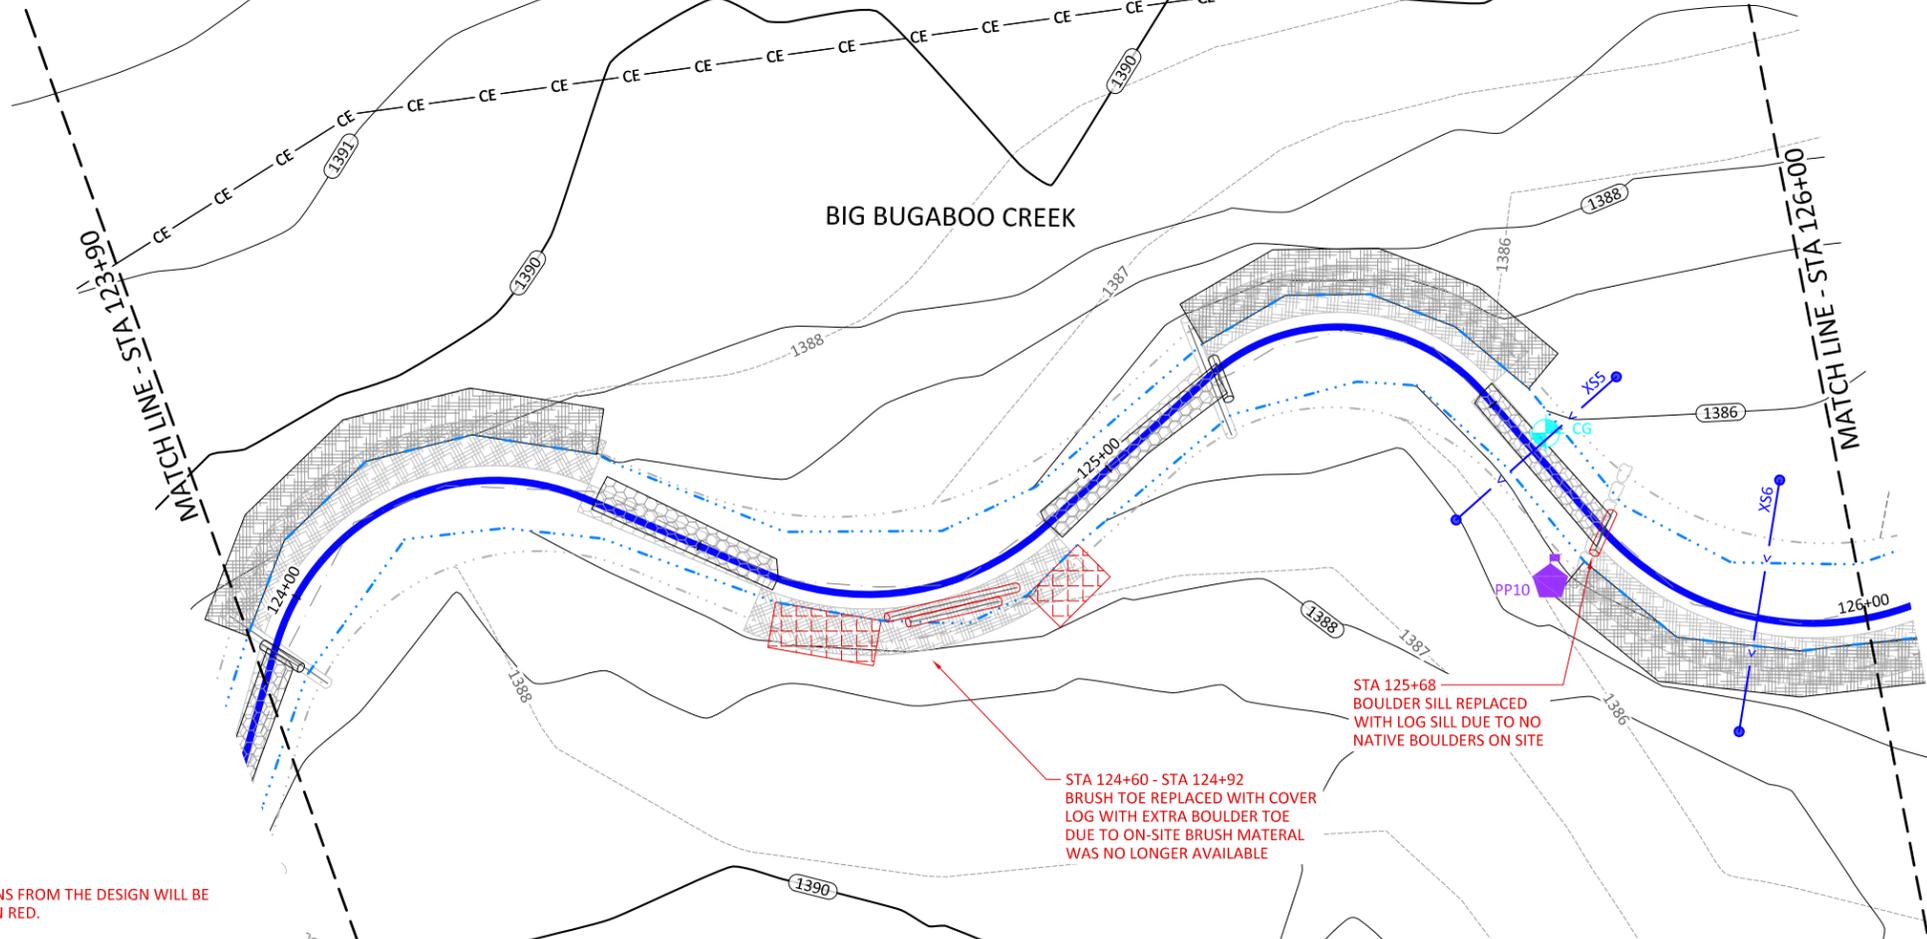
1.11

STA 124+60 - STA 124+92
 BRUSH TOE REPLACED WITH COVER LOG WITH EXTRA BOULDER TOE DUE TO ON-SITE BRUSH MATERIAL WAS NO LONGER AVAILABLE

STA 125+68
 BOULDER SILL REPLACED WITH LOG SILL DUE TO NO NATIVE BOULDERS ON SITE

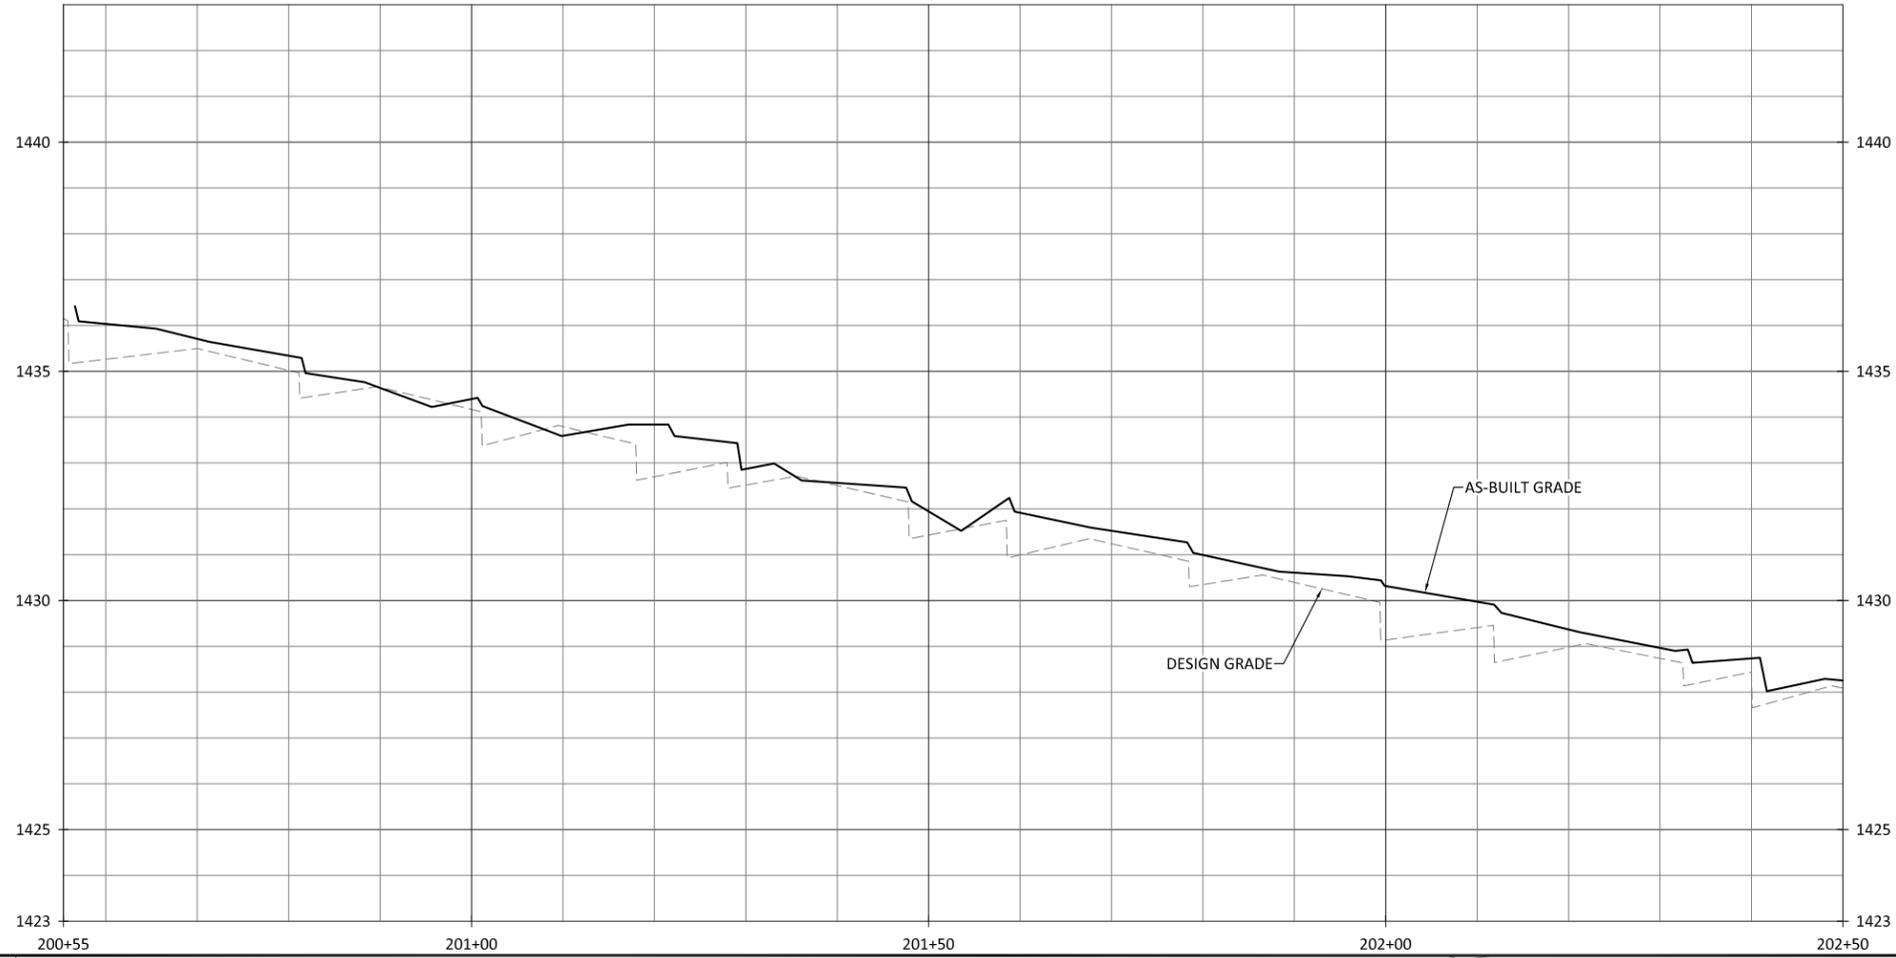
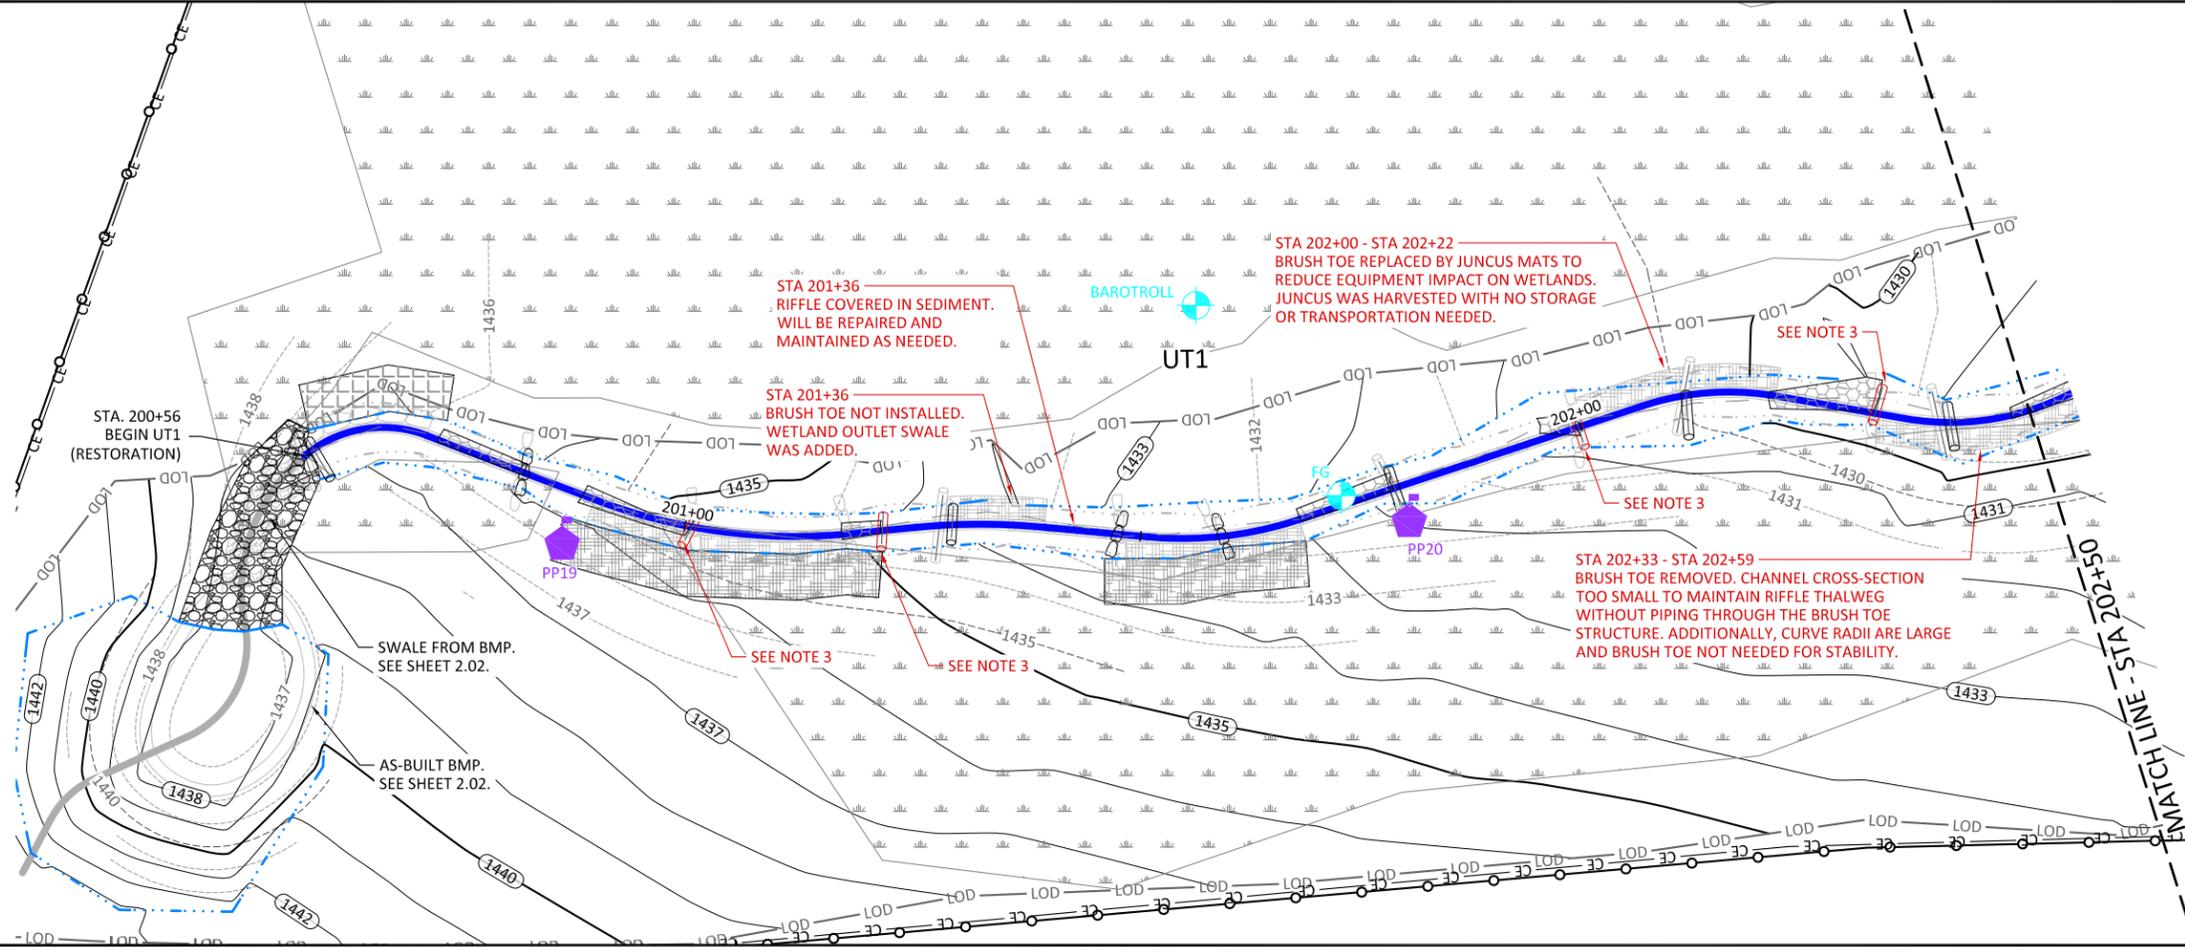
- NOTES:**
1. DEVIATIONS FROM THE DESIGN WILL BE SHOWN IN RED.
 2. AS-BUILT INFORMATION FOR BMP IS ADDRESSED ON SHEET 2.02.
 3. STA 201+01, 201+37, STA 202+00 & STA 202+33: BOULDER SILL REPLACED WITH LOG SILL DUE TO NO NATIVE BOULDERS ON SITE.

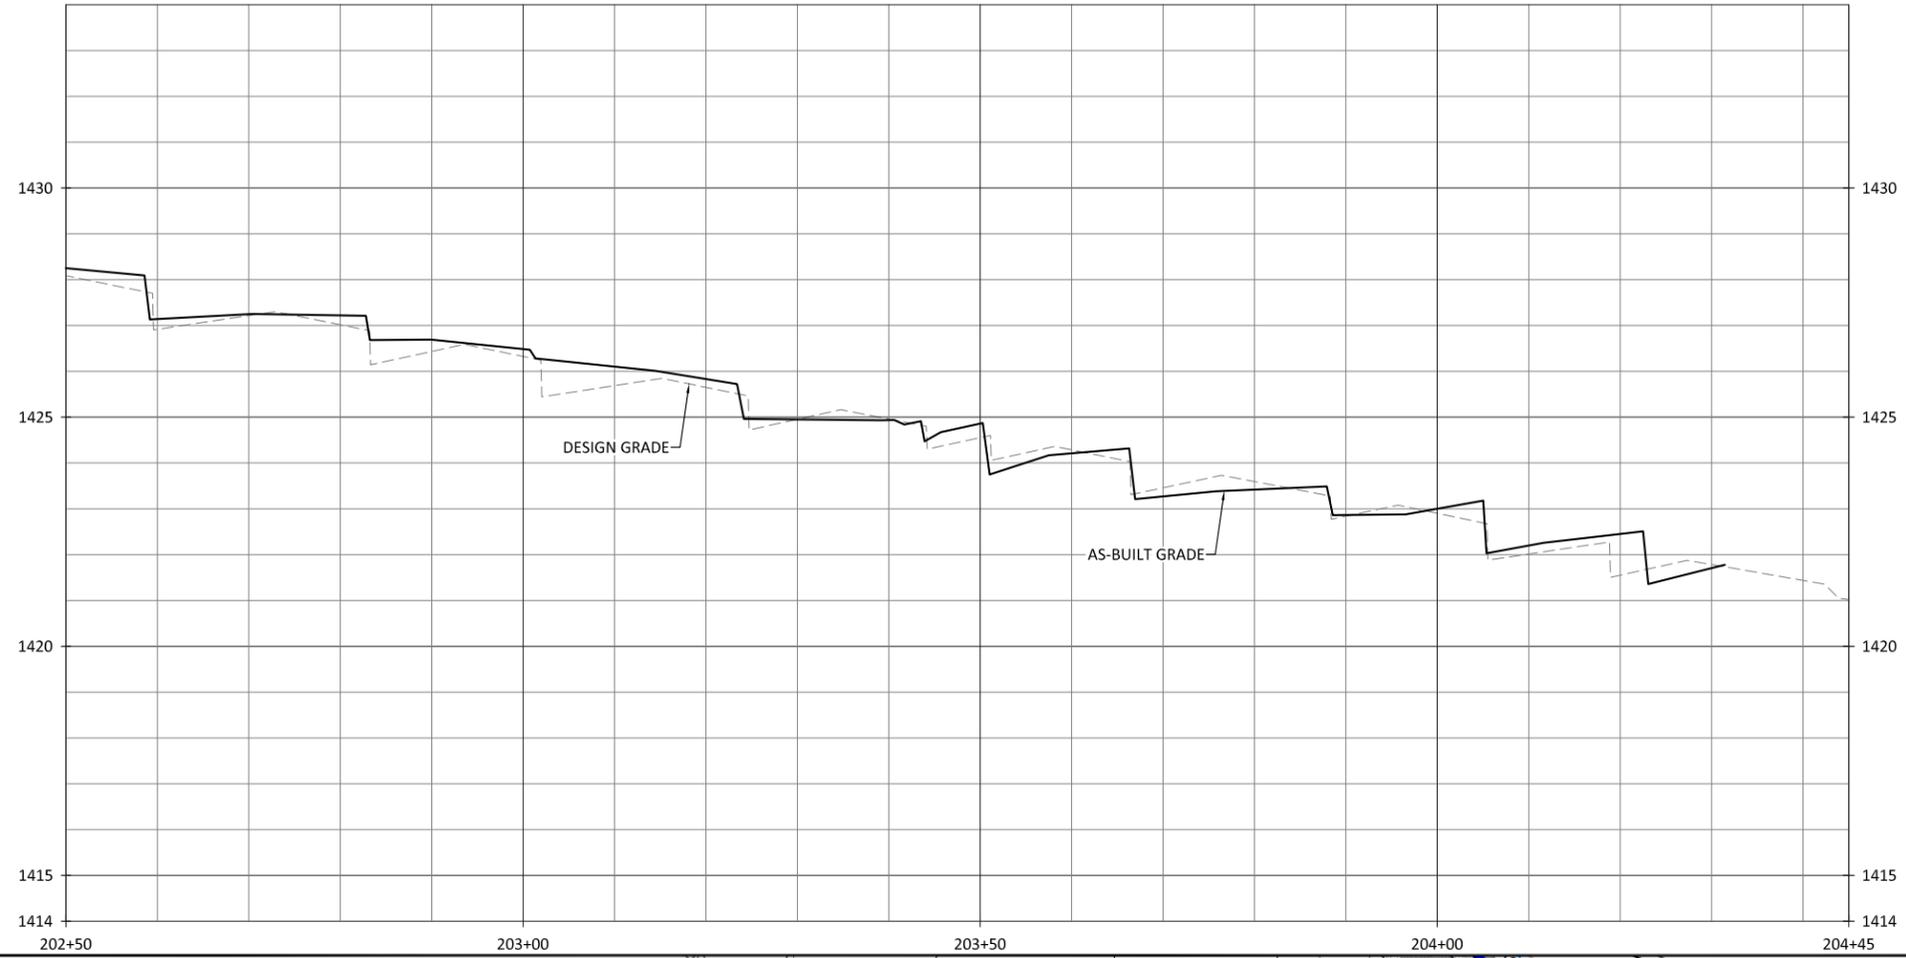
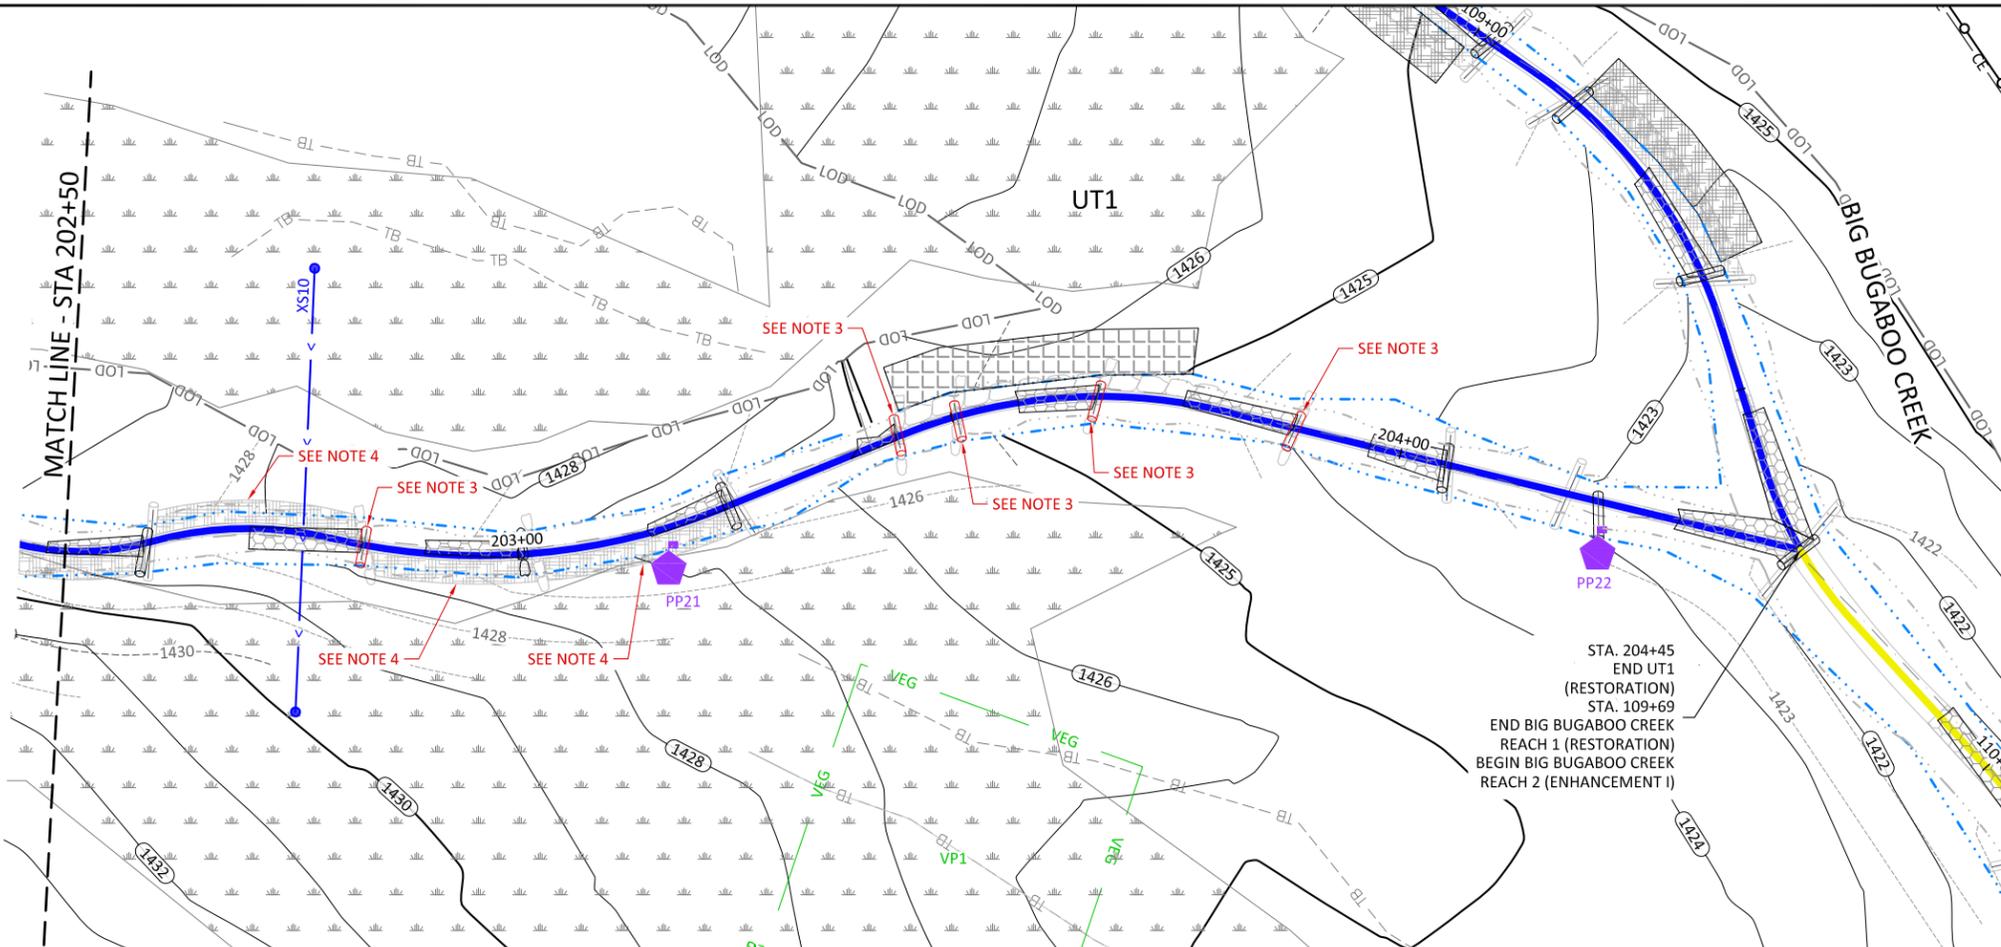
1.21
 Sheet

Sheet 1.21: Note indicates riffle at 201+36 is covered in sediment and will be repaired or maintained as needed. Please add call out to CCPV and provide update in MY1 report.

- NOTES:
1. DEVIATIONS FROM THE DESIGN WILL BE SHOWN IN RED.
 2. AS-BUILT INFORMATION FOR BIG BUGABOO CREEK IS ADDRESSED ON SHEETS 1.01 THROUGH 1.20.
 3. STA 202+83, STA 203+44, STA 203+50, STA 203+66 & STA 203+88 BOULDER SILL REPLACED WITH LOG SILL DUE TO NO NATIVE BOULDERS ON SITE.
 4. STA 202+33 - STA 202+59, STA 202+60 - STA 202+83 & STA 202+83 - STA 203+24 BRUSH TOE REMOVED. CHANNEL CROSS-SECTION TOO SMALL TO MAINTAIN RIFFLE THALWEG WITHOUT PIPING THROUGH THE BRUSH TOE STRUCTURE. ADDITIONALLY, CURVE RADII ARE LARGE AND BRUSH TOE NOT NEEDED FOR STABILITY.
