**MONITORING YEAR 0
ANNUAL REPORT
FINAL**

BUG HEADWATERS MITIGATION SITE

Wilkes County, NC
Yadkin River Basin
HUC 03040101

DMS Project No. 100084
NCDEQ Contract No. 7617
DMS RFP No. 16-007406
USACE Action ID No. 2018-01788
DWR Project No. 2018-1273
Data Collection Dates: April 2021

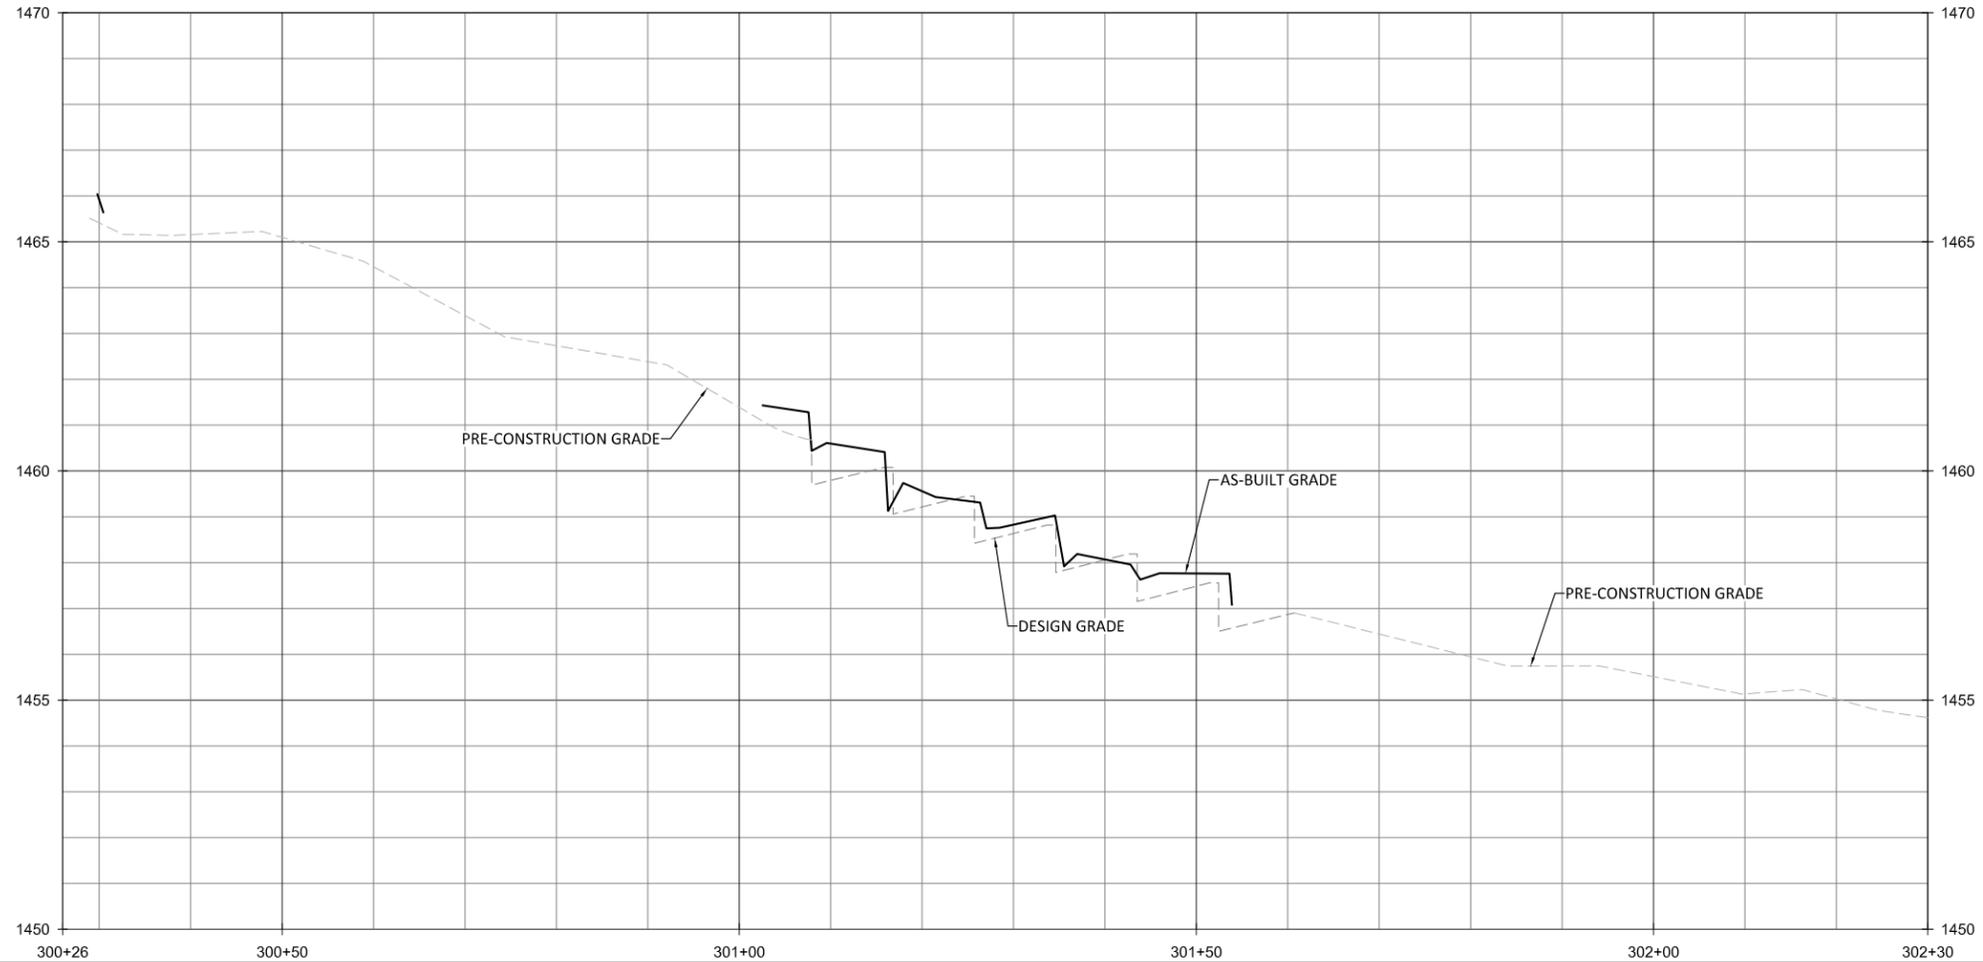
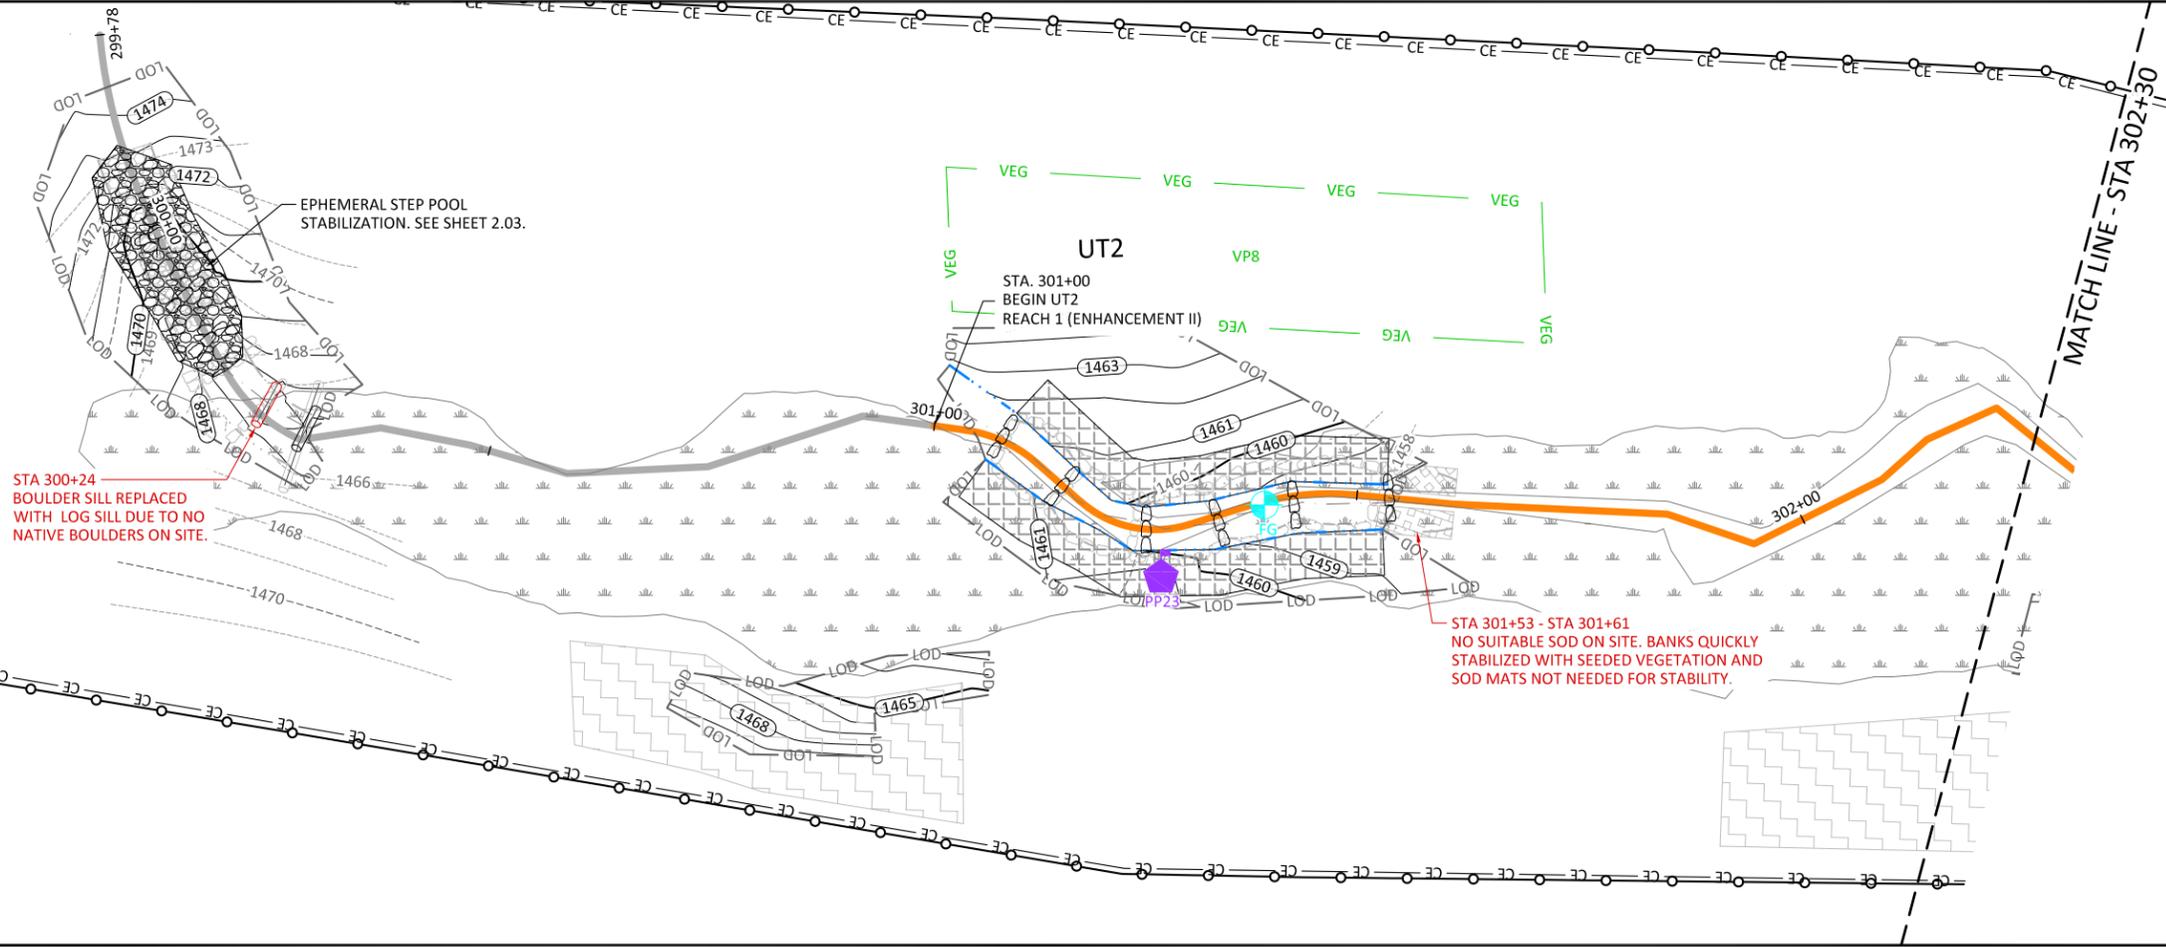
STA 300+24
 BOULDER SILL REPLACED
 WITH LOG SILL DUE TO NO
 NATIVE BOULDERS ON SITE.

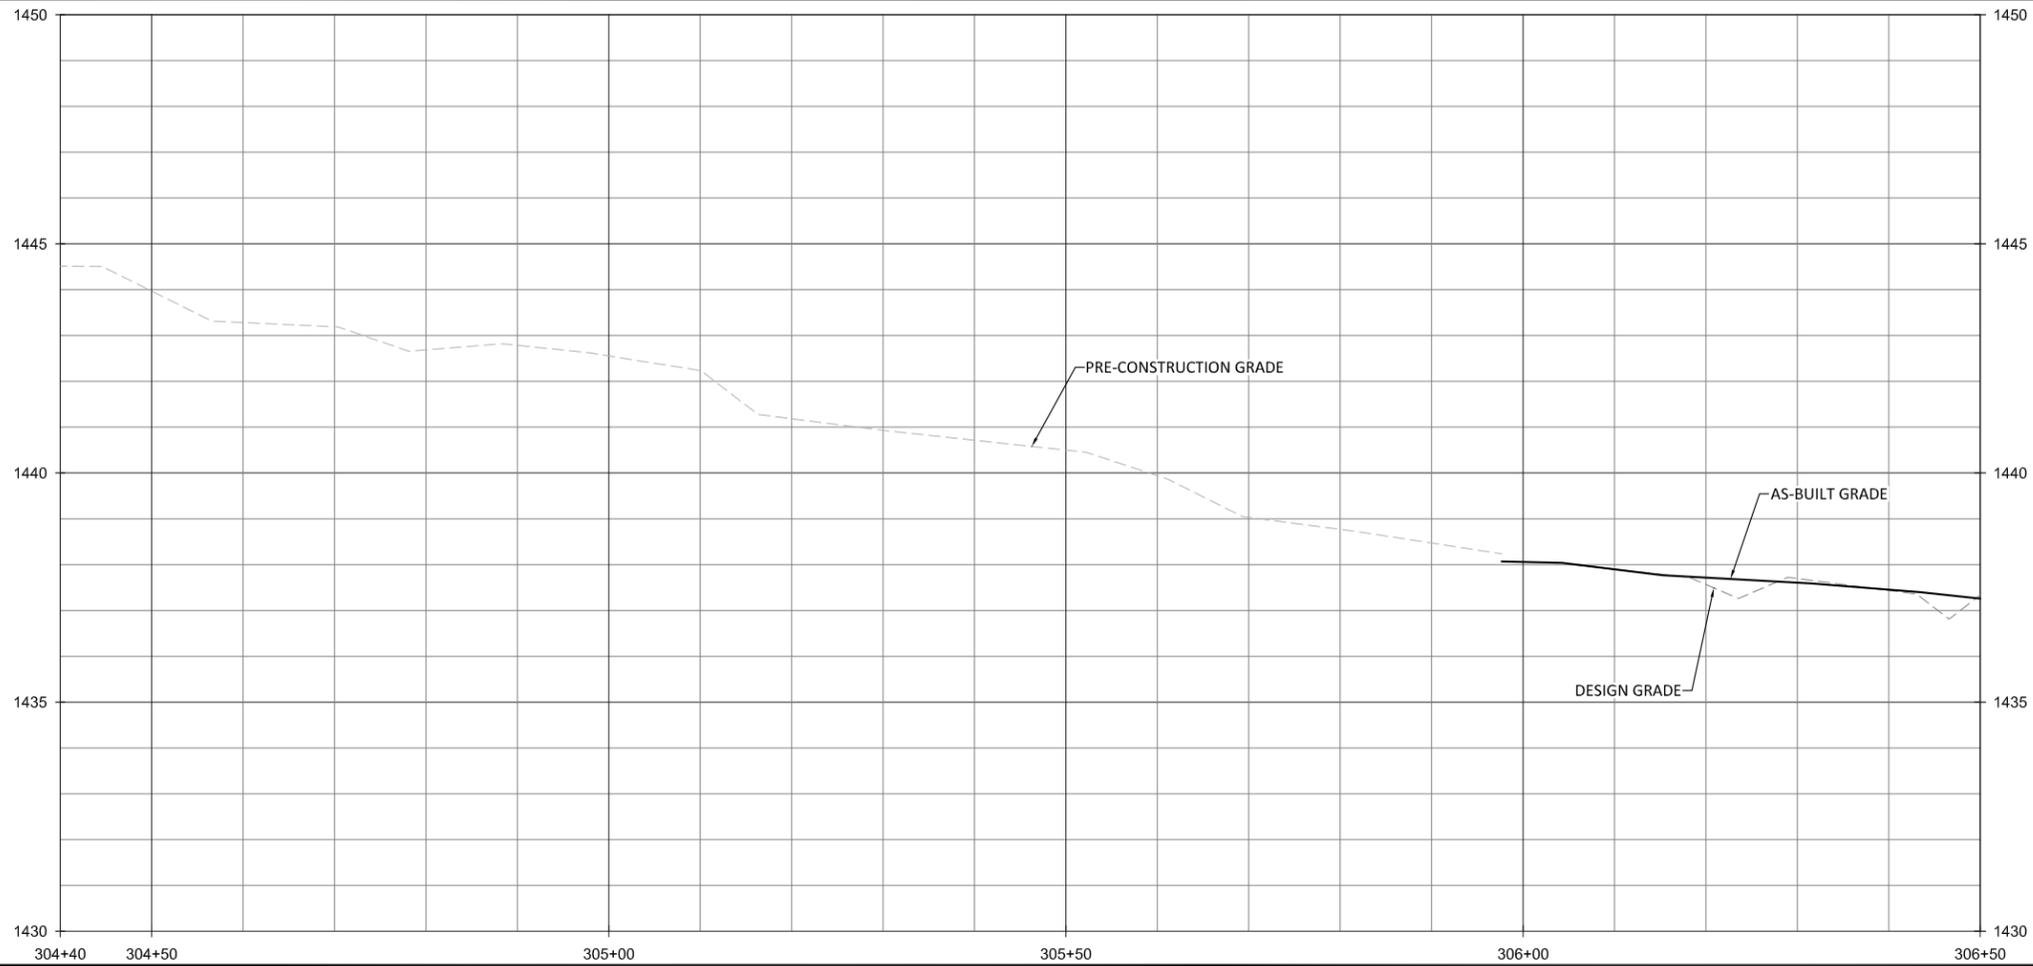
1.24

- NOTES:
1. DEVIATIONS FROM THE DESIGN WILL BE SHOWN IN RED.
 2. STA 306+18 - STA 306+29 & STA 306+43 - STA 306+50 NO SUITABLE SOD ON SITE. BANKS QUICKLY STABILIZED WITH SEEDING VEGETATION AND SOD MATS NOT NEEDED FOR STABILITY.

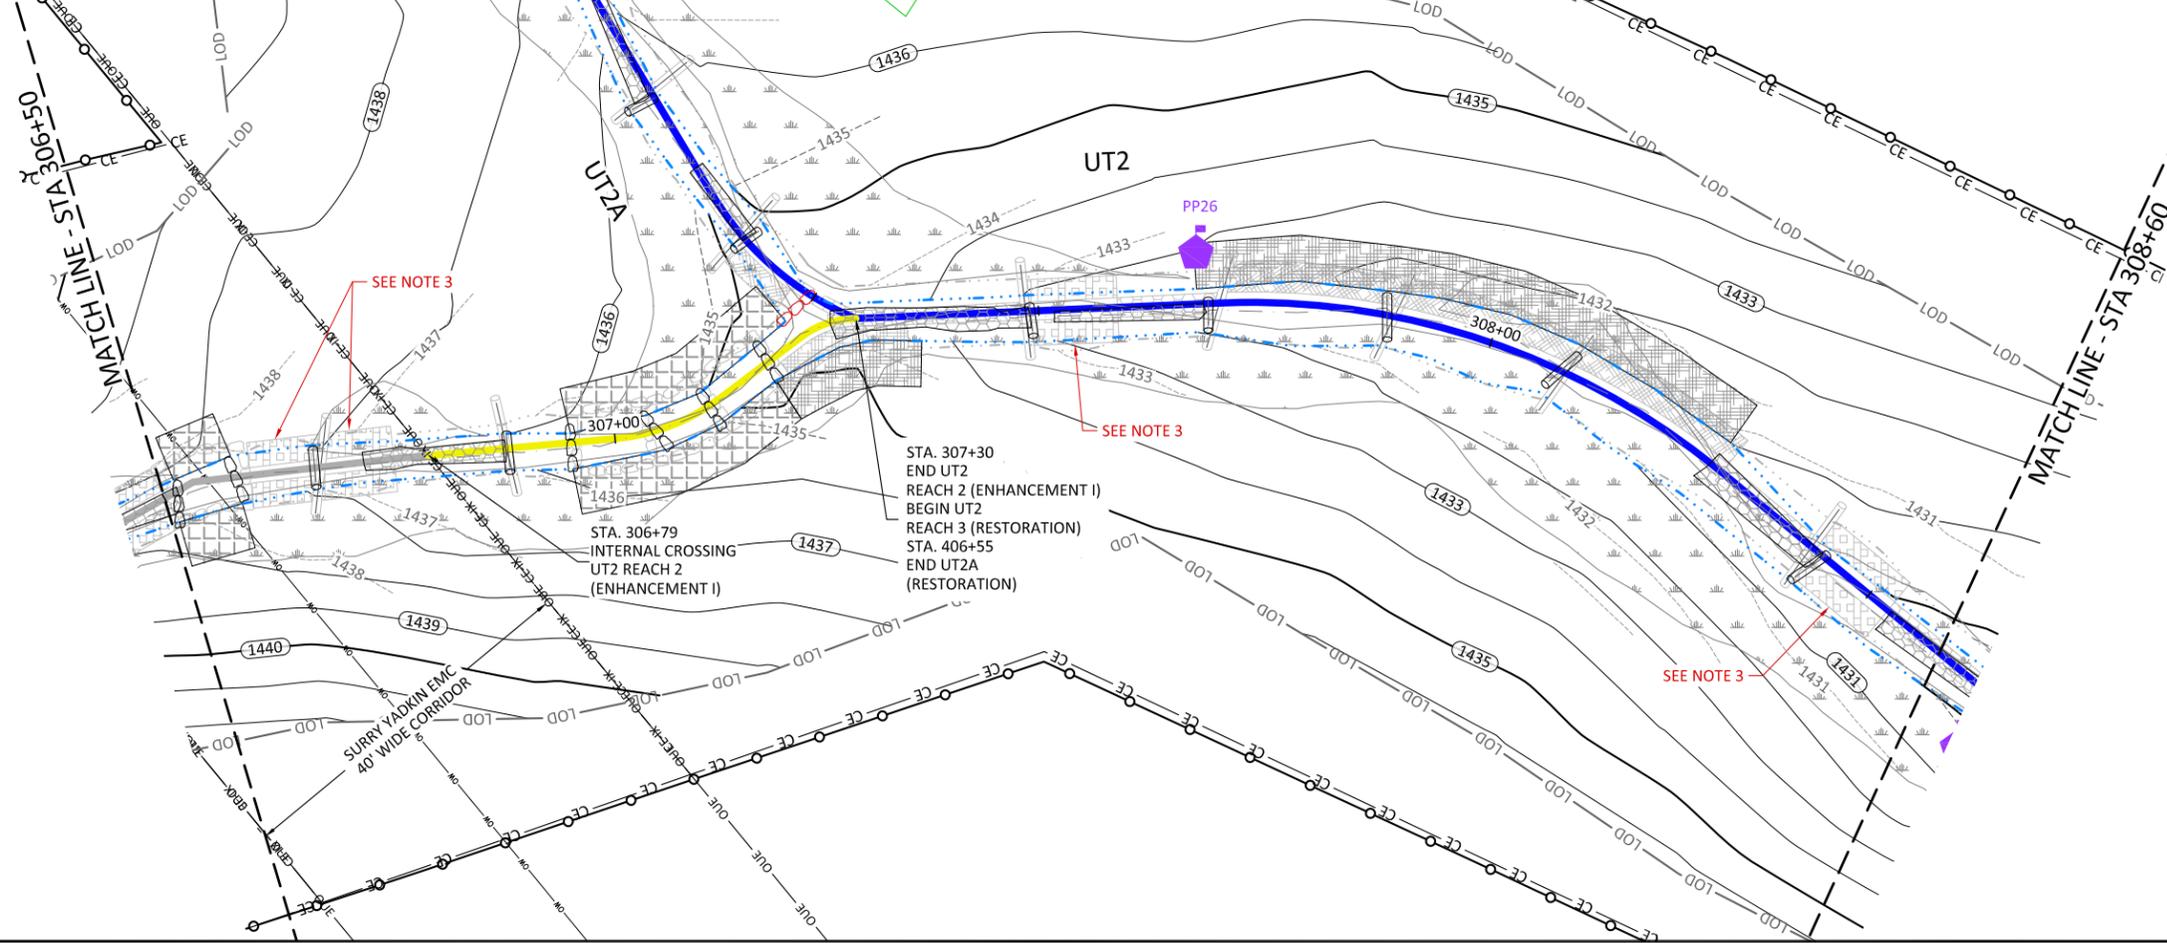
1.25
Sheet

- NOTES:
1. DEVIATIONS FROM THE DESIGN WILL BE SHOWN IN RED.
 2. AS-BUILT INFORMATION FOR UT2A IS ADDRESSED ON SHEETS 1.34 THROUGH 1.36.
 3. STA 306+60 - STA 306+68, STA 306+68 - STA 306+76, STA 307+49 - STA 307+59 & STA 308+42 - STA 308+53 NO SUITABLE SOD ON SITE. BANKS QUICKLY STABILIZED WITH SEEDING VEGETATION AND SOD MATS NOT NEEDED FOR STABILITY.

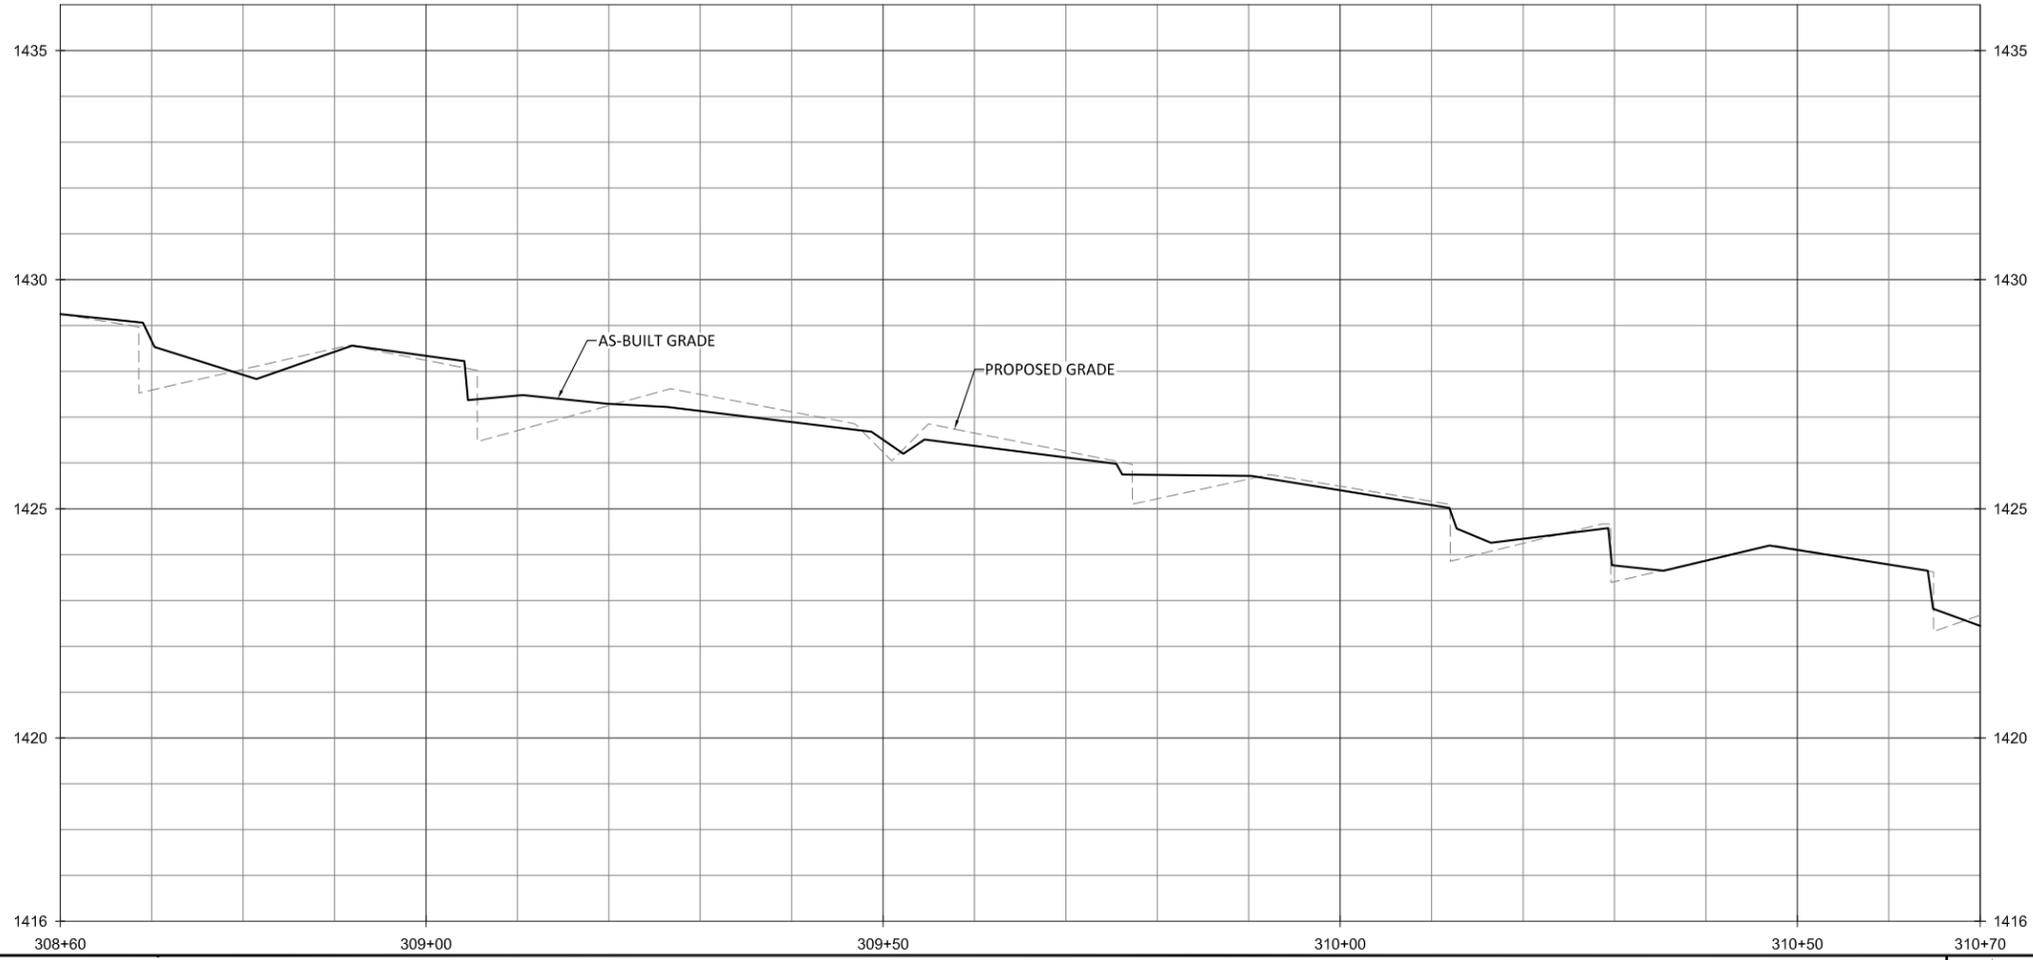
1.26

- NOTES:
1. DEVIATIONS FROM THE DESIGN WILL BE SHOWN IN RED.
 2. STA 309+47 - STA 309+55 & STA 309+77 - STA 309+92
NO SUITABLE SOD ON SITE. BANKS QUICKLY STABILIZED WITH SEEDED VEGETATION AND SOD MATS NOT NEEDED FOR STABILITY.

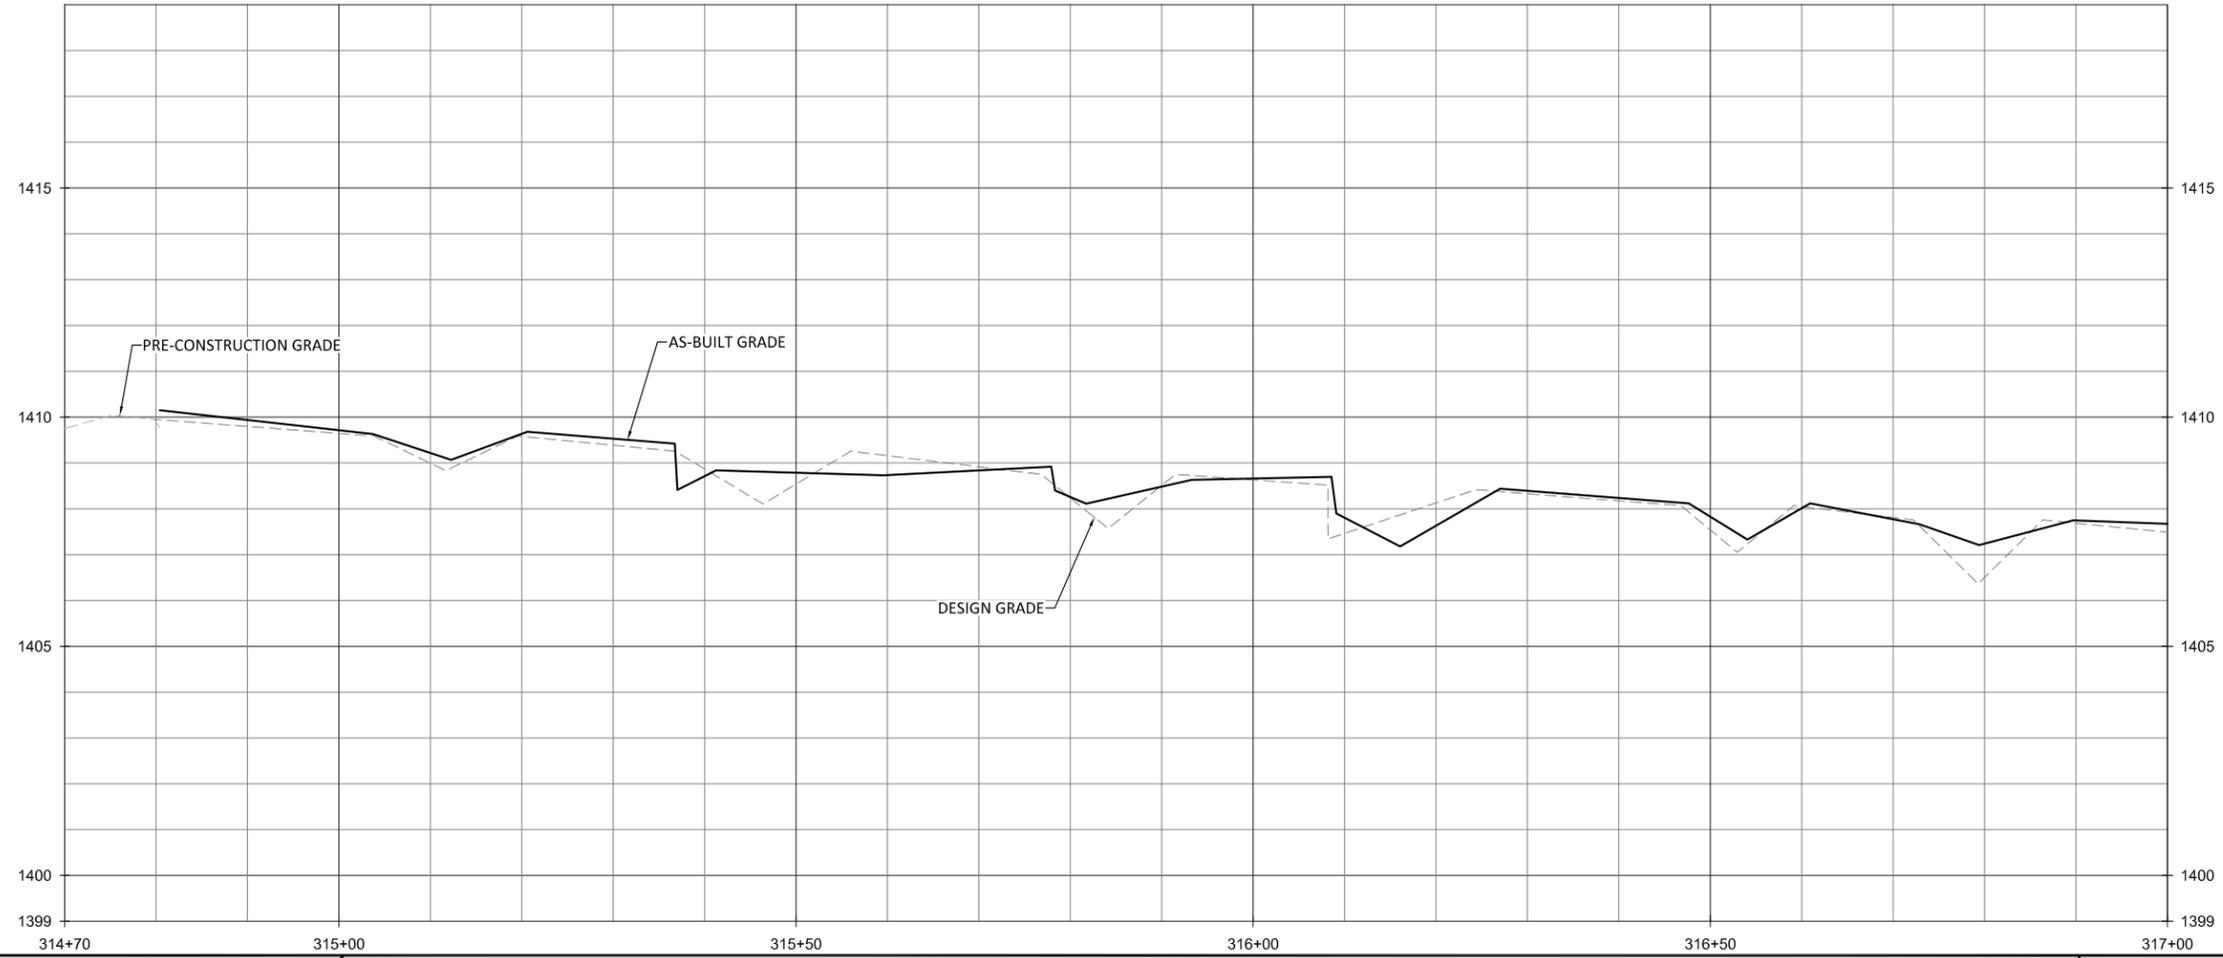
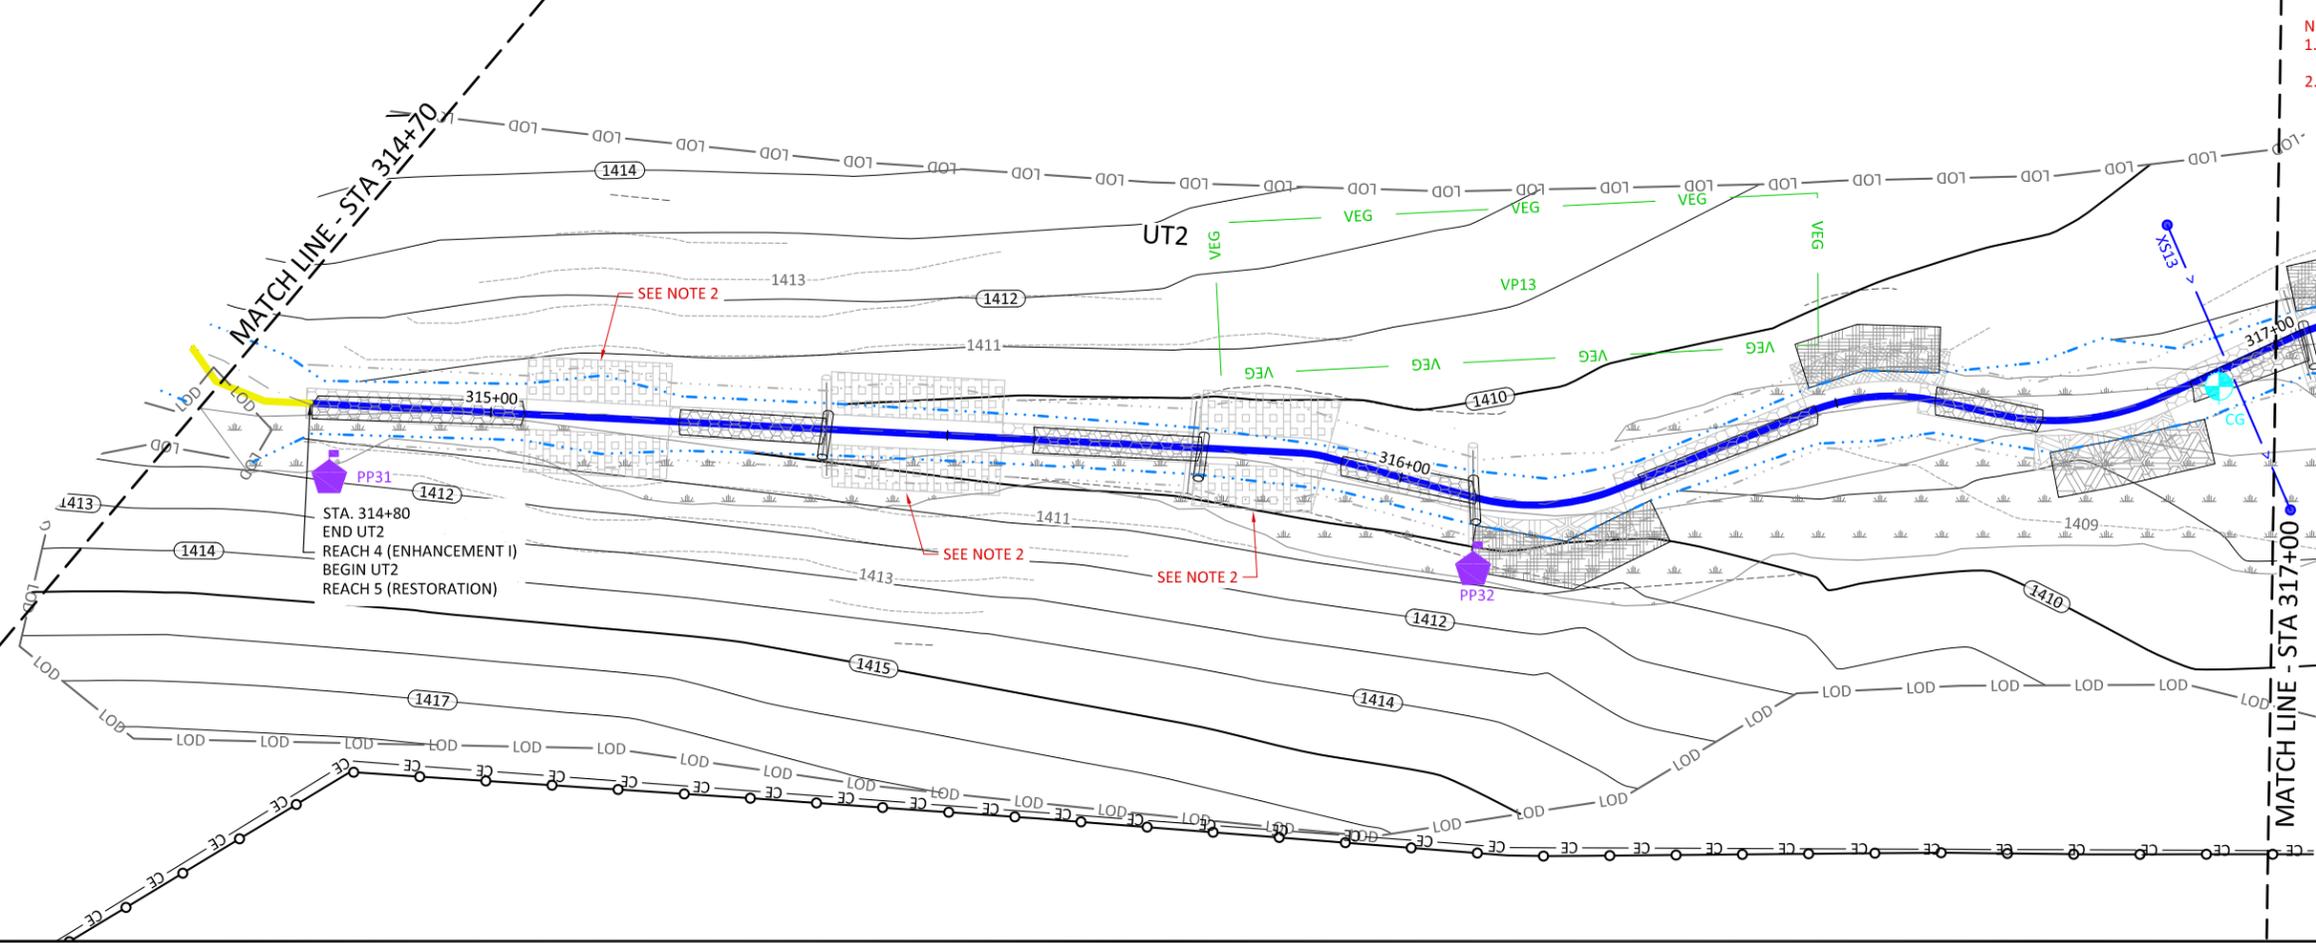
- NOTES:
1. DEVIATIONS FROM THE DESIGN WILL BE SHOWN IN RED.
 2. STA 315+04 - STA 315+20, STA 315+37 - STA 315+56 & STA 315+77 - STA 315+92
NO SUITABLE SOD ON SITE. BANKS QUICKLY STABILIZED WITH SEEDING VEGETATION AND SOD MATS NOT NEEDED FOR STABILITY.

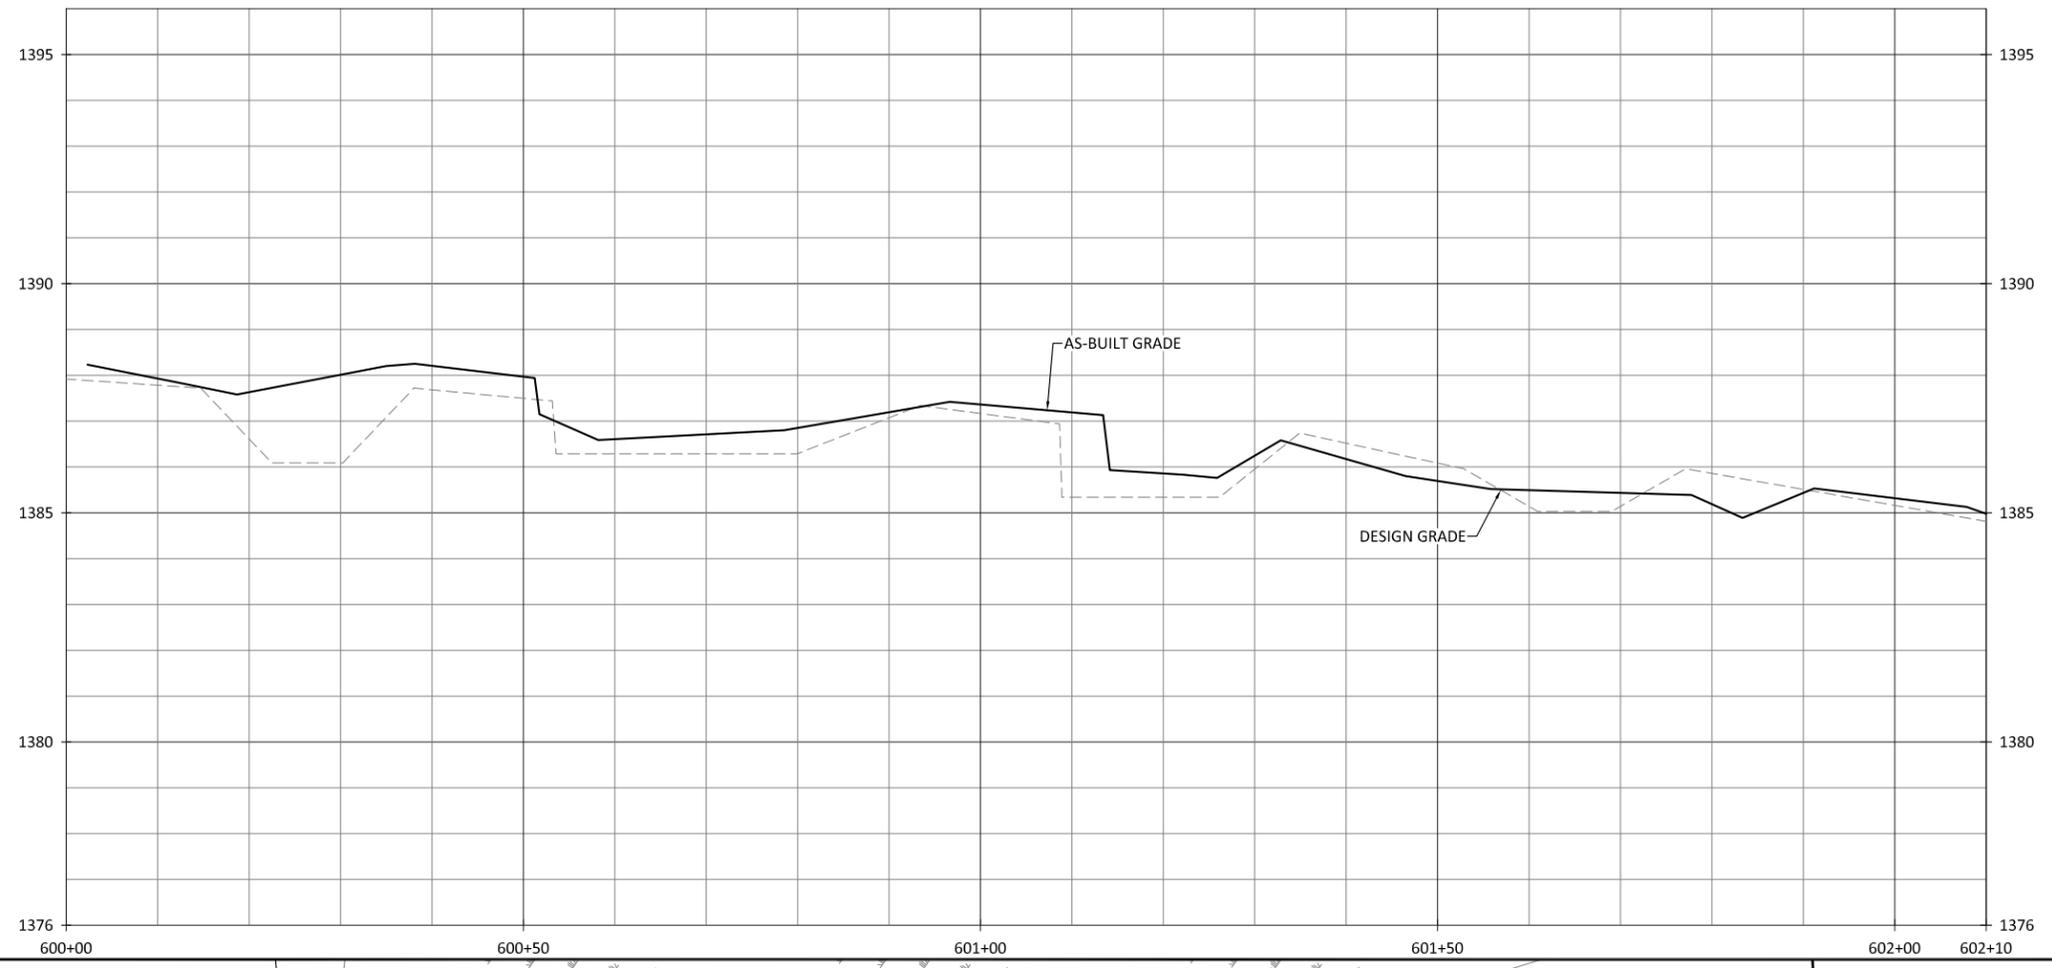
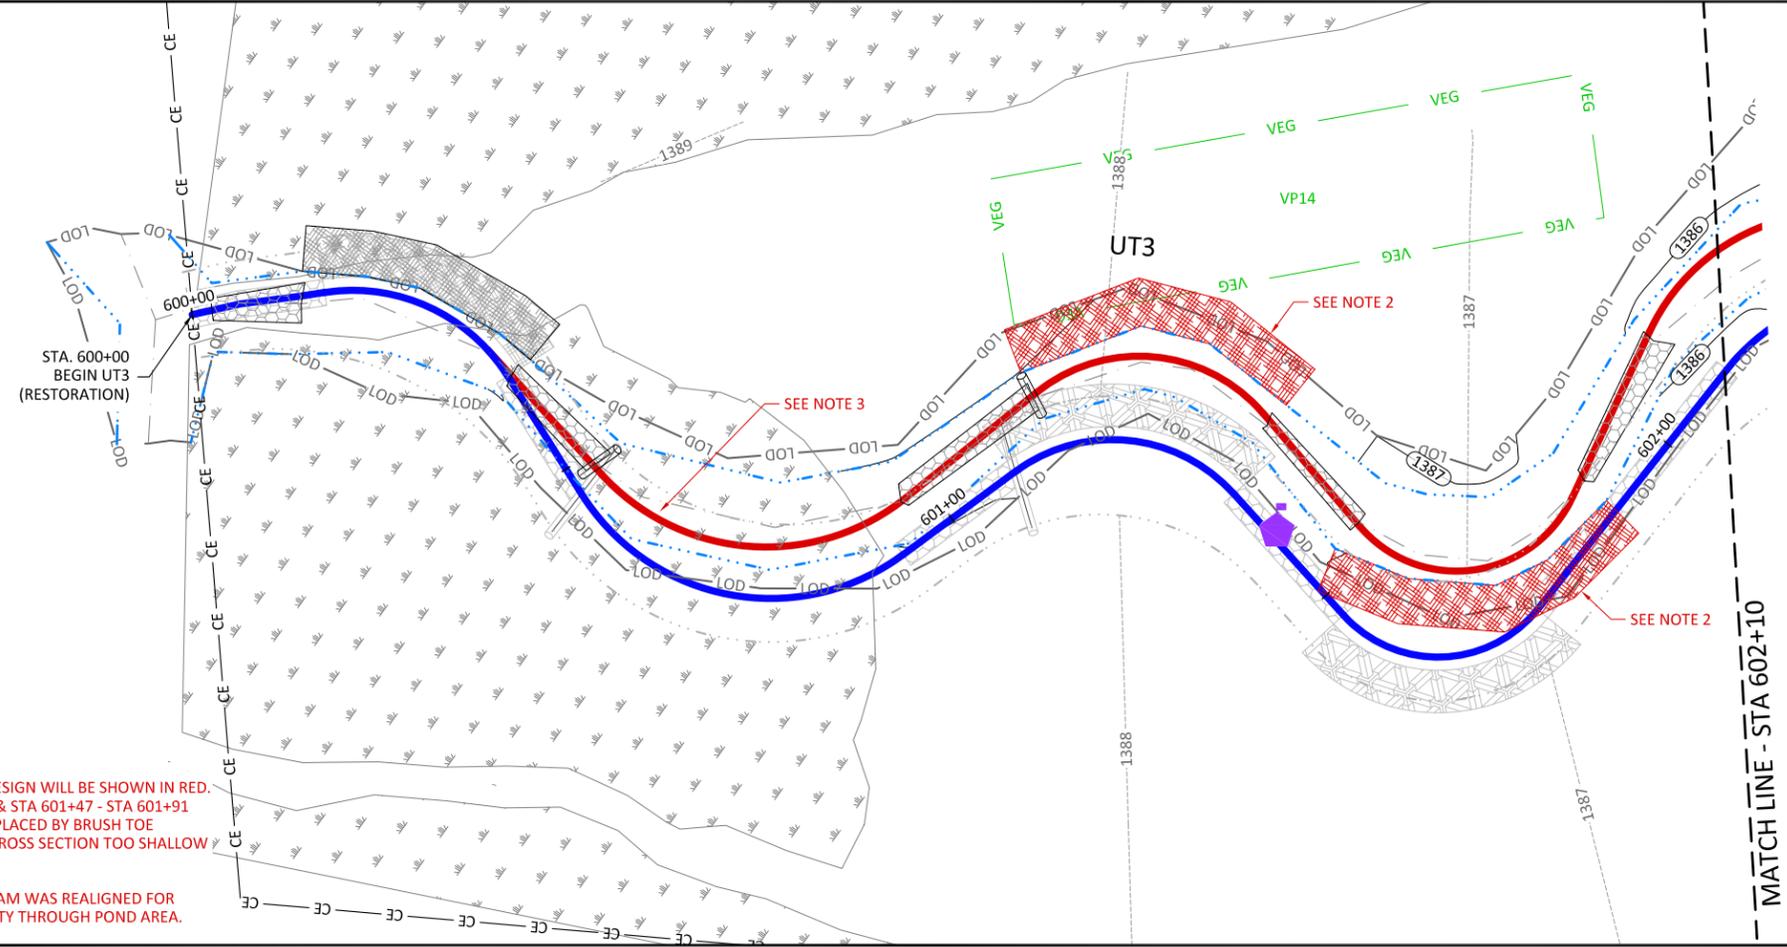
- NOTES:**
1. DEVIATIONS FROM THE DESIGN WILL BE SHOWN IN RED.
 2. STA 601+13 - STA 601+33 & STA 601+47 - STA 601+91 VEGETATED SOIL LIFTS REPLACED BY BRUSH TOE REVETMENT. PROPOSED CROSS SECTION TOO SHALLOW FOR MULTIPLE SOIL LIFTS.
 3. STA 600+34 - STA 602+60
231 LINEAR FEET OF STREAM WAS REALIGNED FOR BETTER CONSTRUCTABILITY THROUGH POND AREA.

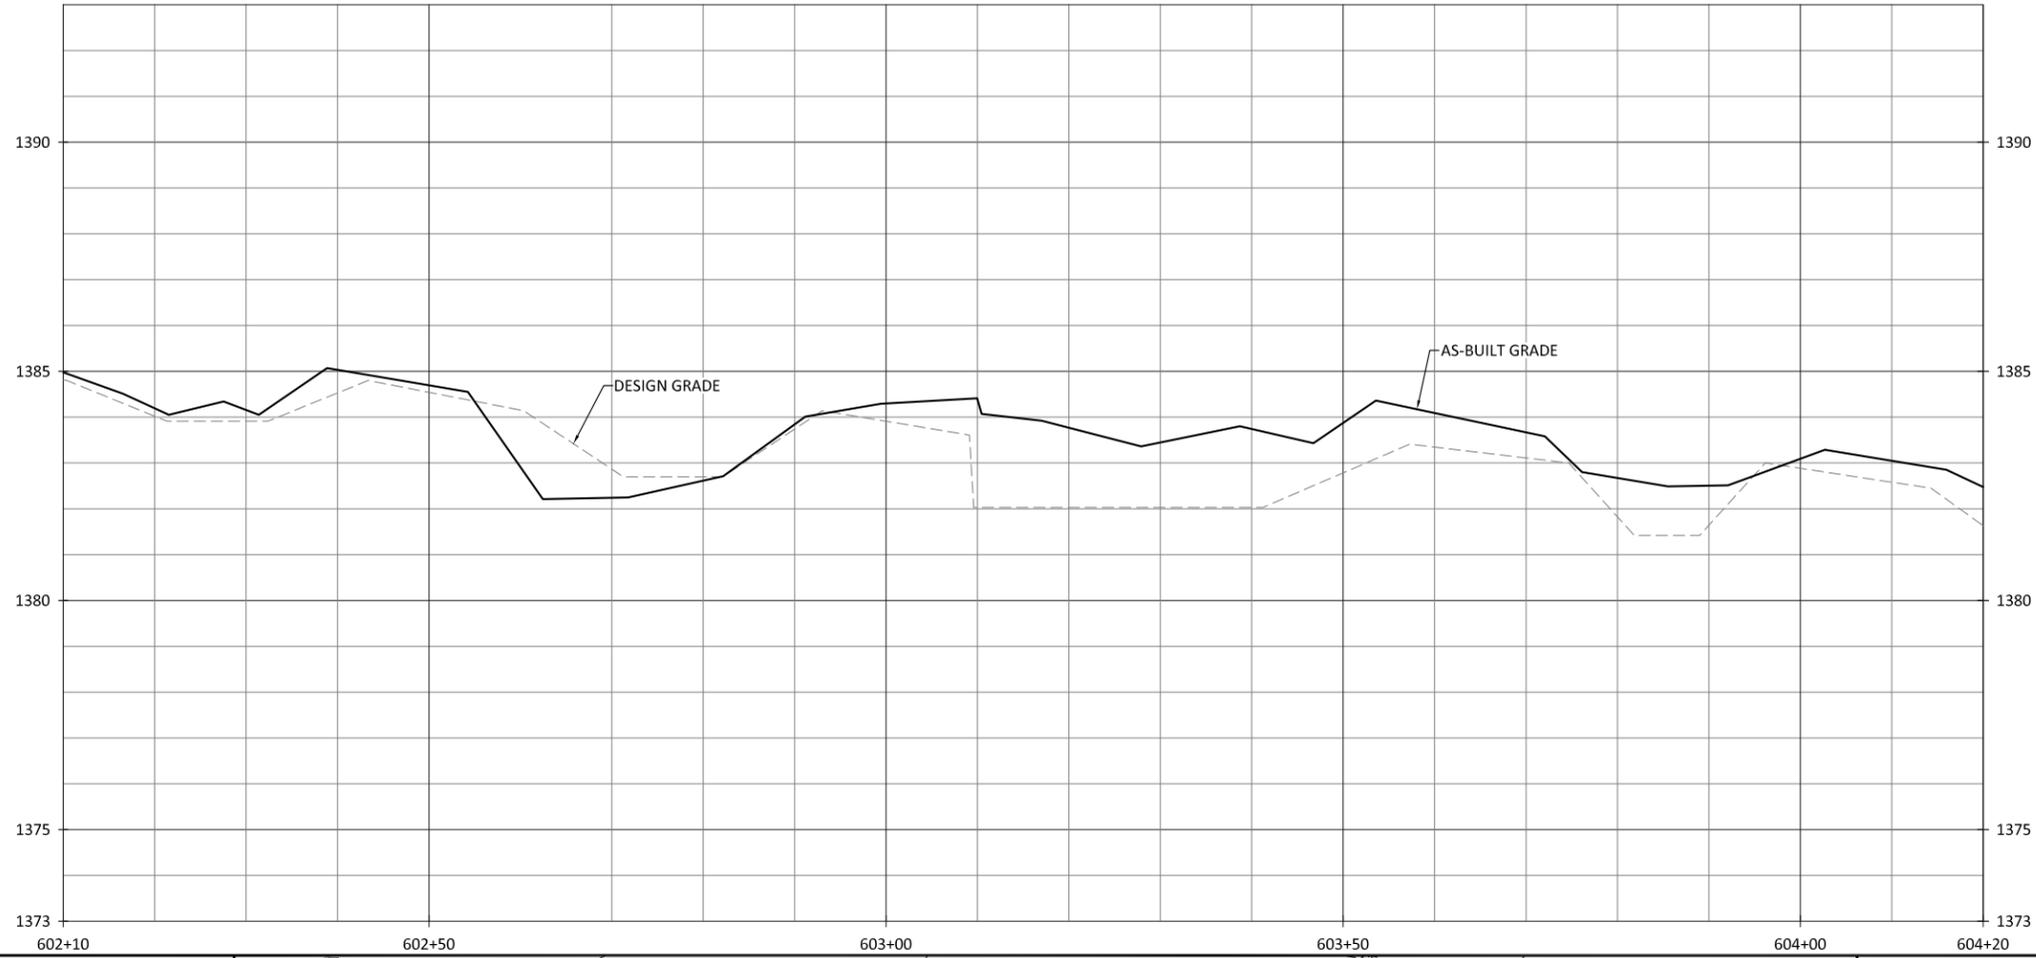
- NOTES:**
1. DEVIATIONS FROM THE DESIGN WILL BE SHOWN IN RED.
 2. STA 600+34 - STA 602+60
231 LINEAR FEET OF STREAM WAS REALIGNED FOR BETTER CONSTRUCTABILITY THROUGH POND AREA.
 3. STA 603+56 - STA 606+69
313 LINEAR FEET OF STREAM WAS REALIGNED FOR BETTER CONSTRUCTABILITY THROUGH POND AREA.

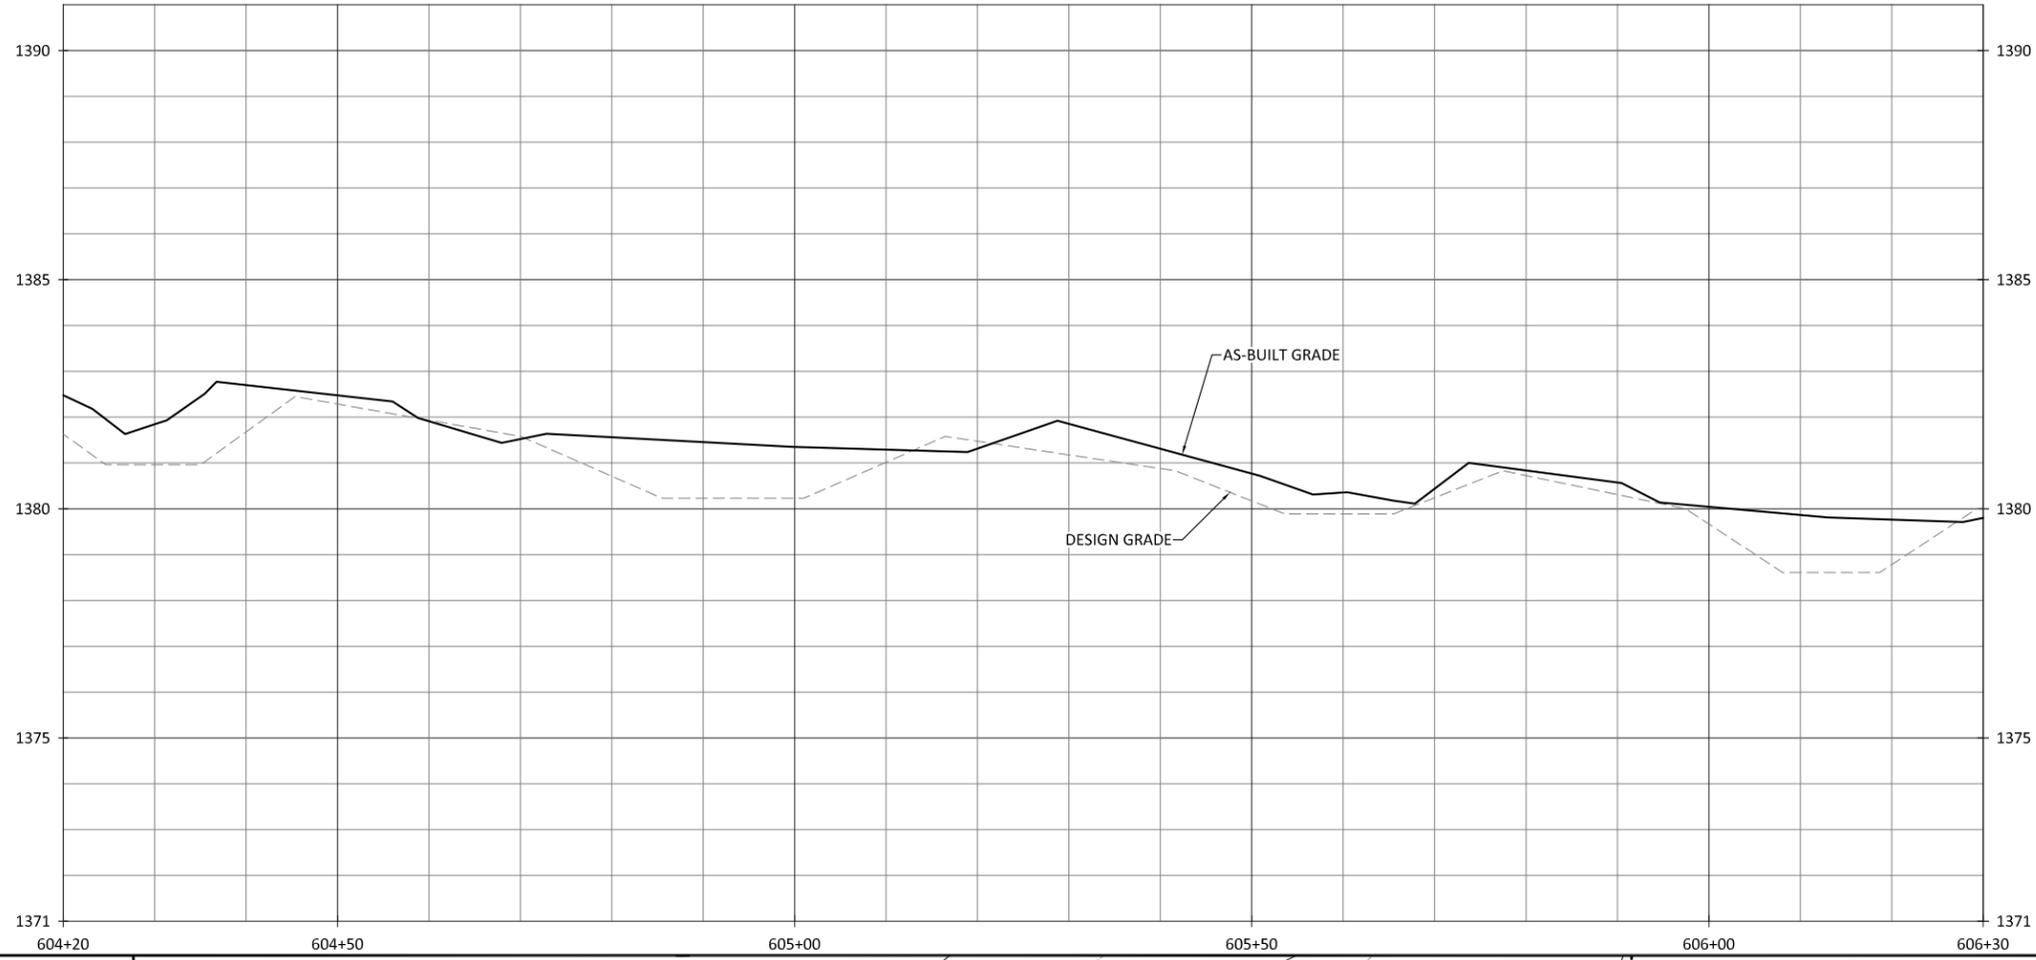
- NOTES:
1. DEVIATIONS FROM THE DESIGN WILL BE SHOWN IN RED.
 2. STA 603+56 - STA 606+69
313 LINEAR FEET OF STREAM WAS REALIGNED FOR BETTER CONSTRUCTABILITY THROUGH POND AREA.
