**MONITORING YEAR 0
ANNUAL REPORT
FINAL**

BUG HEADWATERS MITIGATION SITE

Wilkes County, NC
Yadkin River Basin
HUC 03040101

DMS Project No. 100084
NCDEQ Contract No. 7617
DMS RFP No. 16-007406
USACE Action ID No. 2018-01788
DWR Project No. 2018-1273
Data Collection Dates: April 2021

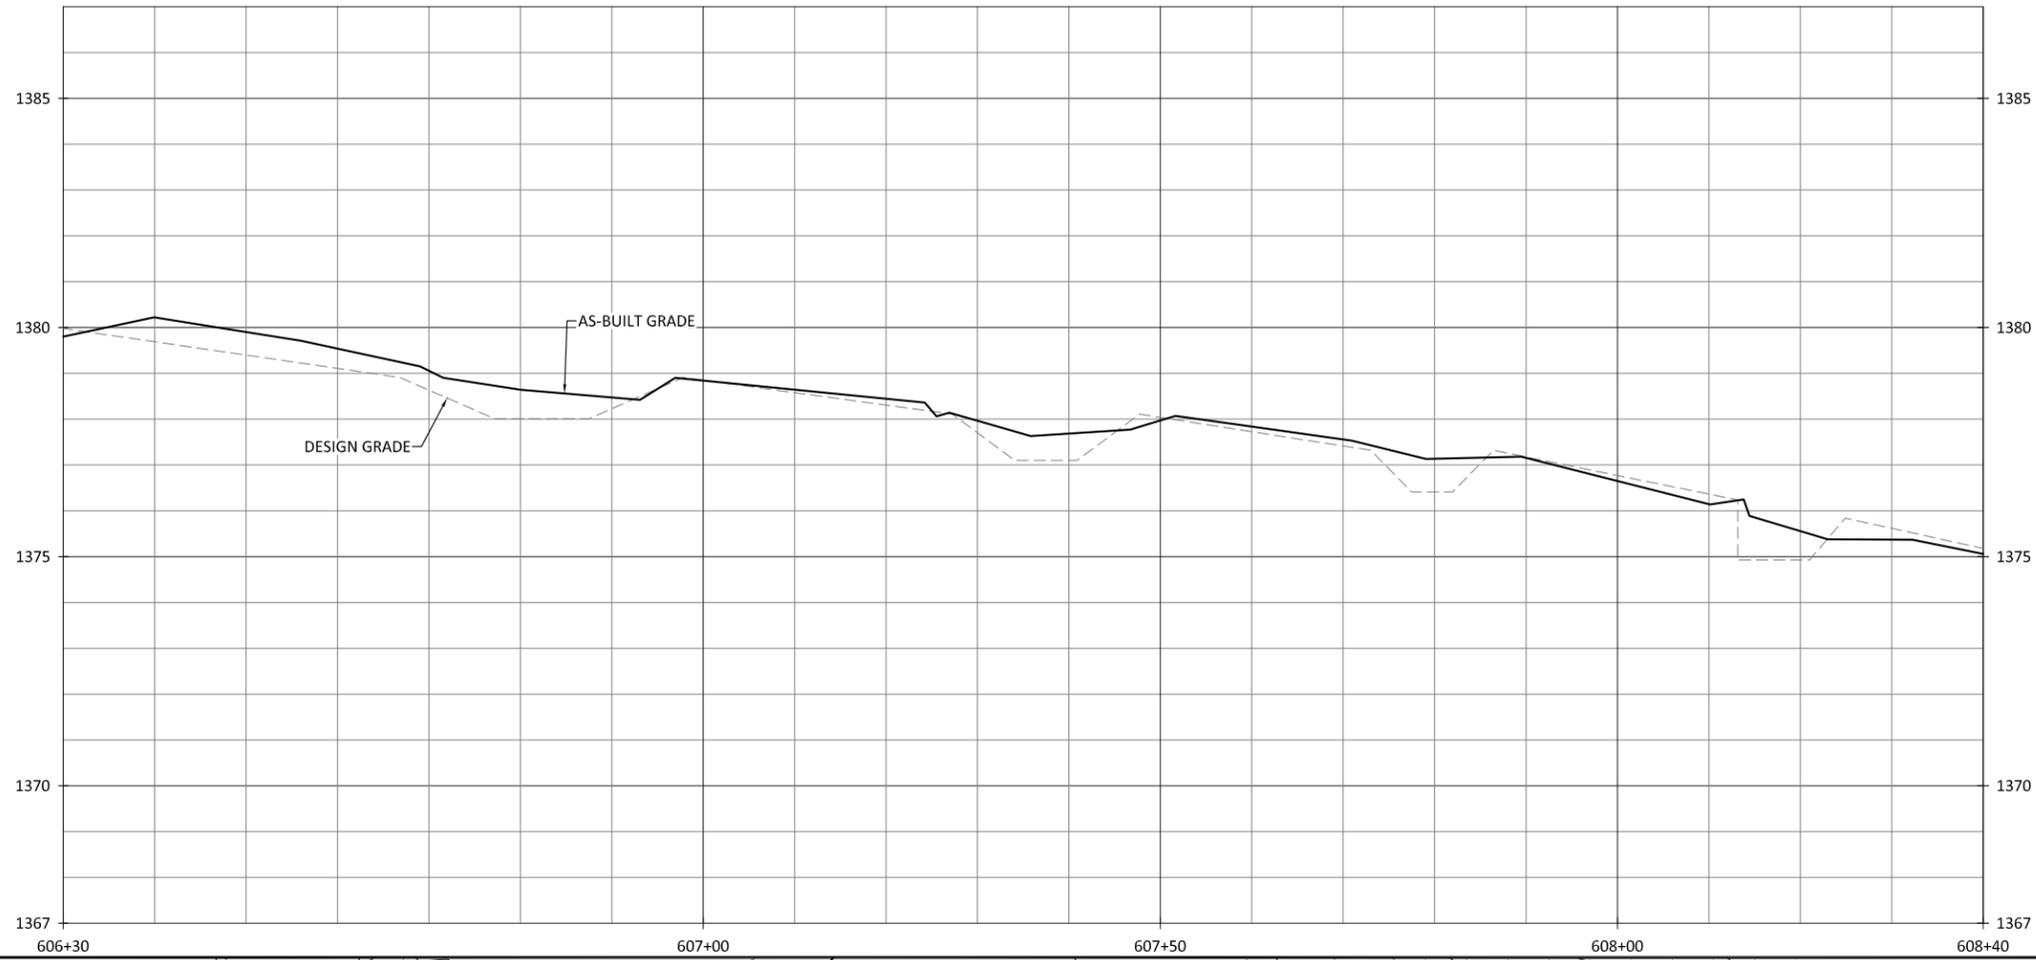
1.40
Sheet

- NOTES:
1. DEVIATIONS FROM THE DESIGN WILL BE SHOWN IN RED.
 2. STA 603+56 - STA 606+69
313 LINEAR FEET OF STREAM WAS REALIGNED FOR BETTER CONSTRUCTABILITY THROUGH POND AREA.

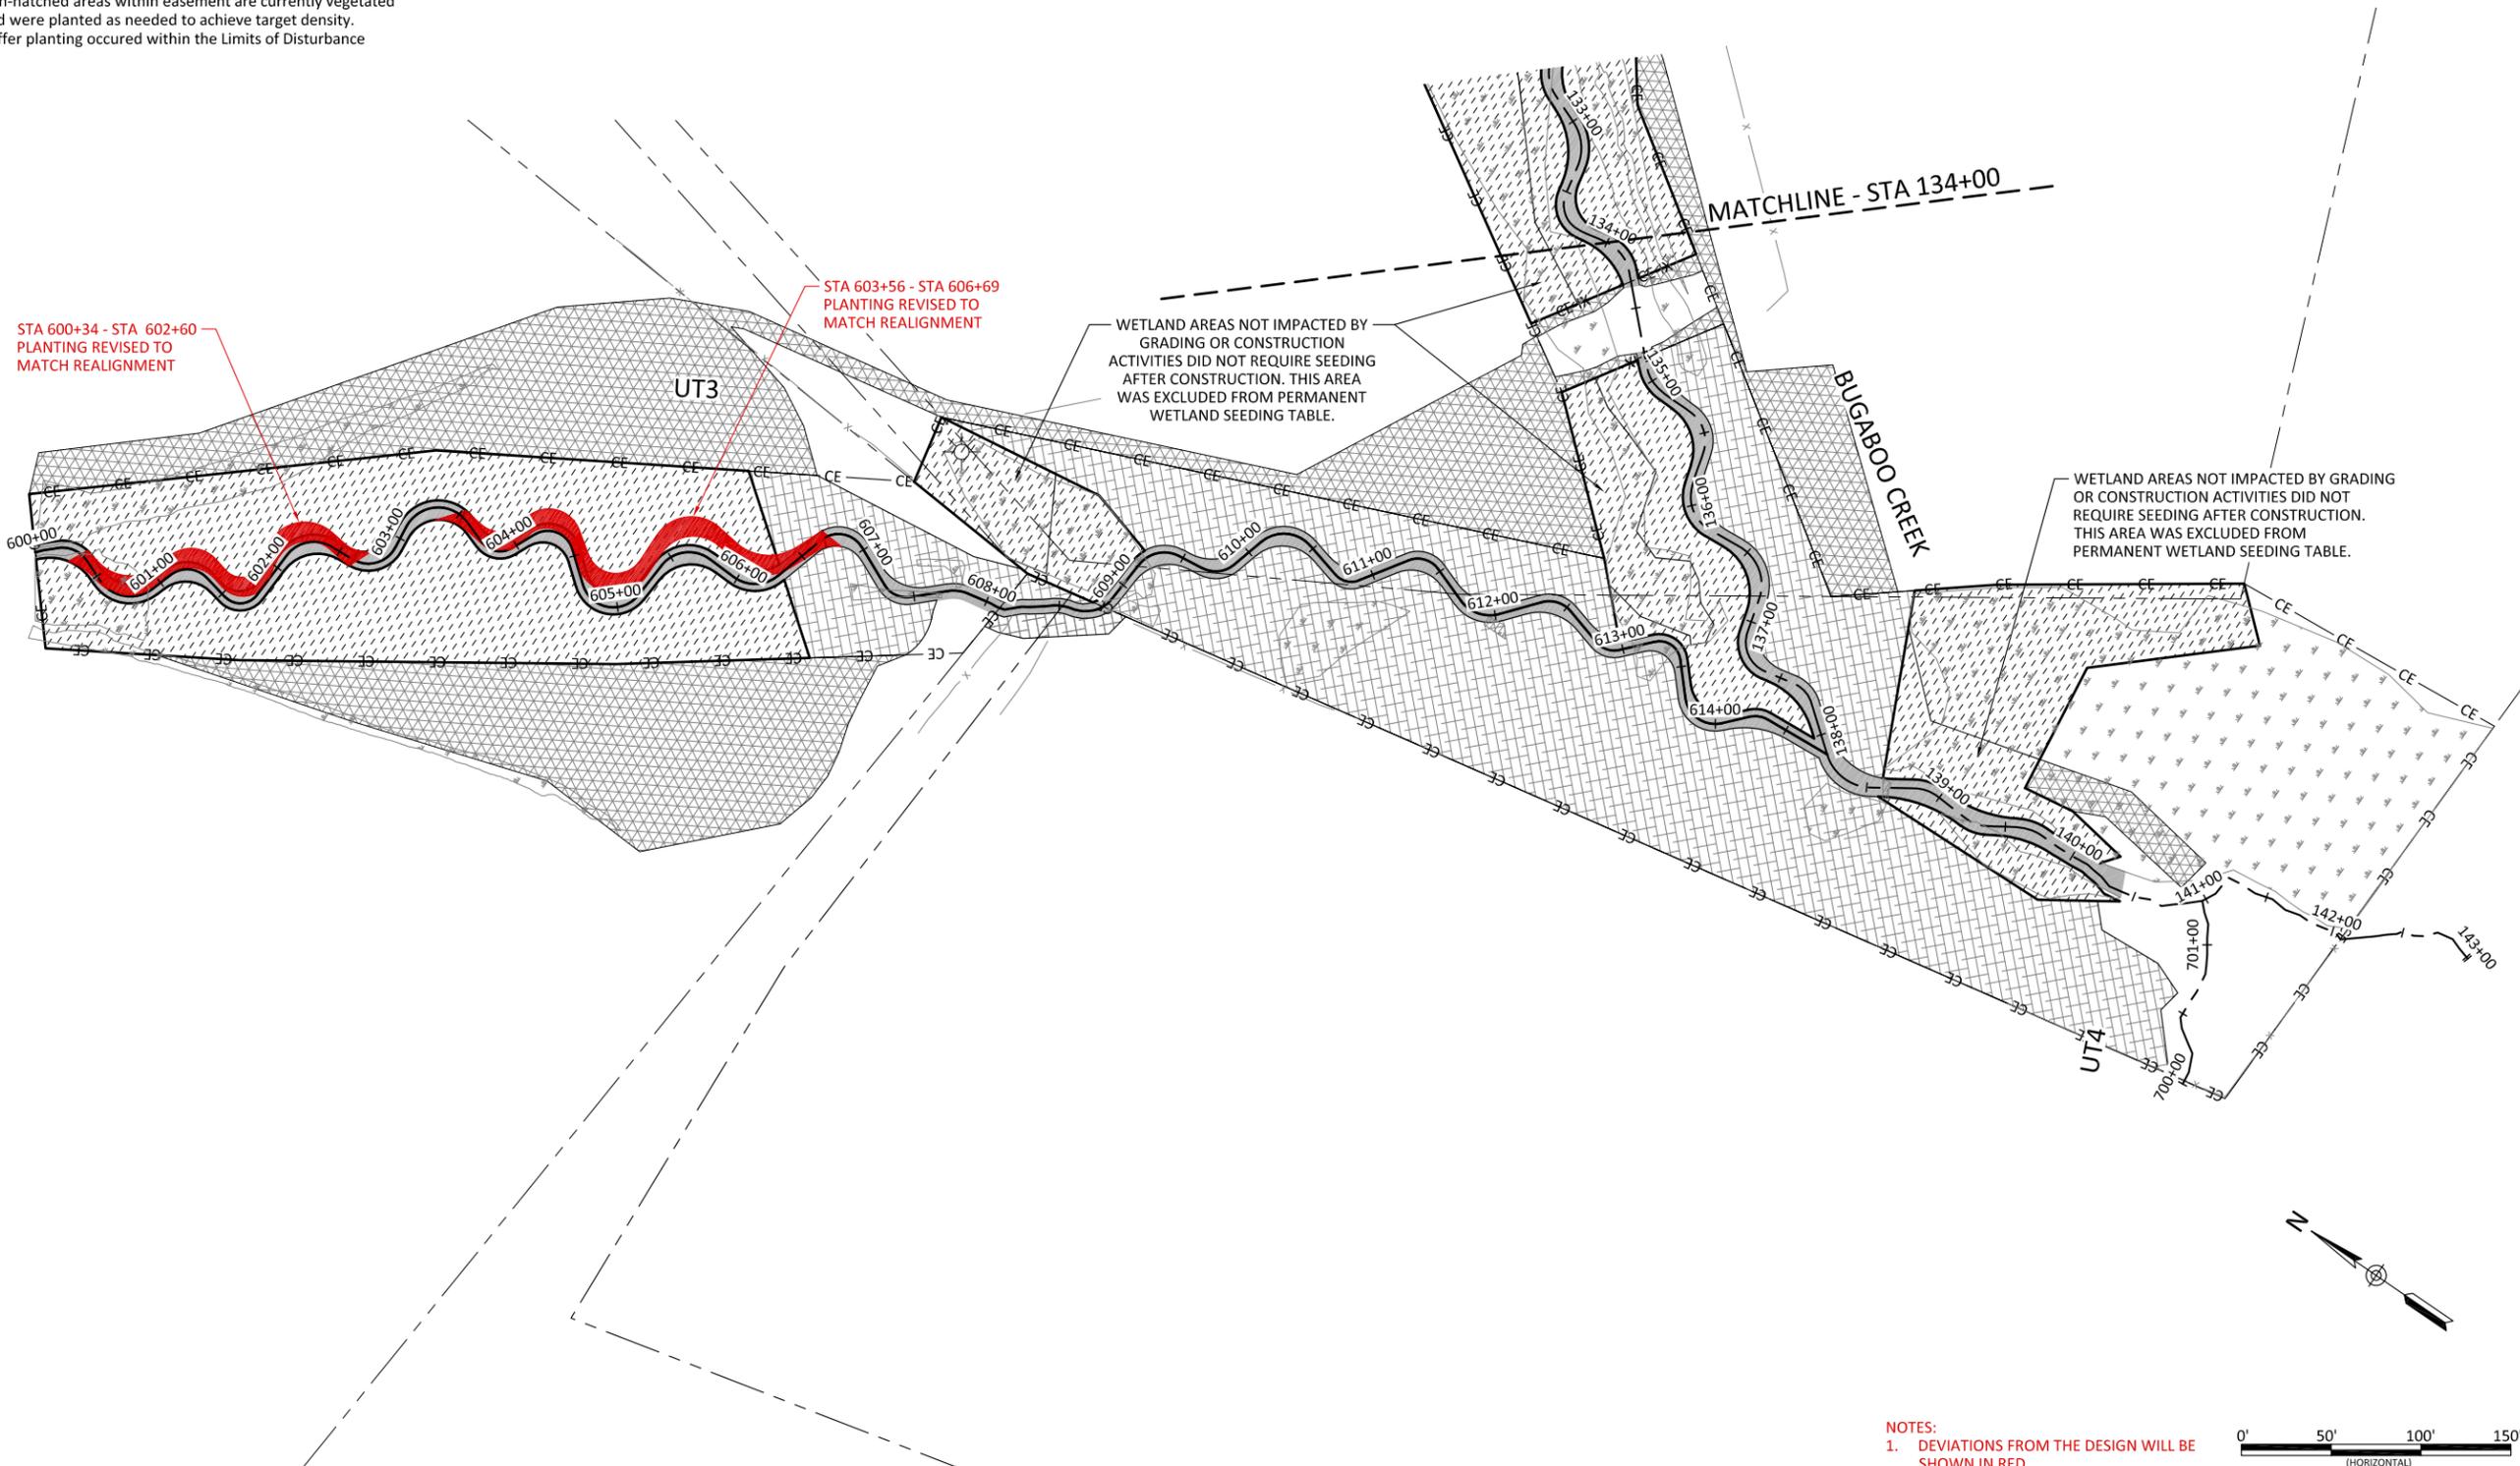
STA 600+34 - STA 602+60
PLANTING REVISED TO
MATCH REALIGNMENT

STA 603+56 - STA 606+69
PLANTING REVISED TO
MATCH REALIGNMENT
