MONITORING YEAR 2 ANNUAL REPORT

BURNETTS CHAPEL MITIGATION SITE-PHASE II

Guilford County, NC NCDEQ Contract No. 7430 DMS ID No. 100045 DWR Project Number 2011-0841

Data Collection Period: September 2020 Submission Date: December 14, 2020

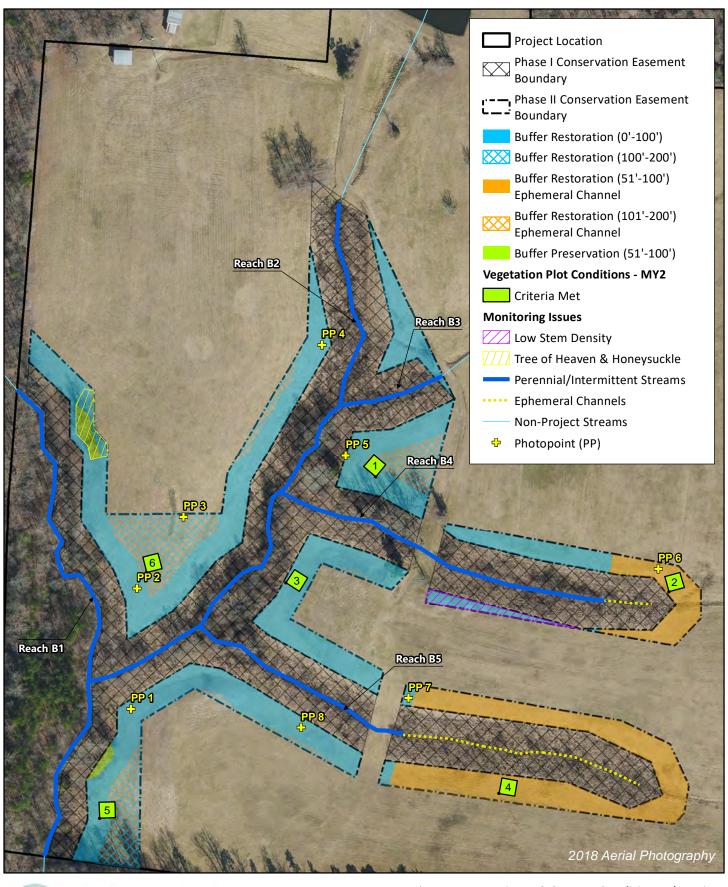
Figure 3 Current Conditions Plan View Burnetts Chapel Mitigation Site - Phase II 2020 Monitoring Report (MY2) Cape Fear River Basin (03030003)

Though a few problems areas were noted throughout the conservation easement in MY2, their presence continues to be minimal and are not negatively affecting the overall vegetative success of the Site. These areas are described below in Section 4.2.1 and 4.2.2. Please refer Figure 3 in Appendix 2 for mapped visual assessment data locations.

As in MY1, a small patch of tree of heaven (*Ailanthus altissima*) and Japanese honeysuckle (*Lonicera japonica*) continue to persist within a patch of intact forest located within the easement. Small pockets or individual stems of seedling Callery pear (*Pyrus calleryana*) and oriental bittersweet (*Celastrus orbiculatus*) were hand-cut in July to keep it under control. Japanese honeysuckle within the Site continued to have only a limited occurrence. Johnsongrass (*Sorghum halepense*) was present during MY1 in small areas but it has expanded to cover a larger area in MY2; it currently covers 16% of the planted acreage. As Johnsongrass is listed as a species of low/moderate concern, and because the species' presence is not affecting the survival or growth of the planted stems, it is not shown on either

Table 6 or Figure 3. Consequently, although there are some invasive species present throughout the Site, none are affecting the survival of the planted stems or the success of the project. Spot herbicide treatments may be applied around the base of the trees as needed to reduce the competition from *S. halepsense* and allow the trees to grow up and shade out the grass. Invasive species populations will continue to be monitored and spot herbicide treatments will be conducted as needed during the appropriate time of year.

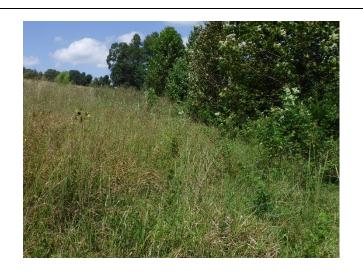
Photo Point 4 – Looking upstream B2 (09/03/2020)

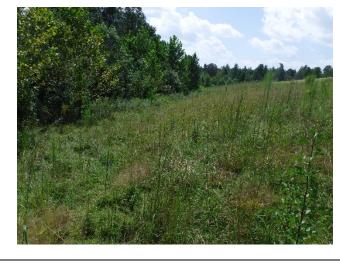
Photo Point 4 – Looking downstream B2 (09/03/2020)

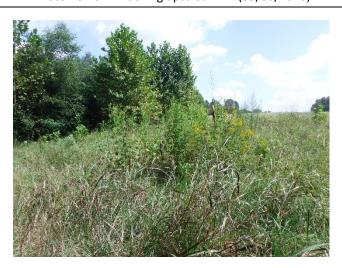
Photo Point 5 – Looking upstream B3 (09/03/2020)

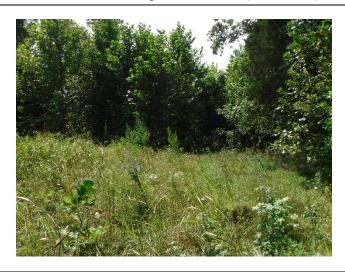
Photo Point 5 – Looking downstream to B2-B4 confluence (09/03/2020)

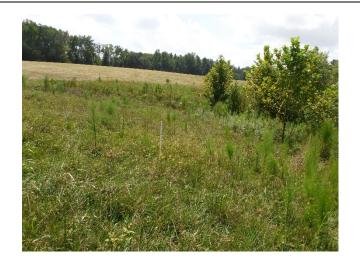
Photo Point 6 – Looking upstream across top of B4 (09/03/2020)

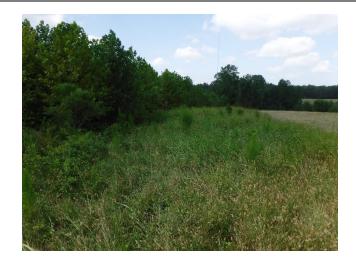
Photo Point 6 – Looking downstream B4 (09/03/2020)

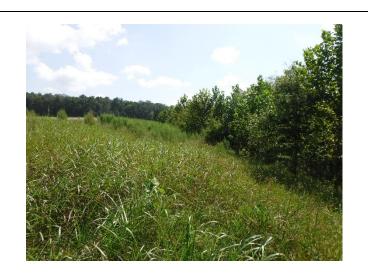
Photo Point 7 – Looking upstream B5 (09/03/2020)

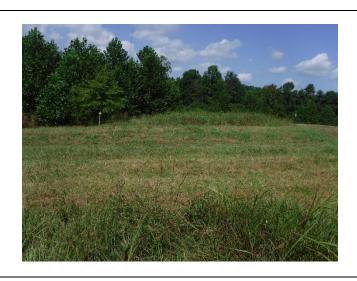
Photo Point 7 – Looking downstream B5 (09/03/2020)

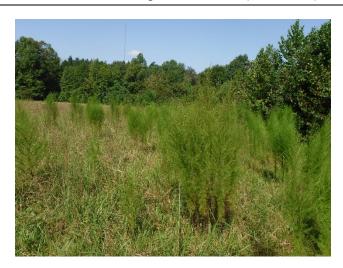
Photo Point 8 – Looking downstream B5 (09/03/2020)
