# **MONITORING YEAR 1 ANNUAL REPORT**

## **CANDY CREEK MITIGATION SITE**

DMS Project Number 96315

Data Collection Period: October 2017

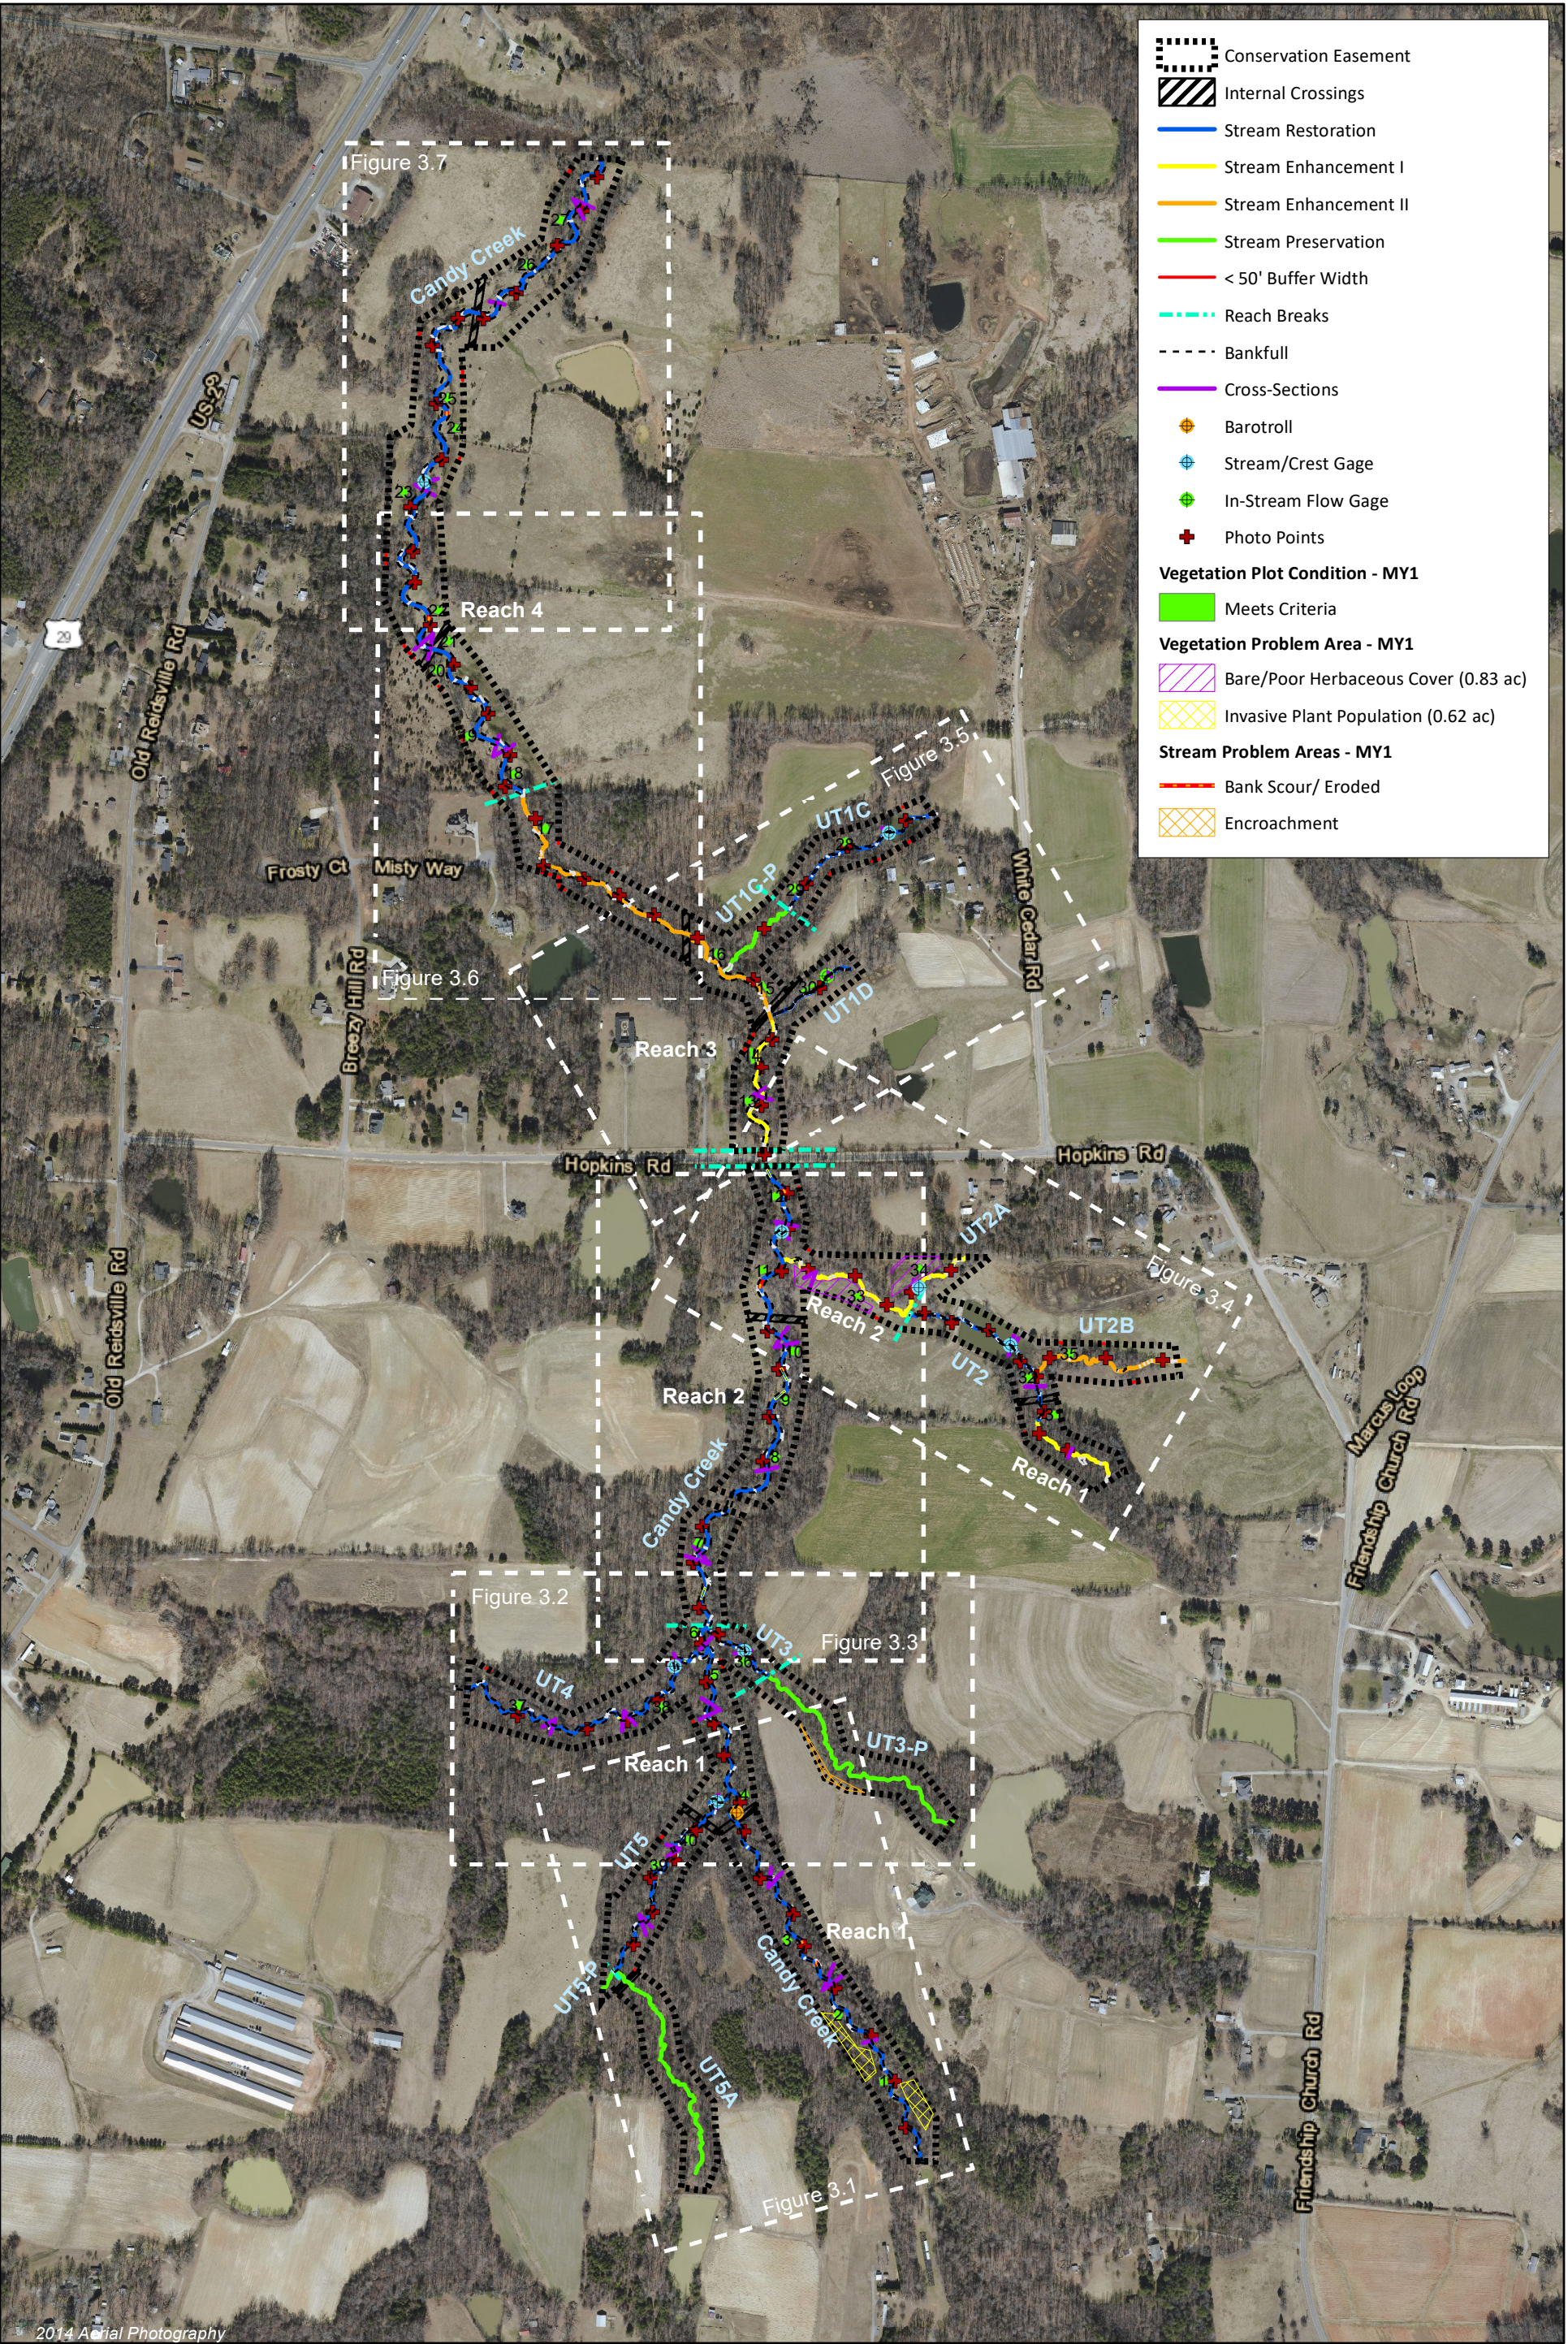
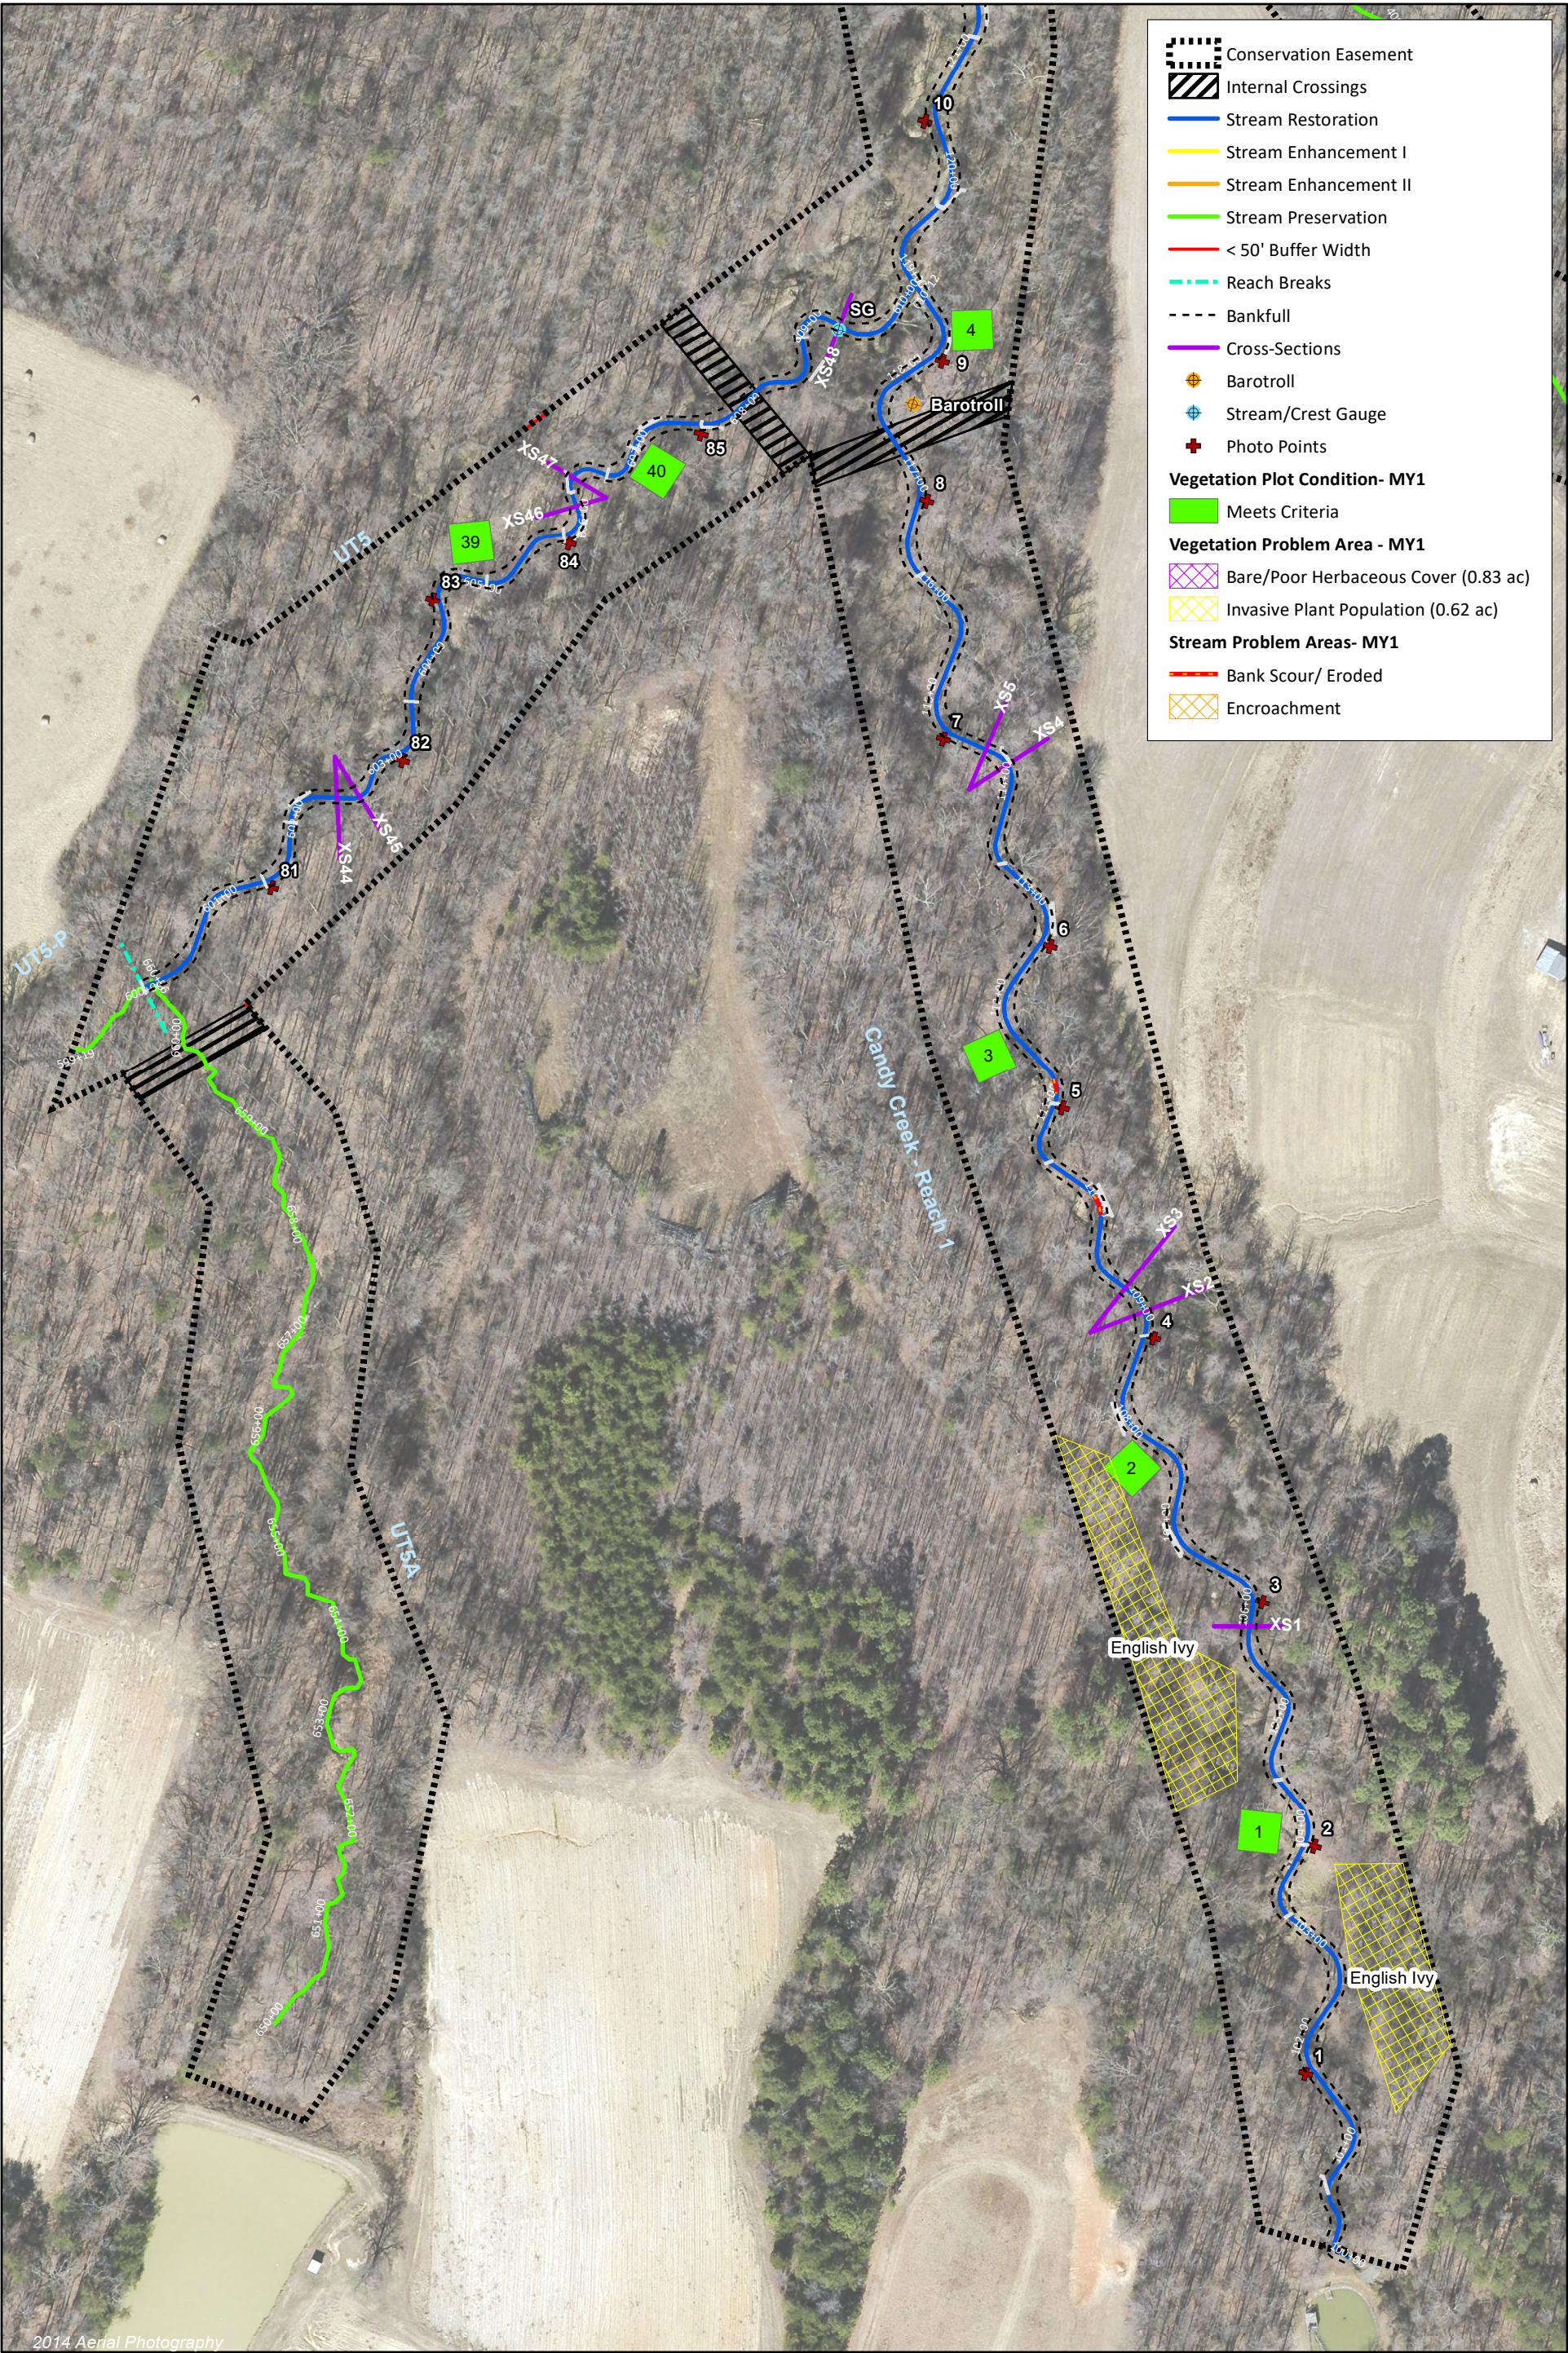
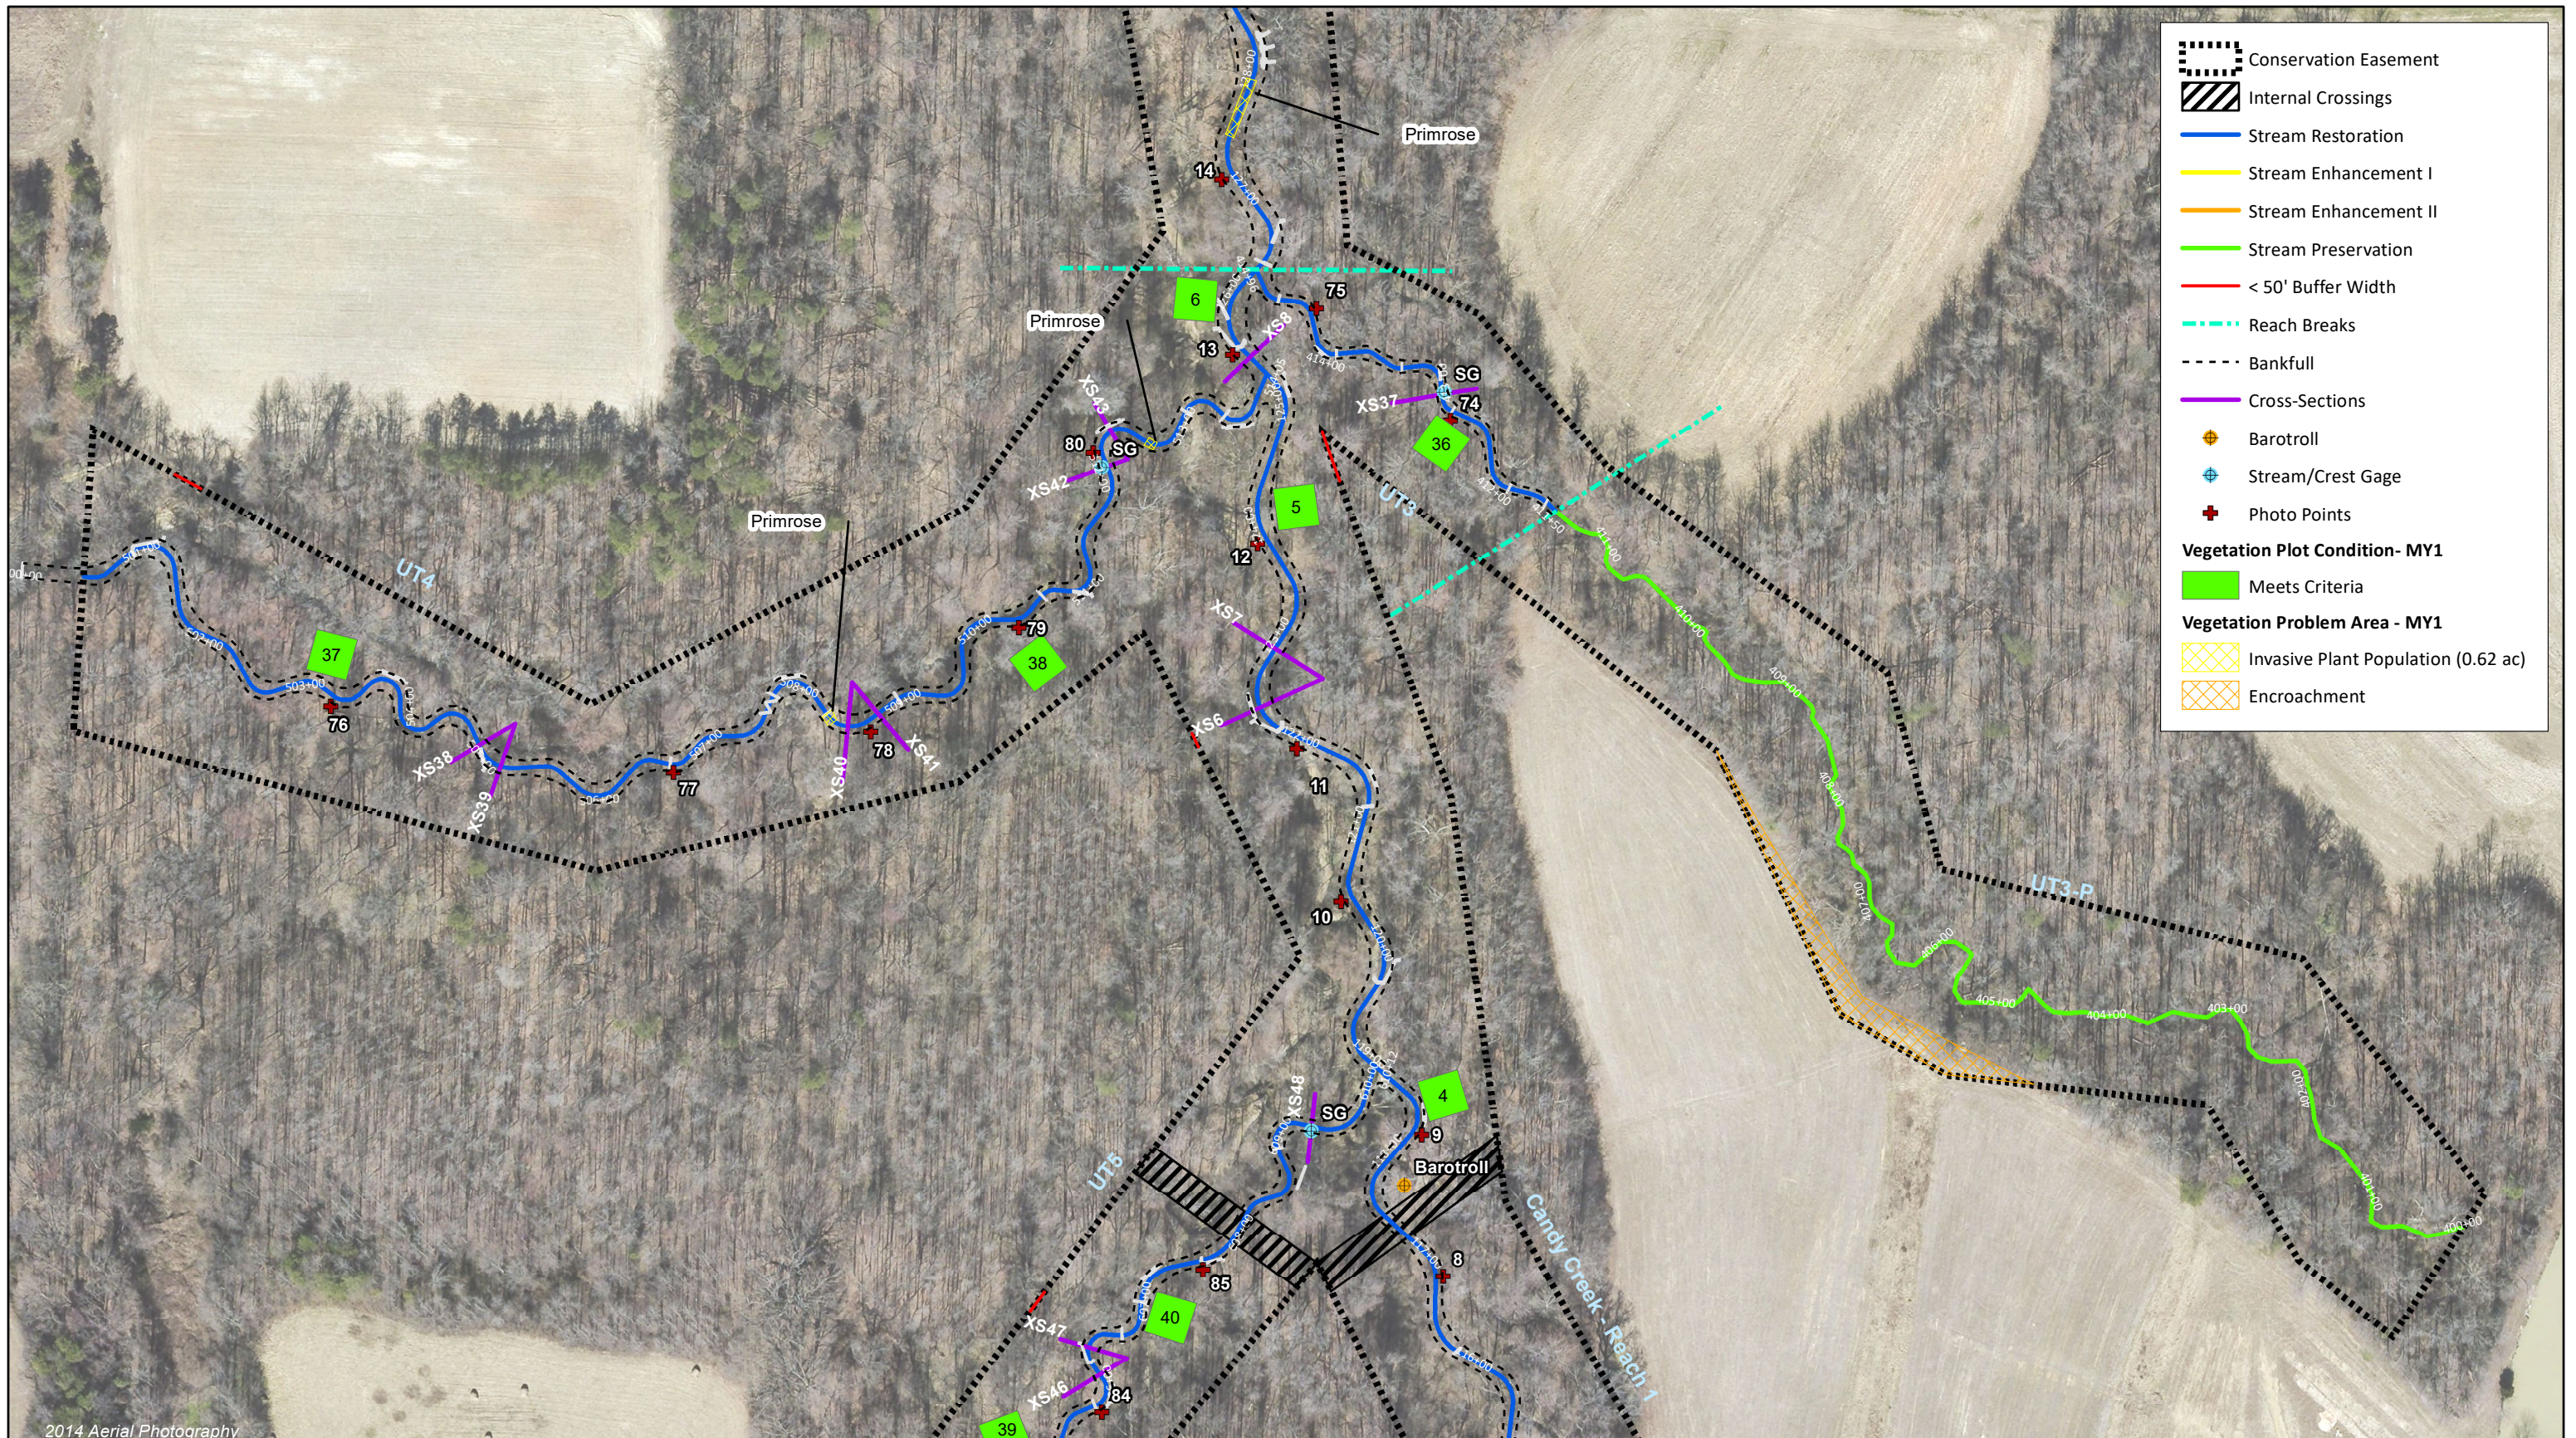
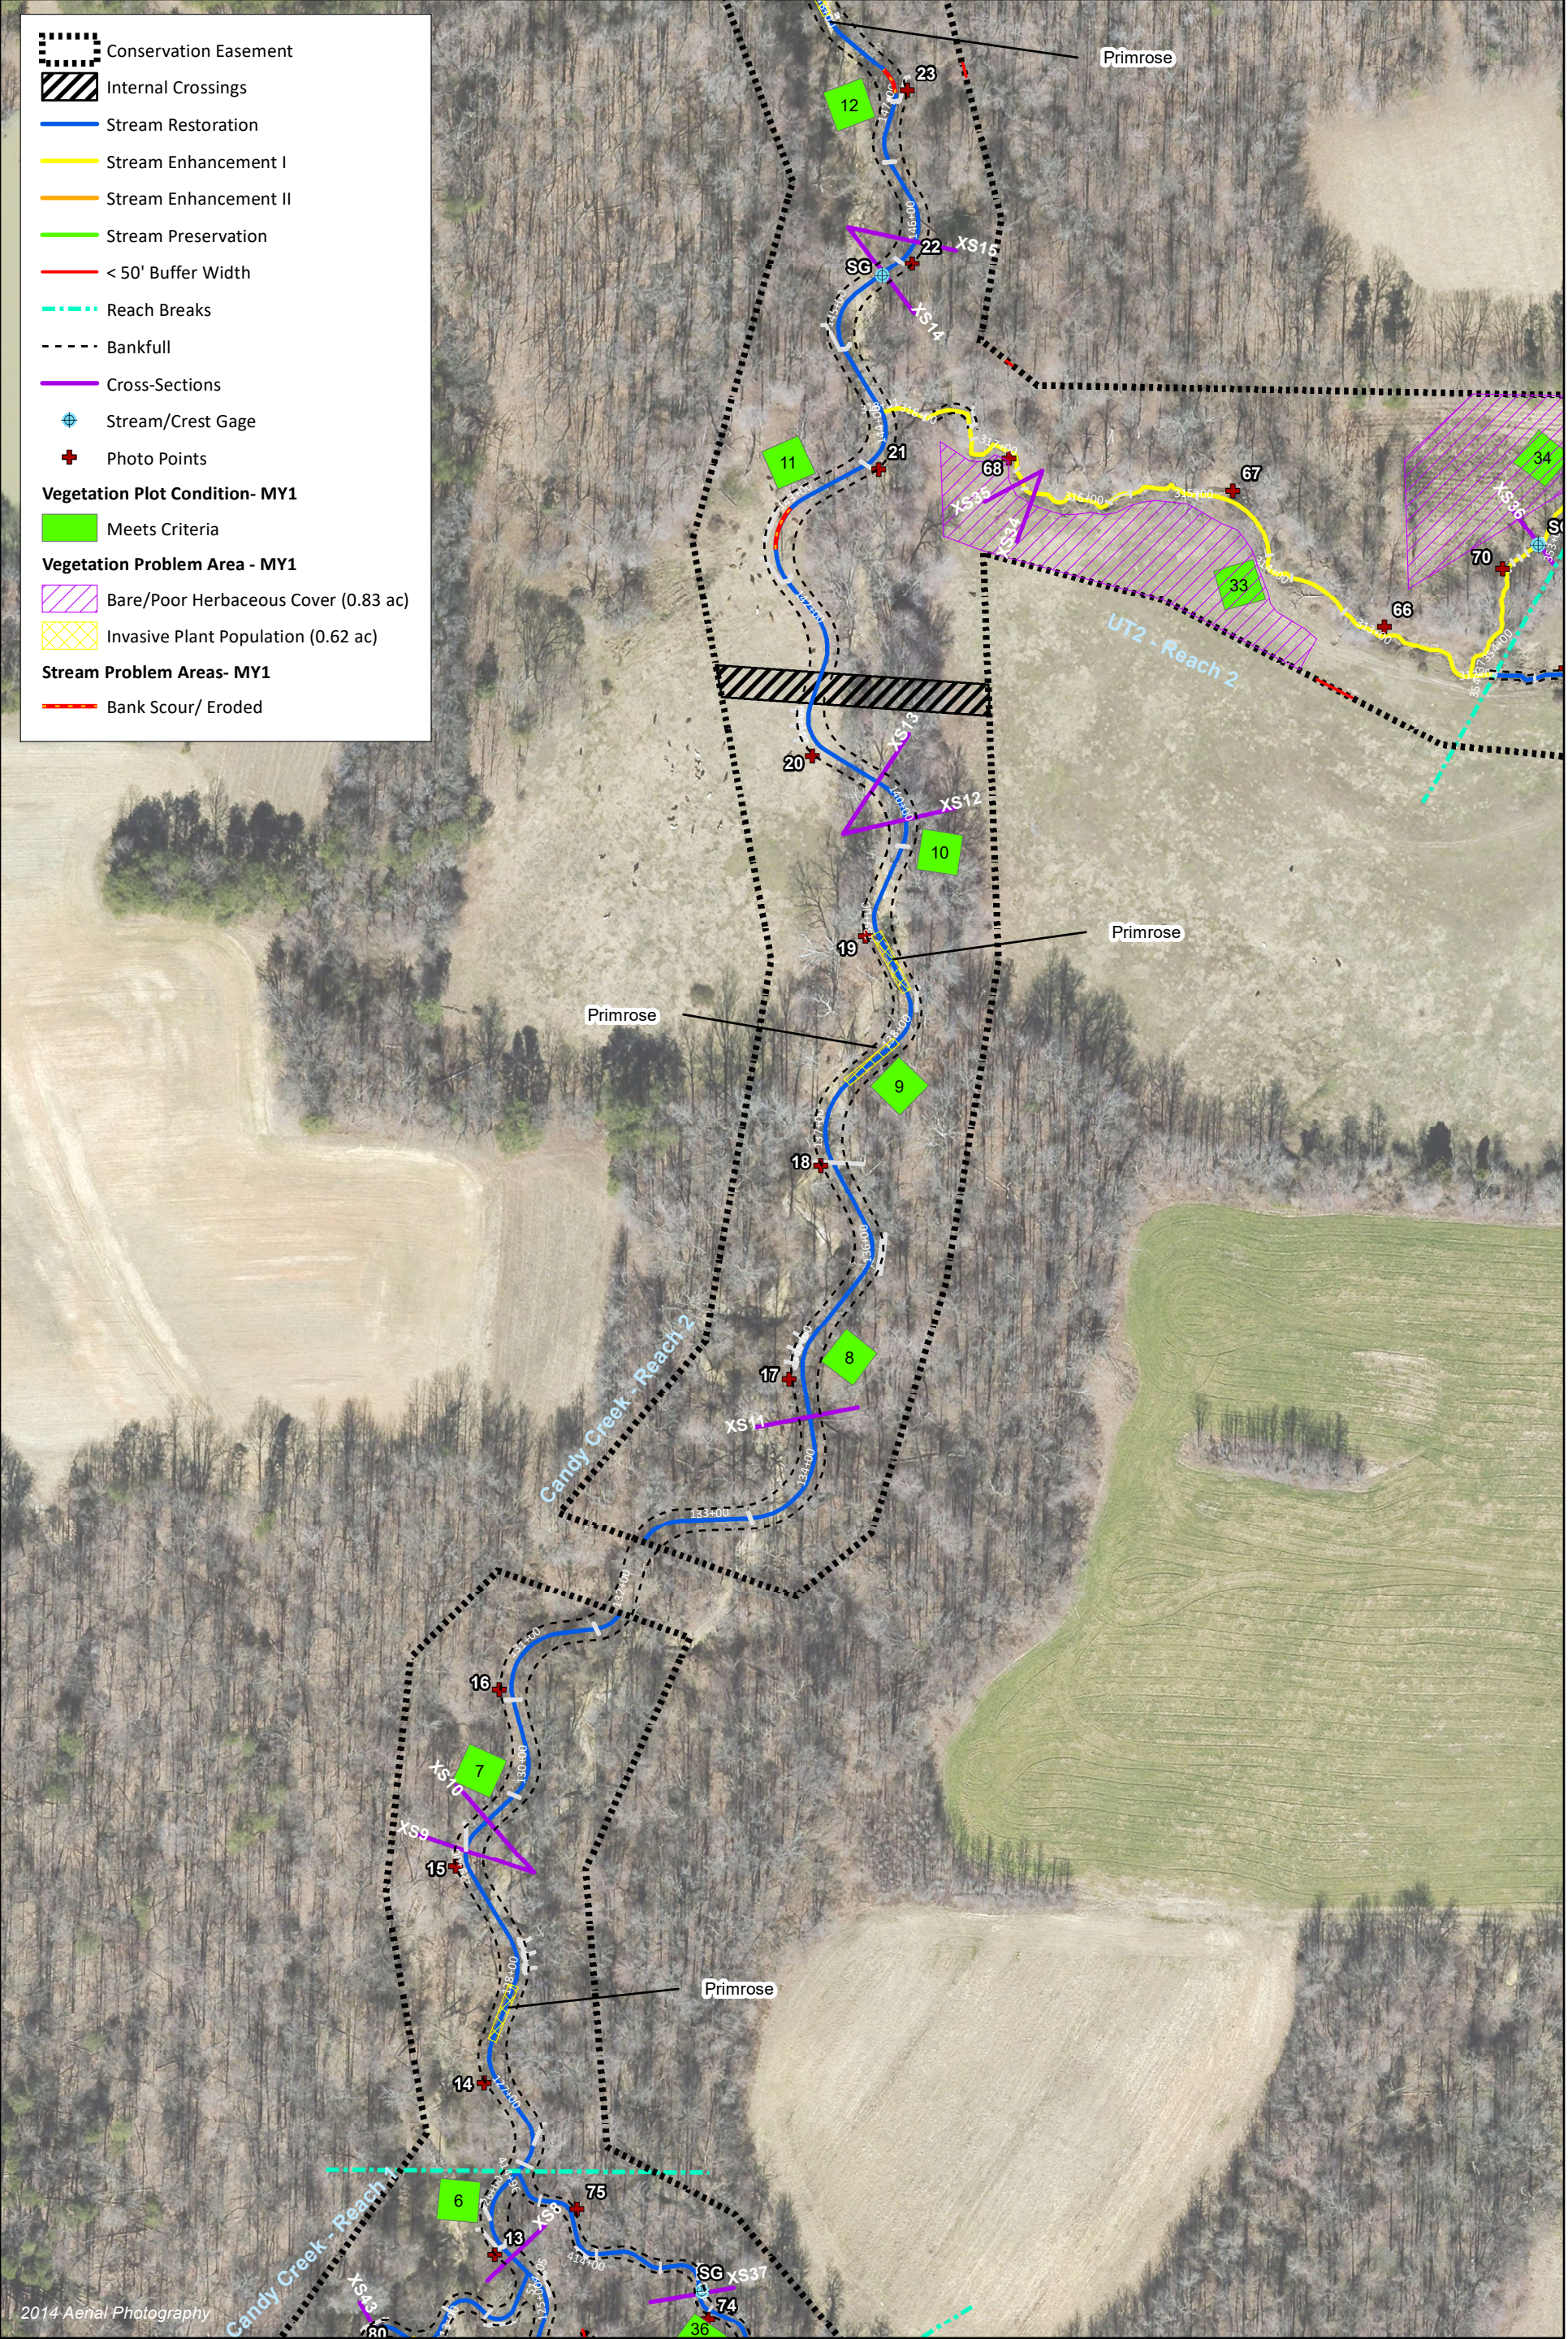
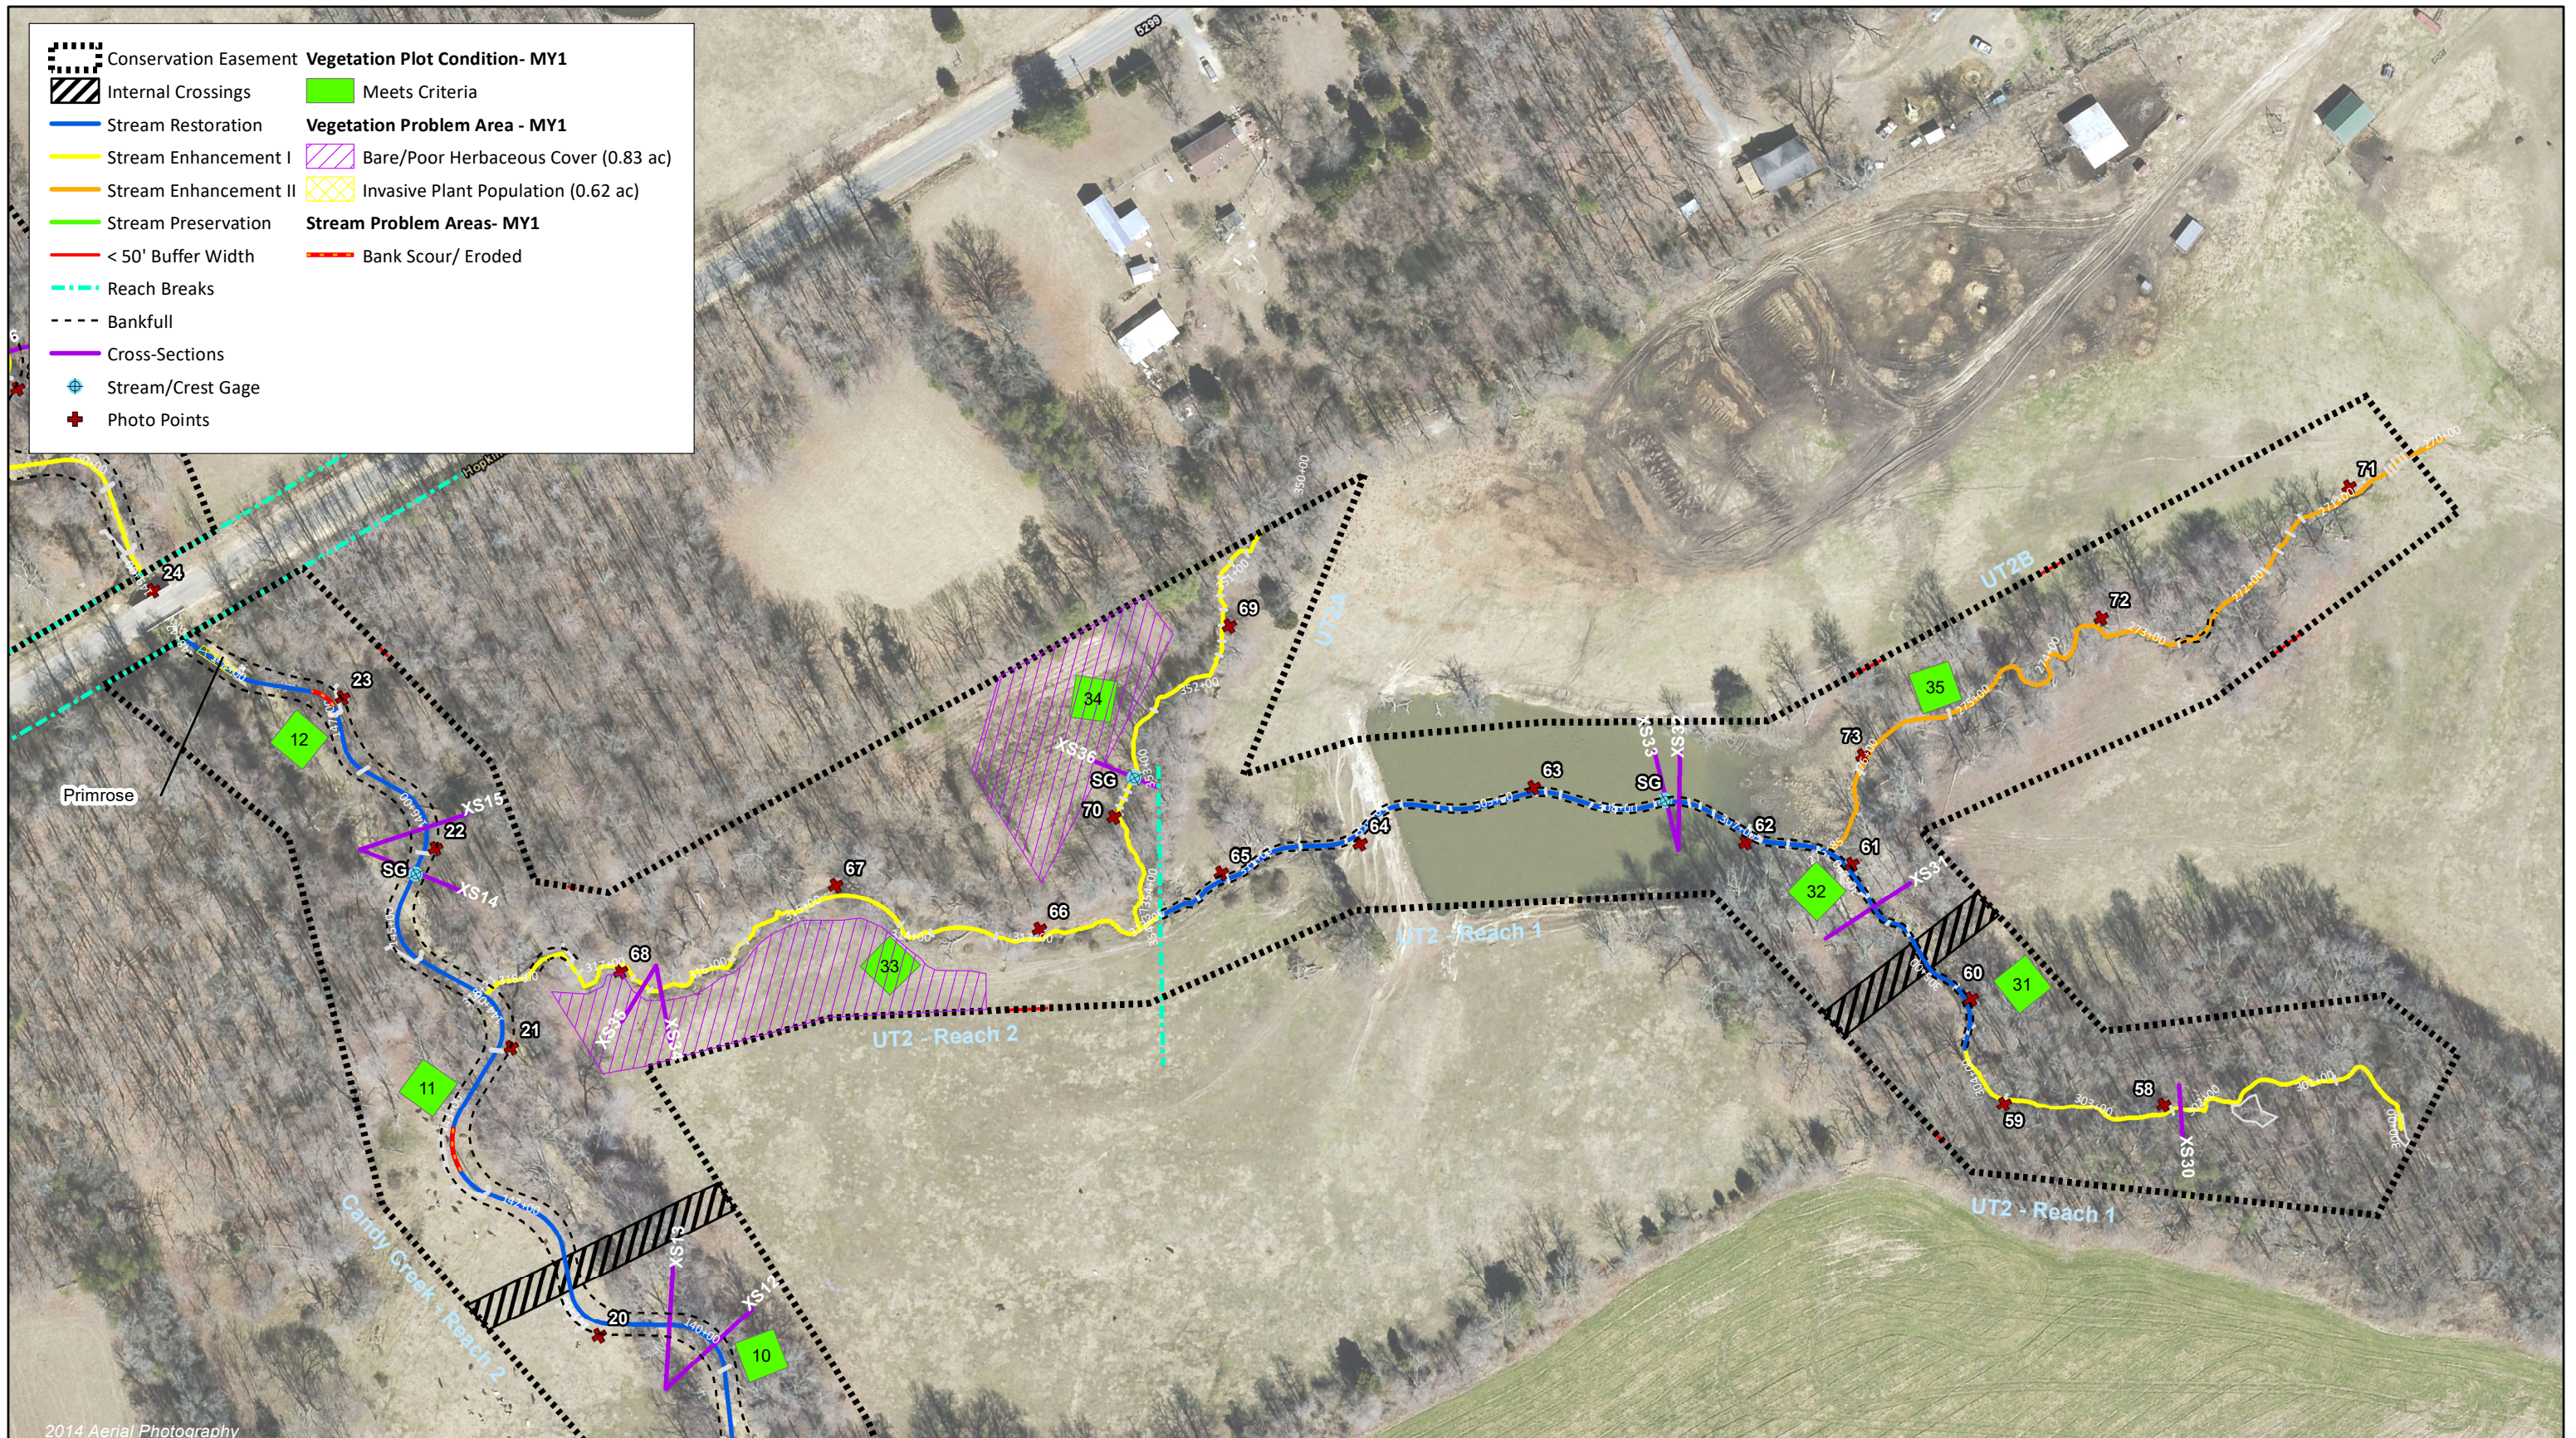
In addition, the Site has several sections noted where the buffer width is less than 50 feet. The total length of these sections is approximately 3.1% of the total project length, less than the 5% allowed by the IRT. Please refer to Figures 2 and 3.

There are two, small bare areas (<1% of the planted acreage) within the floodplain valleys of UT2. In these bare areas, the planted trees appear healthy and volunteer trees are abundant, but the herbaceous layer is not well established. One isolated area of easement encroachment was noted along UT3 which has impacted the establishment of the vegetative community in this location. Refer to Appendix 2 for the vegetation condition assessment table and Integrated Current Condition Plan View (CCPV).

For those areas noted with poor herbaceous growth, lime will be incorporated into the soil which is expected to increase soil pH resulting in improved herbaceous growing conditions. These areas will be monitored and any additional actions deemed necessary to promote herbaceous plant growth will be taken.

The landowner associated with the area of encroachment will be notified of this violation and the area will continue to be monitored during subsequent site visits.

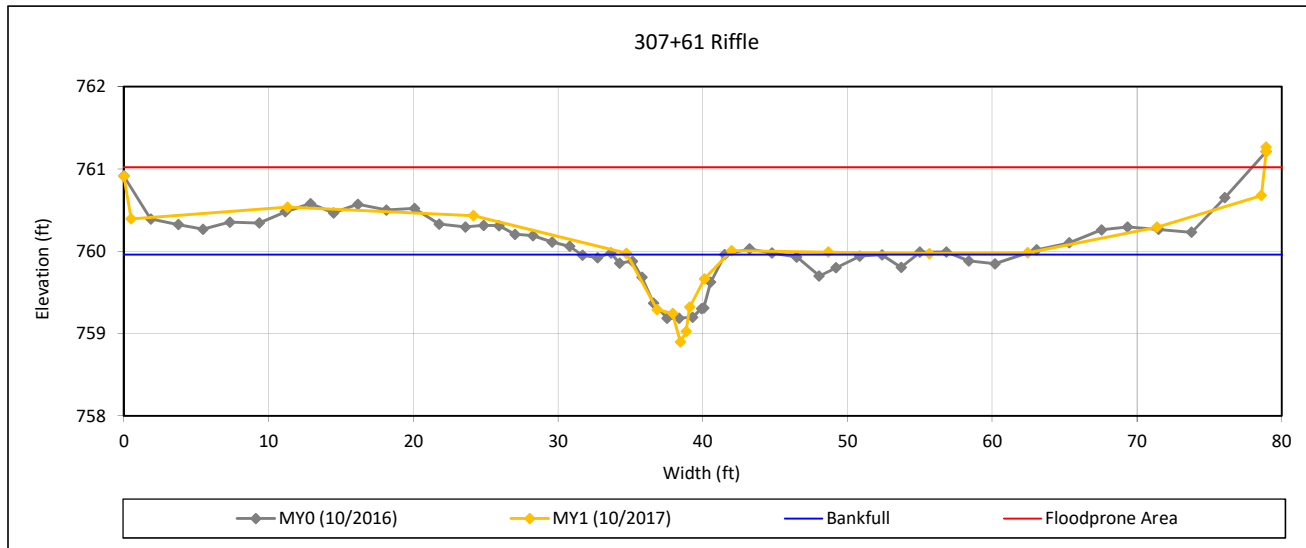
#### Cross-Section 33 - UT2 Reach 1

Bank erosion was observed within some isolated outside meander bends along Candy Creek Reach 1, 2, and 4. A limited area of riffle scour was noted at cross-section 33 on UT2 Reach 1 and an area of pool deposition was observed at cross-section 34 on UT2 Reach 2. These areas will be monitored for advancement in subsequent monitoring years.
