# MONITORING YEAR 7 ANNUAL/CLOSEOUT REPORT

## CANDY CREEK MITIGATION SITE

Guilford County, NC  
NCDEQ Contract 5794  
NCDMS Project Number 96315  
USACE Action ID Number 2015-01209  
DWR Project Number 14-0334  
RFP Number 16-005568

Data Collection Period: February - October 2023  
Draft Submission Date: November 2023  
Final Submission Date: January 2024

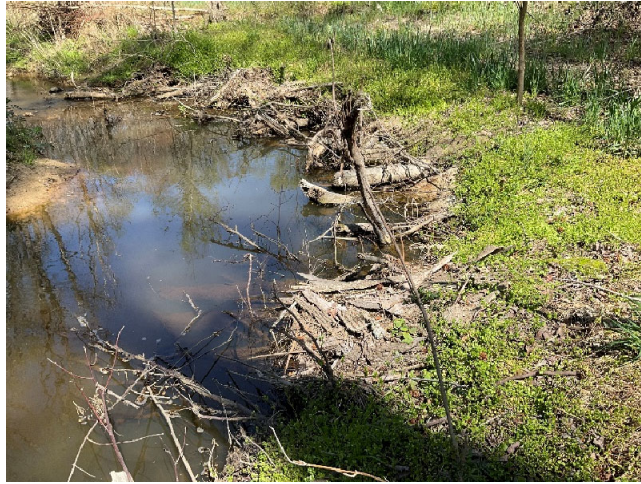
Candy Creek Reach 3 – Bank repair, RB (Sta. 151+75)  
(03/31/2023)

Bank repairs along Candy Creek Reach 3 were completed in September 2022 and discussed in the MY6 monitoring report. MY7 visual assessments revealed that the bank is stable and is revegetating as documented in the Improved AOC Photographs, and in the XS16 plot. The temporary construction path was planted with live stakes, which have resprouted and are doing well, as shown in the Improved AOC Photographs. The step-pool structures along UT1C, UT1D, and several log and rock sills along UT2 were repaired by hand between March and October 2023. Water is no longer piping under or around these structures which are shown in before and after photos in the Improved AOC Photographs.

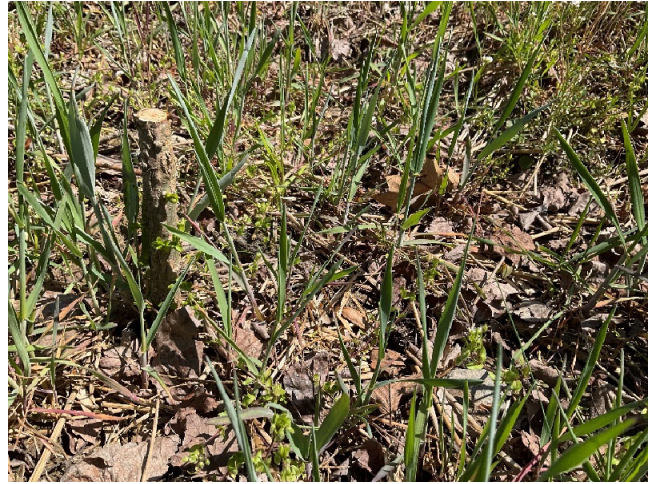
Candy Creek Reach 3 – Repair area replanting (Sta. 152+75)  
(03/31/2023)

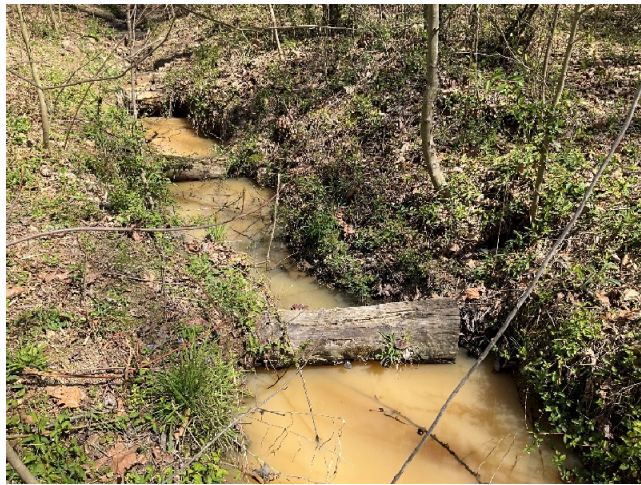
UT1C – Structural issues, prior to repair (Sta. 206+00)  
(03/31/2023)

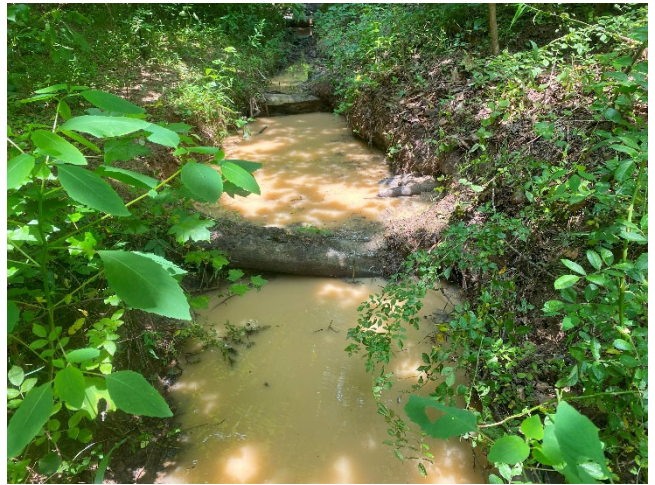
UT1C – Repaired structure (Sta. 206+00) (10/31/2023)

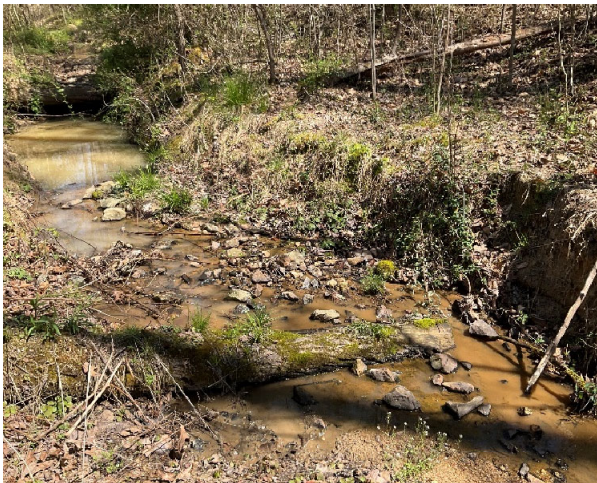
UT1C – Structural issues, prior to repair (Sta. 207+05)  
(03/31/2023)

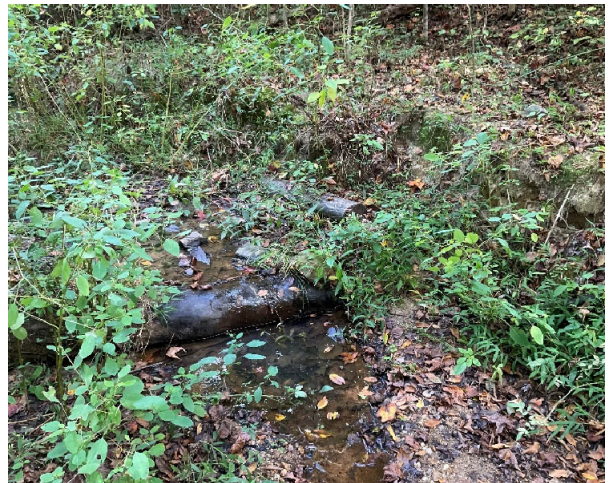
UT1C – Repaired structure (Sta. 207+05) (10/17/2023)

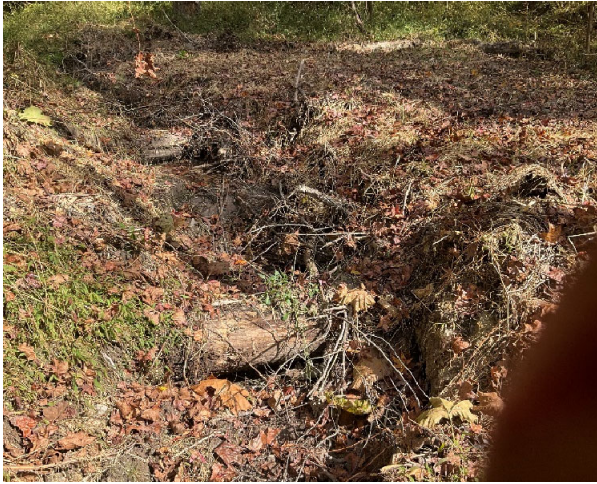
UT1D – Structural issues, prior to repair (Sta. 253+25)  
(10/21/2022)

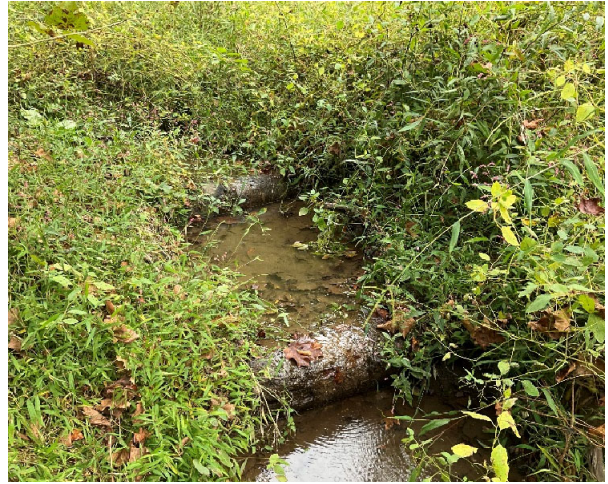
UT1D – Repaired structure (Sta. 253+25) (10/17/2023)

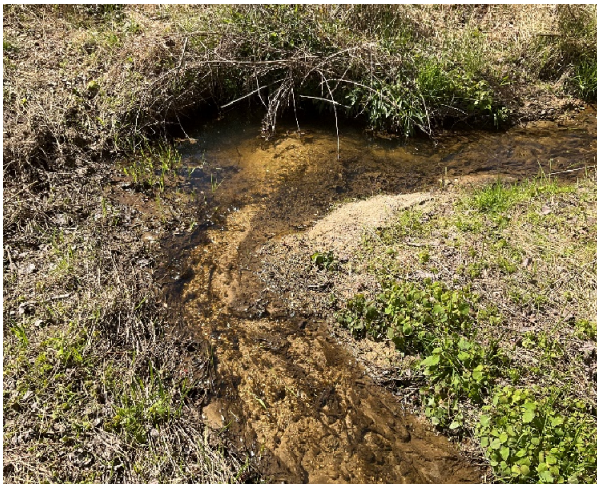
UT2 Reach 2 – Improved deposition (Sta. 316+50)  
(03/31/2023)

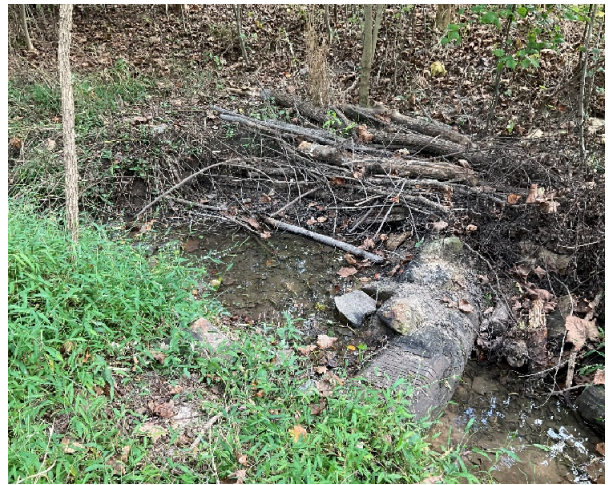
UT2 Reach 2 – Repaired structure (Sta. 311+88) (10/17/2023)

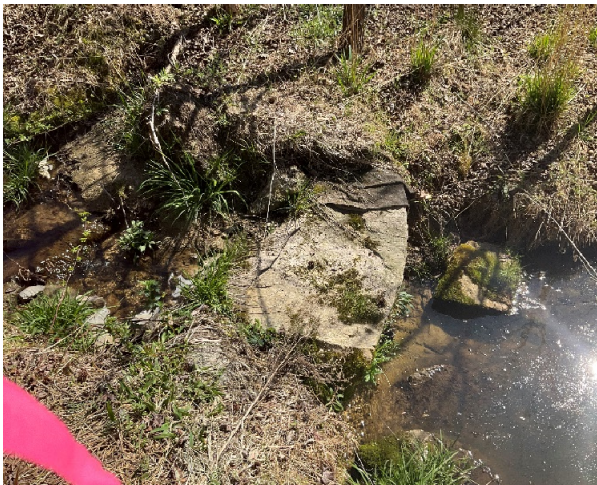
UT2 Reach 2 – Structural issues, prior to repair (Sta. 312+50) (03/31/2023)

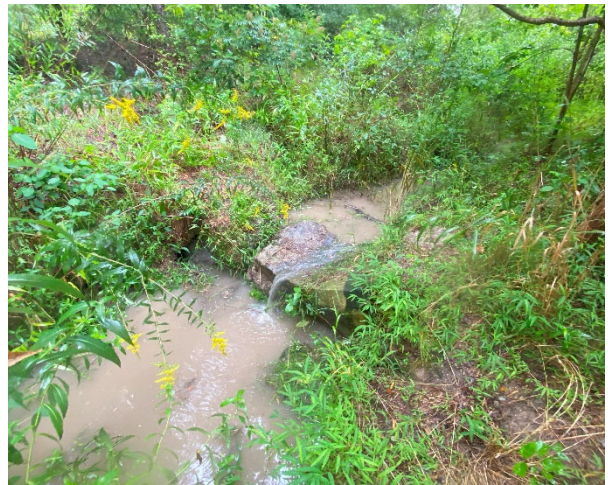
UT2 Reach 2 – Repaired structure (Sta. 312+50) (10/17/2023)

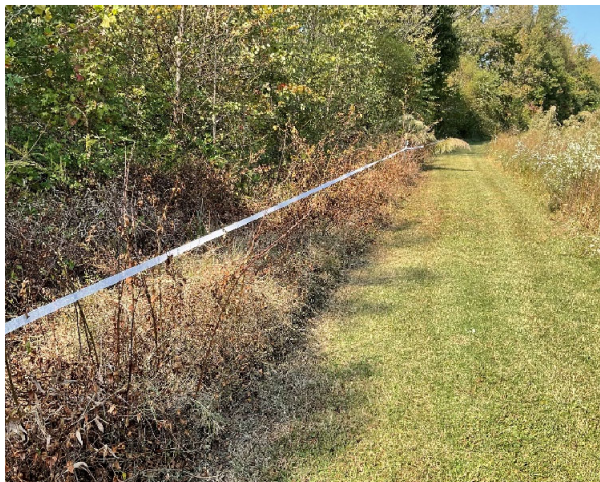
Candy Creek Reach 1 – Resolved mowing encroachment (Sta. 112+00) (10/17/2023)

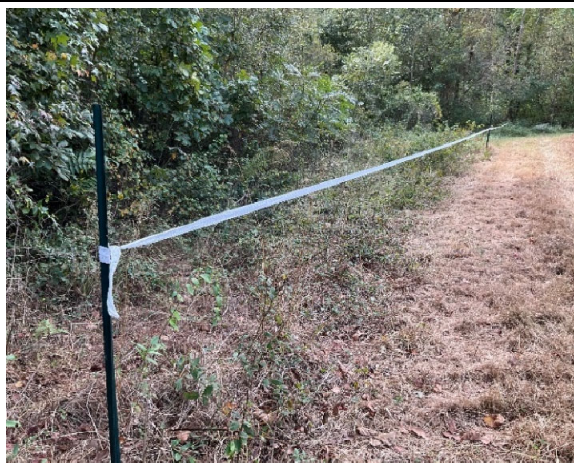
UT1C – Horse tape repaired on encroachment (Sta. 208+50) (10/17/2023)

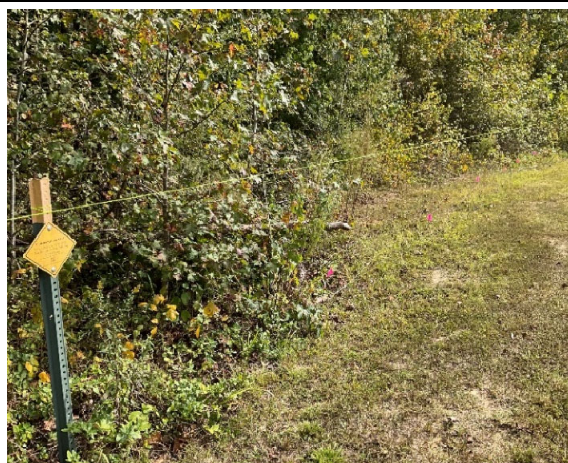
UT3 – Resolved mowing encroachment. The mowing was observed just outside of the boundary, as indicated by the string and flags (Sta. 408+00) (10/17/2023)

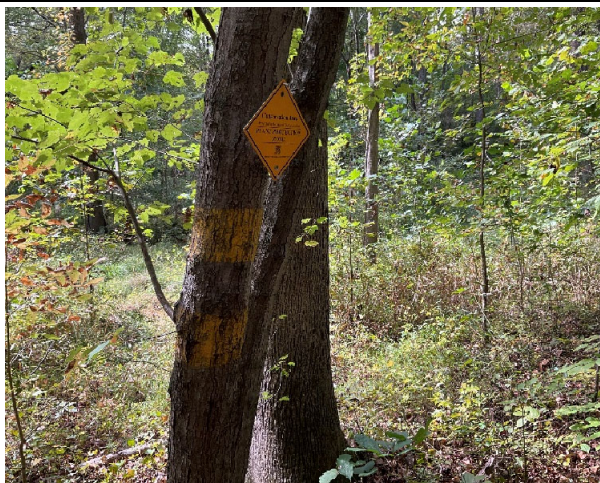
Candy Creek Reach 3 – New sign installed (Sta. 164+00) (10/17/2023)
