Year 3 Monitoring Report

CATBIRD SITE

NCDMS Project #100022 (Contract #7186)

Davie County, North Carolina

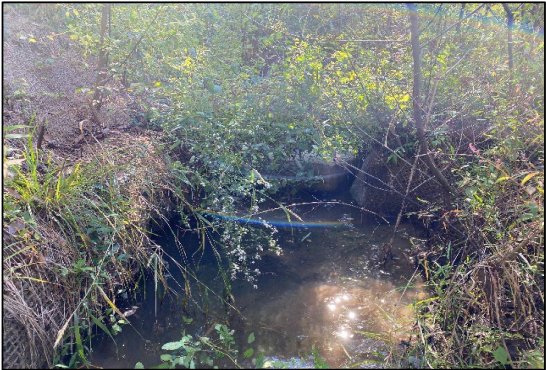
Stream Problem Areas Catbird	
Feature Issue / Location	Photo
Failing Rock Drop Structure / DS2-B (Repaired April 2021)

Visual assessment of the stream channel was performed to document signs of instability, such as eroding banks, structural instability, or excessive sedimentation. The channel is transporting sediment as designed and will continue to be monitored for aggradation and degradation. The rock drop structure below the

confluence of DS2-B and DS-1 that was repaired this structure with smaller rock material, as designed, in April 2021 is stable and functioning as intended.

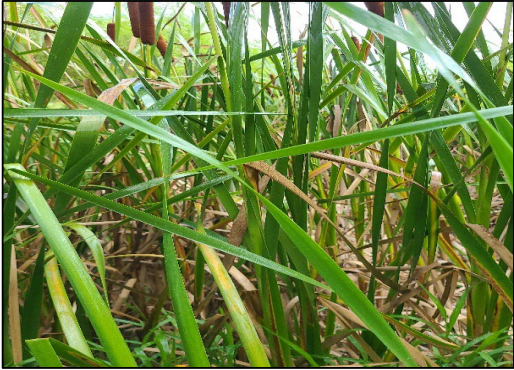
Vegetation Problem Areas Catbird	
Feature Category / Location / Size	Photo
Cattail Foliar Spray Treatment (DS1)

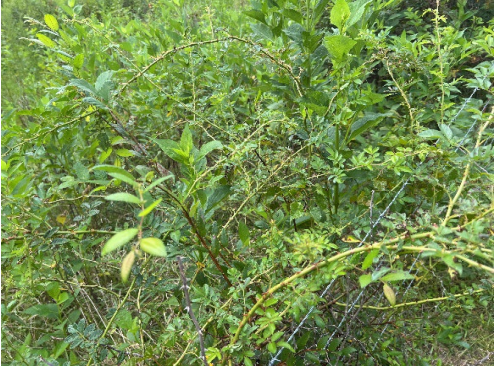
Mutliflora rose Foliar Spray Treatment (DS1)

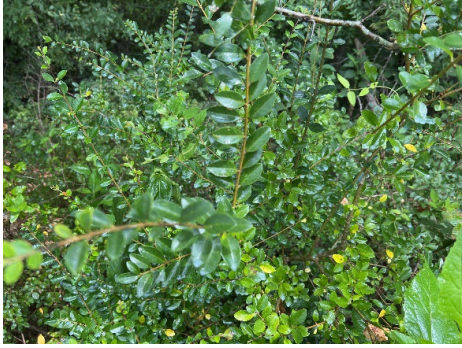
Chinese privet Foliar Spray Treatment (DS1)
