Monitoring Report MY03

**Cedar Branch Restoration Site
Monitoring Year 03
DMS Contract 6598
DMS Project Number 97009**

**DWR #: 20150904
USACE Action ID: 2003-21395
Randolph County, North Carolina**

**Monitoring Data Collected: 2020
Date Submitted: December 2020**

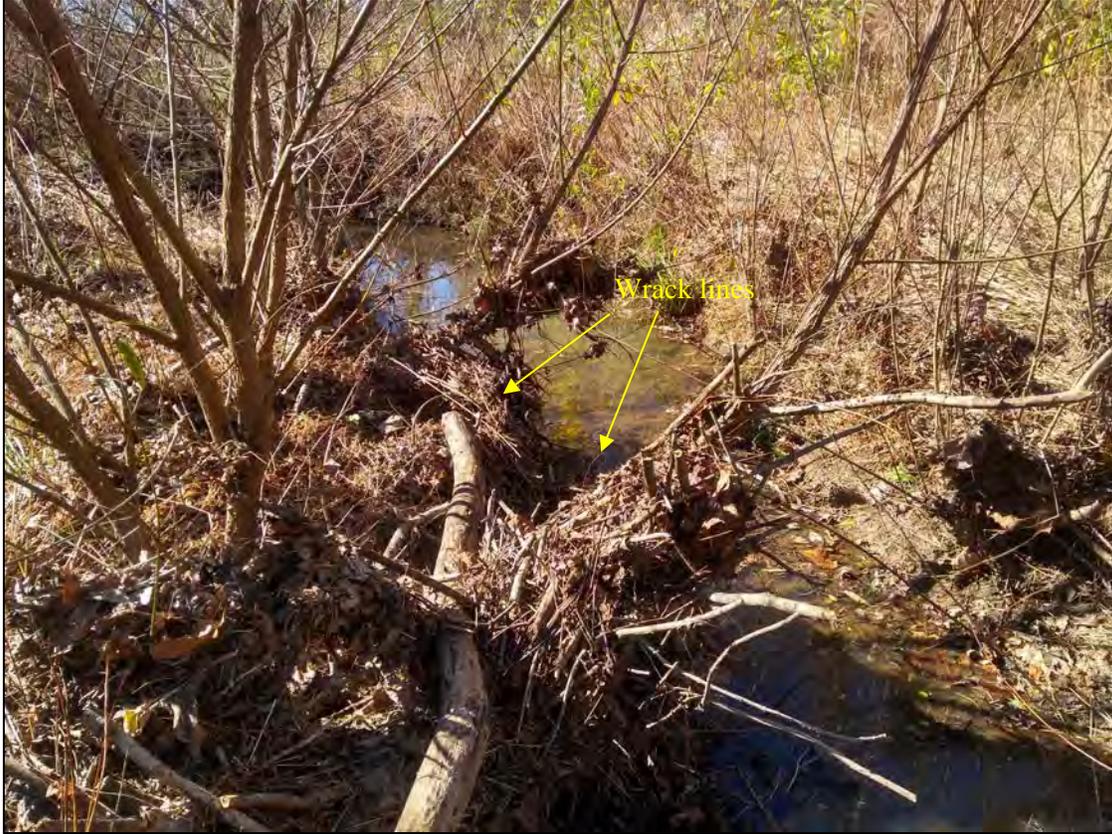
Photo 1. Wrack lines above bankfull, 11/16/2020
