**CEDAR CREEK STREAM AND WETLAND RESTORATION
PROJECT
MONITORING REPORT
MONITORING YEAR 2**

SAMPSON COUNTY, NORTH CAROLINA
CONTRACT No. 005011 - PROJECT No. 95718

January 2017

**Cedar Creek
Sampson County, North Carolina
DMS Project ID 95718**

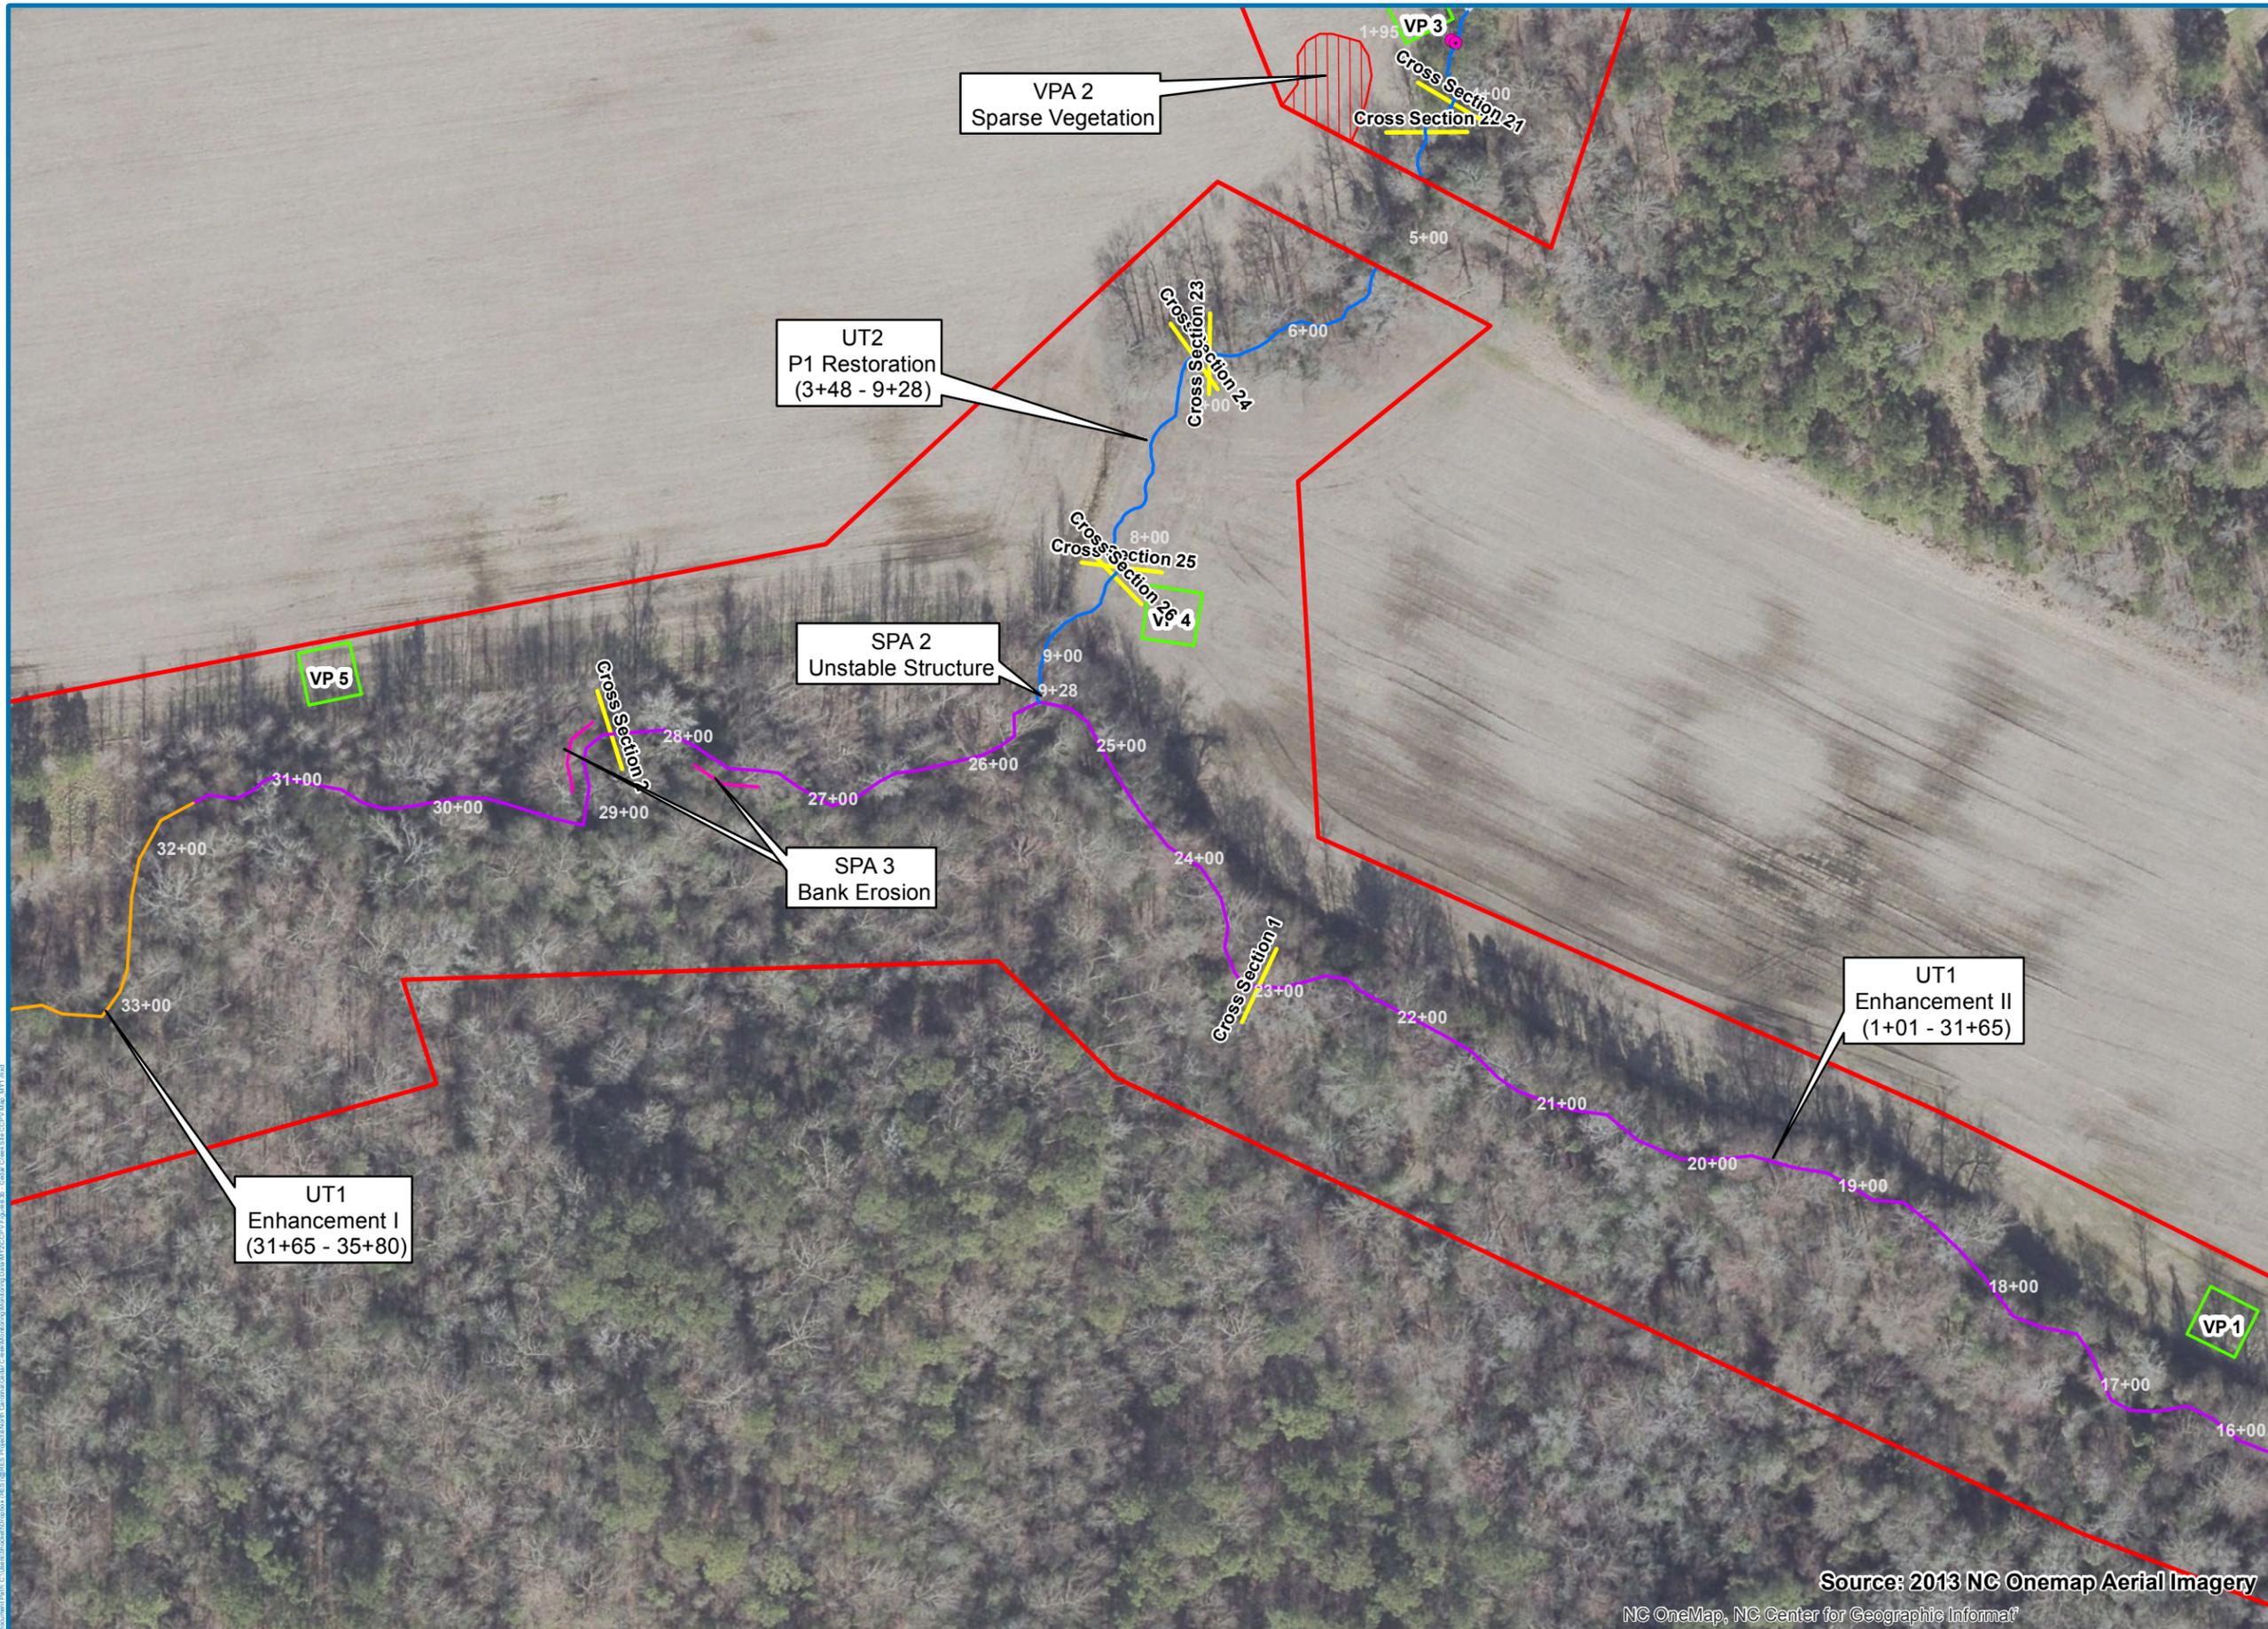
Figure 3b.
Cedar Creek
Restoration Project
UT1
Current Conditions
Plan View Map

One stream problem was identified during the Year 1 monitoring period and was mapped on the Current Conditions Plan View (CCPV), specifically Figure 3b. The problem was noted on the right bank of Reach UT1, just before the confluence with Reach UT2 (Sta 25+50). The problem area consisted of a tree that had fallen into the channel, associated bank erosion, and scouring with the disturbed root system. This problem area was monitored throughout MY2 and did not worsen or need any remediation. Following Hurricane Matthew, several areas with fallen trees similar to the problem area documented in MY1 report are present along UT-1. These areas will be monitored; however, they are not documented on the stream problem areas table or CCPV for MY2. During MY2 activities, three stream problem areas were documented. Stream Problem Area 1 (SPA1) consists of a debris jam associated from a fallen tree at the upstream portion (Sta. 0+50 – 1+00) of UT-2. The fallen tree has diverted stream flow out of the stream channel and across the floodplain on the right stream bank. Minor bank erosion has resulted in this area. Removal of the fallen tree is recommended along with any additional debris within the stream channel to allow natural channel flow pattern. Stream Problem Area 2 (SPA2) is located at the downstream end (Sta. 9+28) of UT-2. SPA2 is a log ramp structure that has become dislodged and non-functional. The footer logs are no longer tied into the banks resulting in piping around and under the log structure. Repair or replacing this log structure is recommended. The last stream problem area (SPA3) is localized erosion along UT-1. Bank erosion on both left and right stream banks was documented from station 27+50 to 28+75. Most areas are minor; however, a few consists of bank failures. These areas are primarily a result of severe flooding and high flow events resulting from Hurricane Matthew. Remediation is recommended on these areas of localized erosion. Most areas can be matted and live staked to remedy the problem. The more extensive bank failures will need the banks sloped back and matting and live stakes installed.
