ANNUAL REPORT FOR 2004

**South Fork Big Pine Creek Stream Mitigation Site
(Charles/McGinnis Site)
Madison County
WBS Element 32573.4.1
TIP No. A-10WM**

Prepared By:
Office of Natural Environment & Roadside Environmental Unit
North Carolina Department of Transportation
January 2005

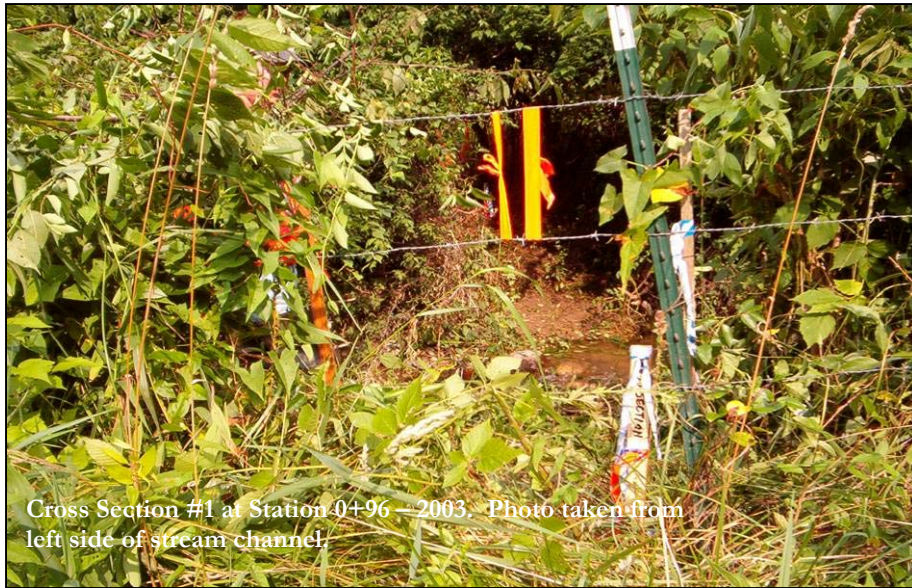
Cross Section #1 at Station 0+96 - 2003. Photo taken from left side of stream channel.

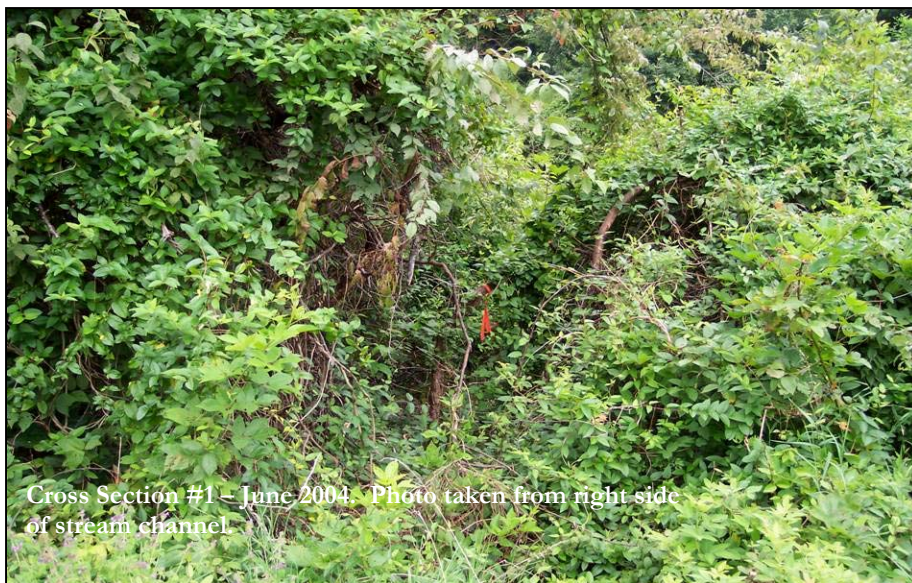
- ◆ Station 0+96 at Cross Section #1. The existing coir log along the left streambank (facing downstream) has been undermined by 2003. The structure remained in its

same state during both 2004 surveys. NCDOT will continue to monitor this area through the next monitoring period.

Cross Section #1 - June 2004. Photo taken from right side of stream channel.

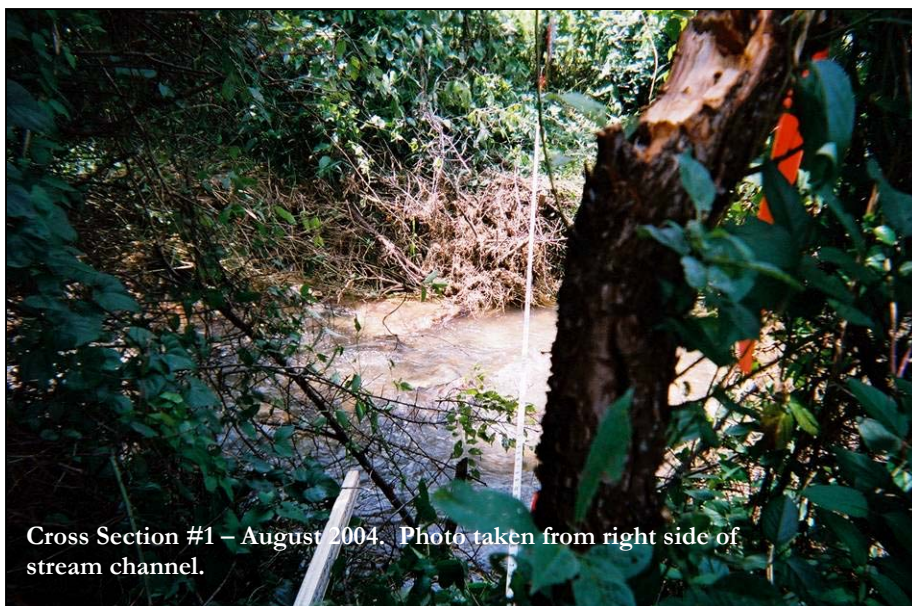
- ◆ Station 1+89 through 2+00. In August of 2004 it was noted that severe erosion was undercutting the left bank due to formation of a pool immediately downstream of cross section #1. This area should be monitored closely during the next monitoring period.

Cross Section #1 - August 2004. Photo taken from right side of stream channel.

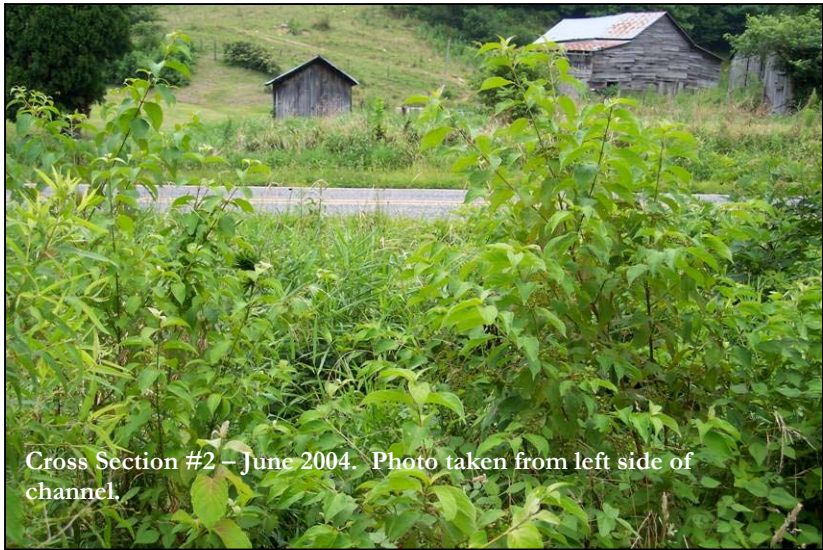
Cross Section #2 - June 2004. Photo taken from left side of channel.

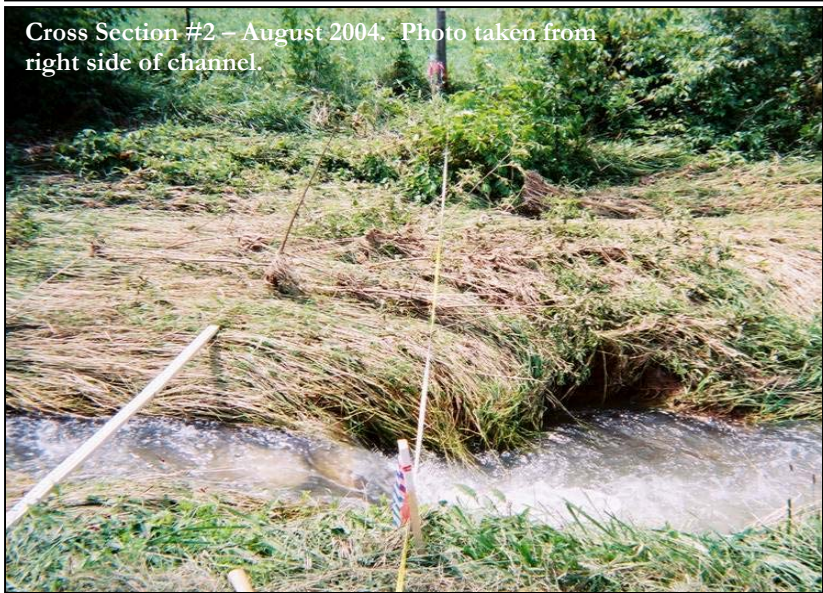
Cross Section #2 - August 2004. Photo taken from right side of channel.

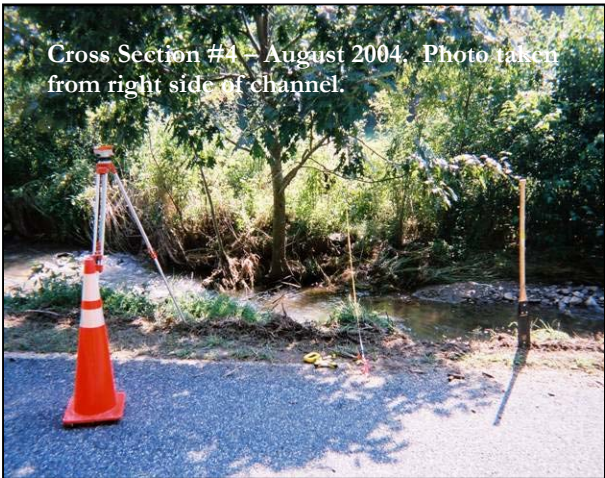
- ◆ Station 5+99 at Cross Section #4. Active erosion is present along outside of meander bend. This meander bend experienced erosional problems during the summer of 2003. NCDOT maintenance crews were forced to repair the outside of this bend due to severe erosion along the roadway embankment. As a result, one rootwad was removed and not replaced. Due to the bankfull event in July of 2004 the right bank has continued to undercut to a point where was under the roadway pavement. NCDOT maintenance crews will likely stabilize this area; however, remedial actions should be considered due to its close proximity to the existing roadway and ease of access. These actions should include the placement of a vane structure to divert the thalweg away from the roadway.

Cross Section #4 - August 2004. Photo taken from right side of channel.

5. Rock vanes should be the structures considered in the vicinity of Cross Section #4 to help stabilize the outside of the meander bend.
6. Cross Section #5 appears to be degrading. Placement of cross vanes through this section (from Stations 7+67 to 8+00) would assist with grade control issues. It will also assist with stabilizing the adjacent stream banks.

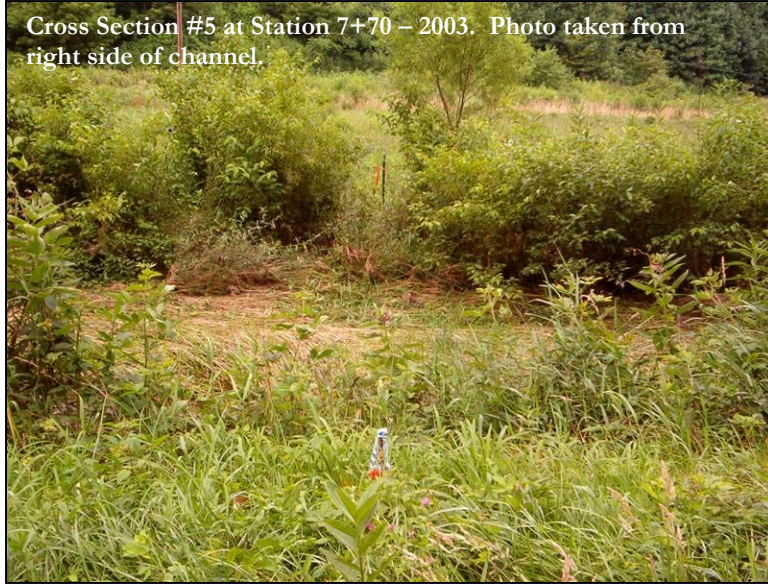
Cross Section #5 at Station 7+70 – 2003. Photo taken from right side of channel.

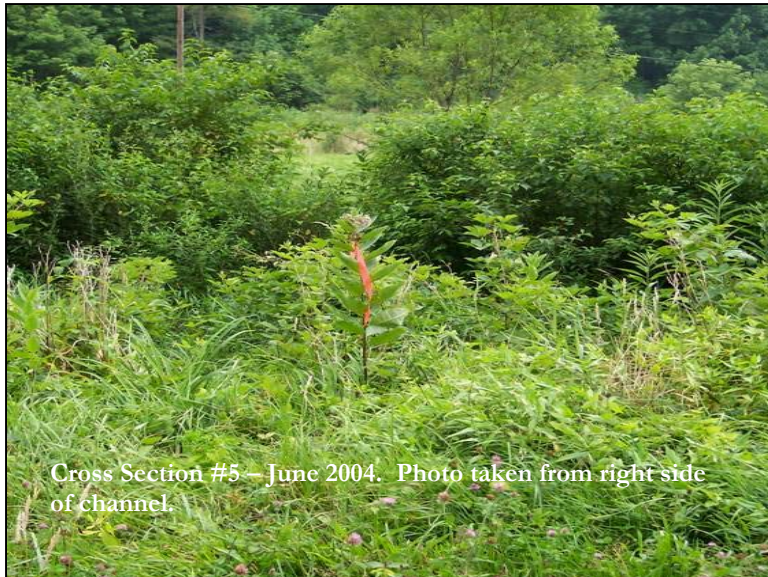
Cross Section #5 – June 2004. Photo taken from right side of channel.

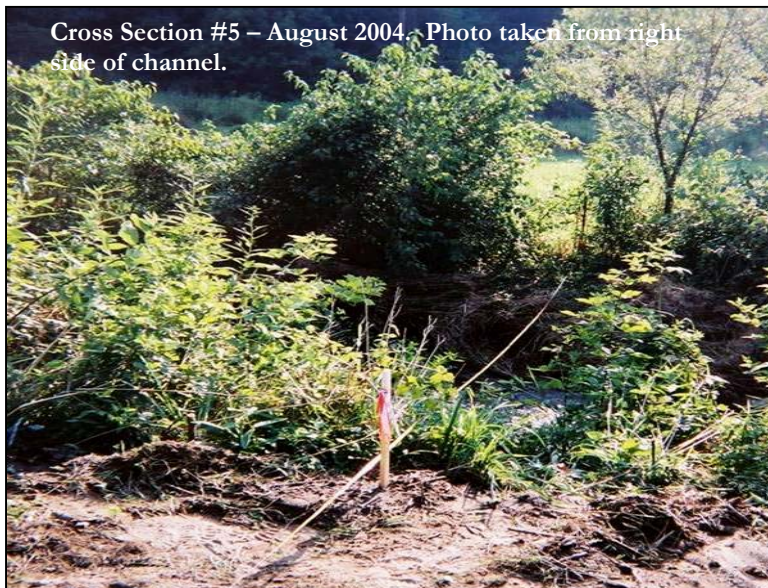
- ◆ Station 7+66 at Cross Section #5. In August 2004 it was noted that streambank was undercut on the left side approximately 1.2 feet. This was the result of the high flows experienced through this area. This area should be re-evaluated during the next monitoring period.

Cross Section #5 – August 2004. Photo taken from right side of channel.

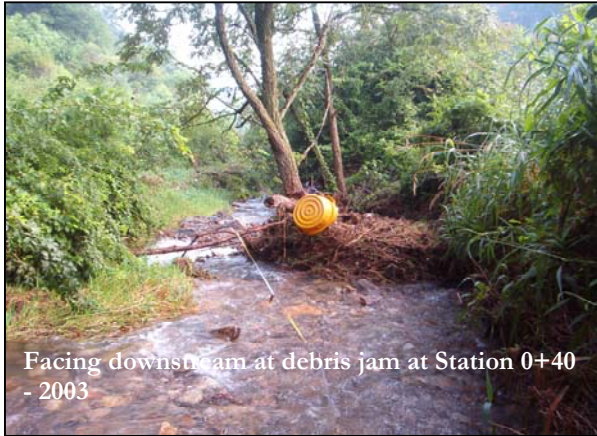
Several potential head cuts or niche points were noted during the survey of the longitudinal profile in 2003. The first was noted at Station 0+40. This cut was causing debris to accumulate in the center of the channel and exacerbating bank erosion along both sides of the channel. The cut was due to an old fence crossing the channel at this location which had accumulated debris along the upstream side and thus raised the overall elevation of the channel. The estimated drop of the thalweg was approximately two feet. This cut had adjusted by the 2004 survey resulting in less accumulation of debris and an improvement in bank stabilization. The other two cuts were observed at Stations 4+70 and 7+63. The second cut exhibited a vertical drop of nearly 1.5 feet while the third dropped approximately one foot. Both the second and third cuts had resulted in minor bank scouring. These cuts had also adjusted by the 2004 survey causing bank scouring to cease.

Facing downstream at debris jam at Station 0+40 - 2003

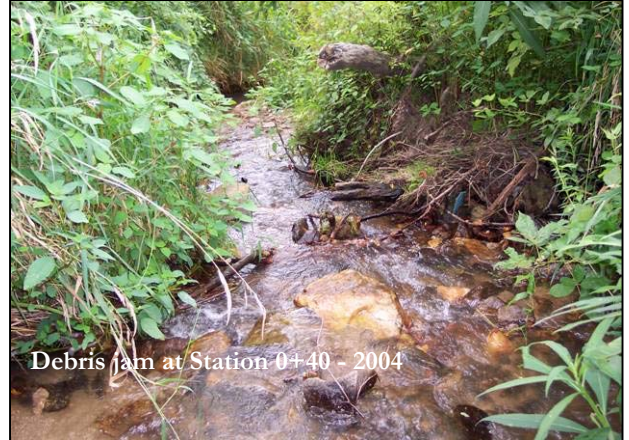
Debris jam at Station 0+40 - 2004

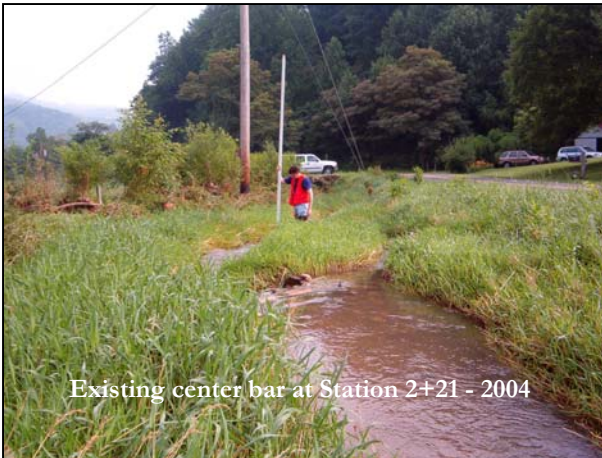
- ◆ Stations 2+21 through 2+54. A center bar was observed through this section of the reach in 2003. The thalweg is currently following the left channel; however, the right channel also funnels water during normal and high flows as noted during the August 2004 surveys. This area should be re-assessed during the next monitoring period.

Existing center bar at Station 2+21 - 2004

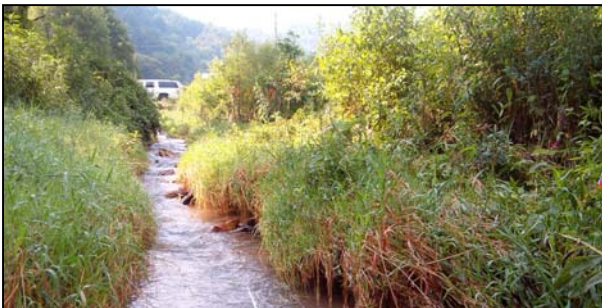
- ◆ Stations 5+33 through 5+63. The right streambank was undermined and actively sloughing by the 2003 survey. During the first 2004 survey, the majority of the undercut material had been washed downstream. The August 2004 survey revealed a vertical streambank through this area.

- ◆ Stations 5+33 through 6+50. The left streambank was severely undercut by 2003. This streambank remained unstable in 2004. This area should continue to be monitored.

Facing upstream at undercut banks at Station 5+65 - June 2004

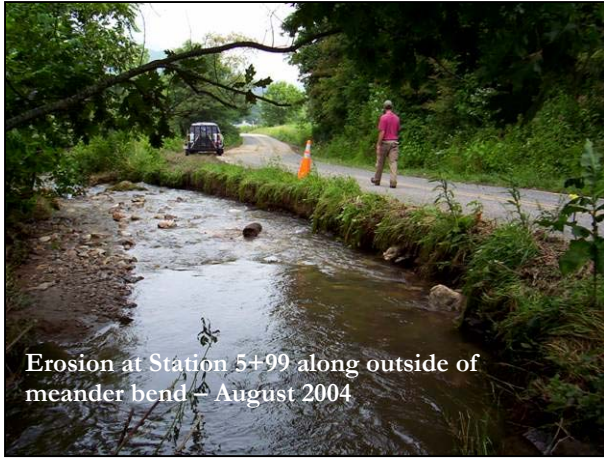
Erosion at Station 5+99 along outside of meander bend - August 2004

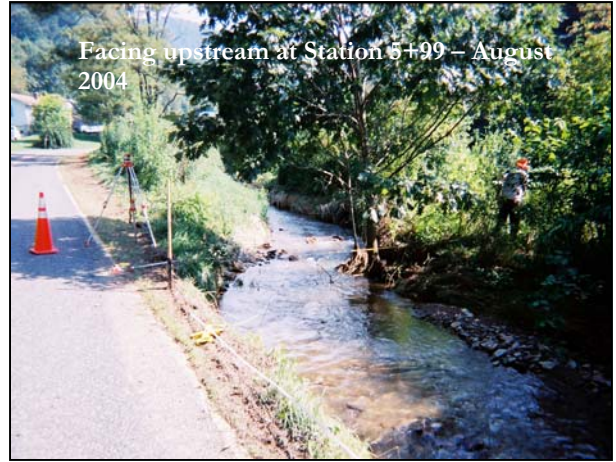
Facing upstream at Station 5+99 - August 2004

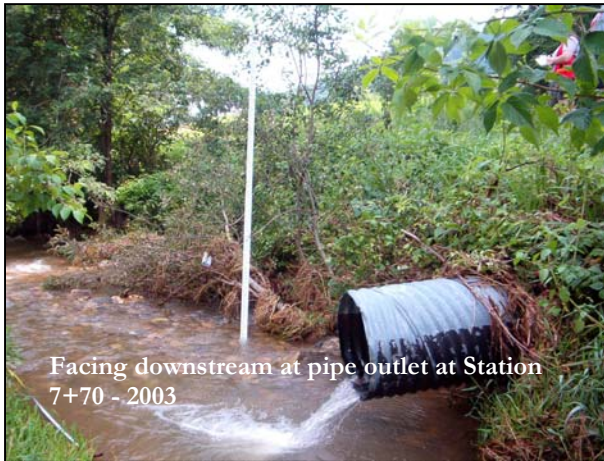
- ◆ Stations 7+67 through 8+00. Active erosion was noted at and around the pipe outlet entering from the right side. This area should continue to be monitored during the next monitoring period.

Facing downstream at pipe outlet at Station 7+70 - 2003

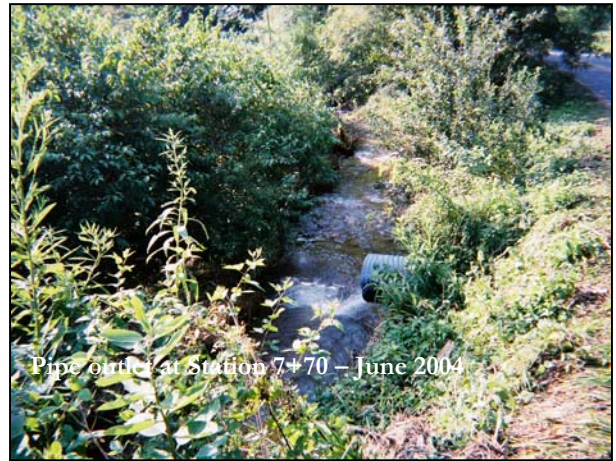
Pipe outlet at Station 7+70 - June 2004
