CLEGHORN CREEK STREAM RESTORATION PROJECT
ANNUAL MONITORING REPORT FOR 2010 (YEAR 5)
Project Number: D-04010

CLEGHORN CREEK YEAR 5 MONITORING PLANS RUTHERFORDTON, RUTHERFORD COUNTY, NC

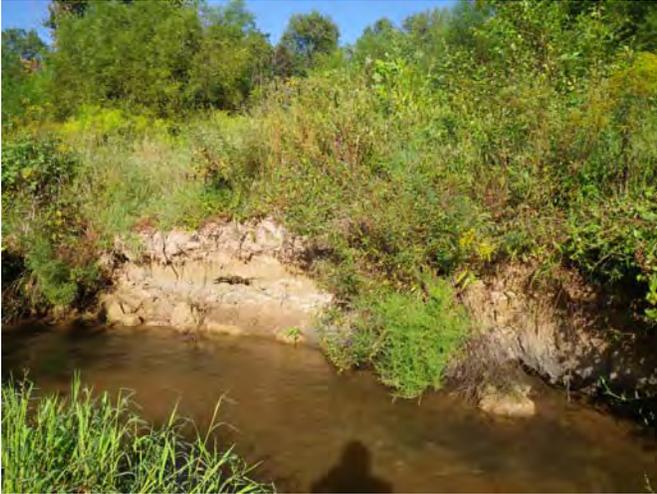
Bank erosion at Sta. 117+00 caused by growth of a mid-channel bar near the left bank.

suspected of playing a role in the current condition of the bank. During winter 2010, these bank sections will be stabilized by resloping the banks and planting a series of tag alders or other woody vegetation. Based on the overall stability of both channels, no other maintenance or repair work is required at this time.

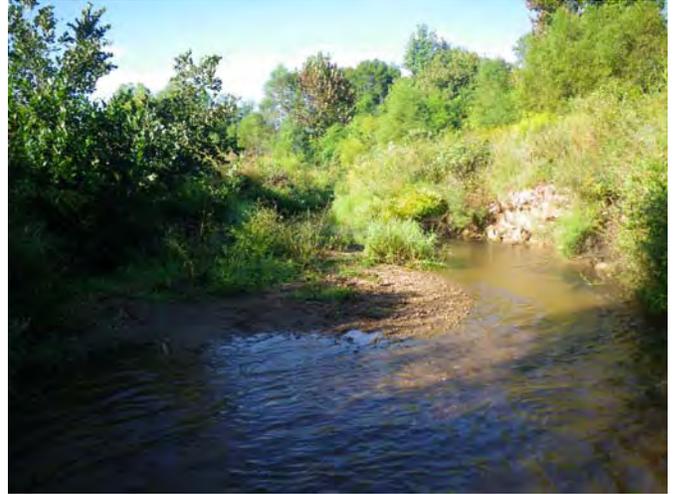
Mid-channel bar causing erosion on right bank at Sta. 117+00.

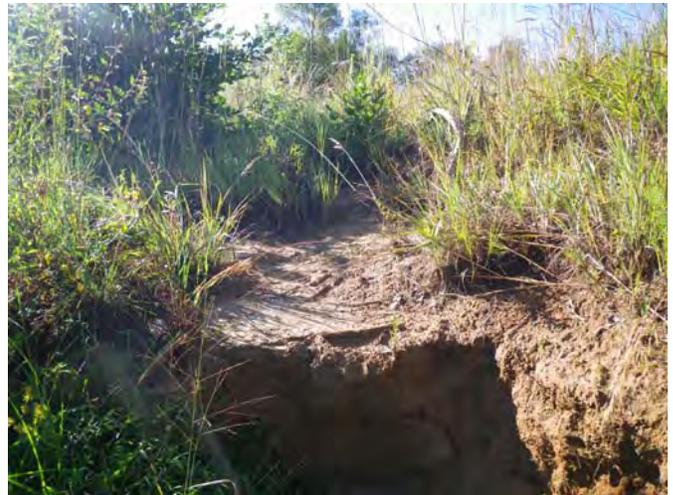
Approximately 15-feet of scour along right bank at Sta. 121+50.

Worn animal path at Sta. 121+50 (same area located on left side of previous photo).

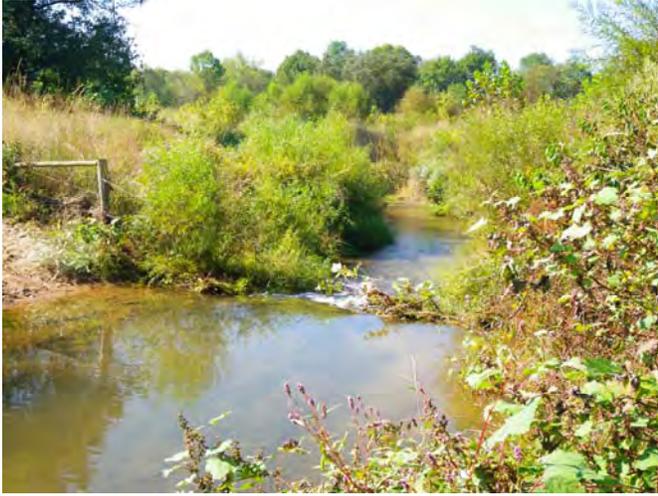
Sta. 131+50 where rope for crossing will be re-installed. Beaver dam was also scheduled for removal once survey crews were out of the area.
