CUTAWHISKIE CREEK STREAM AND WETLAND RESTORATION SITE 2011 ANNUAL MONITORING REPORT (YEAR 4)

HERTFORD COUNTY, NORTH CAROLINA NCEEP CONTRACT NO. D06066-A

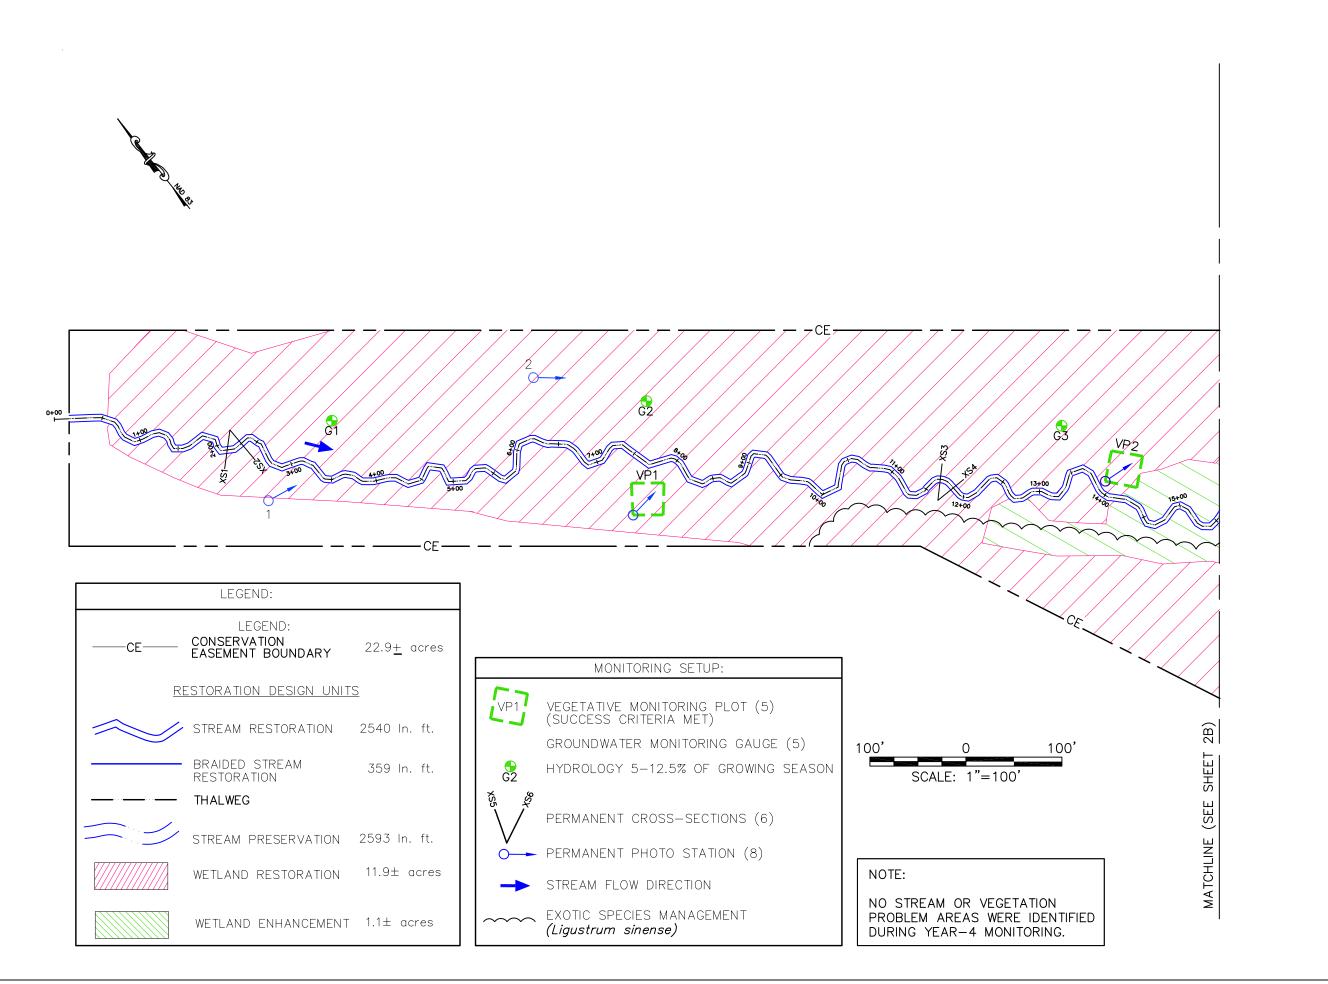
Chinese privet (*Ligustrum sinense*), an exotic invasive, was found growing densely along the lower reach of the stream channel. During the winter of 2010, the Prime Contractor (Restoration Systems LLC) initiated their plan to manage exotic species Chinese privet on the Site. Dense thickets of Chinese privet

were sprayed along the southwestern Site boundary (Figure 2A and 2B, Appendix D) and solitary specimens located along Cutawhiskie Creek. Given the vigorous nature of Chinese privet, the Site will continue to be monitored in order to maintain control of the species.
