# **MONITORING YEAR 5 ANNUAL REPORT FINAL**

## **DEVIL'S RACETRACK MITIGATION SITE**

Johnston County, NC

NCDEQ Contract 003989

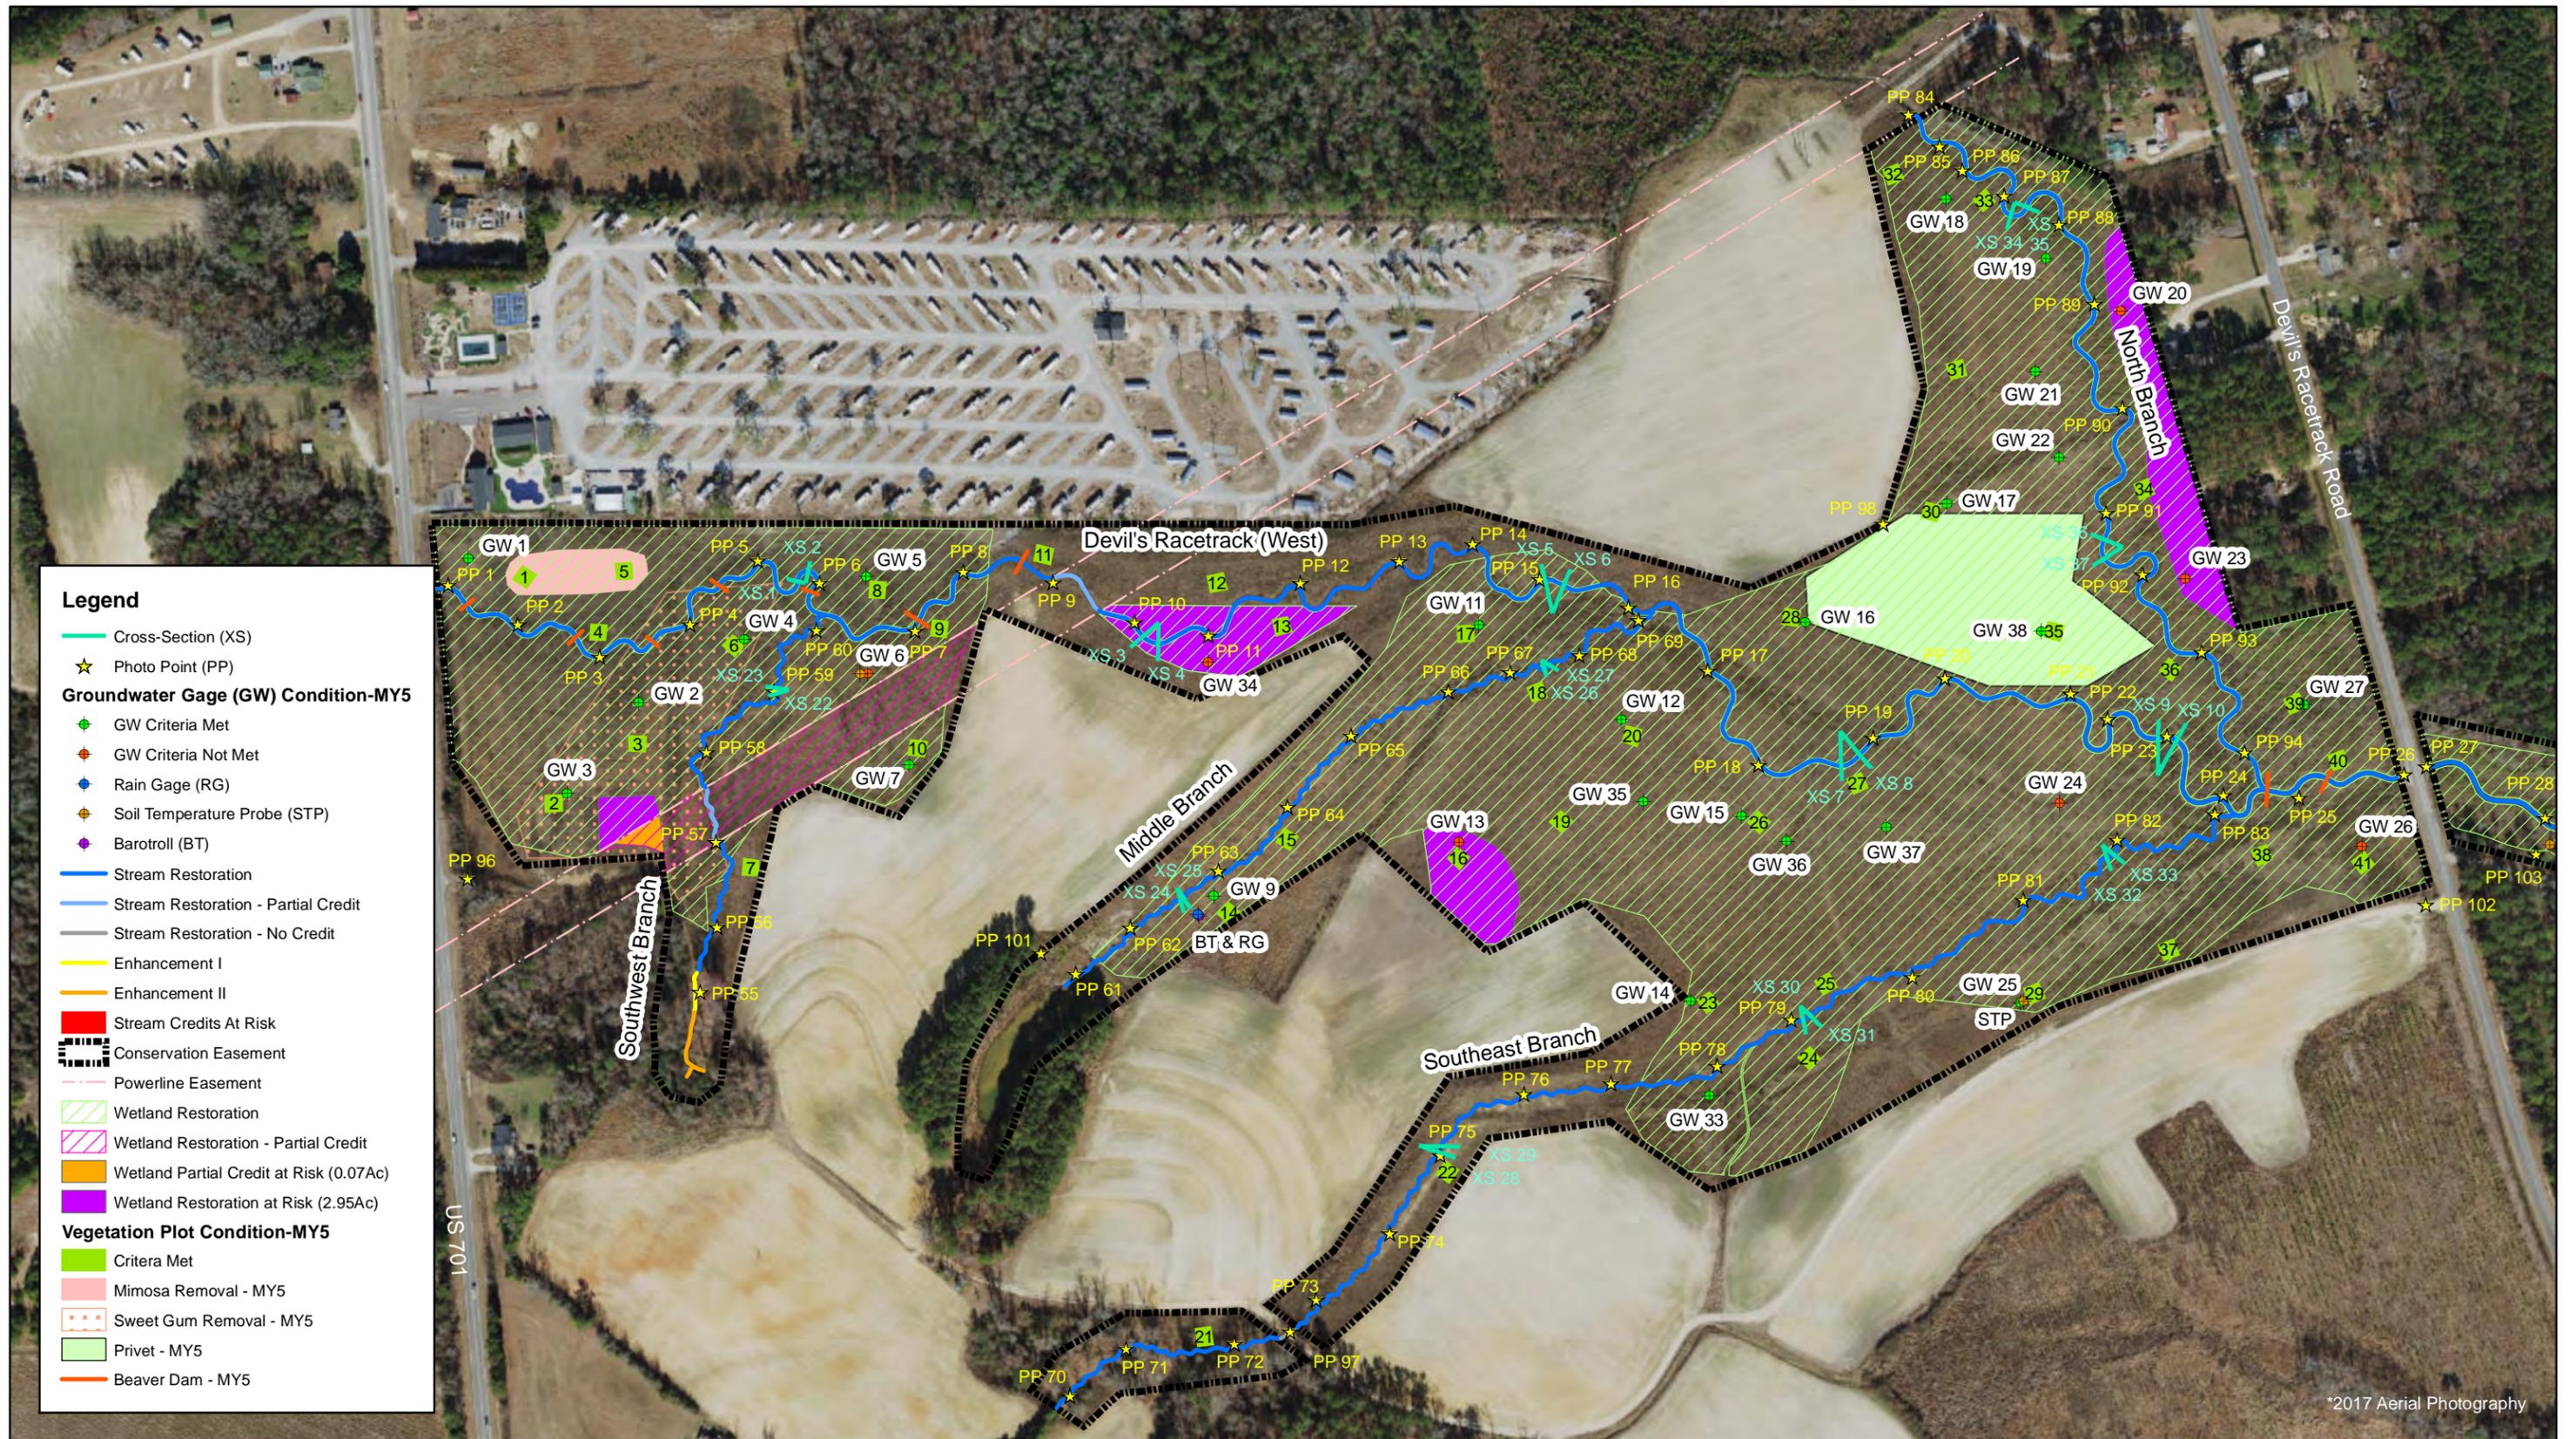
Figure 3.1 Integrated Current Condition Plan View  
 (Sheet 1 of 2)  
 Devil's Racetrack Mitigation Site  
 DMS Project No. 95021  
 Monitoring Year 5 - 2018  
 Johnston County, NC

During a site walk in the summer of 2018, the IRT expressed concerns about the density of sweetgum (*liquidambar styraciflua*) seedlings growing along the west side of Southwest Branch. In October 2018, this area of sweetgum was treated using the cut stump method to apply triclopyr. In November 2018, a small patch of mimosa (*albizzia julibrissin*) was treated on the west side of the project near US Highway 701. Scattered, low densities of Chinese privet (*Ligustrum sinense*) were also treated on the west side of the project in November 2018. An area containing Chinese privet exists between Devil's Racetrack (West) and North Branch. This area will be treated during MY6. The Current Condition Plan View in Appendix 2 shows vegetation areas of concern.

Several beaver dams were observed along Devil's Racetrack (West) in November 2018. Most of the dams were located between the start of the project at US Highway 701 and the powerline easement on Devil's Racetrack Creek. Two beaver dams were also located near Devil's Racetrack Road near the confluence of North Branch (CCPV, Appendix 2). The USDA has been contacted and is in the process of removing beaver from the Site. The site will be monitored for future beaver activity during subsequent monitoring years.
