**Dog Bite Stream Restoration Site
Monitoring Report – MY03
Mitchell County, NC
Basin 06010108
EEP Project ID # 92533
Contract # D06056-A**

February 2013

**Project Contact: Adam Spiller
Email: adam.spiller@kci.com
KCI Project No: 12065439**

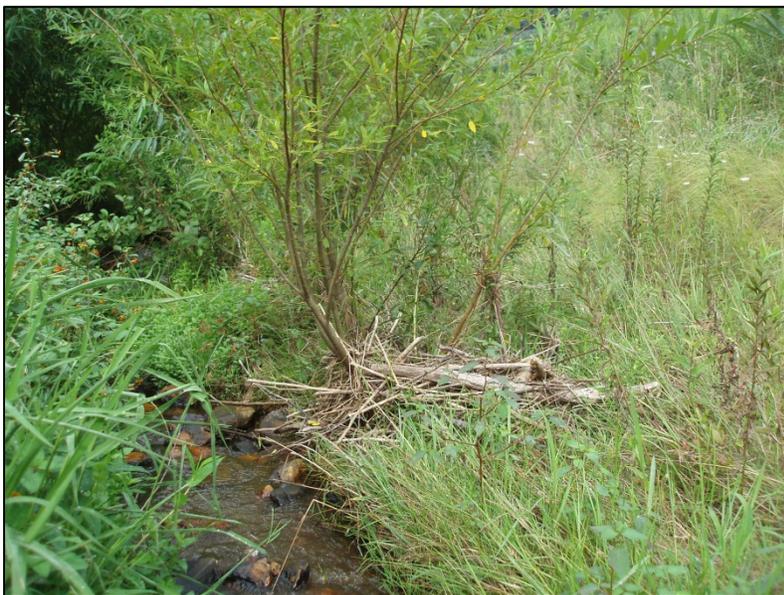
During an August site visit, a photo depicting a wrack line was taken to document a bankfull event. See Section 2.2.1 Bankfull Events.

Table 5. Verification of Bankfull Events		
Dog Bite Stream Restoration Site		
Date of Data Collection	Date of Occurrence	Method
None in 2010 or 2011		
August 9, 2012		See photo below

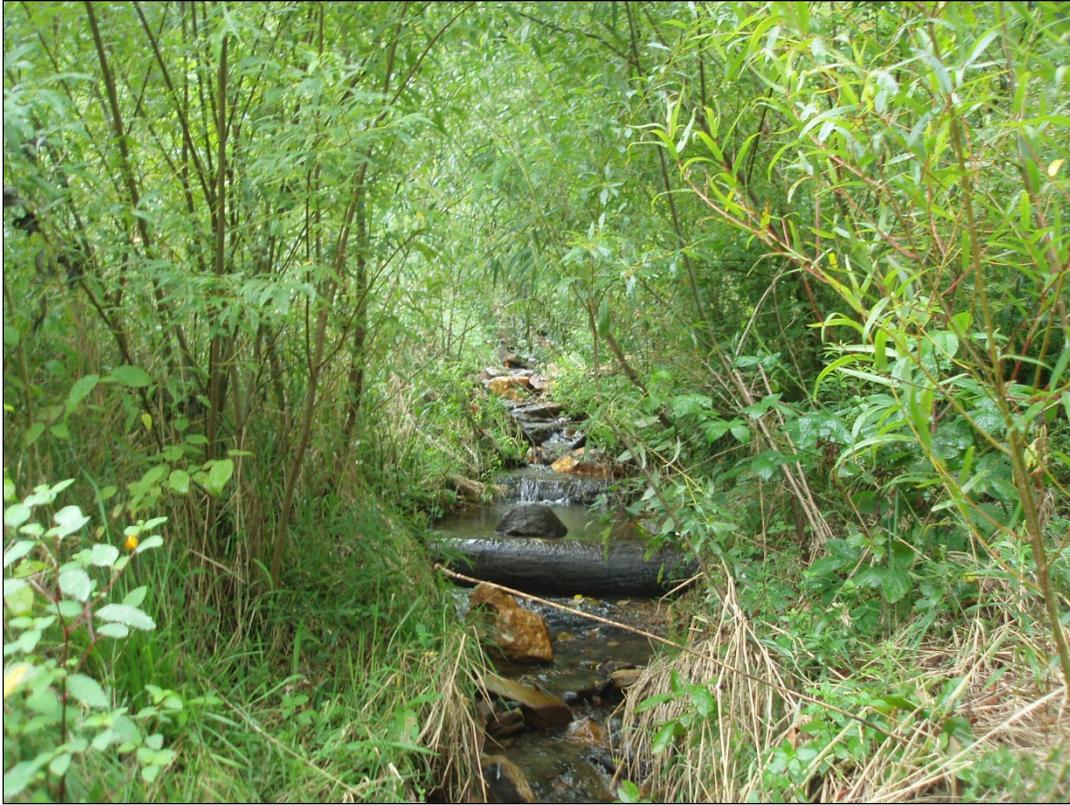
Photo Point 1: View looking upstream, from ford crossing near Station 12+50. 9/28/12 – MY03

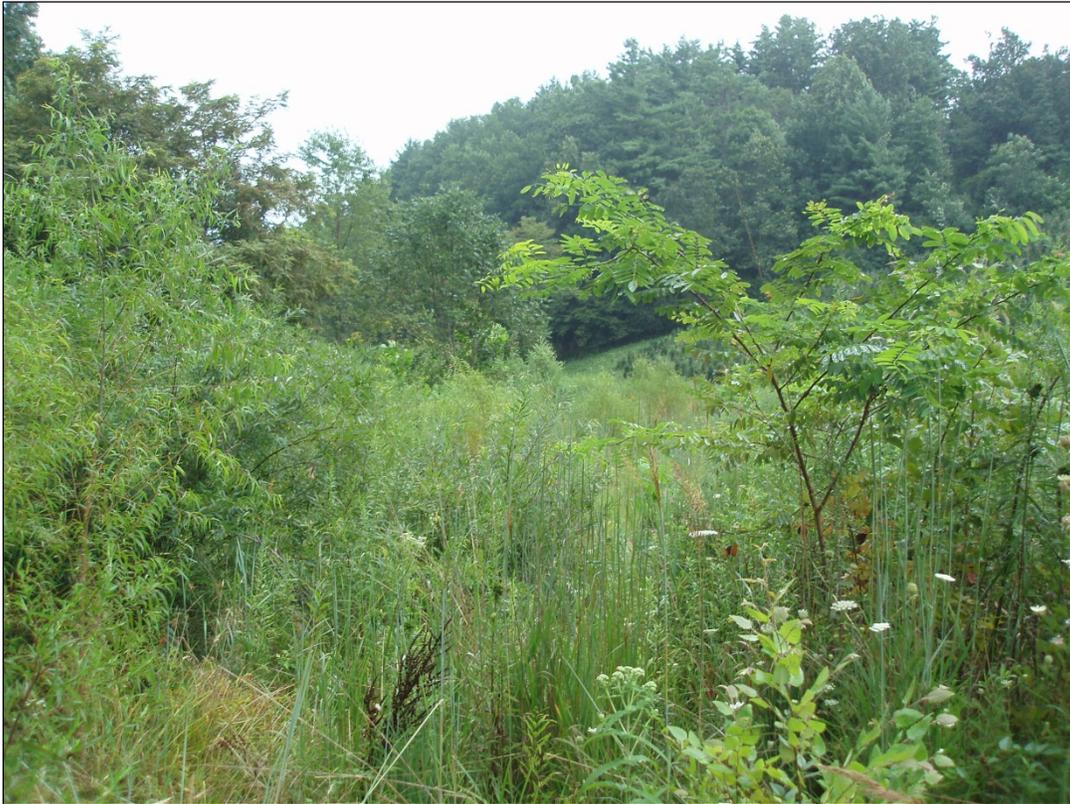
Photo Point 2: View looking downstream, near Station 14+00. 9/28/12 – MY03

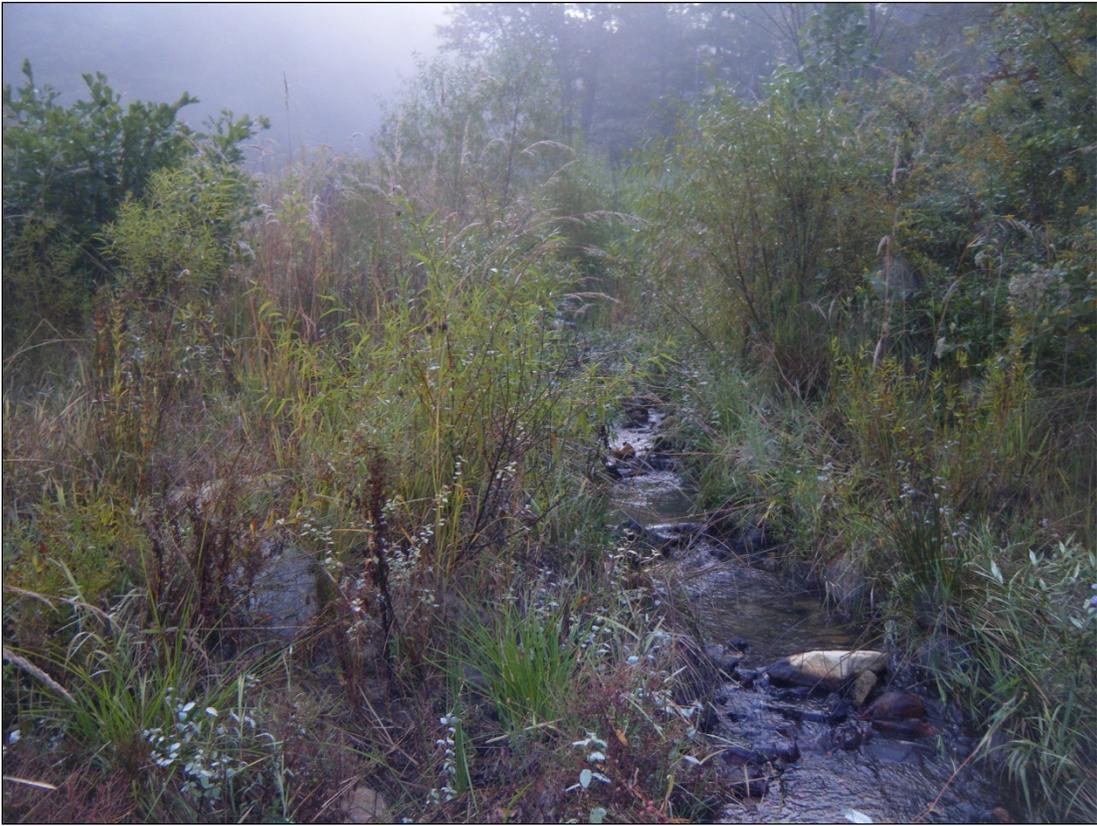
Photo Point 3: View looking upstream at the confluence of WOC and T1. 9/28/12 – MY03

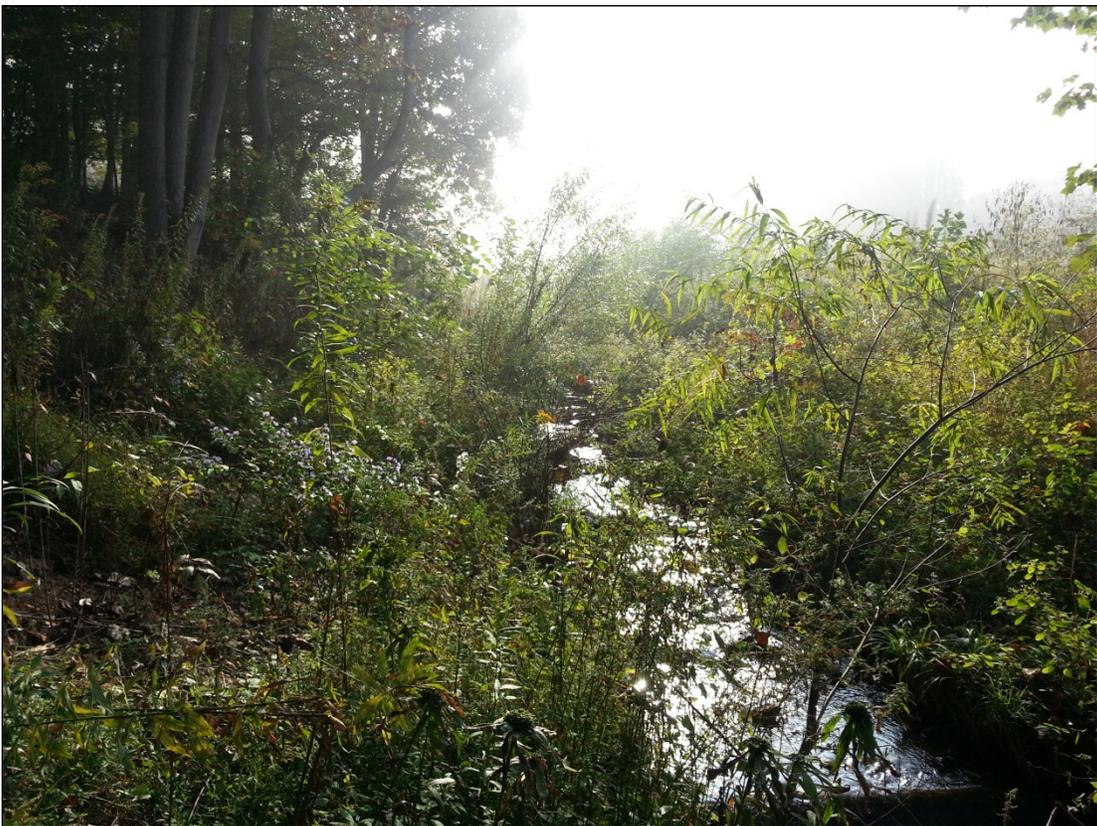
Photo Point 4: View looking upstream taken near Station 20+50. 9/28/12 – MY03

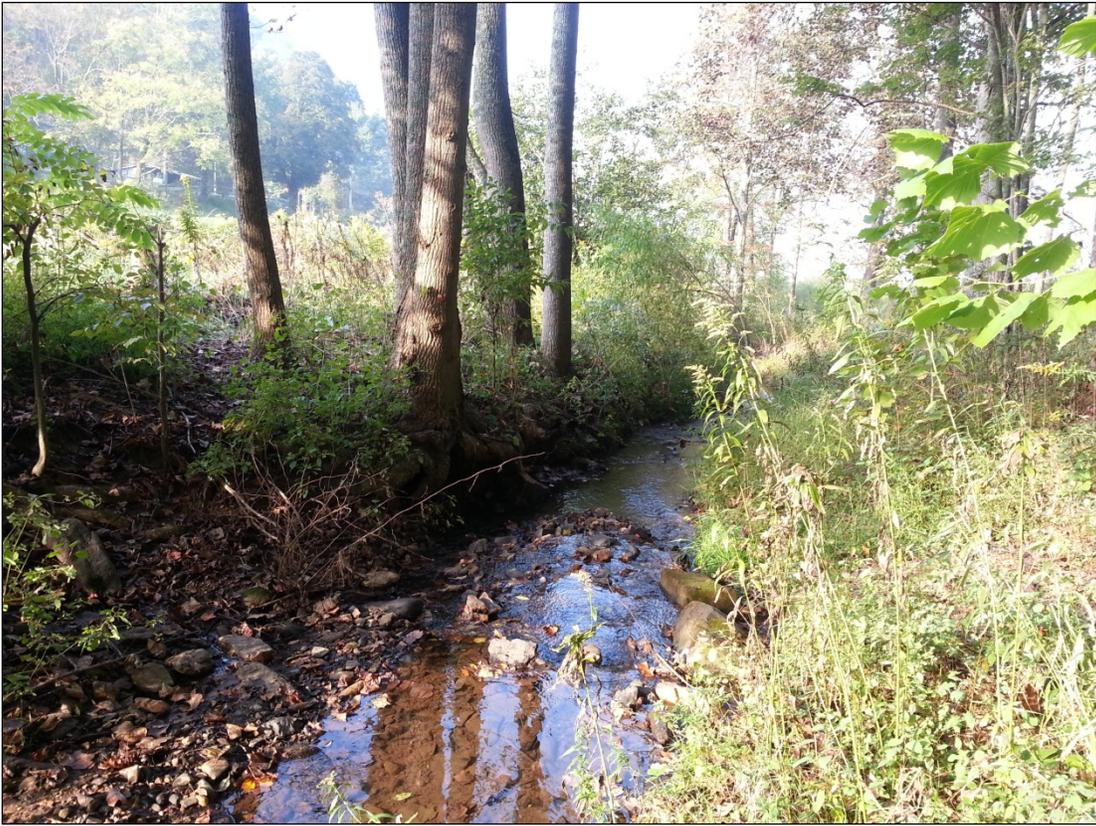
Photo Point 4: View looking downstream near Station 20+50. 9/28/12 – MY03

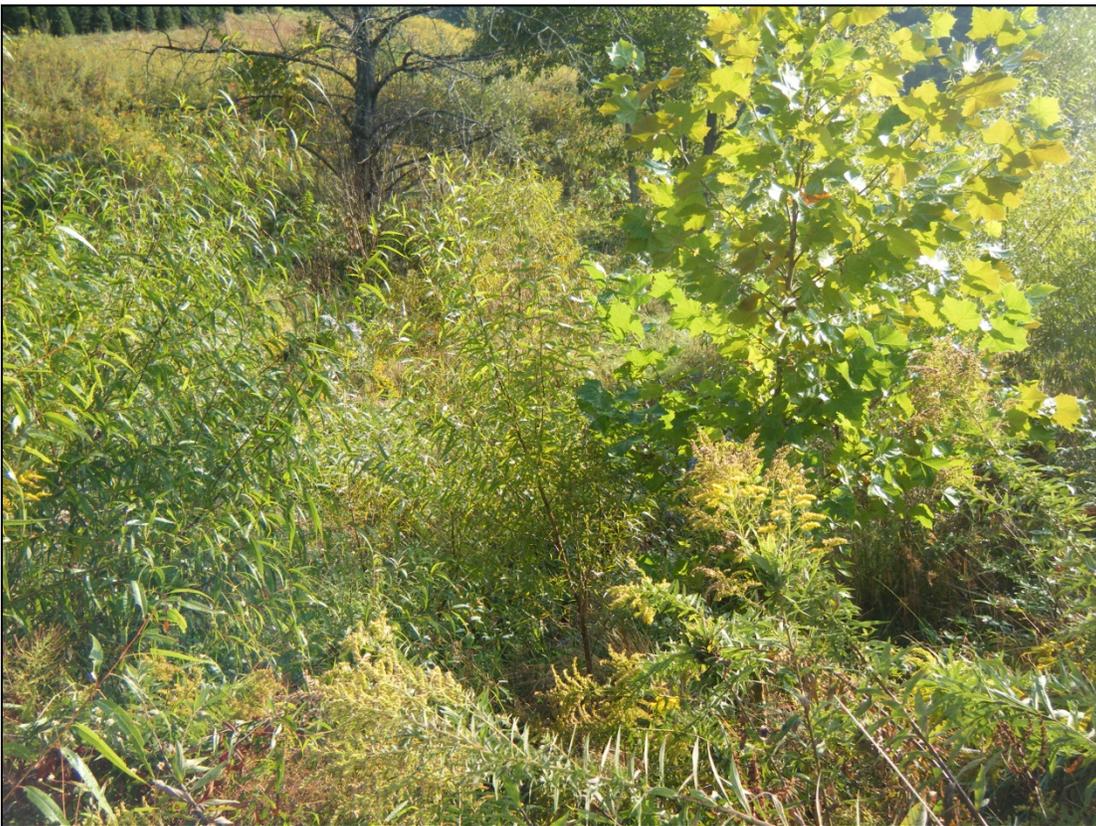
Photo Point 5: View looking upstream at WOC, near Station 26+25. 9/28/12 – MY03

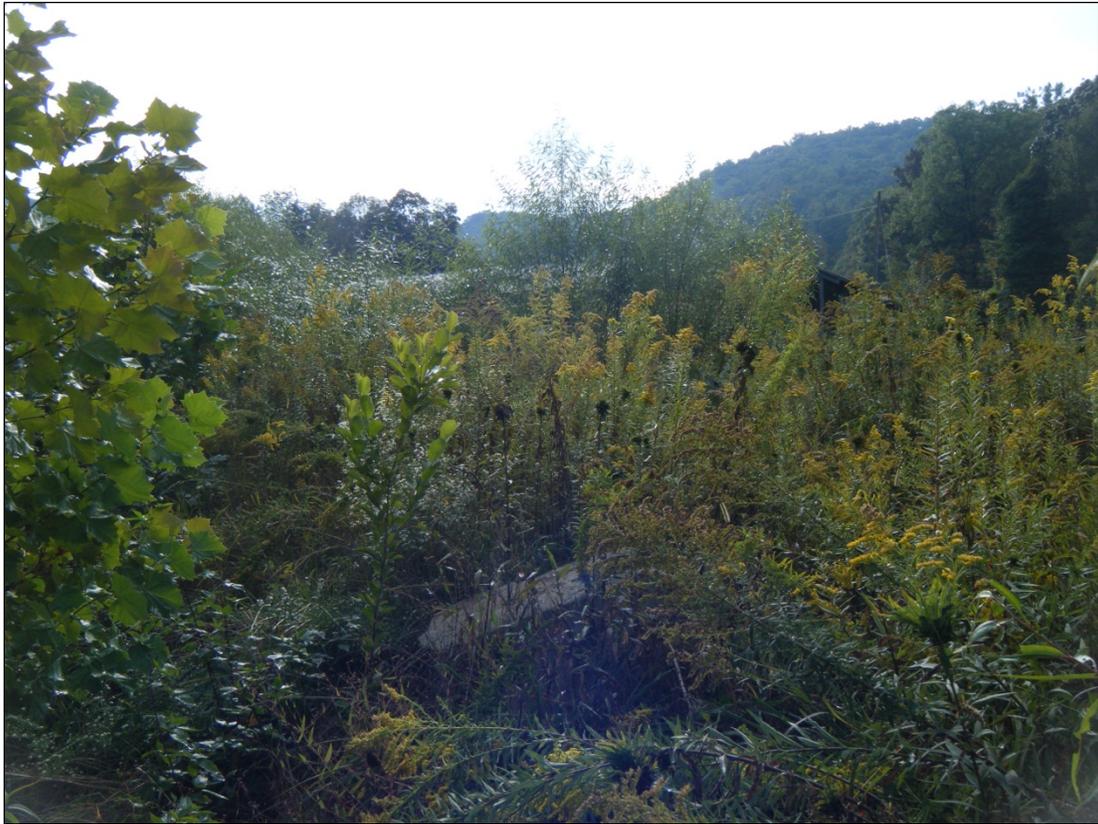
Photo Point 5: View looking at water treatment pool, near Station 26+25. 9/28/12 – MY03

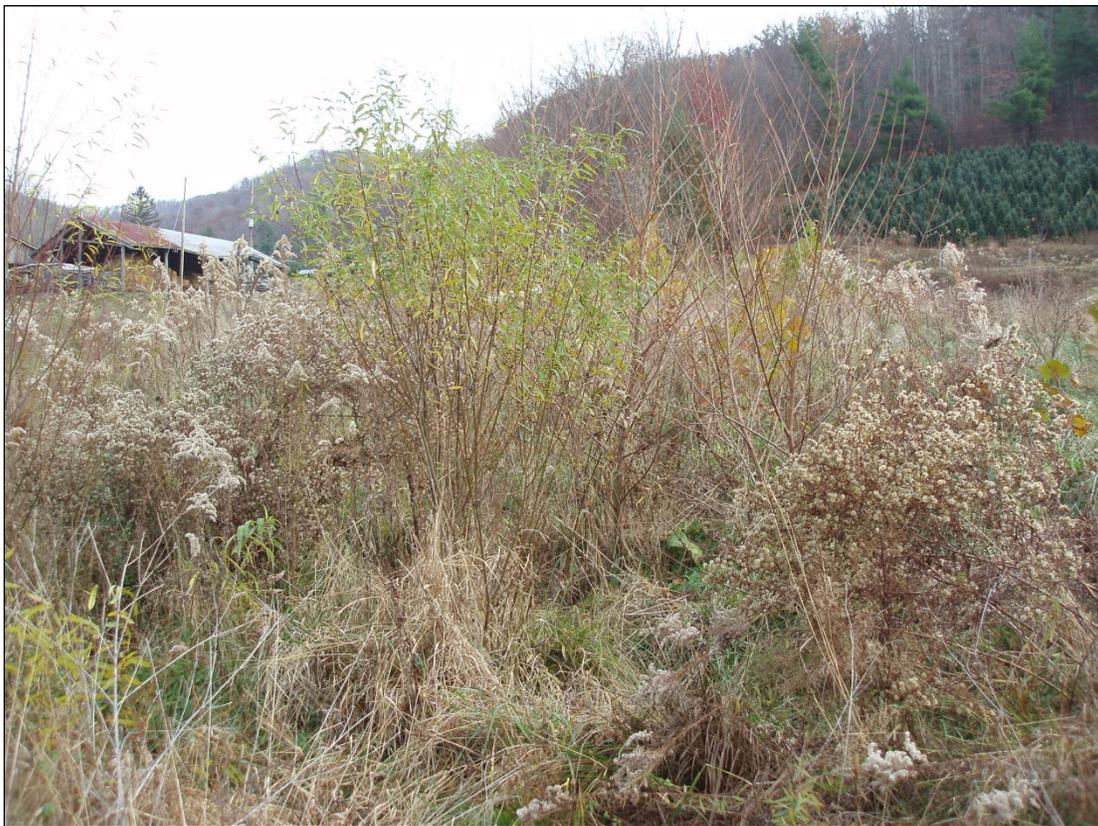
Photo Point 6: View looking upstream at T2, near Station 27+75. 9/28/12 – MY03

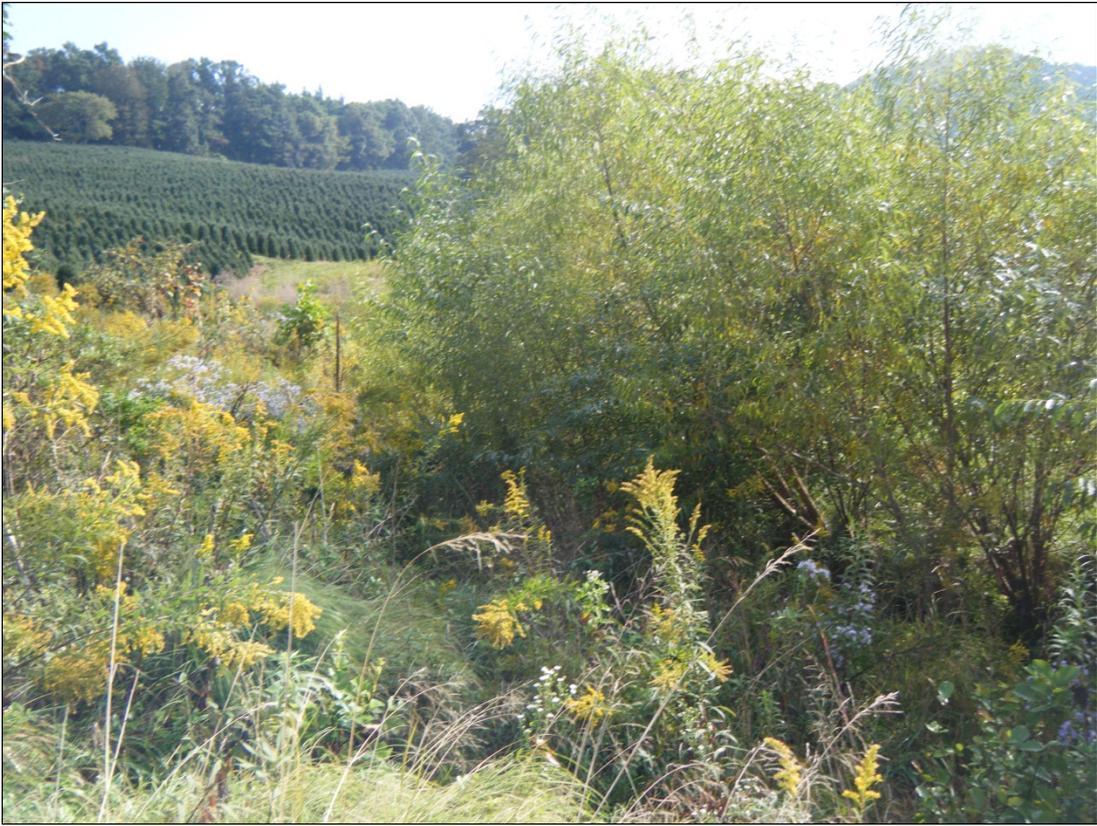
Photo Point 7: View looking upstream near Station 29+25. 9/28/12 – MY03

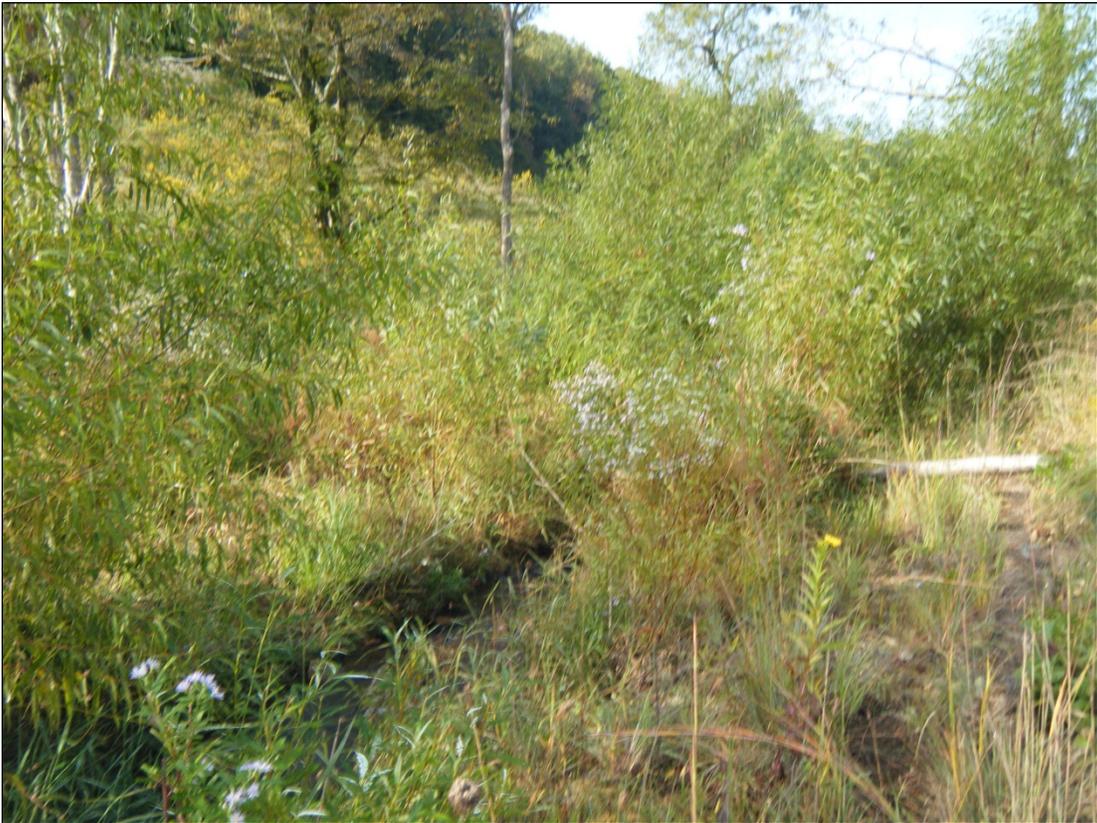
Photo Point 7: View looking downstream near Station 29+25. 9/28/12 – MY03

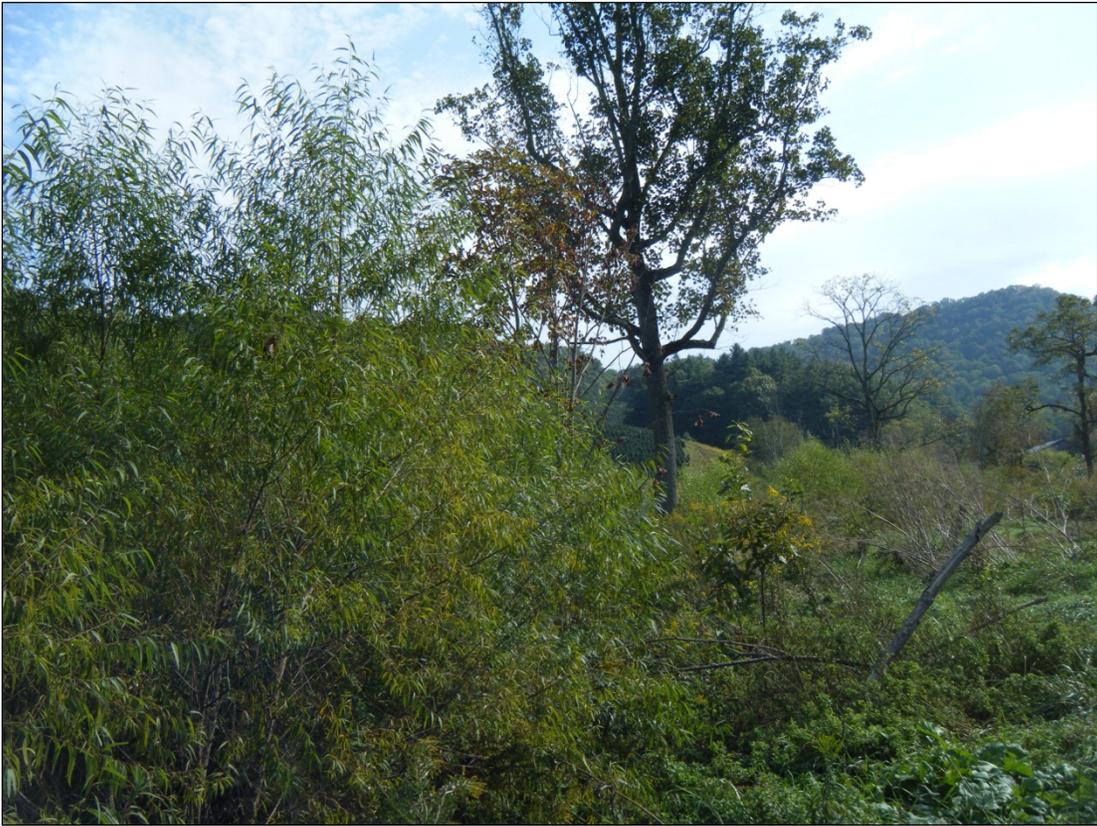
Photo Point 8: View looking upstream near Station 34+00. 9/28/12 – MY03

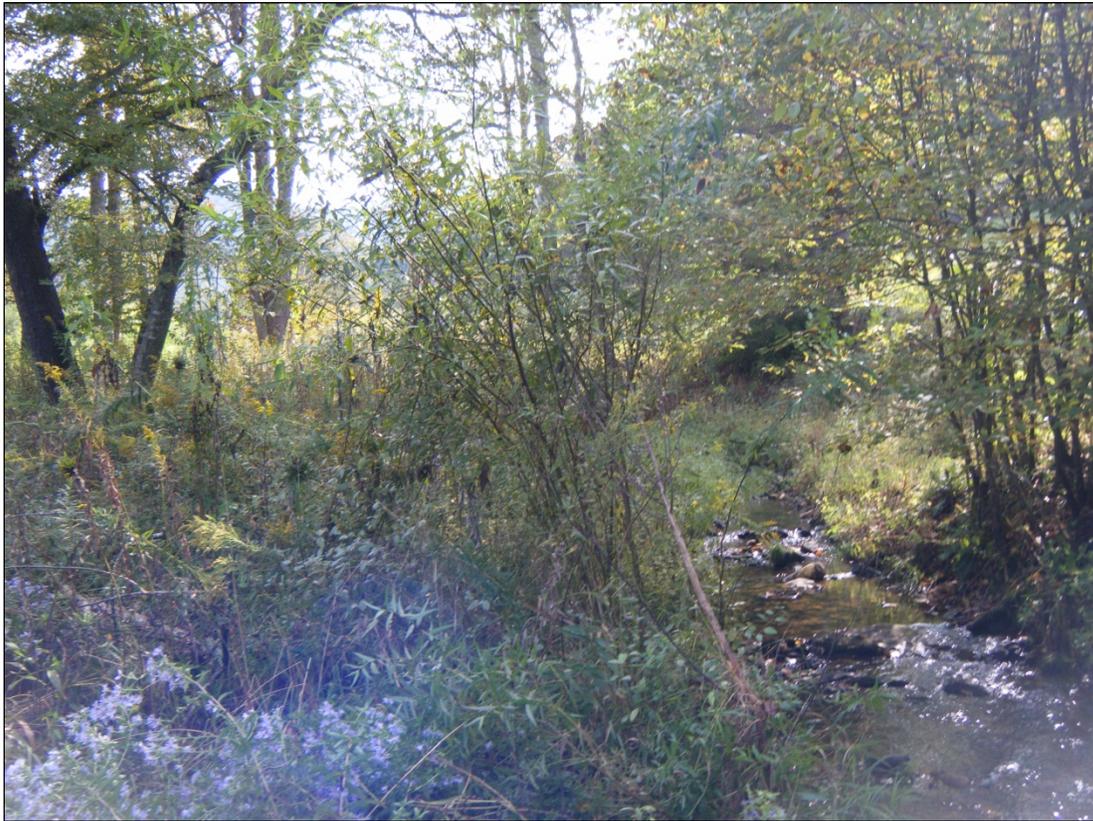
Photo Point 9: View looking upstream near Station 39+25. 9/28/12 – MY03

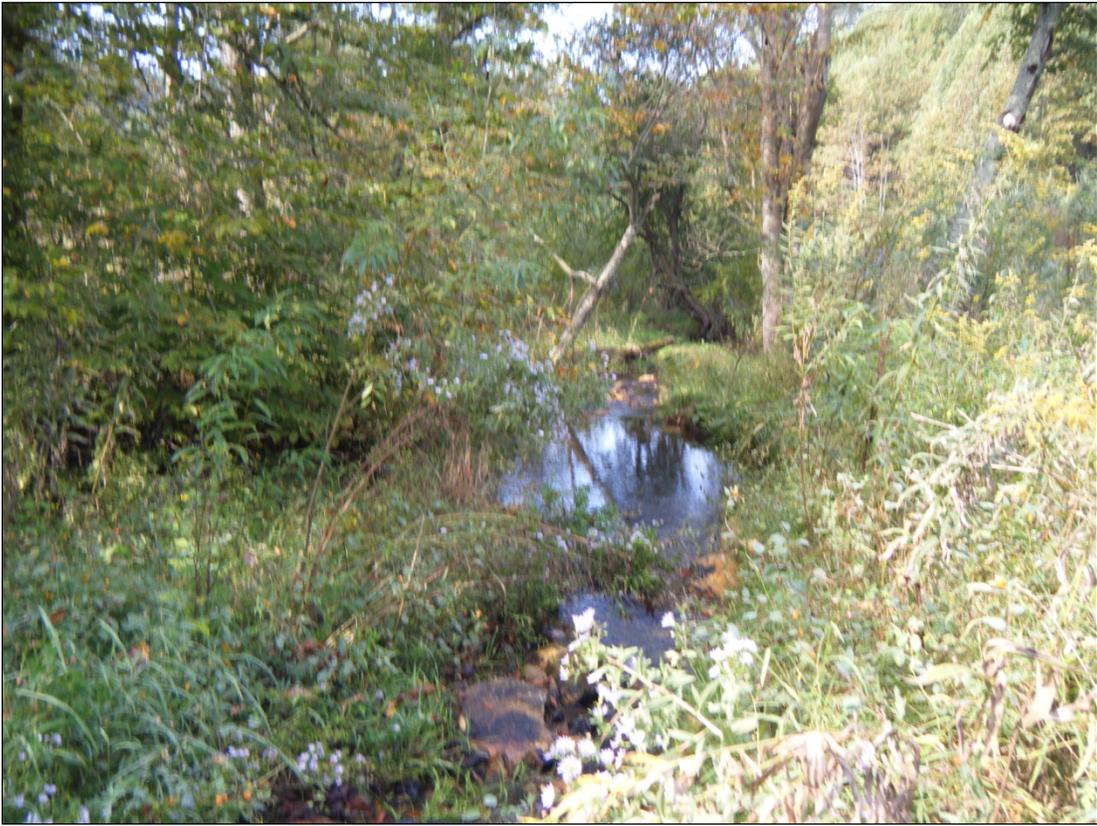
Photo Point 9: View looking downstream near Station 34+00. 9/28/12 – MY03

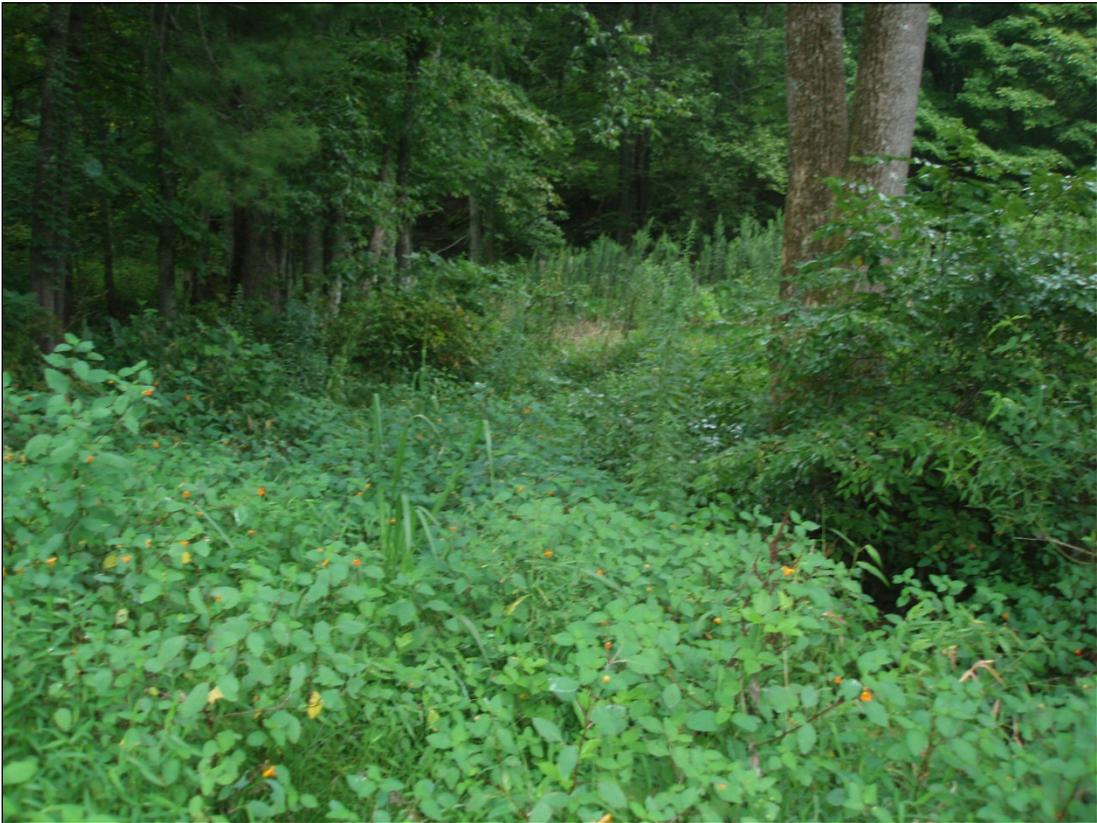
Photo Point 10: View looking upstream on T1 near Station 51+00. 9/28/12 – MY03

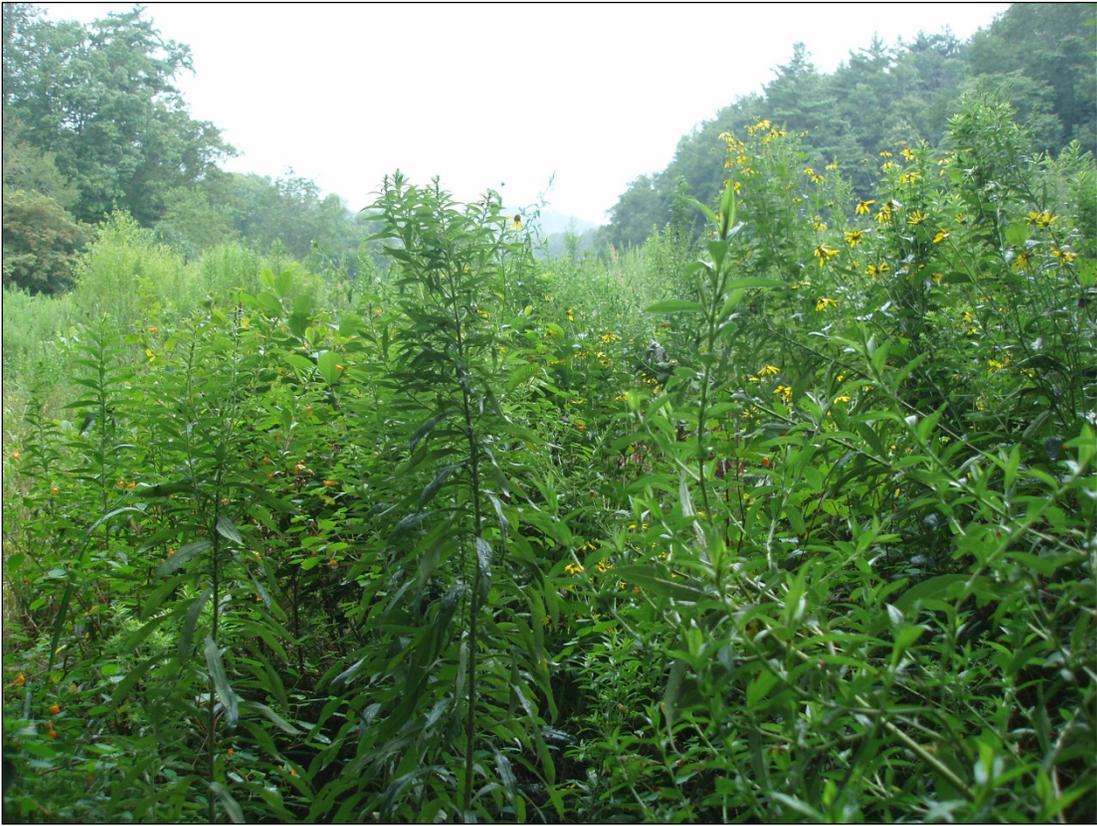
Photo Point 10: View looking downstream on T1 near Station 51+00. 9/28/12 – MY03

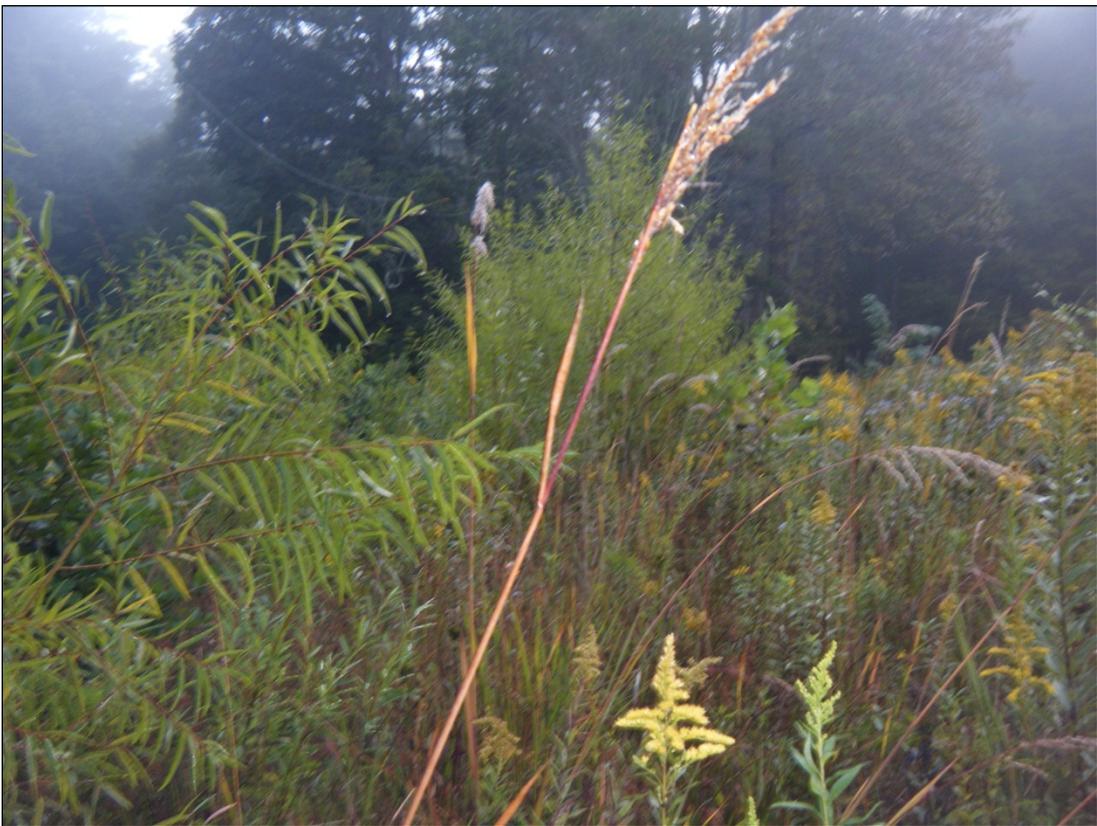
Photo Point 11: View looking upstream on T1 near Station 52+50. 9/28/12 – MY03

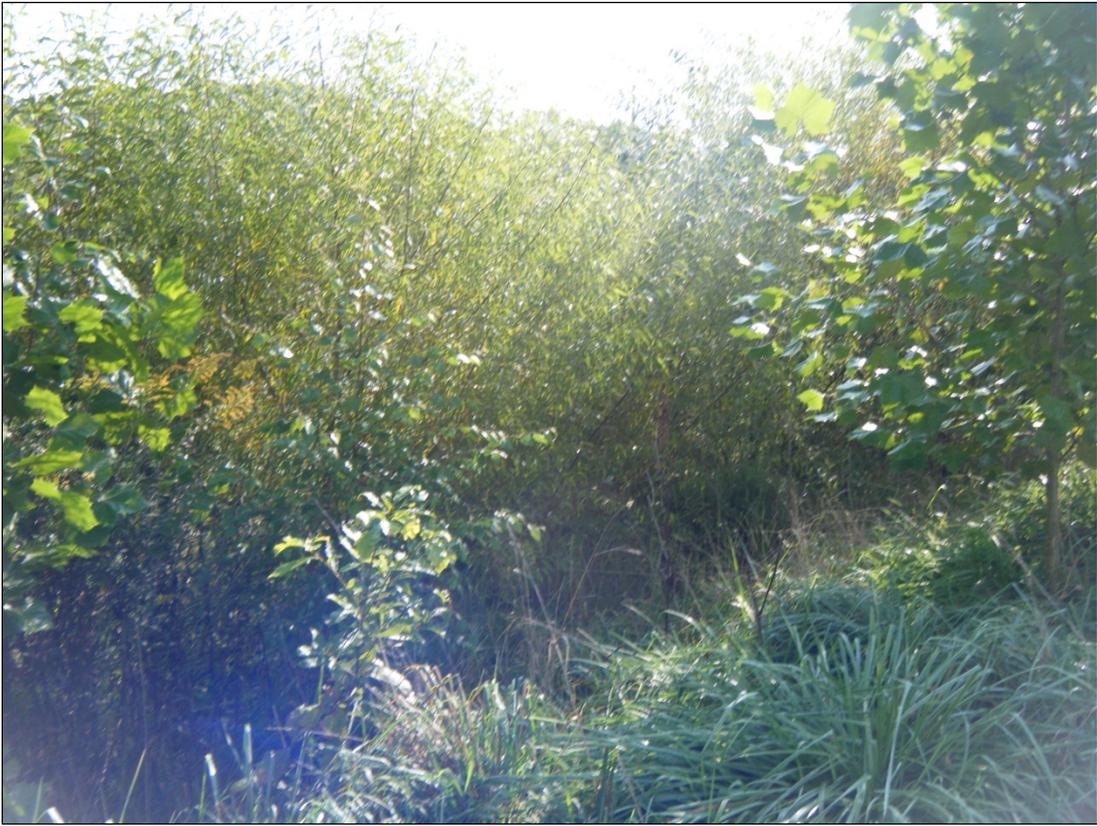
Photo Point 12: View looking upstream on T2 near Station 60+50. 9/28/12 – MY03
