BISHOP SITE STREAM AND WETLAND RESTORATION

2007 Annual Monitoring Report (Year 1) (**FINAL**)

Anson County
EEP Project No. D05010S
Design Firm: EcoScience Corporation

April 2008

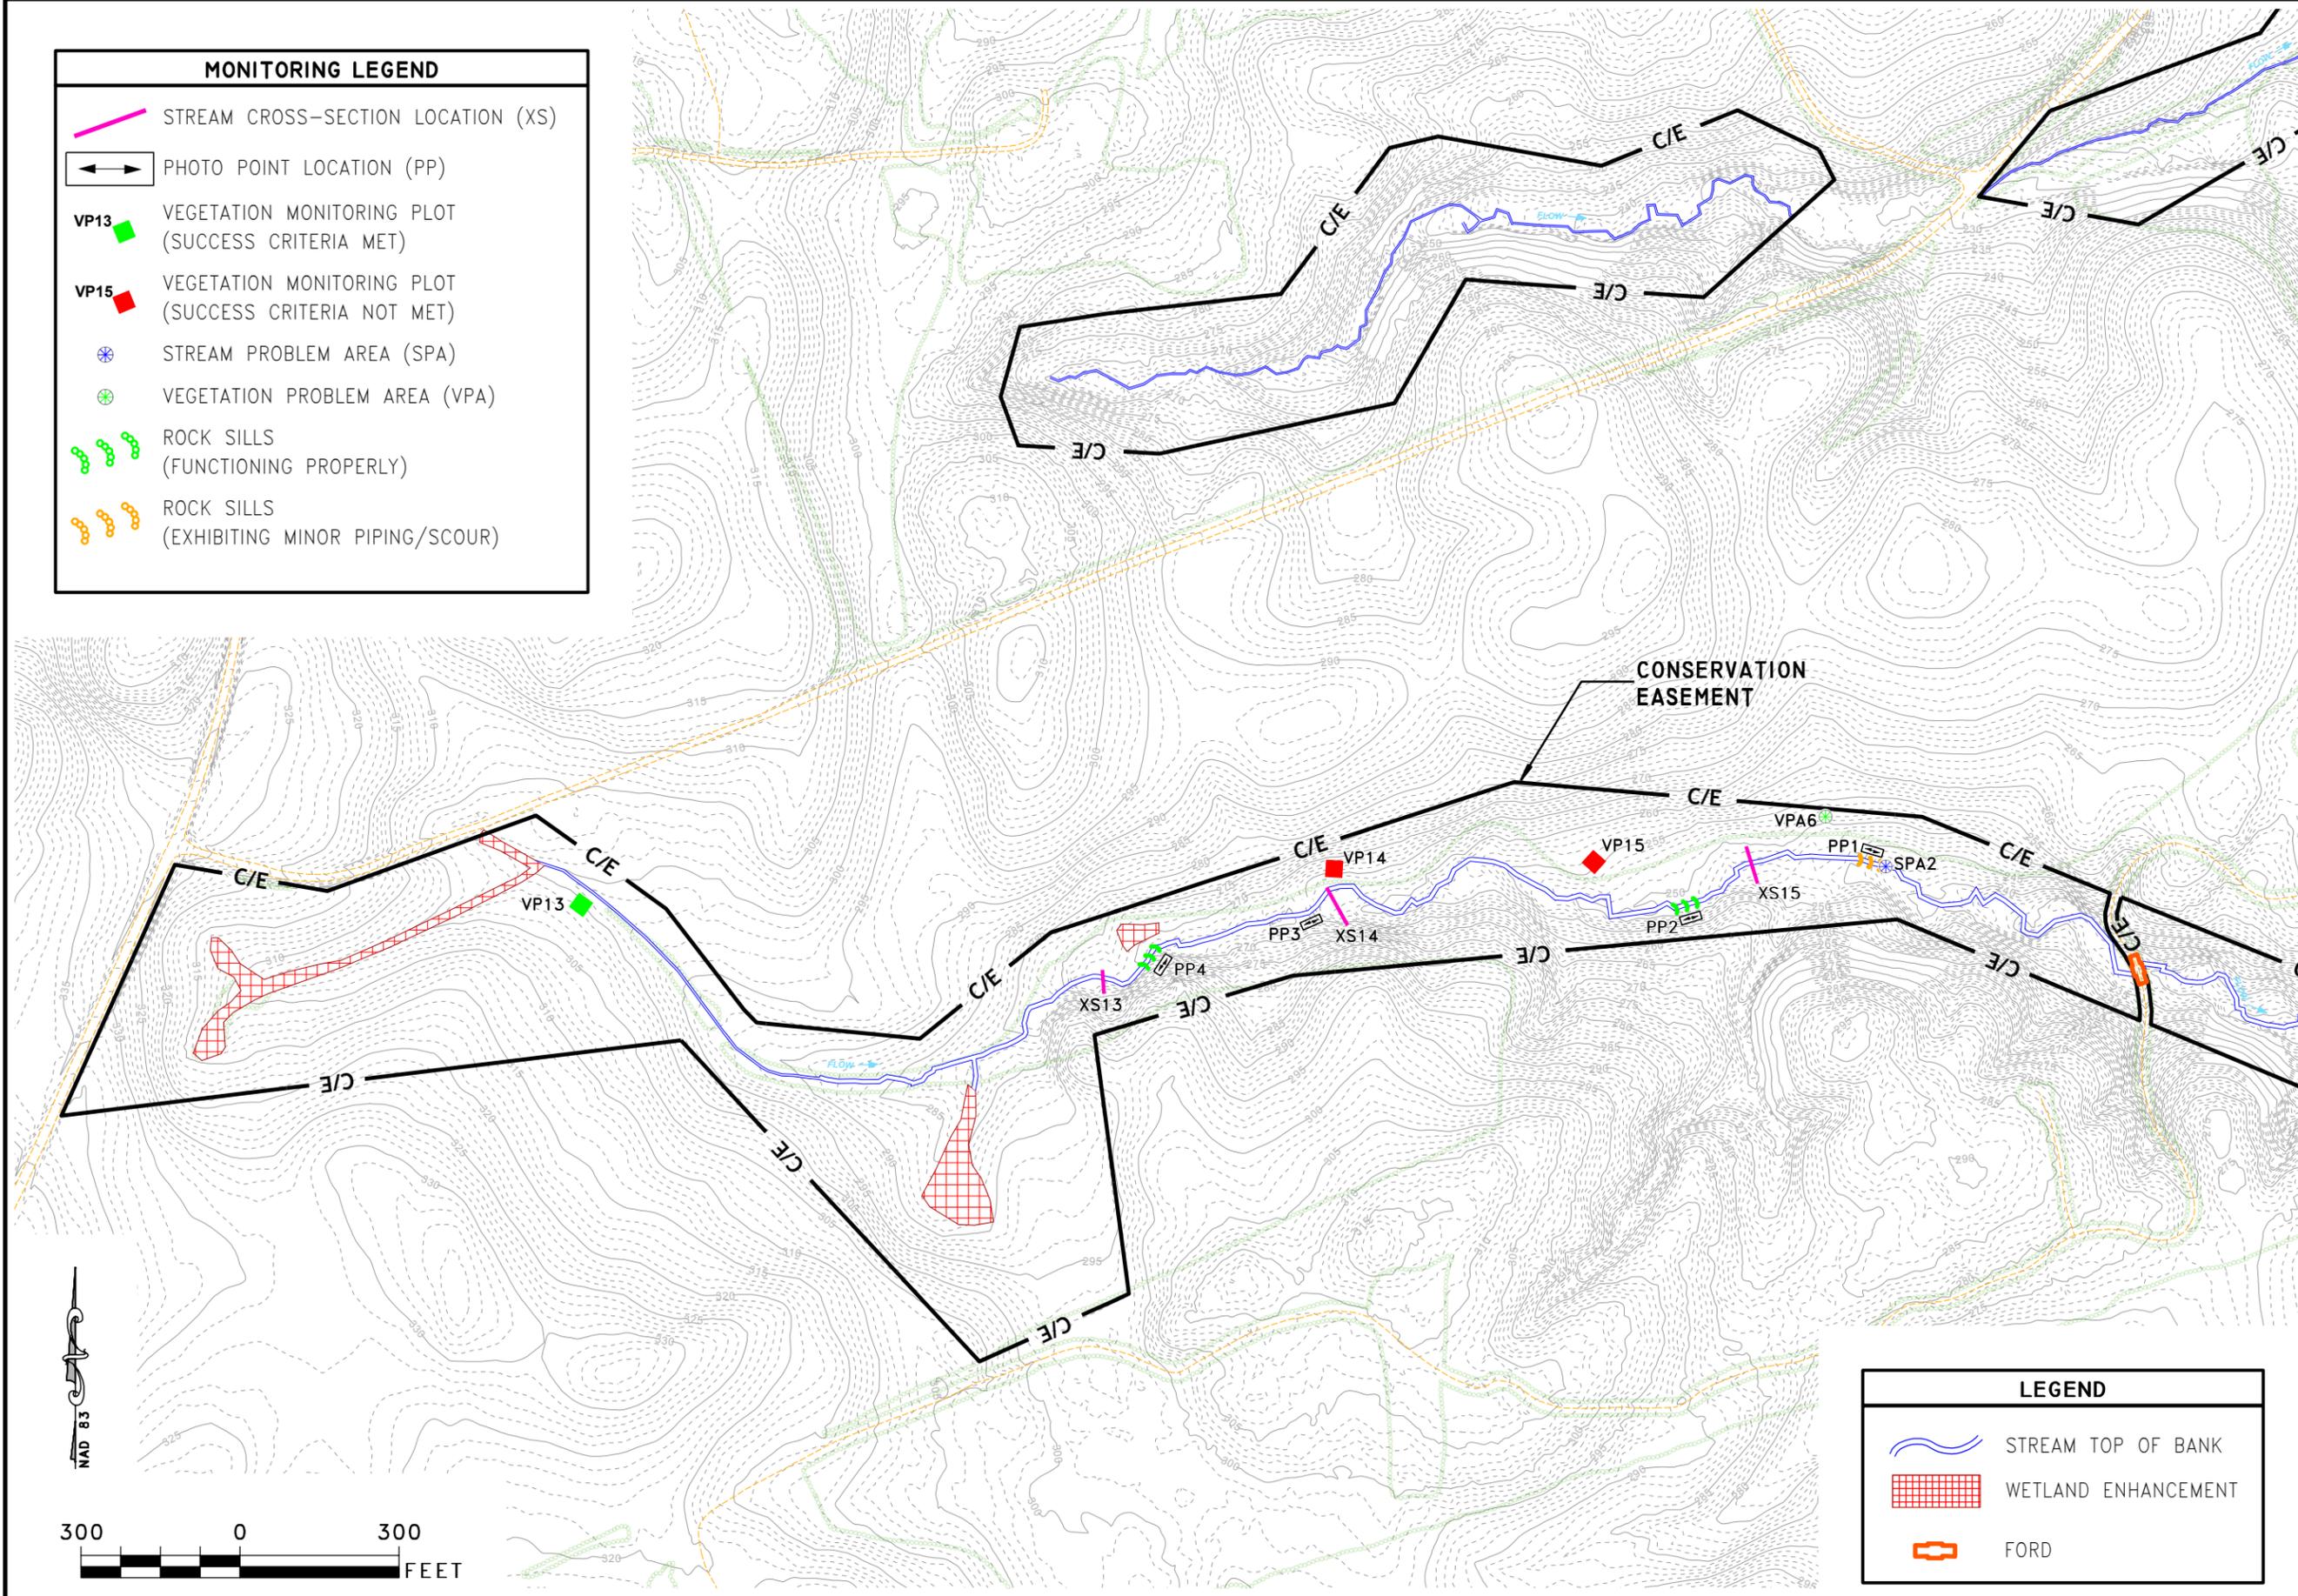
ROCK SILLS (EXHIBITING MINOR PIPING/SCOUR)

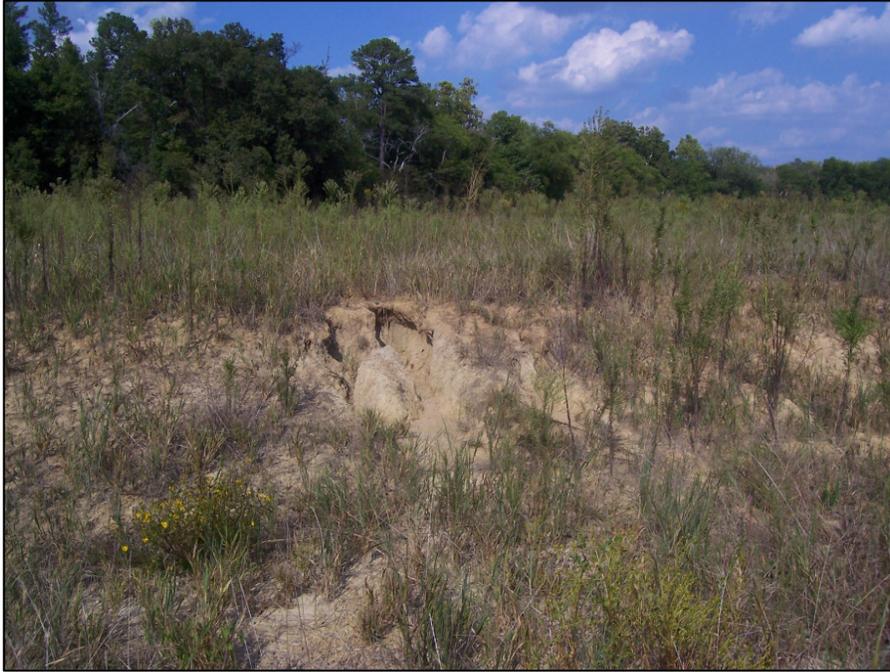
VPA1: Rill erosion along floodplain cut (Camp Branch, Figure 3A)

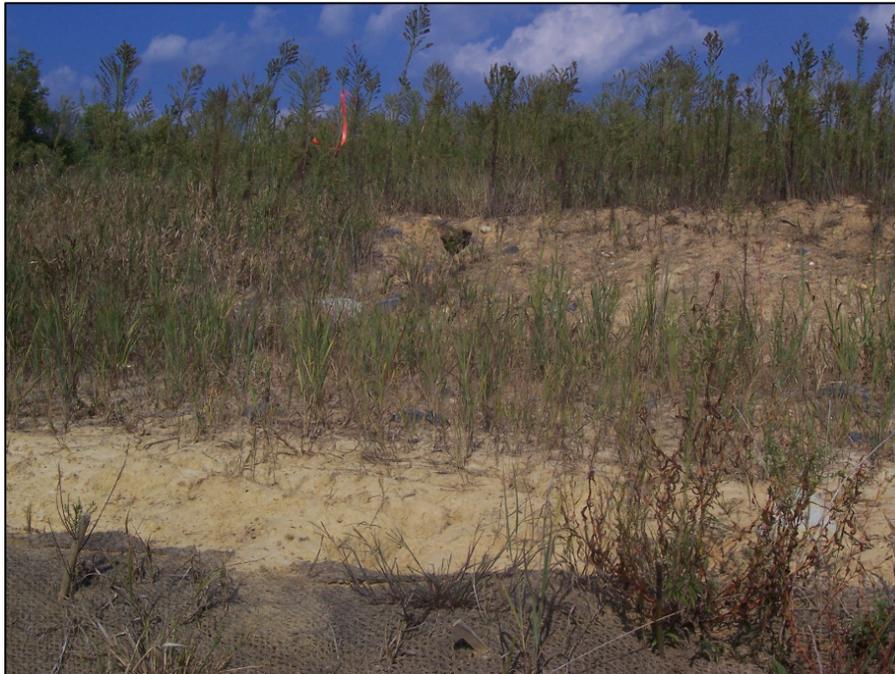
VPA2: Rill erosion along floodplain cut (Camp Branch, Figure 3A)

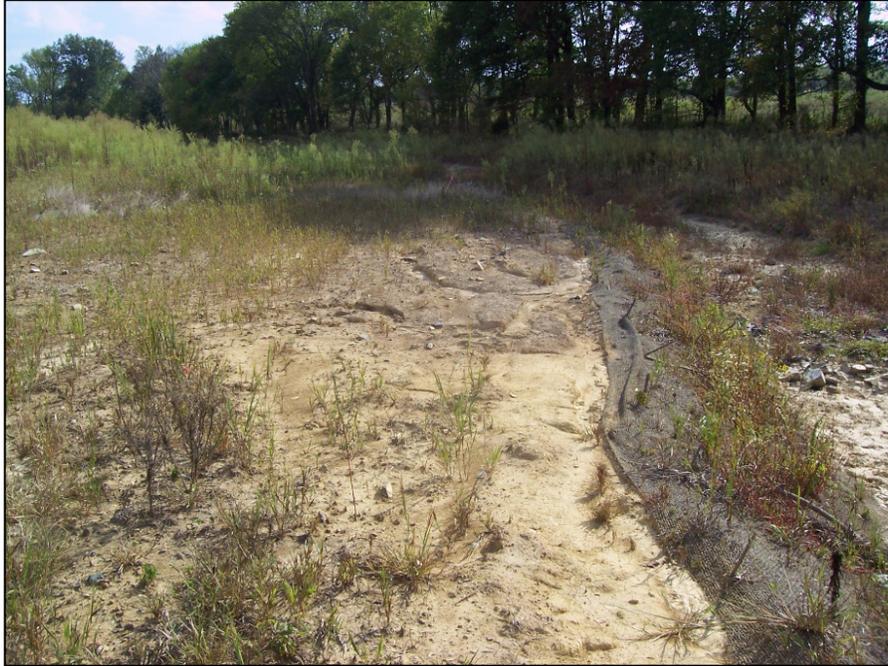
VPA3: Bare floodplain area adjacent to Camp Branch (Camp Branch, Figure 3A)

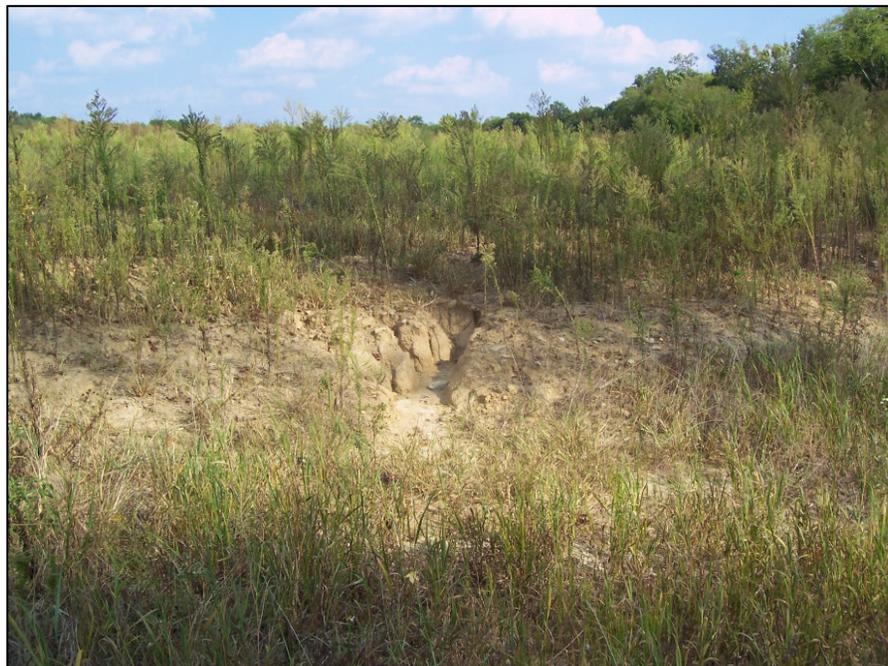
VPA4: Rill erosion along floodplain cut (Camp Branch, Figure 3A)

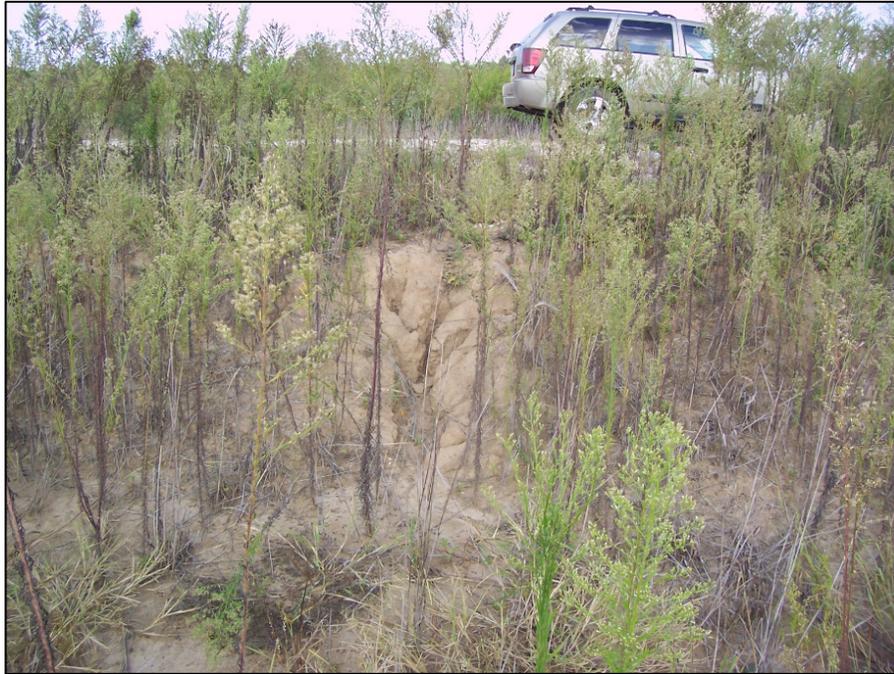
Table A-6. Vegetation Problem Areas Bishop Site Stream and Wetland Restoration/EEP Project No. D05010S			
Feature Issue*	Station #/ Range	Probable Cause	Photo Number
Floodplain cut erosion/minor rill	Figure 3A	Drought conditions inhibiting herbaceous vegetation growth to buffet floodplain cut stability	VPA1
Floodplain cut erosion/minor rill	Figure 3A	Drought conditions inhibiting herbaceous vegetation growth to buffet floodplain cut stability	VPA2
Bare floodplain area	Figure 3A (30-40 ft. in length along channel)	Drought conditions inhibiting herbaceous and woody vegetation growth along floodplain; naturally rocky subsoil in this location	VPA3
Floodplain cut erosion/minor rill	Figure 3A	Drought conditions inhibiting herbaceous vegetation growth to buffet floodplain cut stability	VPA4
Floodplain cut erosion/minor rill	Figure 3B	Drought conditions inhibiting herbaceous vegetation growth to buffet floodplain cut stability	VPA5

VPA5: Rill erosion along floodplain cut (Dula Thoroughfare, Figure 3B)

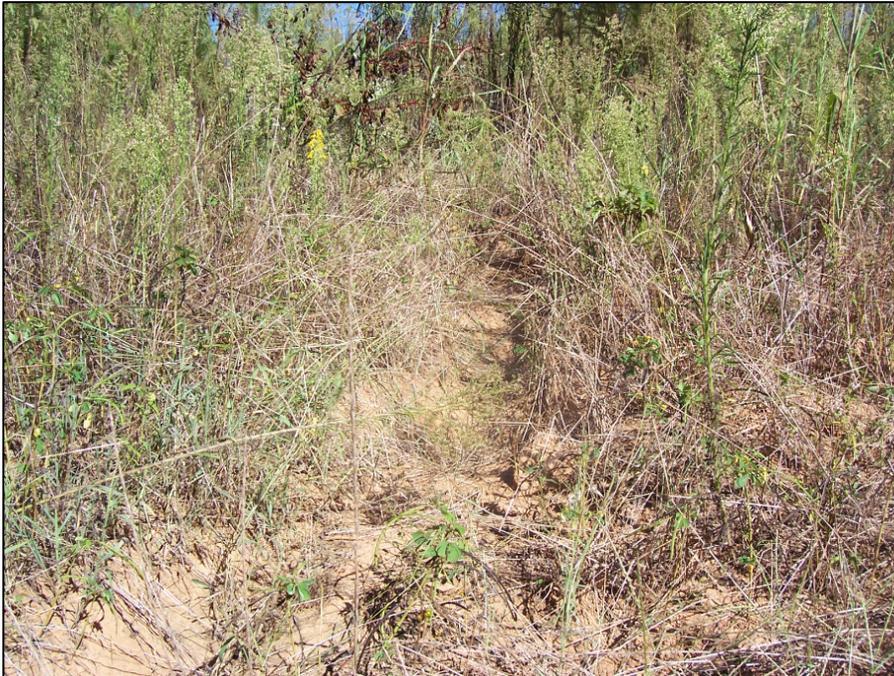
Rill formation along valley slope	Figure 3C	Drought conditions inhibiting herbaceous vegetation growth to buffet floodplain cut stability; erosion from agricultural field upland from easement boundary	VPA6

VPA6: Rill erosion along valley slope (UT to Dula Thoroughfare, Figure 3C)

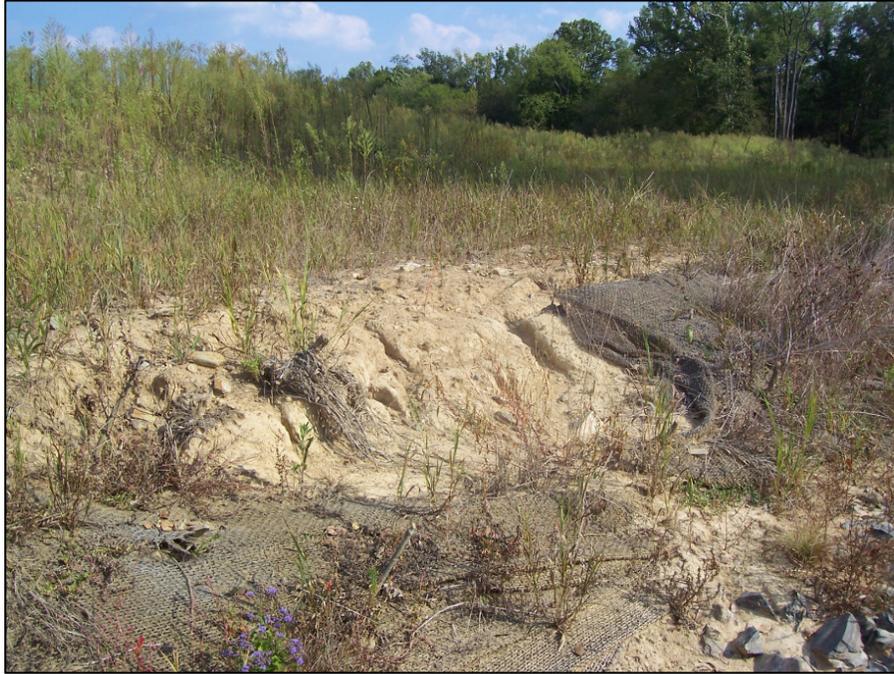
Table B-1. Stream Problem Areas Bishop Site Stream and Wetland Restoration/EEP Project No. D05010S			
Feature Issue	Station Numbers	Suspected Cause	Photo Number
Minor left bank erosion (Camp Branch, Reach 1)	14+00 - 14+10	Drought conditions inhibiting herbaceous vegetation growth to buffet bank stability	SPA1
Piping within downstream-most rock sill set (UT to Dula Thoroughfare, Reach 7)	N/A*	Unknown	SPA2 (PP1) ¹

SPA1: Bank erosion on left bank of Camp Branch, Reach 1 (14+00-14+10)

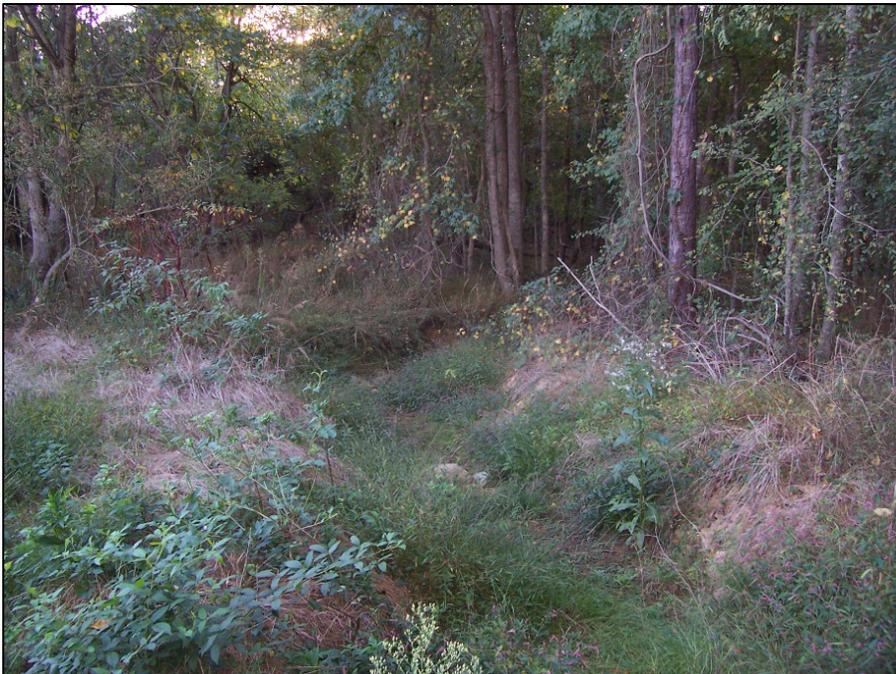
¹Due to dry channel conditions, dense herbaceous growth within the stream impeded photographing this problem area clearly

SP2A: Piping within downstream-most rock sill set on UT to Dula Thoroughfare (Reach 7)
